MINERALS PROGRAM INSPECTION REPORT
PHONE: (303) 866-3567

MINE NAME: Bottomless Pit	MINE/PROSPECTING ID#: M-2001-068	MINERAL: Gravel and sand	COUNTY: Las Animas
INSPECTION TYPE: Monitoring	INSPECTOR(S): Daniel Cunningham	INSP. DATE: August 28, 2020	INSP. TIME: 13:30
OPERATOR: Tamrock Gravel LLC	OPERATOR REPRESENTATIVE: Mrs. Tamburelli	TYPE OF OPERATION: 112c - Construction Regular Operation	
REASON FOR INSPECTION: Normal I&E Program	BOND CALCULATION TYPE: Complete Bond	BOND AMOUNT: \$56,204.00	
DATE OF COMPLAINT: NA	POST INSP. CONTACTS: None	JOINT INSP. AGENCY: None	
WEATHER: Clear	INSPECTOR'S SIGNATURE:

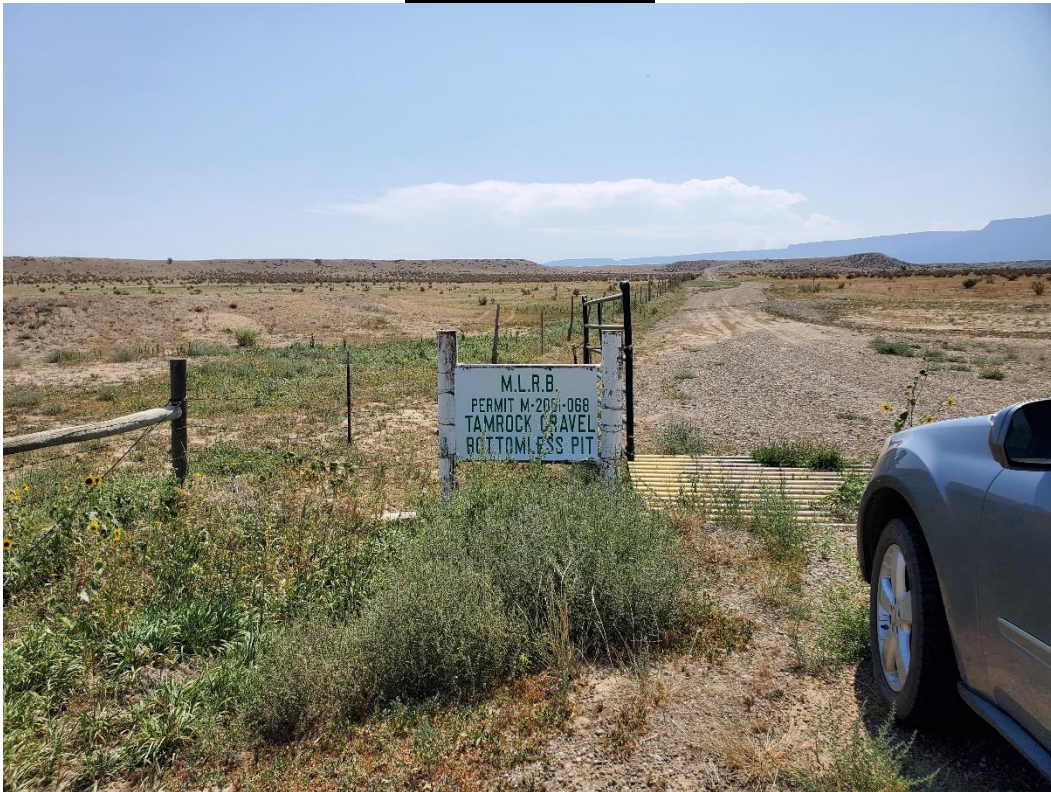
The site identification sign was posted at the mine entrance and the permit boundary were marked. All slopes were graded to 3H:1V or greater. The site has been seeded and has vegetation beginning to be established. However at this time, it is not ready for release.

Mine Entrance Sign

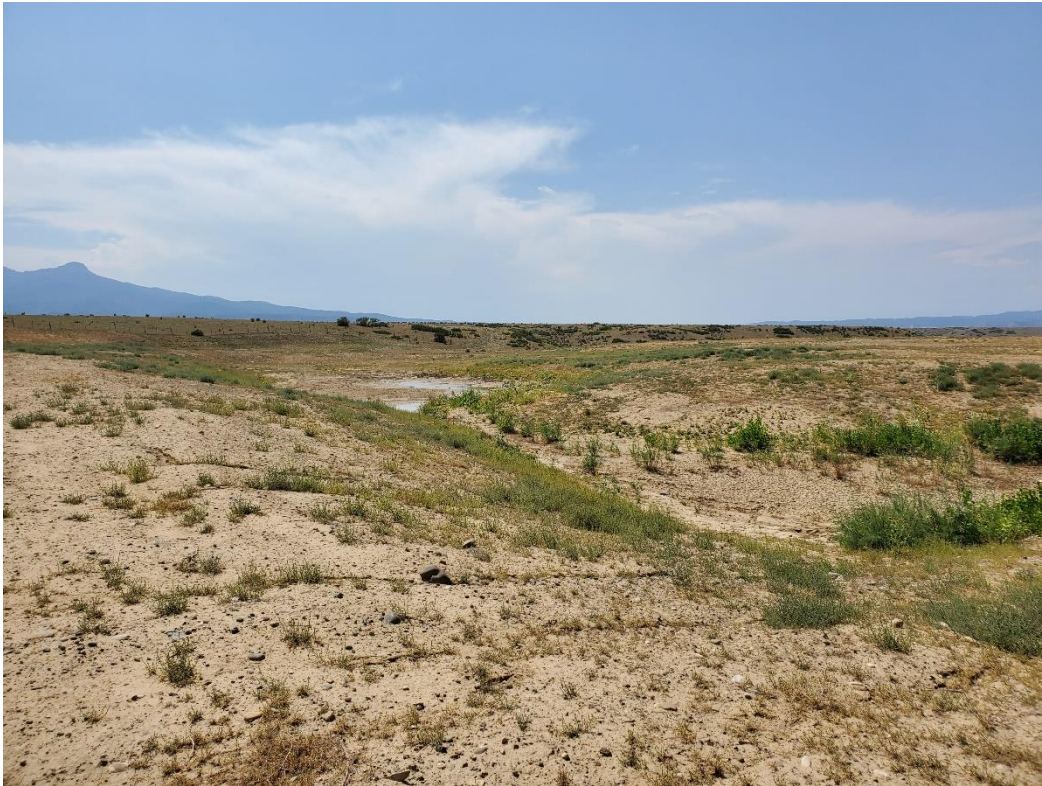
A small body of water, with less than 1" of water, was noted on the permitted site. Due to the recent rain that came through the area this is not sited as a problem at this time. The Division recommends the Operator monitor this area and correct the low area if water is retained longer than 72 hours.

Small Body of Water
