MINERALS PROGRAM INSPECTION REPORT
PHONE: (303) 866-3567

MINE NAME: Cresson Project	MINE/PROSPECTING ID#: M-1980-244	MINERAL: Gold	COUNTY: Teller
INSPECTION TYPE: Monitoring	INSPECTOR(S): Brock Bowles	INSP. DATE: August 18, 2020	INSP. TIME: 09:00
OPERATOR: Cripple Creek & Victor Gold Mining Company	OPERATOR REPRESENTATIVE: Katie Blake and Jeana Ratcliff	TYPE OF OPERATION: 112d-3 - Designated Mining Operation	
REASON FOR INSPECTION: Normal I&E Program	BOND CALCULATION TYPE: None	BOND AMOUNT: \$209,491,188.00	
DATE OF COMPLAINT: NA	POST INSP. CONTACTS: None	JOINT INSP. AGENCY: None	
WEATHER: Clear	INSPECTOR'S SIGNATURE:

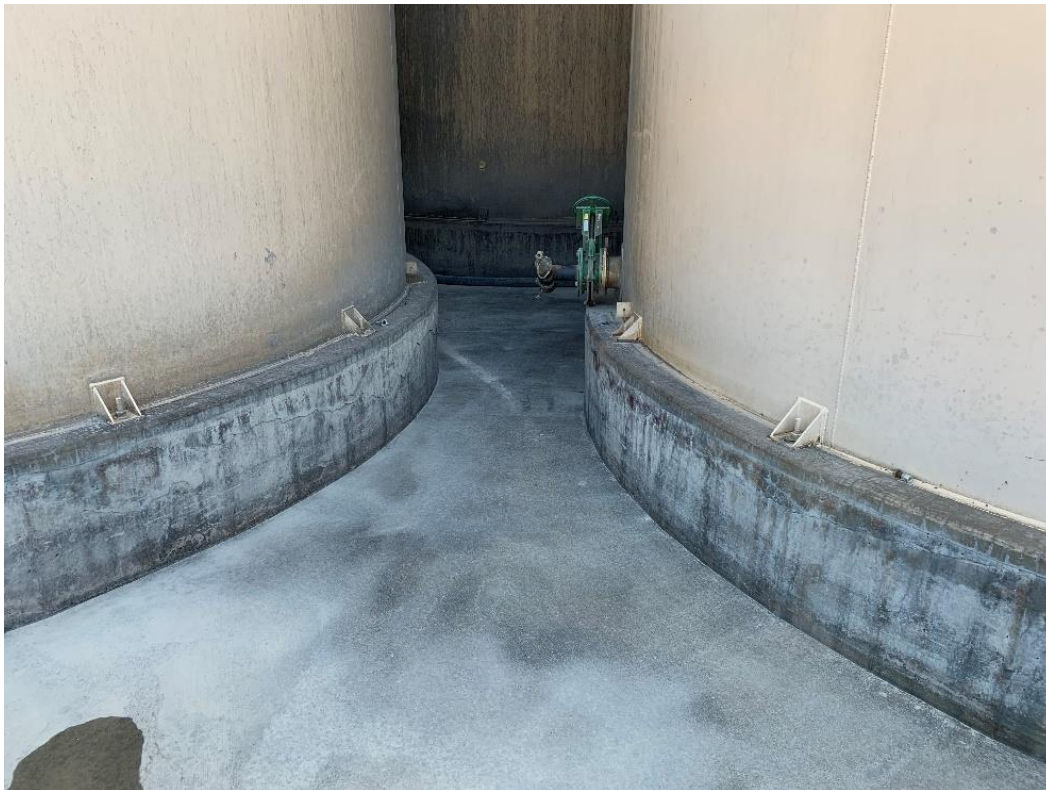
Andy Orser accompanied DRMS in the mill exterior walk-around. The Vat Leach tank area on the west side of the HGM was clean and no sludge was observed (photo 1). The ore concentrate apron area on the south side of the HGM was clean. All concentrate material was inside the con barn cover (photo 2). The secondary containment areas on the east side of the mill were inspected. The individual containment areas around the neutral water, high pH thickener and process ore thickener (photo 3) were clean and clear of sludge.

Photo 1 - Vat Leach area on west side of high grade mill

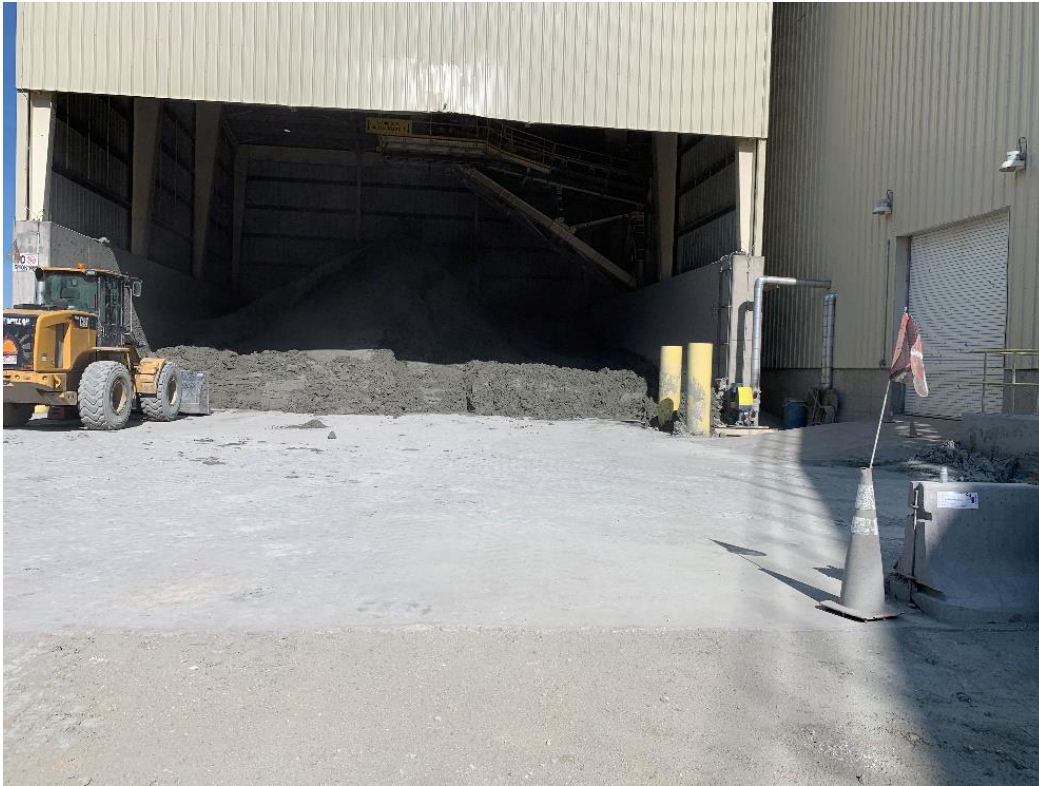
Photo 2 - Con barn area on south side of high grade mill

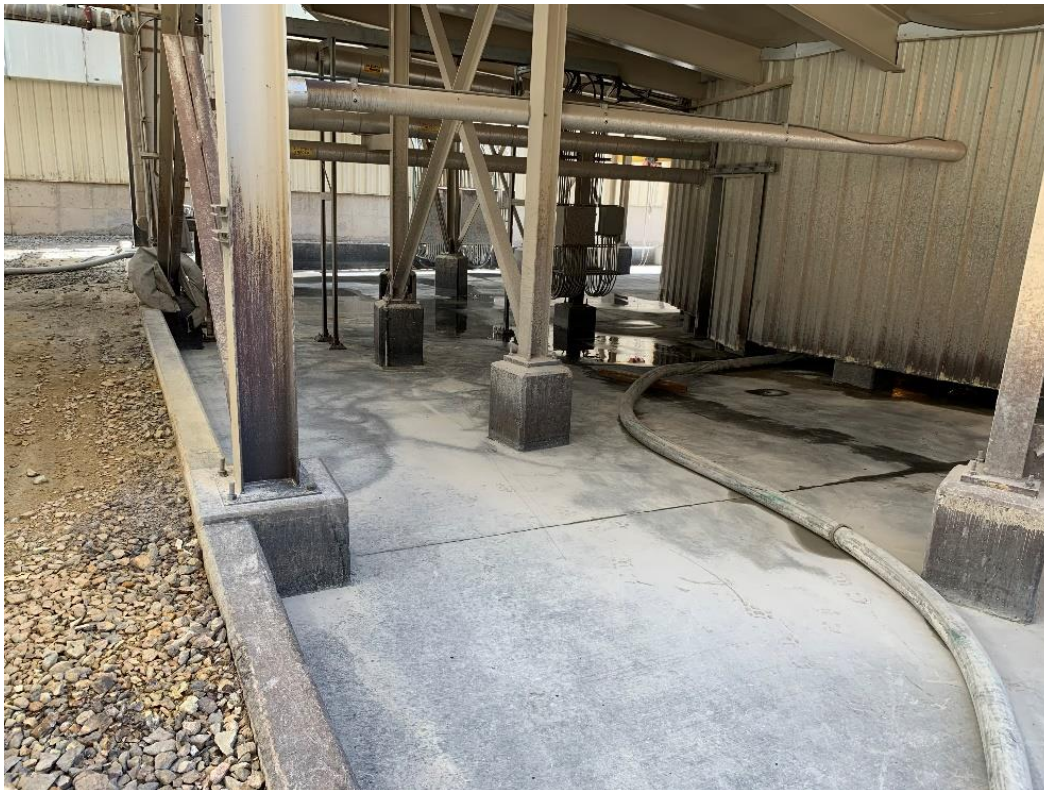
Photo 3 - Process ore thickener containment area, east side high grade mill

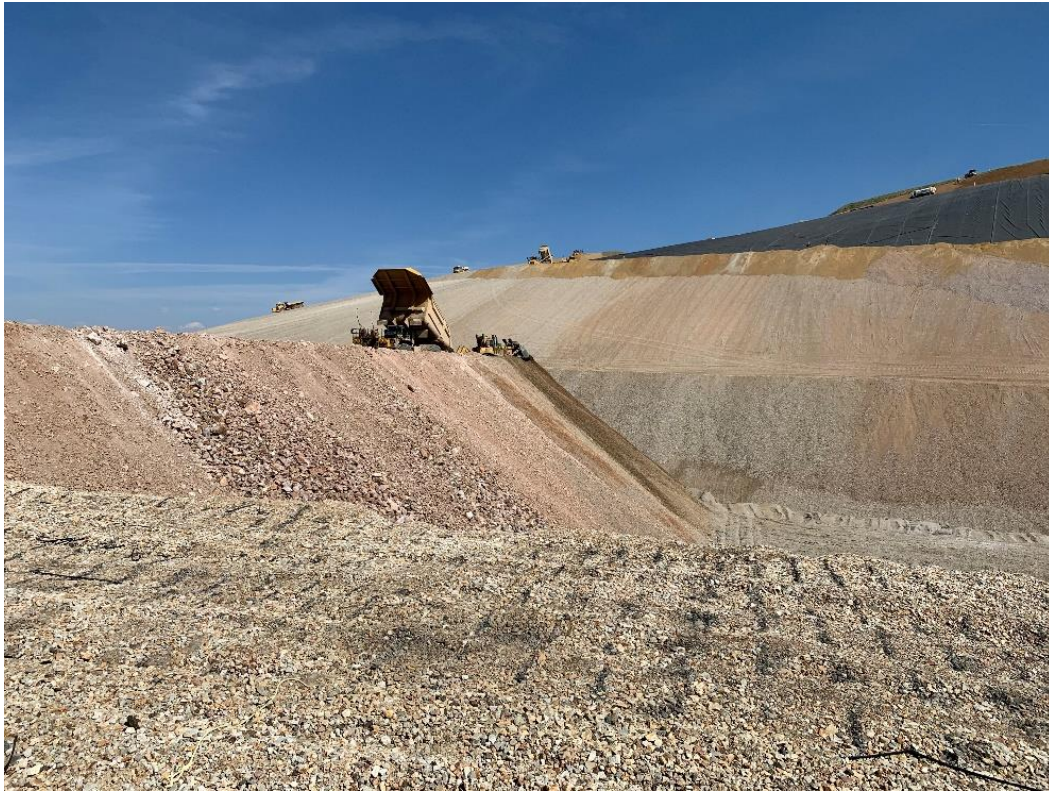
Charles Bissue and Steve Blaskovich accompanied DRMS on this part of the inspection. Ore was being stacked on the Phase 2 area from west to east, up Squaw Gulch Canyon. The lift appeared to be about 50 feet thick and the dozer was pushing the material in a perpendicular orientation to the slope (photo 4).

Photo 4 - Ore stacking in Squaw Gulch

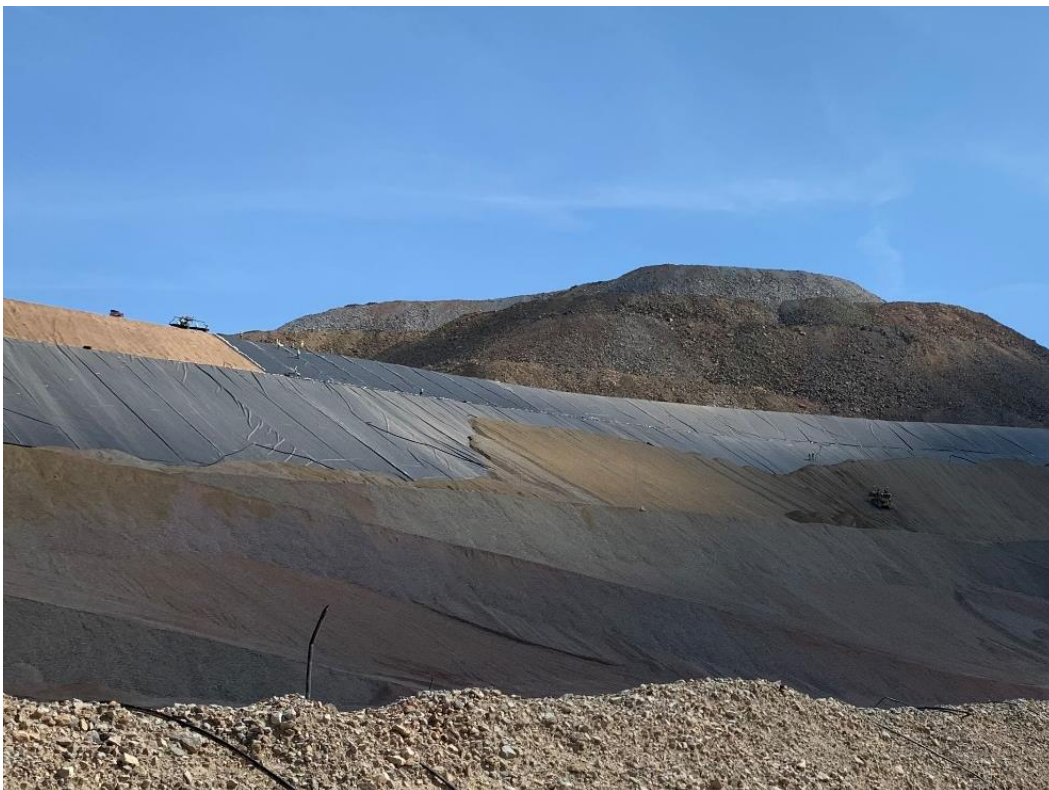
The liner was being installed at the top of the gulch. Drain cover fill was being spread on the bench below the liner installation. The DCF was staged at the bottom of the bench and being pushed uphill by a dozer (photo 5).

Photo 5 - Liner installation-upper left, DCF spreading- right side of photo

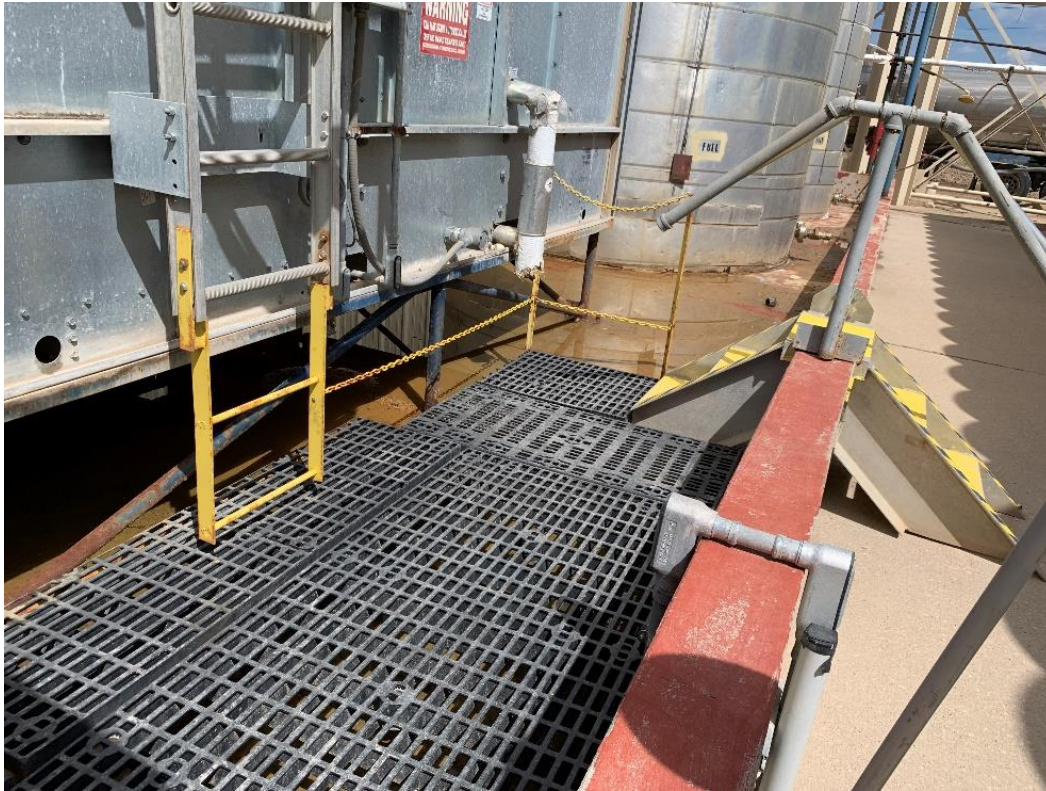
Jessie Darby, John Garamendi and Brian Crawford accompanied DRMS in the Buckley Facility. John Garamendi guided the inspection. He explained how the ammonium nitrate (AN) is delivered and stored. AN was being delivered by a truck during the inspection. The secondary containment area for the AN had a small amount of water in the southern end but was overall clean (photo 6). The filter system to remove storm water from the secondary containment area was explained. The emulsion delivery truck maintenance area and the emulsion mixing process was explained. All areas of the facility were clean, walkways were free of obstructions and no spills were noted. No pictures were taken inside the emulsion facility.

Photo 6 - AN storage and cooling unit secondary containment

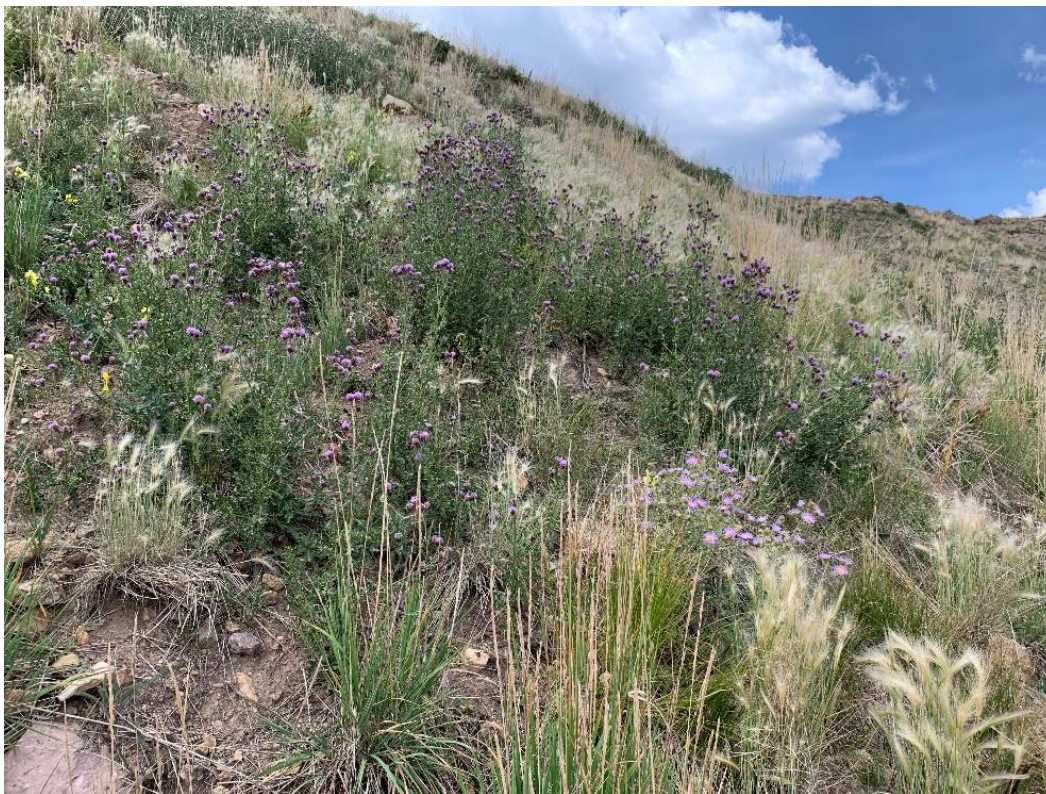
INSPECTION TOPIC: Topsoil
PROBLEM/POSSIBLE VIOLATION: Problem: There are state-listed noxious weeds present on site. This is a problem for failure to employ weed control methods for state listed noxious weed species within the permitted area, and to reduce the spread of weeds to nearby areas as required by Section 3.1.10 (6) of the rule.
CORRECTIVE ACTIONS: Implement approved weed control plan and provide proof to the Division that the weed control plan has been implemented.
CORRECTIVE ACTION DUE DATE: 10/09/20

Weed control: Several species of Colorado Noxious Weeds B-List species were noted on the topsoil stockpiles. On pile #6- Yellow toadflax and Canada thistle (photo 7), pile #21- Dalmatian toadflax (photo 8), and pile #1A/1B- Yellow toadflax and musk thistle. A Problem has been cited for the noxious weeds noted on the topsoil stockpile. The Weed Control Plan that was approved in TR-75 needs to be implemented and proof that the plan has been implemented needs to be submitted to the Division within 30 days. The Annual Reports for years 2017-2019 shows that the topsoil stockpiles were not treated (Carlton Tunnel excluded). The topsoil stockpiles should be a high priority area for continued weed

Photo 7 - Canada thistle on topsoil stockpile #6

treatment to prevent seed bank establishment.

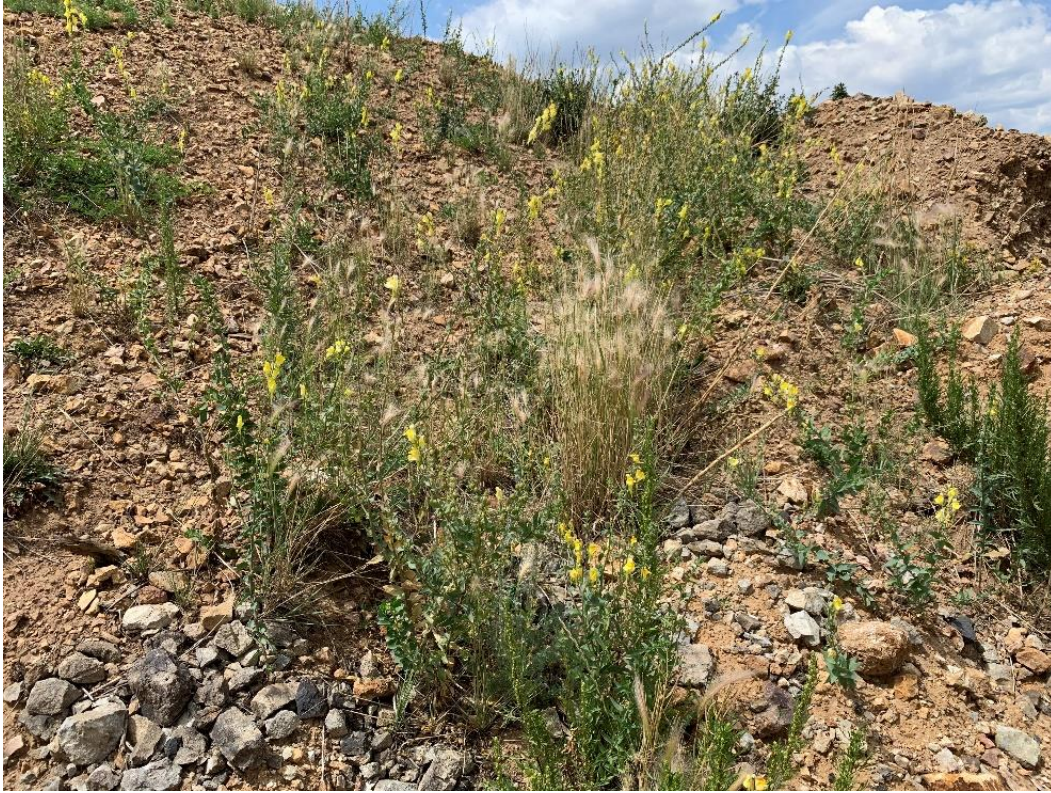
Photo 8 - Dalmatian toadflax on topsoil stockpile #21

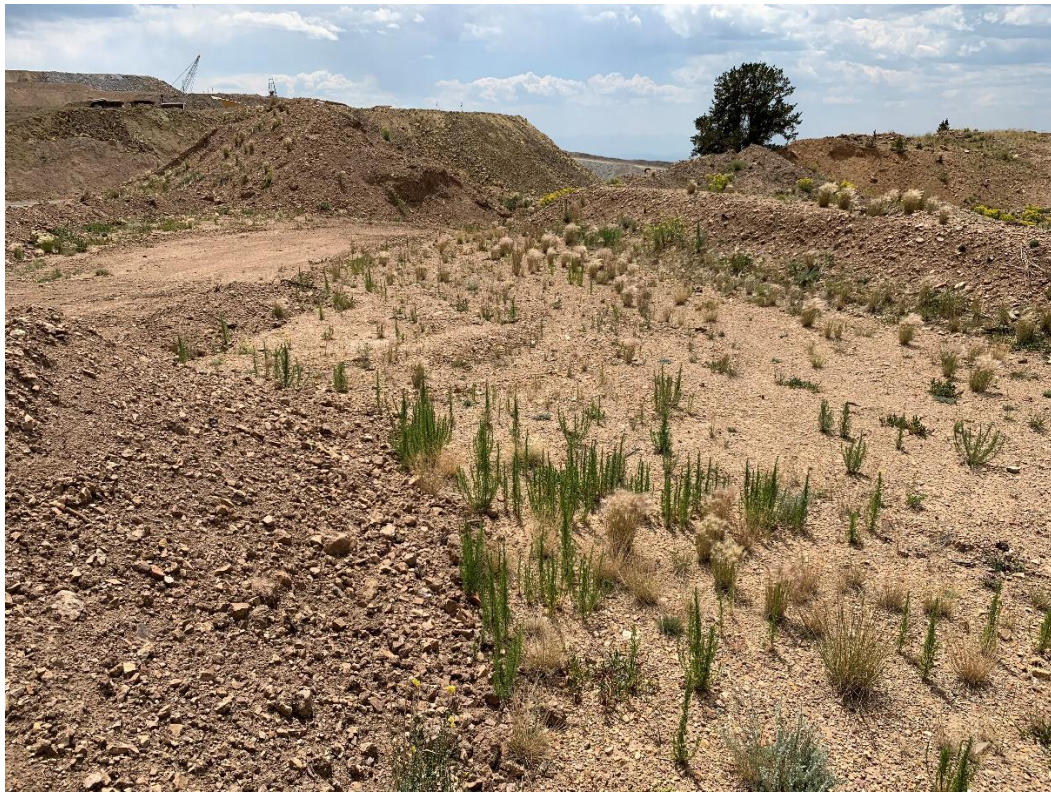
Erosion control: No erosion features were noted on the topsoil piles that were inspected. Topsoil piles #11 and #21 (photo 9) had limited vegetation on them to control wind and water erosion. Vegetation needs to be established on these piles to comply with Rule 3.1.9(3). Topsoil pile #21 was approved to be moved to pile #39 in TR-102. If pile #21 is not moved by the Spring of 2021, then vegetation needs to be established to control erosion.

Photo 9 - Topsoil stockpile #21, needs vegetation to control wind and water erosion

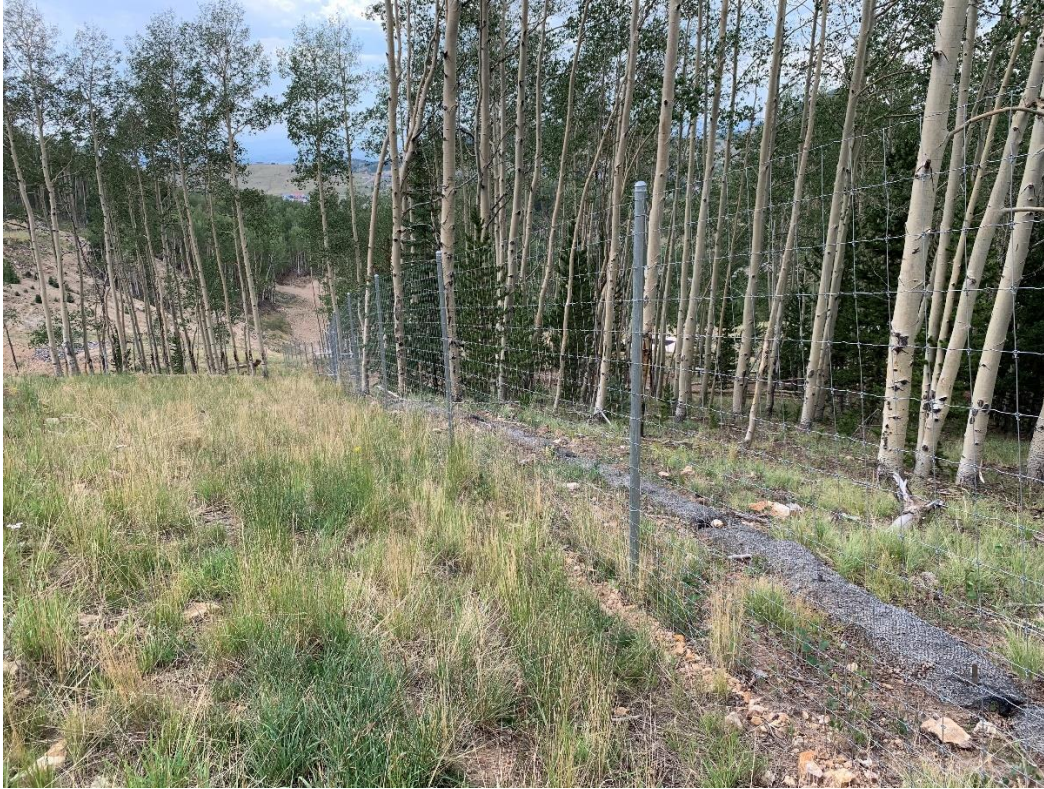
The wildlife fence in the area of topsoil stockpile 1A/1B was in good condition (photo 10).

Photo 10 - Wildlife fence in the area of topsoil stockpile 1A/1B
