TR-75 Borrow Area Field Survey

Summary

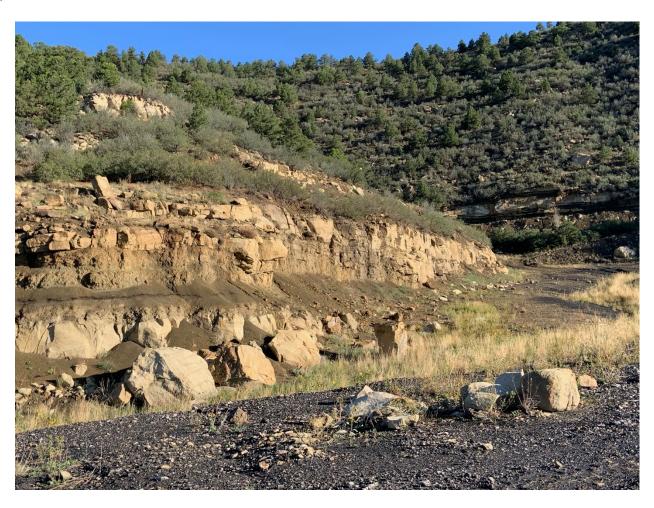
The following phots were taken along the back wall of the RDA. There is not much material to be harvested from these areas.

Back Wall of RDA - Rock can be harvested below Clean Water Ditch

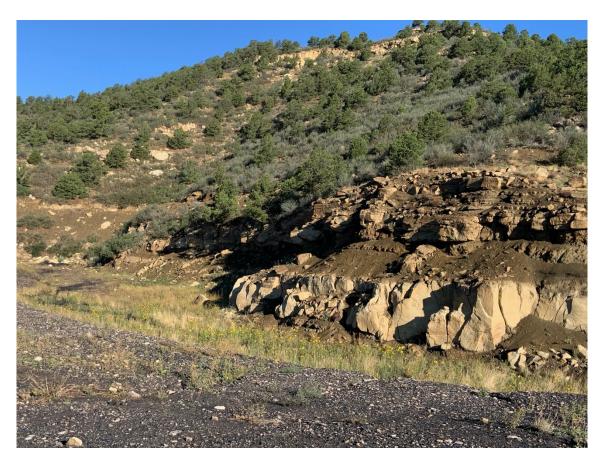
Back wall of RDA - Material can be harvested below Clean Water Ditch

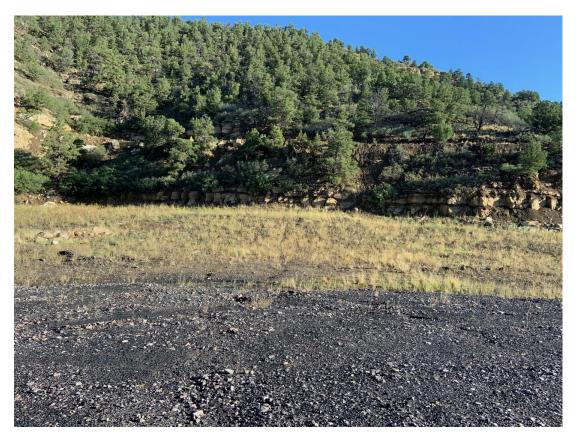
Back wall of RDA – Material can be harvested between Refuse and Wall

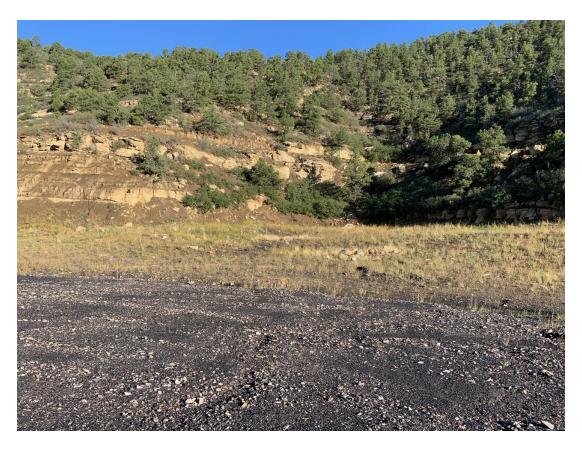
Back wall of RDA – Material can be harvested between Refuse and Wall

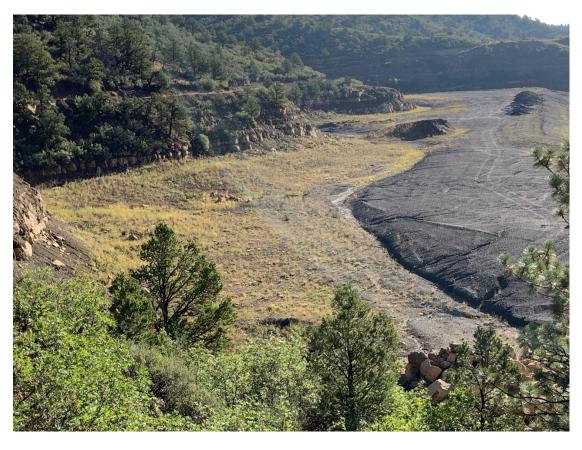
Back wall of RDA – Material can be harvested between Refuse and Wall

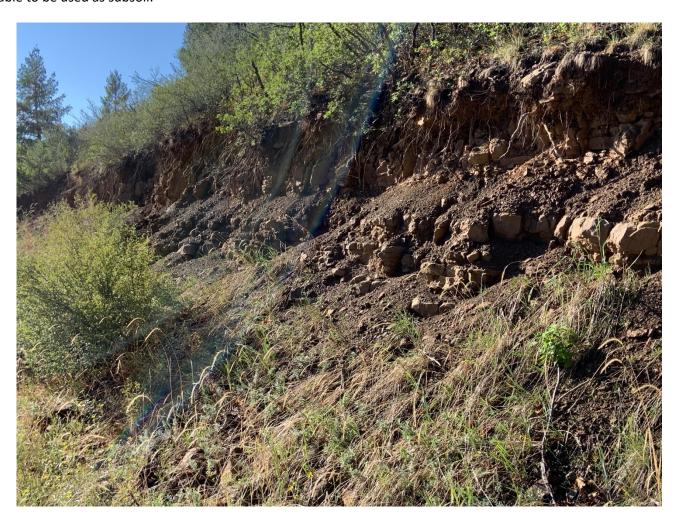
Location SP-1 is located within the proposed borrow area in the current clean water ditch. This location shows some sandstone seams. These sandstone seams are very fractured and can be moved easily with machinery. The rock should be able to be used as subsoil.

Location SP-1 - Shows fractured sandstone outcrop

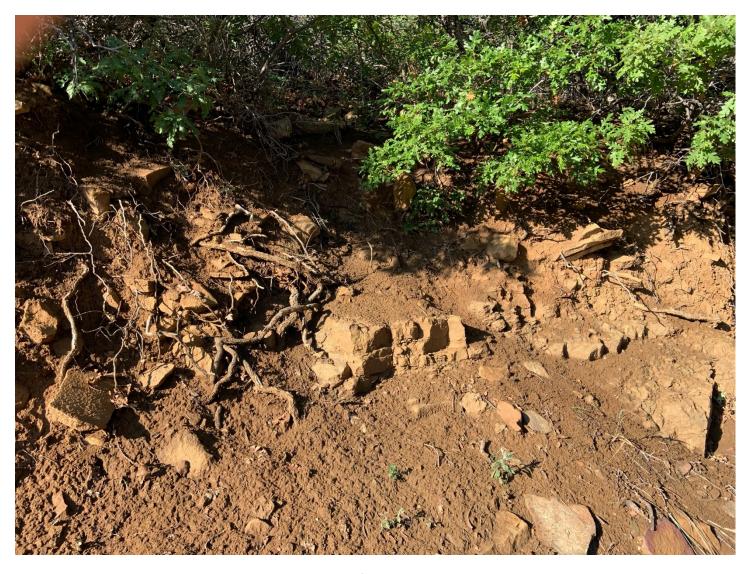
Location SP-1 - Shows fractured sandstone outcrop

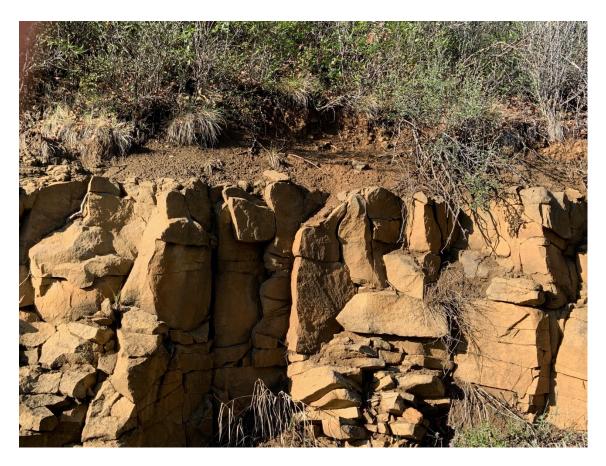
Location SP-2 is located within the proposed borrow area in the current clean water ditch. This location shows a large sandstone seam. These sandstone seam is somewhat fractured and should be able to be moved with machinery. This seam is at a higher elevation and should not affect the amount of material to be harvested in the borrow area. The rock should be able to be used to rock line ditches.

Location SP-2 - Shows fractured sandstone outcrop

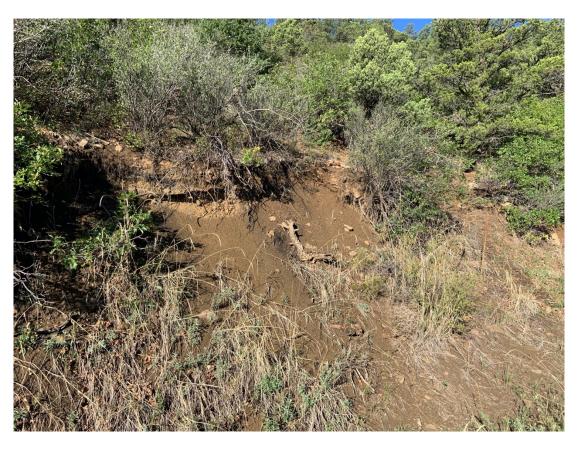
Location SP-2 — Shows dirt above the fractured sandstone outcrop

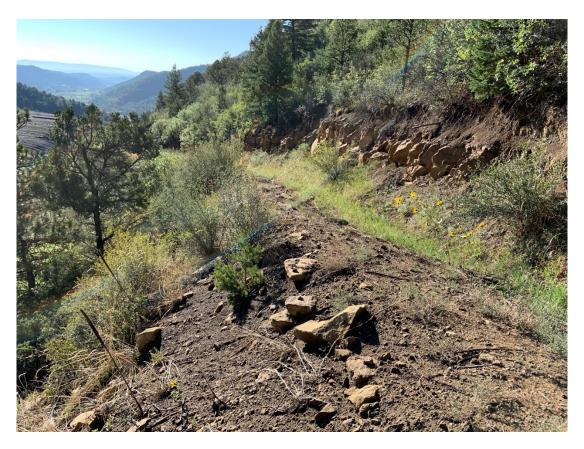
Location SP-2 - Shows dirt and fractured sandstone outcrop on the left side of picture

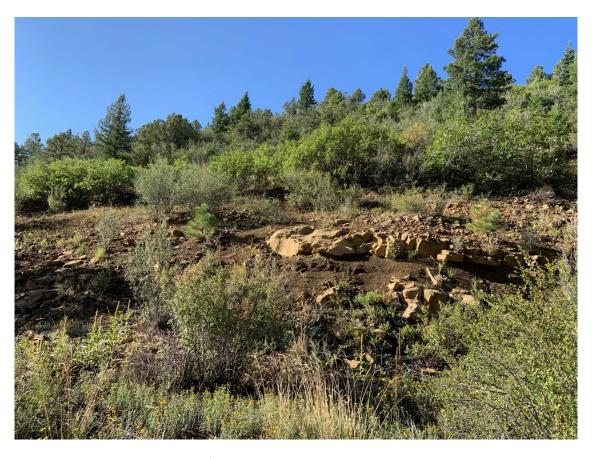
Location SP-2 - Shows dirt and fractured sandstone outcrop above current clean water ditch

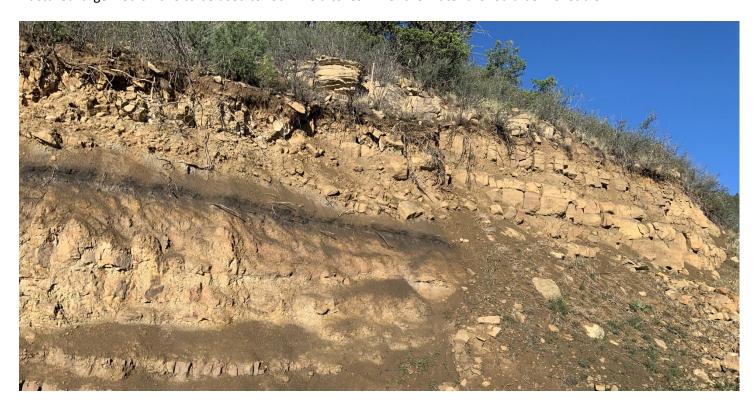
Location SP-3 is located along the current road to the RDA. It shows a good outcrop of the material in the southeast corner of the proposed borrow area. The material is mostly dirt with fractured sandstone. Some of the sandstone is fractured large would have to be used to rock line ditches. All of the material should be moveable.

Location SP-3 - Shows dirt and fractured sandstone outcrop above current RDA access road

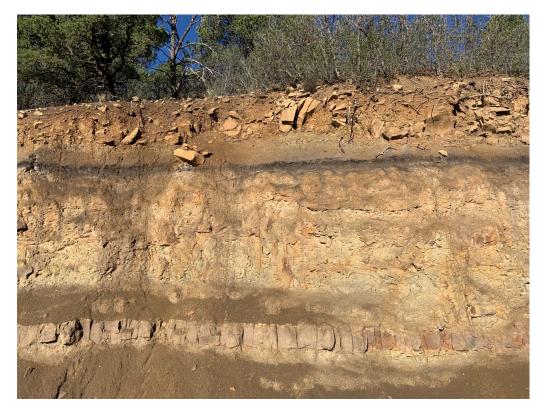
Location SP-3 - Shows dirt and fractured sandstone outcrop above current RDA access road

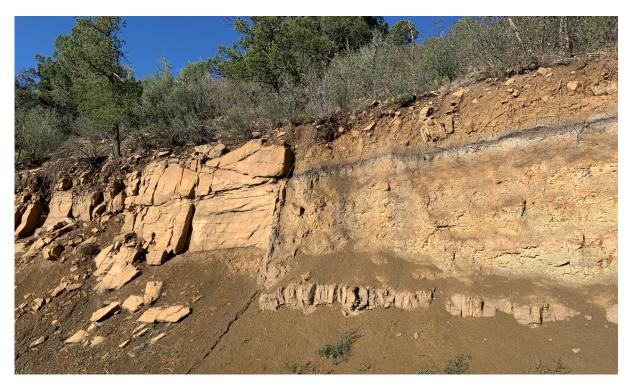
Location SP-3 - Shows dirt and fractured sandstone outcrop above current RDA access road

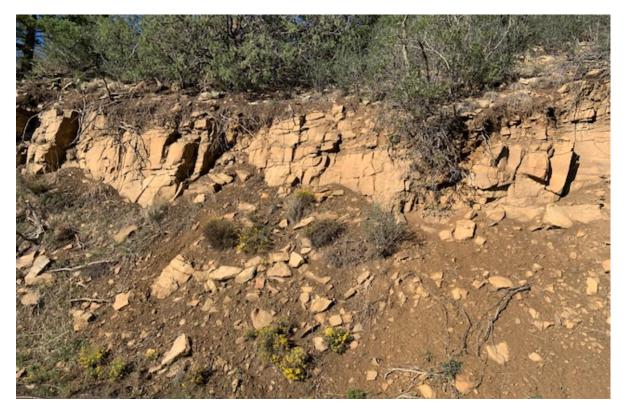
Location SP-3 - Shows dirt and fractured sandstone outcrop above current RDA access road

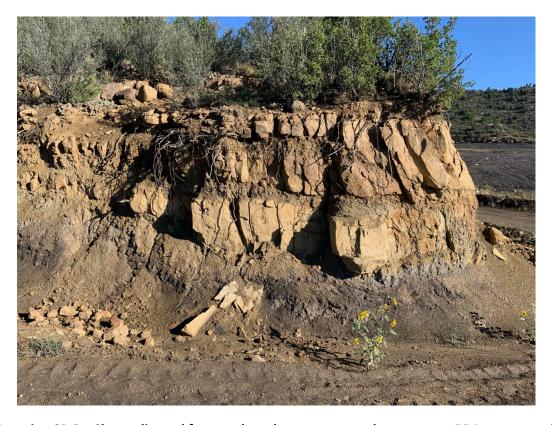
Location SP-4 is located along the current road to the RDA. It shows a good outcrop of the material in the southeast corner of the proposed borrow area. The material is mostly dirt with fractured sandstone. All of the material should be moveable.

Location SP-5 – Shows dirt and fractured sandstone outcrop above current RDA access road

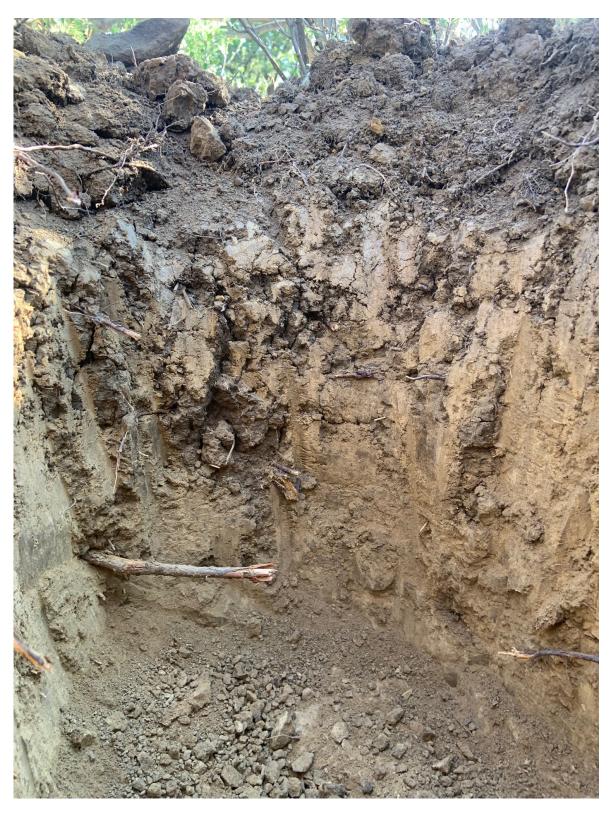
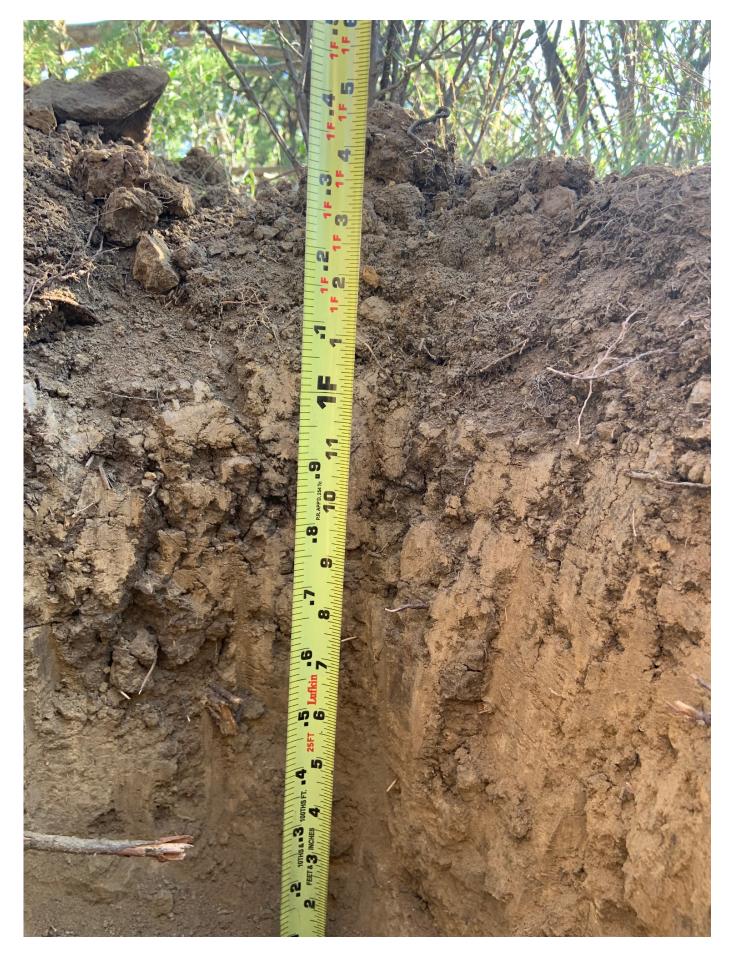
TH-1 was dug by hand and there was little rock removed from the hole. The hole was dug on a flat spot in the borrow area. The topsoil appears to be from the surface about four inches below the surface.

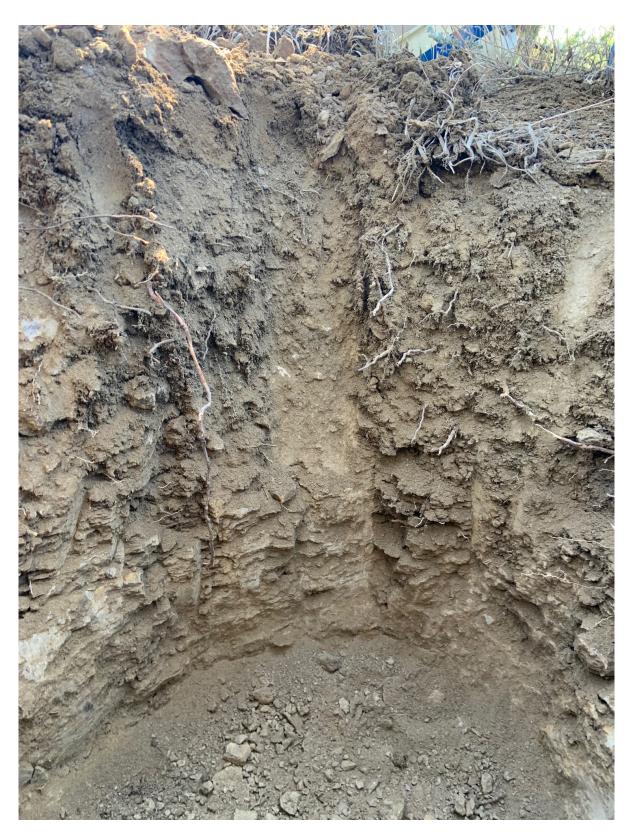
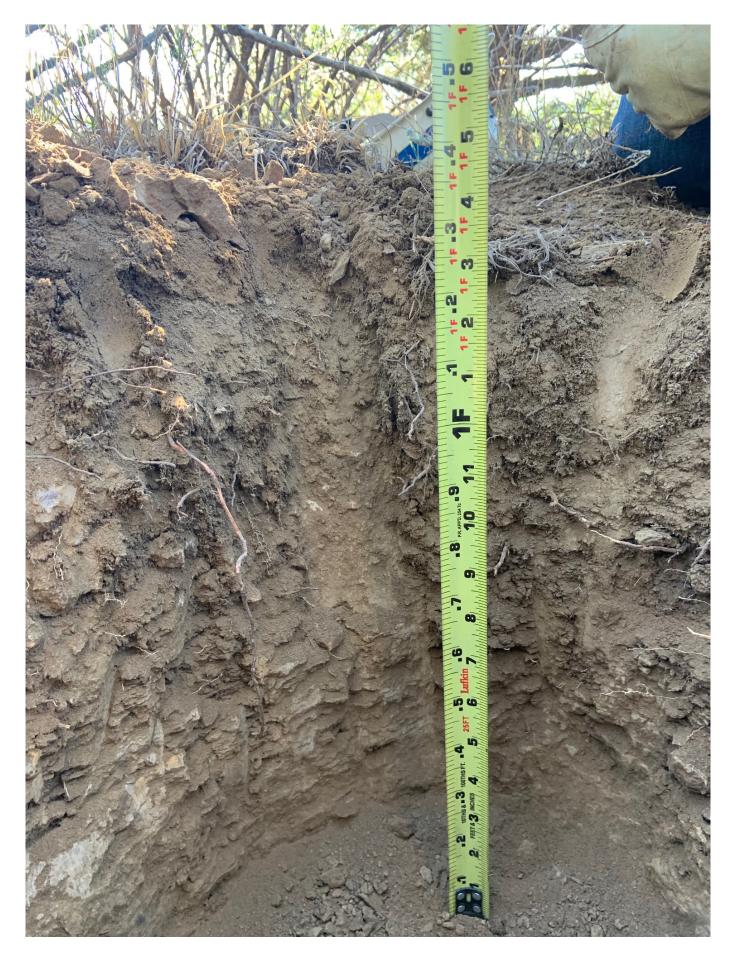
TH-2 was dug by hand and there was little rock removed from the hole. The hole was dug on a relatively flat spot in the borrow area. The topsoil appears to be from the surface about four inches below the surface.

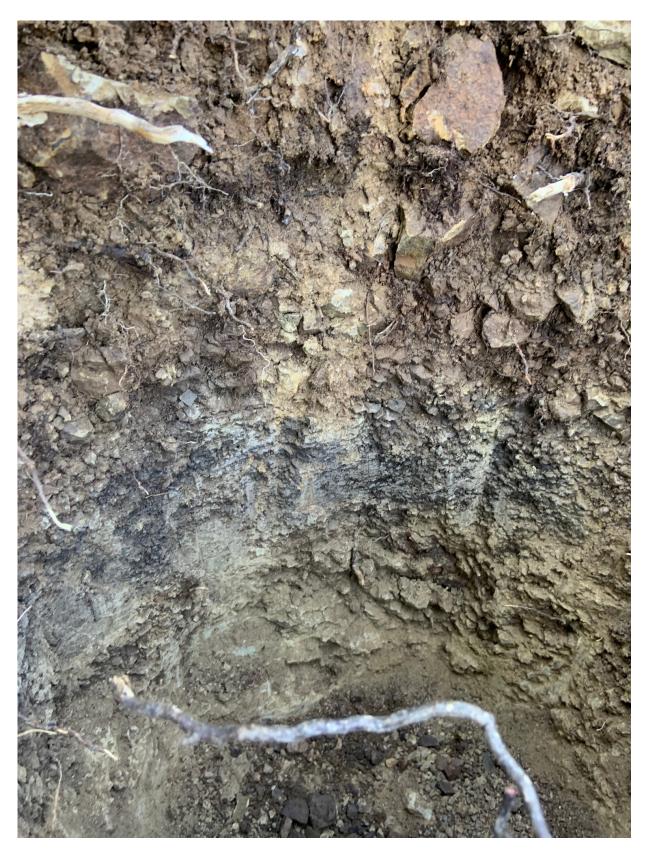
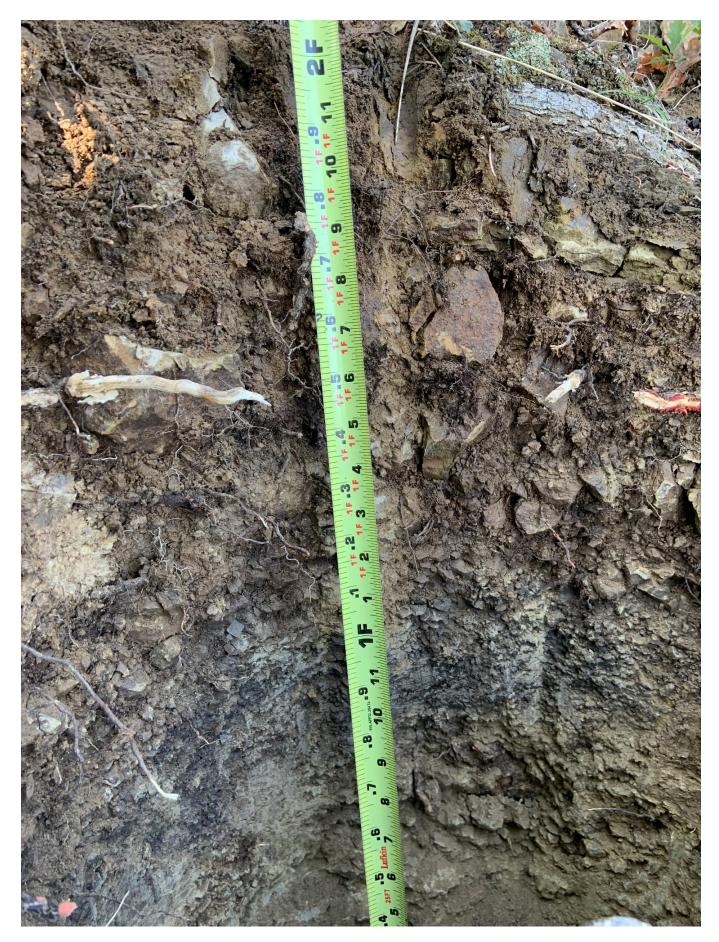
TH-3 was dug by hand and there was almost no rock removed from the hole. The hole was dug on the side of a hill in the borrow area, representative of the entire hill side. The topsoil appears to be from the surface about six to eight inches below the surface.
