Bowie #2 inspection for September

PERMIT INFORMATION

Permit Number: C-1996-083 Mine Name: Bowie No. 2 Mine Operator: Bowie Resources, LLC Operator Address: Mr. Basil Bear P.O. Box 1488 Paonia, CO 81428	County: Delta Operation Type: Underground Permit Status: Active Ownership: Private
	Operator Representative Present: Basil Bear
Operator Representative Signature: (Field Issuance Only)

Inspection Start Date: September 16, 2020 Inspection Start Time: 07:45 Inspection End Date: September 16, 2020 Inspection End Time: 15:30		Inspection Type: Coal Complete Inspection Inspection Reason: OSM Oversight Inspection Weather: Clear	
Joint Inspection Agency: OSM		Joint Inspection Contacts: 	
Post Inspection Agency: OSM		Post Inspection Contacts: 	
Inspector(s): Robert Zuber, P.E.	Inspector's Signature:

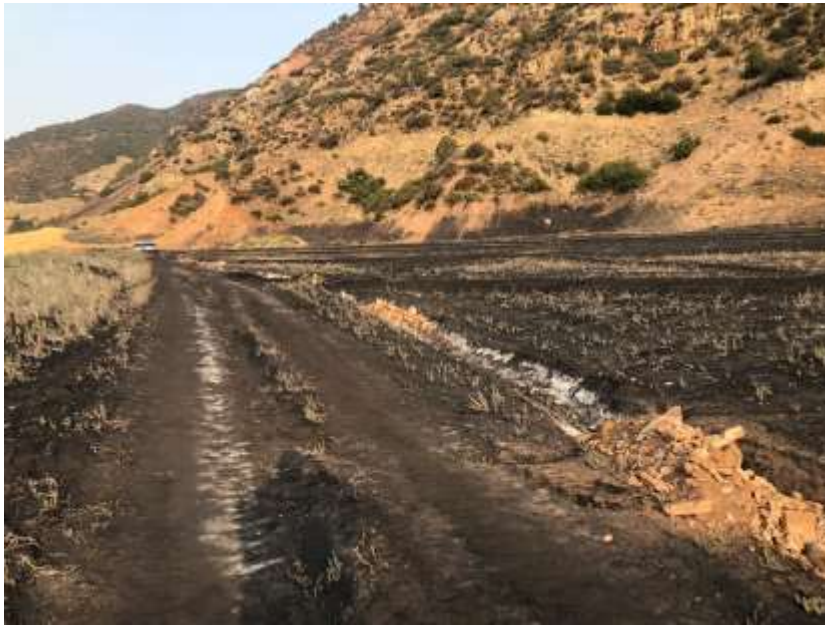
Improvements have been made to the small contour ditches on the un-reclaimed portion of Gob Pile #2, including small check dams. These appear to be functioning well. The depth of the sediment sump has been decreased (as requested in a previous DRMS report) and BMPs added. This improvement looks like it will work well, but requires continued inspection to assure that significant water does not pond at this structure. The “Smart Ditch” below the sump appears stable but also requires continual inspection. Rills on Gob Pile #2 remain small (less than a foot deep), and are not problematic but should be watched to determine if they are getting worse.

Gob Pile #2 – contour ditches with check dams

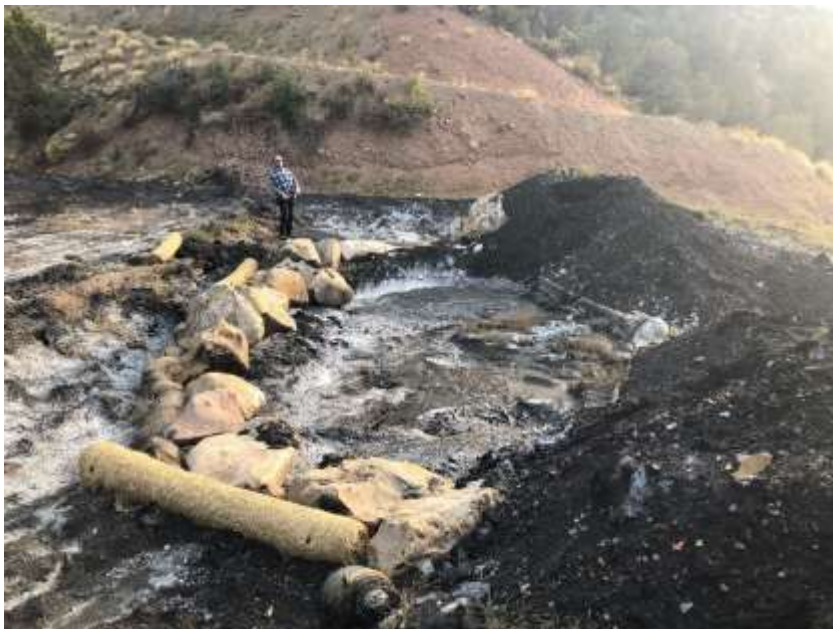
Gob Pile #2 sump and other BMPs

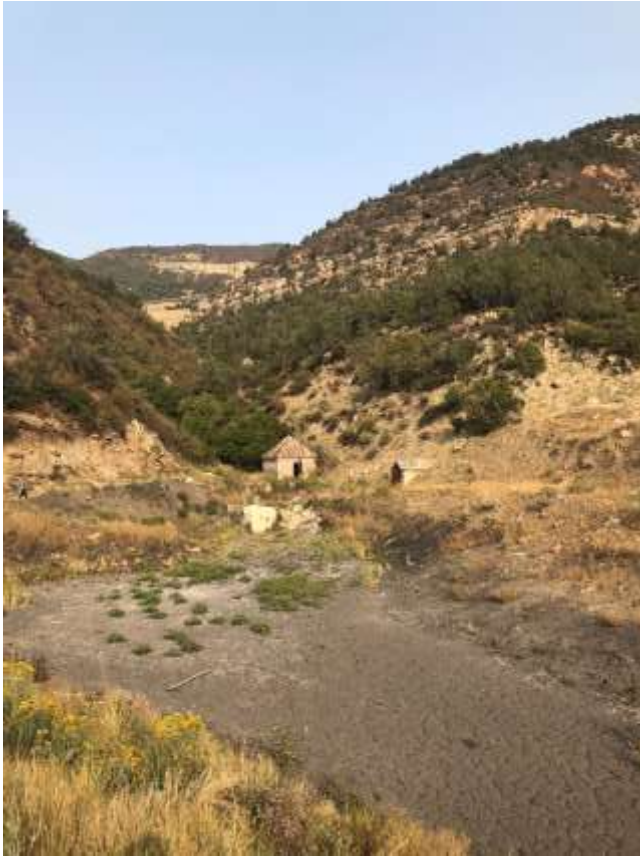
Drainage above Pond C

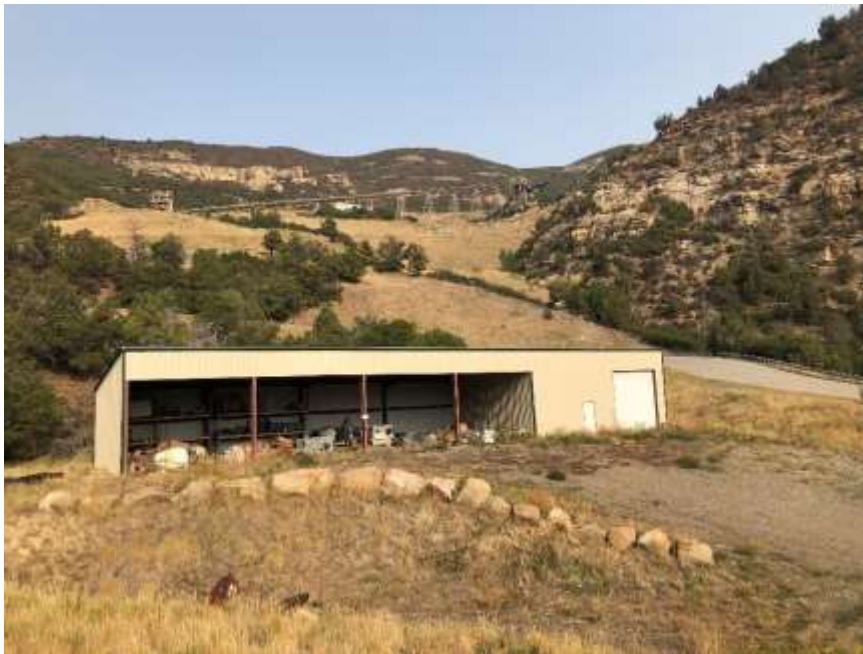
No problems were seen with the haul road to the portals or the hillsides above and below the haul road, many of which are very steep.

Material Storage at TSS A and slopes along haul road to portals

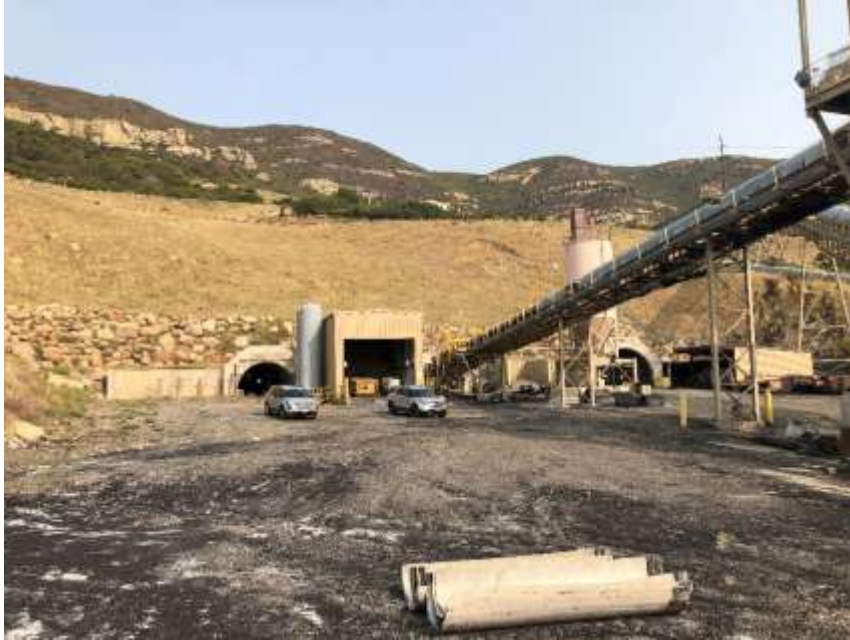
It appears that slumps have not moved significantly in the recent past. These include slumps by the B Portal and by Curve Number 11 along the Haul Road.

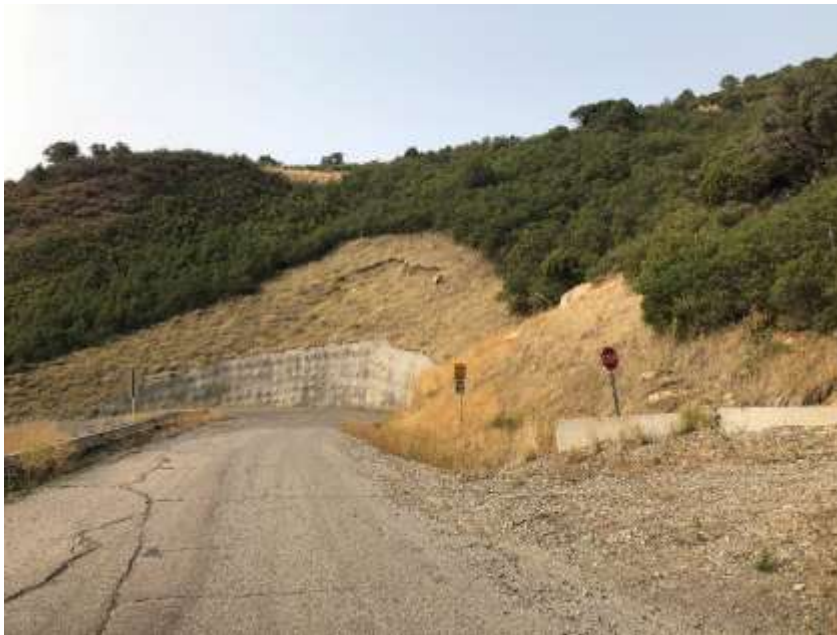
Curve 11 – slump has not worsened

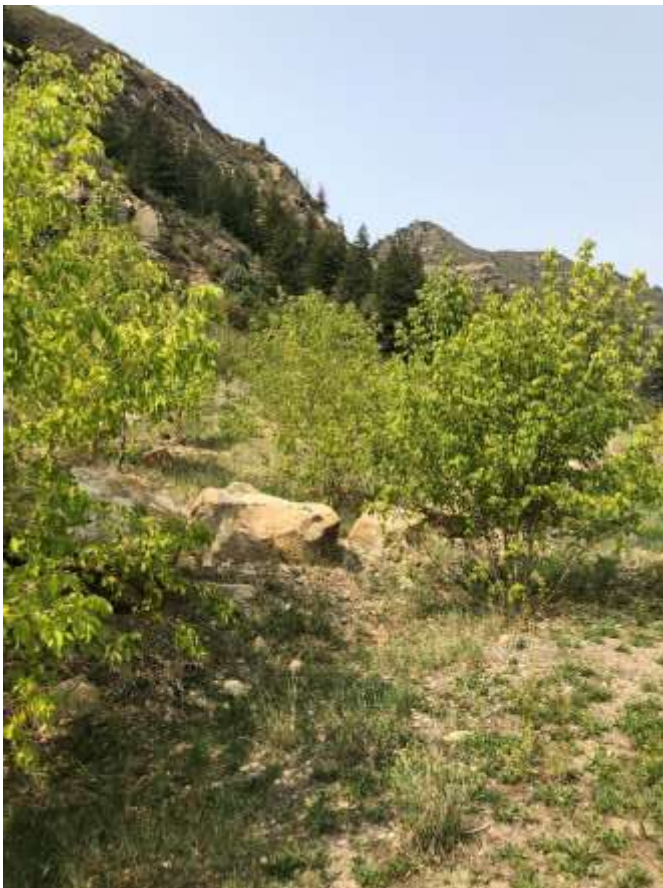
The reclaimed pad at the former Hubbard Creek Vent Shaft is in good shape (no erosion or weed patches were seen), and the divots appear to be helping with diversity of species. Many boxelder trees are growing there, but are not problematic.

Boxelder trees at reclaimed pad for Hubbard Creek Vent Shaft

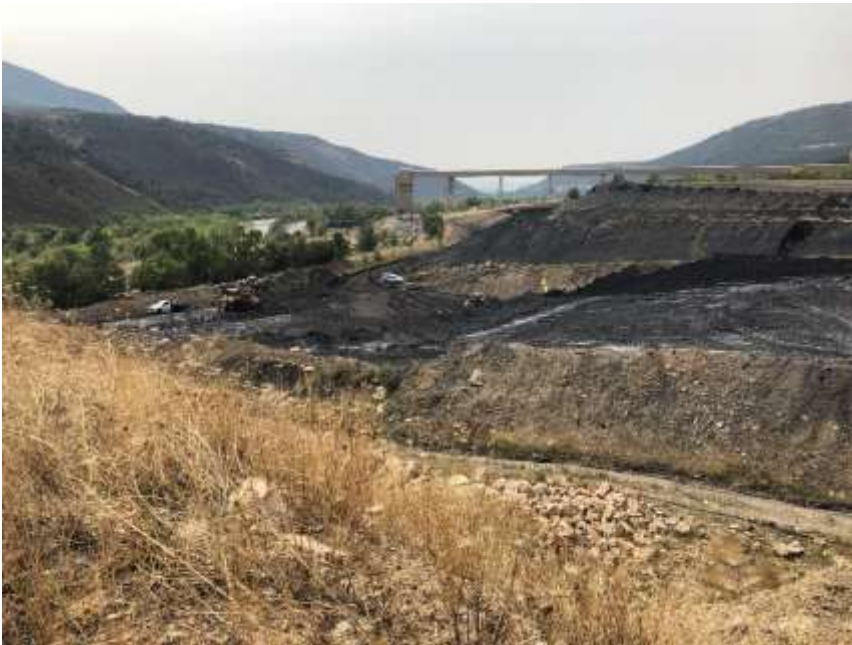
Gob Pile #3, looking southwest at southern portion of pile

As noted above, BRL’s work on Gob Pile #3 during the inspection entailed hauling coverfill material from the eastern portion of the pile to the southwest corner. No significant issues were seen with the pile, although it is recommended that erosion and sediment control (BMPs) be used on the steeper portions to prevent transport of waste off the pile.

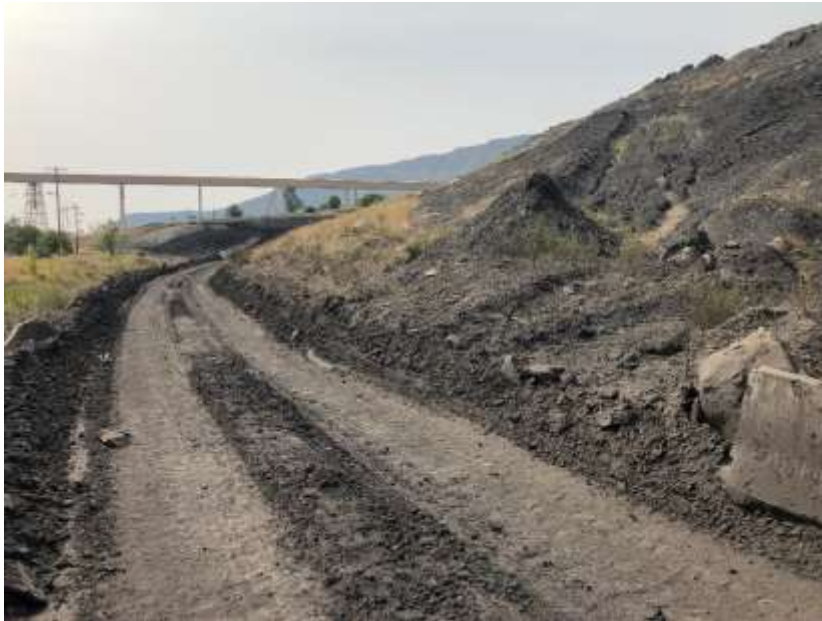
The haul road at Gob Pile #3 was in good shape.

Gob Pile #3 haul road and south side of pile
