## Bowie #1 inspection report

**PERMIT INFORMATION**

<b>Permit Number:</b> C-1981-038 <b>Mine Name:</b> Bowie No. 1 Mine <b>Operator:</b> Bowie Resources, LLC <b>Operator Address:</b> Mr. Basil R Bear P.O. Box 1488 Paonia, CO 81428	<b>County:</b> Delta <b>Operation Type:</b> Underground <b>Permit Status:</b> Active <b>Ownership:</b> Private
	<b>Operator Representative Present:</b>  None
<b>Operator Representative Signature: (Field Issuance Only)</b>

<b>Inspection Start Date:</b> September 17, 2020 <b>Inspection Start Time:</b> 09:30 <b>Inspection End Date:</b> September 17, 2020 <b>Inspection End Time:</b> 11:05		<b>Inspection Type:</b> Coal Partial Inspection <b>Inspection Reason:</b> Normal I&E Program <b>Weather:</b> Clear	
<b>Joint Inspection Agency:</b>  None		<b>Joint Inspection Contacts:</b>  	
<b>Post Inspection Agency:</b>  None		<b>Post Inspection Contacts:</b>  	
<b>Inspector(s):</b>  Robert Zuber, P.E.		<b>Inspector's Signature and Date:</b>

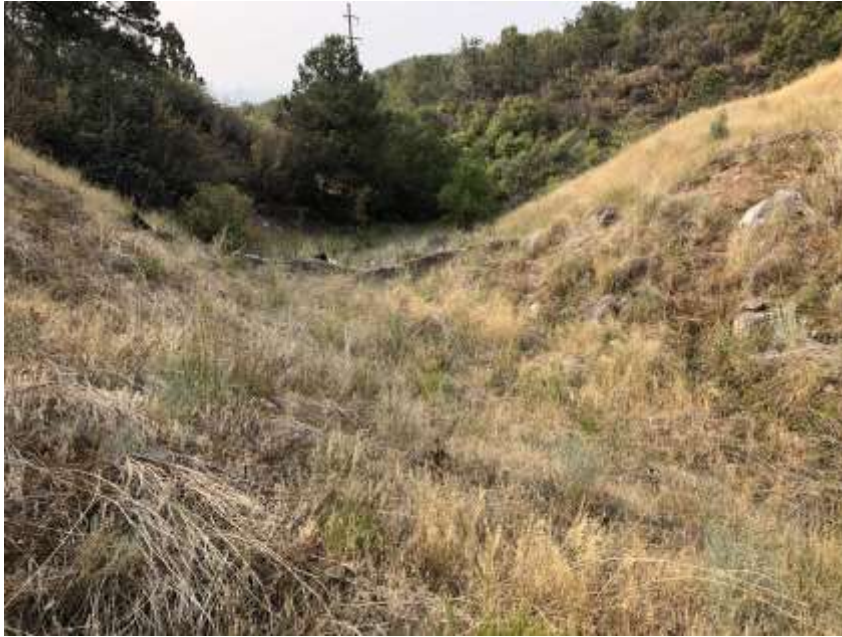
The erosion control BMPs below Ponds 3 and 4 are functioning. The silt fence below the Refuse Disposal Area should be maintained; sediment behind the fence should be removed to prevent it from causing the fence to fail.

**Silt fence below reclaimed Pond 4 (East Mine)**

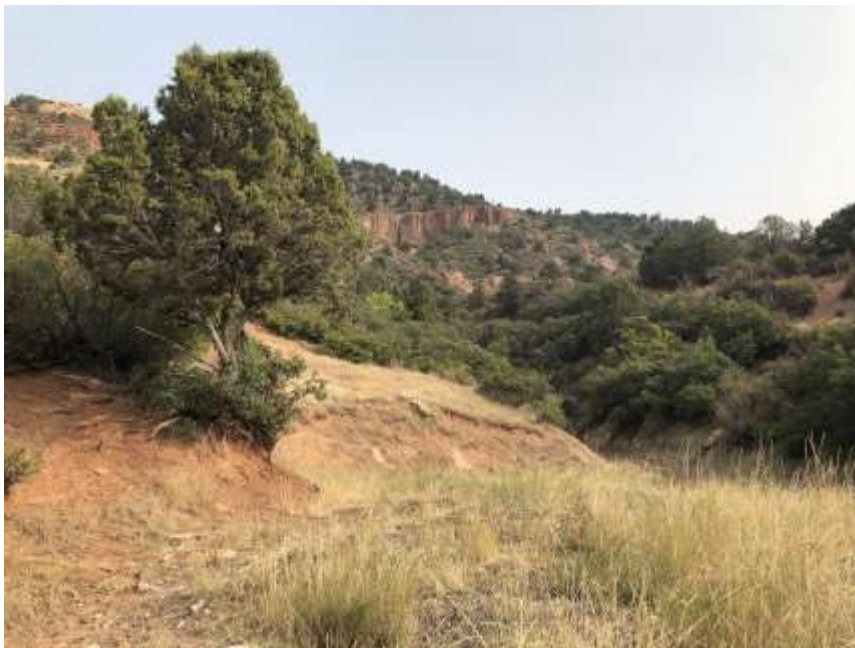
Erosion at the west side of reclaimed Pond 1 (East Mine) is threatening a juniper tree. BRL should explain that this is not mine related or consider action to protect this tree.

**Juniper tree near reclaimed Pond 1**

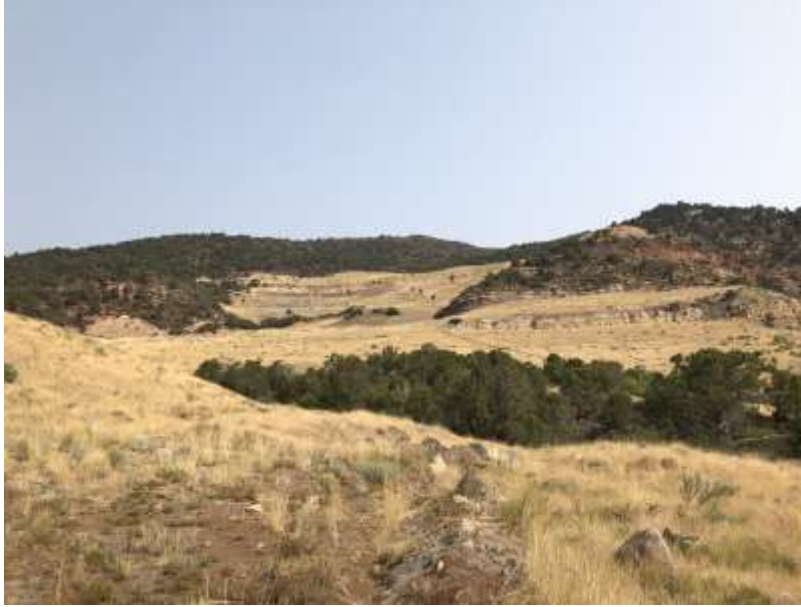
**East Mine**

Good stands of vegetation were seen at the reclaimed area of the East Mine (including the RDA, reclaimed ponds, and the Old Waste Disposal Area), the ROM and Timber Storage areas, and the West Mine.

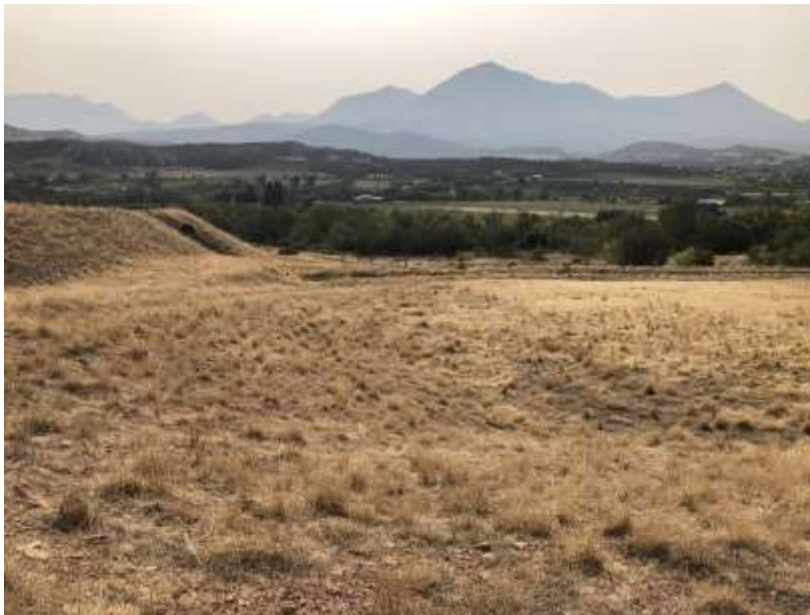
**Coal Storage at Highway 133 and Black Bridge Road**

No problems were seen with the Coal Storage Area by the highway or with the loadout.

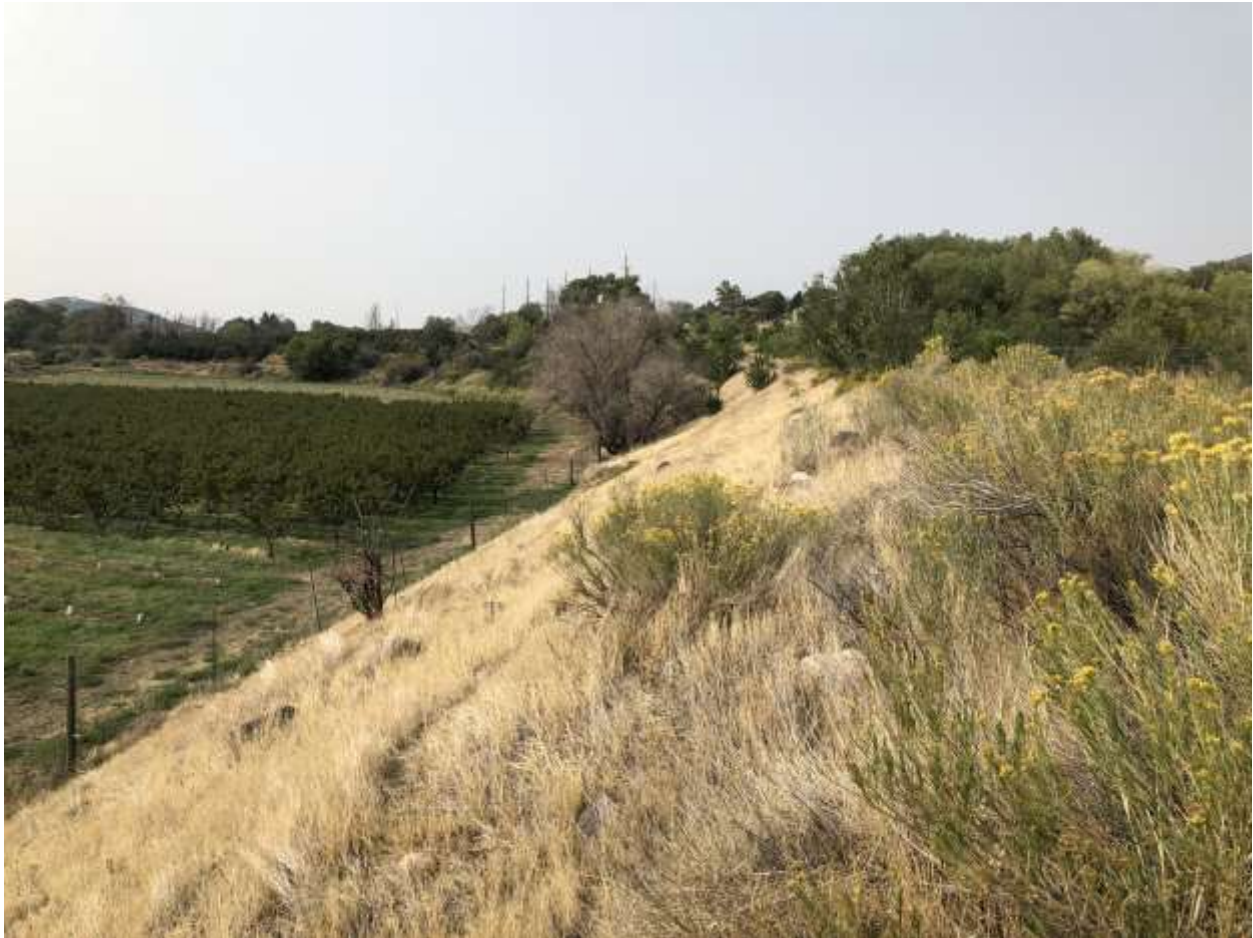
**Hillside below the loadout (adjacent orchard on left)**
