Report from September inspection for North Thompson Creek Mine

PERMIT INFORMATION

Permit Number: C-1981-025 Mine Name: North Thompson Creek Mine Operator: MINREC, Inc. Operator Address: Mr. Stan Muhr 627 241/2 Road, Unit H Grand Junction, CO 81505	County: Garfield Operation Type: Underground Permit Status: Inactive Ownership: Private
	Operator Representative Present: None
Operator Representative Signature: (Field Issuance Only)

Inspection Start Date: September 15, 2020 Inspection Start Time: 10:30 Inspection End Date: September 17, 2020 Inspection End Time: 13:15		Inspection Type: Coal Complete Inspection Inspection Reason: OSM Oversight Inspection Weather: Clear	
Joint Inspection Agency: OSM		Joint Inspection Contacts:	
Post Inspection Agency: OSM		Post Inspection Contacts:	
Inspector(s): Robert Zuber, P.E.	Inspector's Signature:

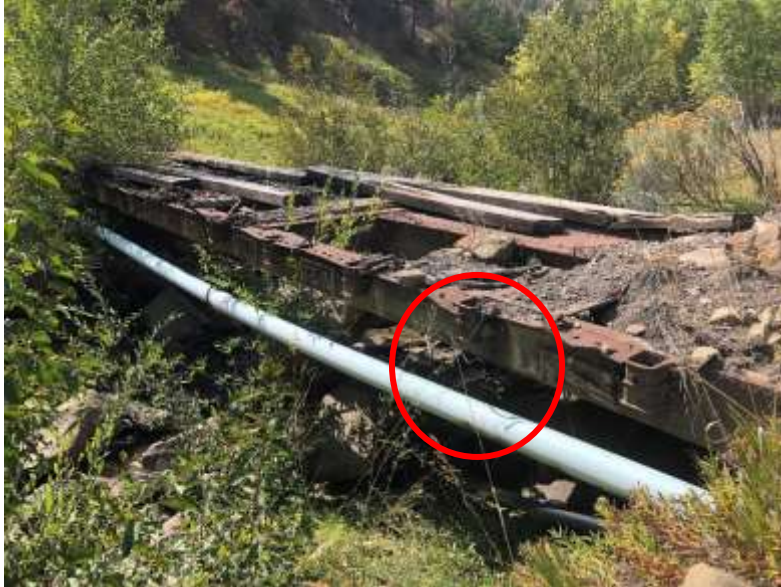
The pipeline across the creek (attached to a bridge) that carries mine water to the treatment system was intact.

However, one of the cable supports for the pipe has come undone, and this should be fixed to keep the pipe stable.

Pipe on bridge across creek (circle around disconnected support)

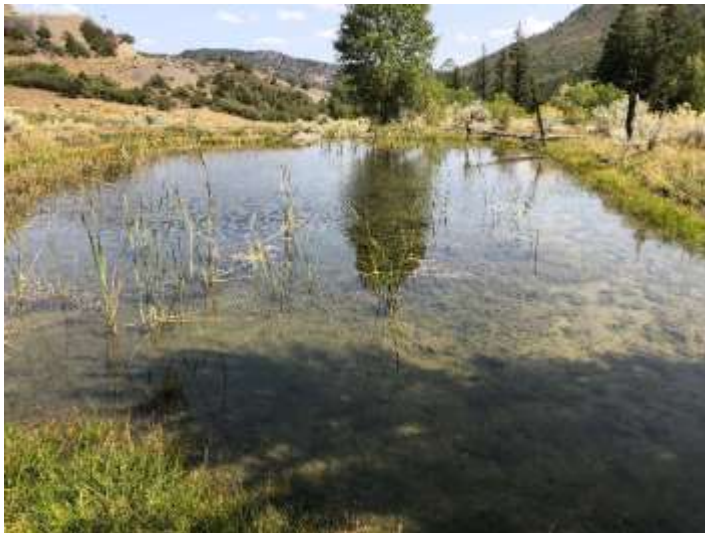
The following ponds were inspected: the Long Pond, Treatment Pond T-1, Treatment Pond T-2, the Polishing Pond (Pond P-9), and the Refuse Pond. All but the Refuse Pond were discharging. At the upper end of the treatment system, orange precipitate was visible, indicating iron in the water. The water discharging from Pond 9 was relatively clear, with no mineral staining or odor. The flow through the ponds appeared to be approximately the same at the upper end (pipe from mine above the Long Pond) and out of Pond 9. The flow also appeared to be similar to the flow during previous inspections. No problems were identified with the ponds, although the amount of biomass in some of the ponds is significant, and this material may need to be removed in the next couple years to assure proper functioning of the pond treatment system.

Pond T-2, with significant biomass

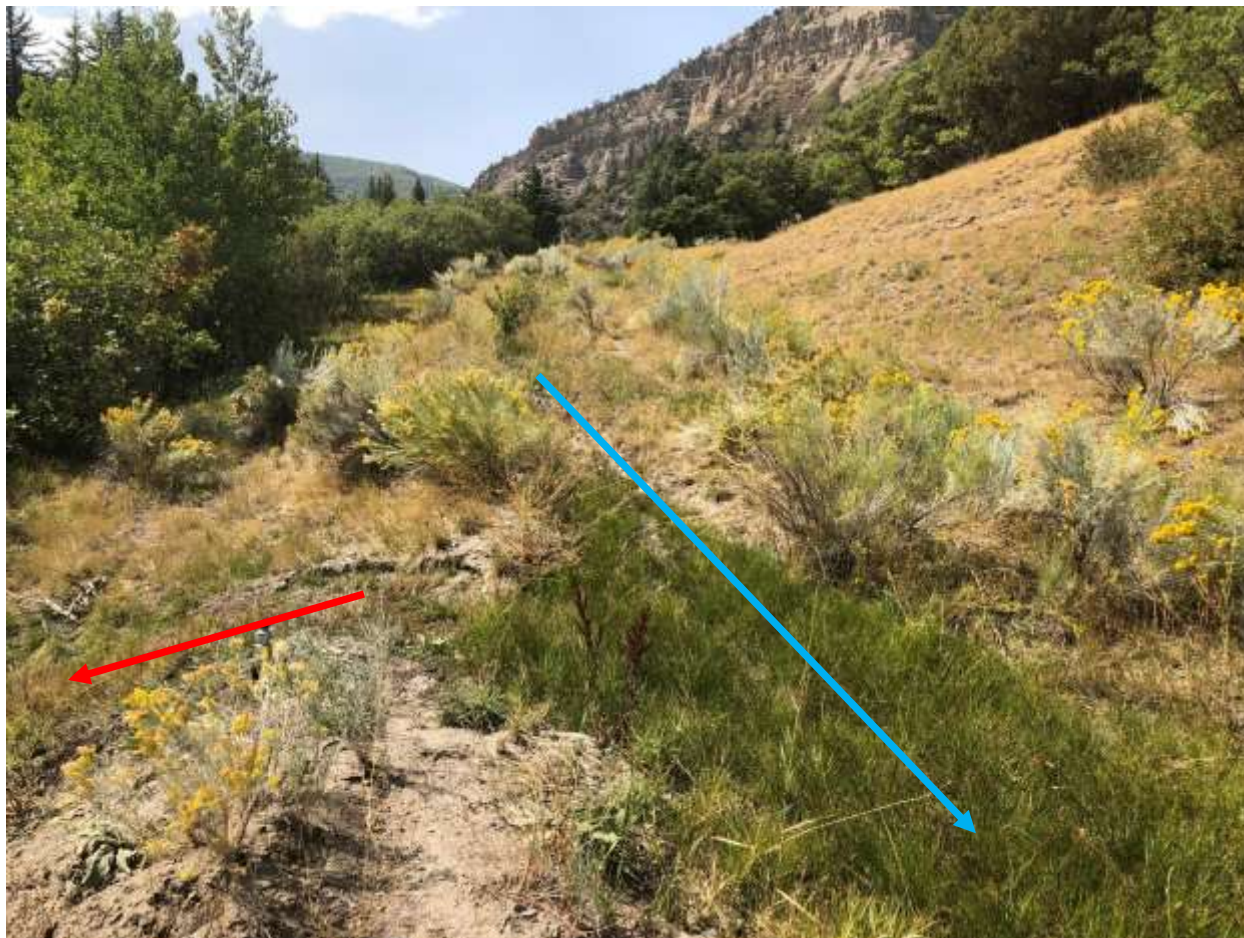
The ditch into the Refuse Pond (from Pond 9) was not functioning. Water was flowing over a breach in the berm and into the wooded area adjacent to the mine site. This was approximately 100 feet west of the Refuse Pond. The source of the problem appeared to be a buildup of sediment and vegetation in the channel. The water was infiltrating before reaching North Thompson Creek. Rob Zuber notified Jim Stover of this problem after the inspection on September 15. Rob returned to the site on September 17, and the problem was fixed. Sediment and vegetation had been removed from the ditch, the berm had been built-up, and water was flowing to the Refuse Pond. However, this channel has other reaches where this same issue could happen in the future. **It is recommended that this ditch be cleared of sediment and/or vegetation to prevent more breaches.**

Breach of ditch near Refuse Pond, looking west

Note buildup of vegetation

Blue arrow is proper direction of flow to Refuse Pond

Red arrow is direction of flow when berm was breached

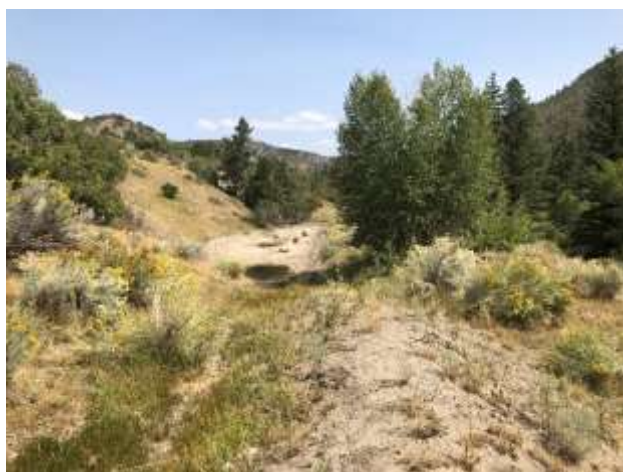
Nearly empty Refuse Pond before breach was fixed

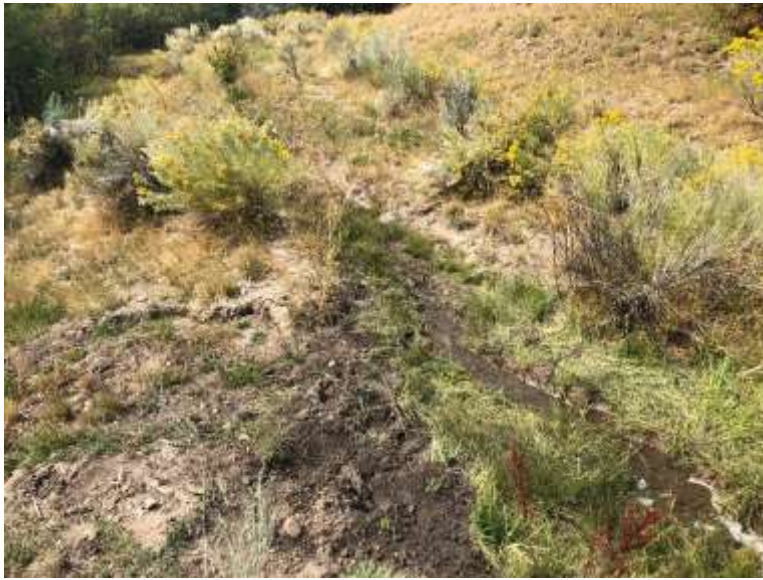
Repaired breach in berm (9/17/2020)

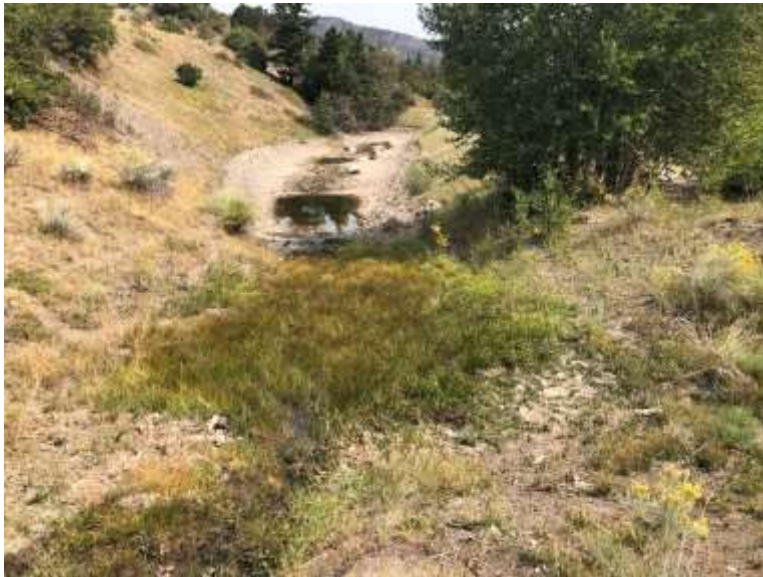
Refuse Pond approximately one day after repair (9/17/2020)

Somewhat more water than in photo above
