South Taylor Fill Inspection Certification

INSPECTION REPORT ~ SOUTH TAYLOR FILL (Including Both the East Taylor and West Taylor Fill Segments)

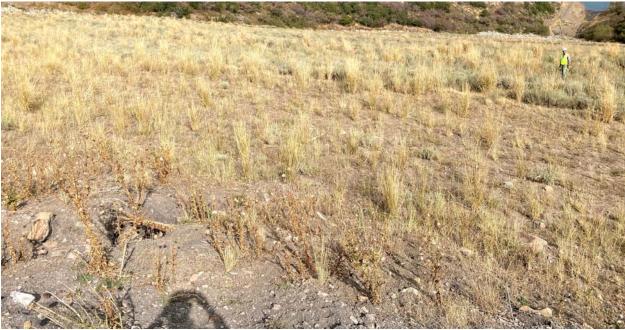
09-14-20 - West Taylor fill looking northwest from monitoring well location

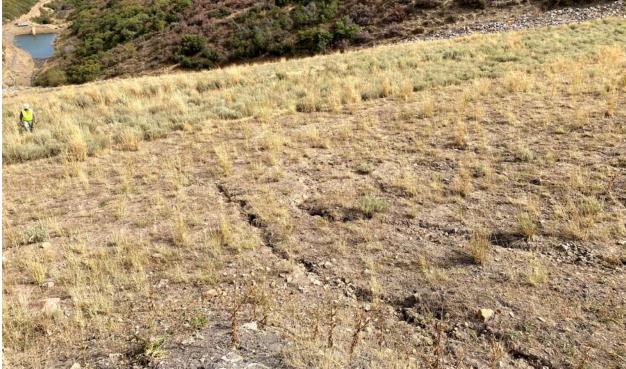
09-14-20 - West Taylor fill looking northeast from monitoring well location

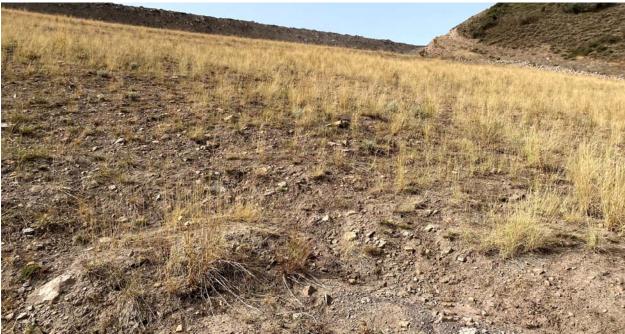
09-14-20 - West Taylor Fill West Flank from monitoring well location

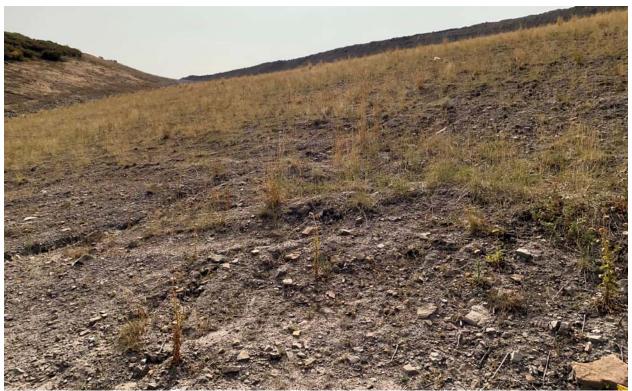
09-14-20 - West Taylor Fill East Flank from monitoring well location

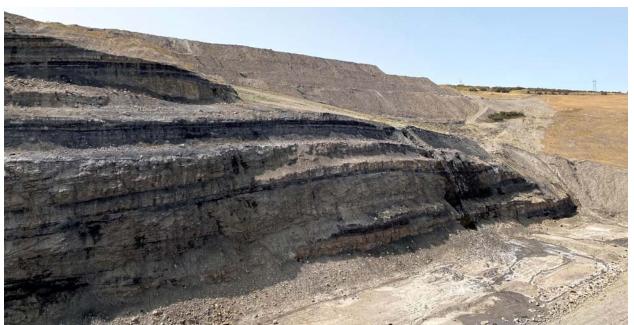
09-14-20 - East Taylor Fill looking southwest from the West Pit reclamation
