**PERMIT INFORMATION**

<b>Permit Number:</b> C-1981-018 <b>Mine Name:</b> Deserado Mine <b>Operator:</b> Blue Mountain Energy, Inc. <b>Operator Address:</b> Mr. Kurtis Blunt 3607 County Road 65 Rangely, CO, 81648	<b>County:</b> Moffat, Rio Blanco <b>Operation Type:</b> Underground <b>Permit Status:</b> Active <b>Ownership:</b> Private
	<b>Operator Representative Present:</b>  Kurt Blunt
<b>Operator Representative Signature: (Field Issuance Only)</b>

**INSPECTION INFORMATION**

This was a complete inspection of the Deserado Mine conducted on September 16, 2020. The inspection was completed by Clayton Wein of the Division. Kurt Blunt represented Blue Mountain Energy, Inc. during the inspection. The weather was clear with a temperature of 84 degrees F. The ground conditions were dry.

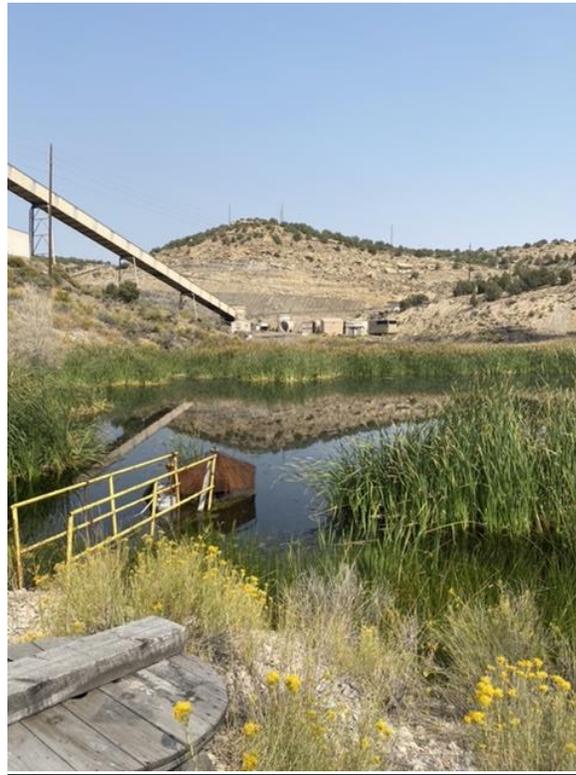
Three ponds are located at the main facilities area; the DP-1 Pond, the PP-1 Pond and the PP-2 Pond. The DP-1 pond (Photo 1) was impounding water during the inspection. The level of the water had reached the primary discharge outlet and was discharging into Scullion Gulch. The Primary outlet's trash rack was clear of obstructions and functioning as designed. The emergency spillway was dry and stable. The embankment for the pond was vegetated and stable. There were no indications of erosion. The DP-1 Pond had been recently cleaned and a portion of the cattails had been removed to increase the ponds holding capacity. The PP-1 pond was holding water (Photo2). The pond's embankments were stable with vegetation. There were no erosional features. The

**Photo 1:** The outlet of the DP-1 Pond.

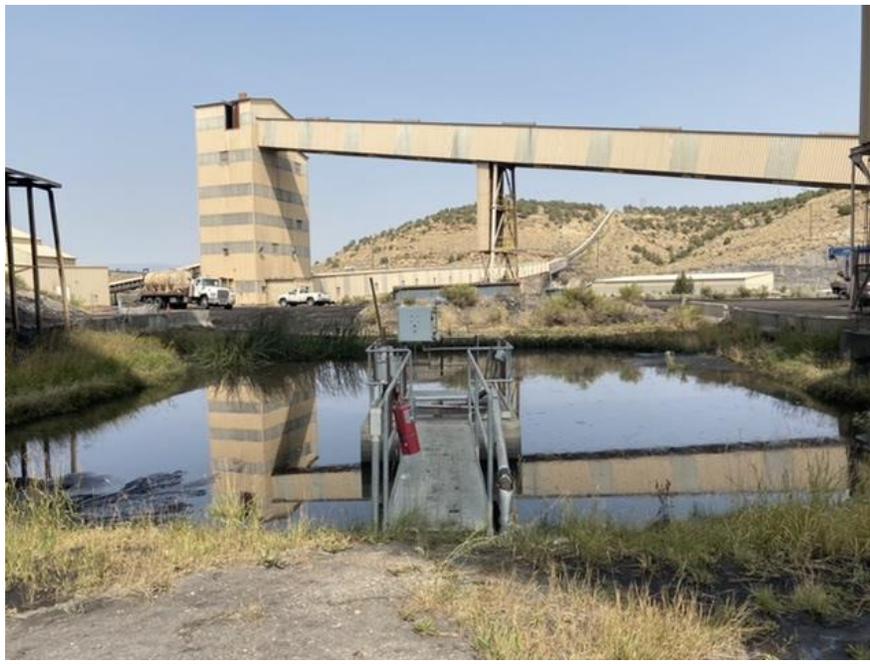
**Photo 2:** The PP-1 Pond.

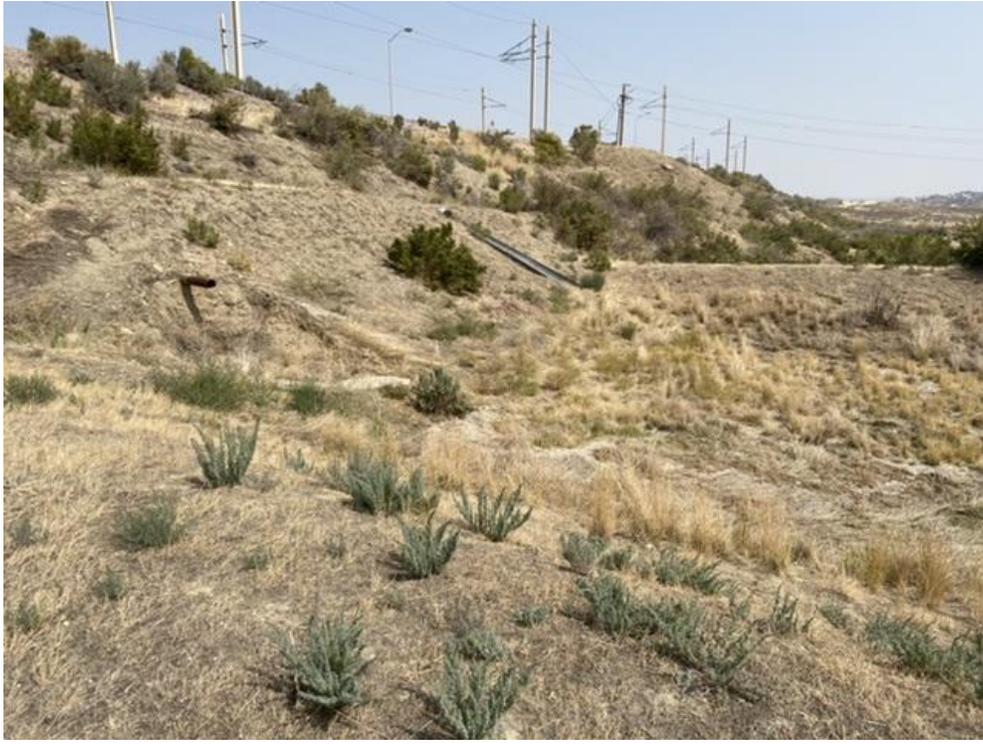
There is one sump and one pond located on the south end of the rail loadout. The RS-1 Sump was observed to be dry. The embankments of the sump were vegetated and stable. There were no indications of erosion. The outlet for the sump was clear. The RR-1 pond was also observed to be dry (Photo 3). The embankment was stable with vegetation. No erosional features were observed. The outlet for the pond was in good condition. A ditch located on the south side of the rail loadout transports runoff to the RR-1 Pond. The ditch was dry. The berm was vegetated and stable. There were no obstructions observed.

**Photo 3:** The inlet to the RR-1 Pond.

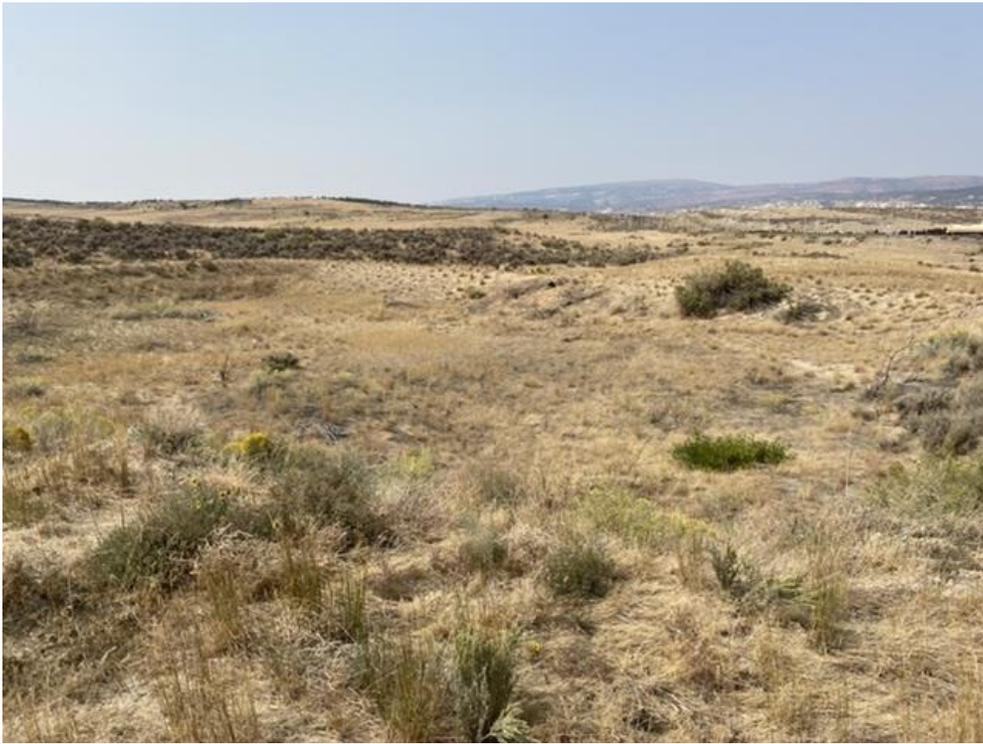
There are two ponds located to the north of the Slot Storage. The SS-1 pond is located directly north of the facility. The pond was dry. The embankments were stable with vegetation. The outlet for the pond was clear. The SS-2 Pond is located to the northwest of the facility. The pond was observed to be dry (Photo 4). The embankment was vegetated and stable. There were no indications of erosion. The outlet for the pond was clear of debris.

**Photo 4:** The SS-2 Pond.

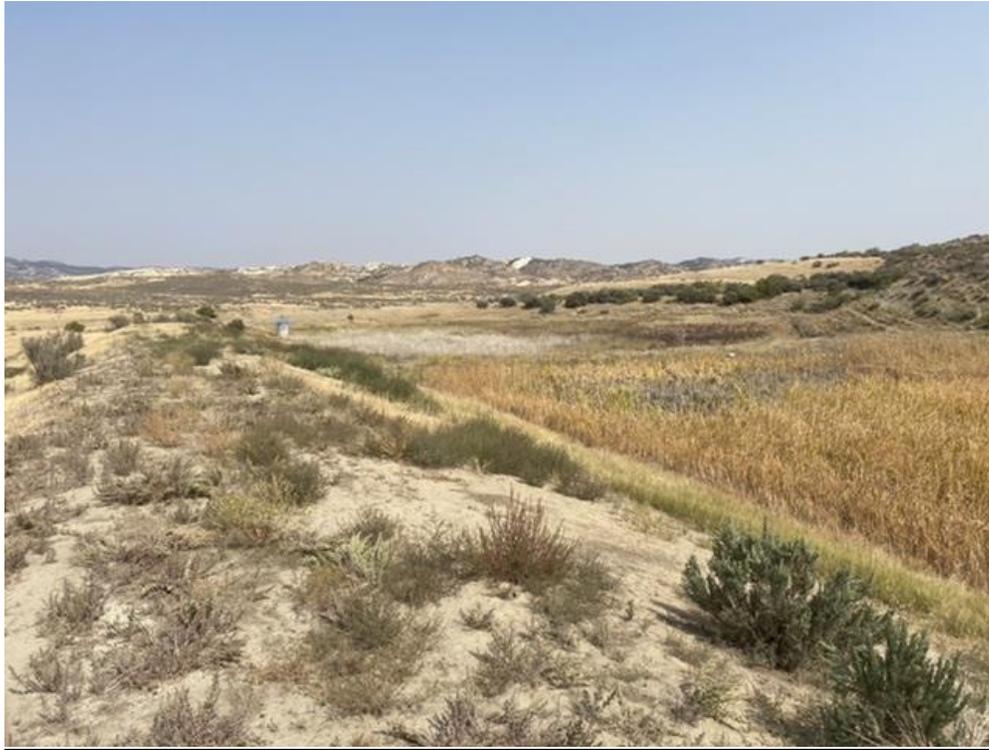
The RP-2/3 Pond consists of three cells and is located at the northeast base of the RP-2/3/4 Refuse Pile. The west cell and the main cells were dry (Photo 5). The east cell was damp. The east cell had been recently cleaned. The embankments of the cells were vegetated and stable. There were no erosional features identified. The trash rack on the primary spillway was clear of debris.

**Photo 5:** The West cell and main cell of the RP-2/3 Pond.

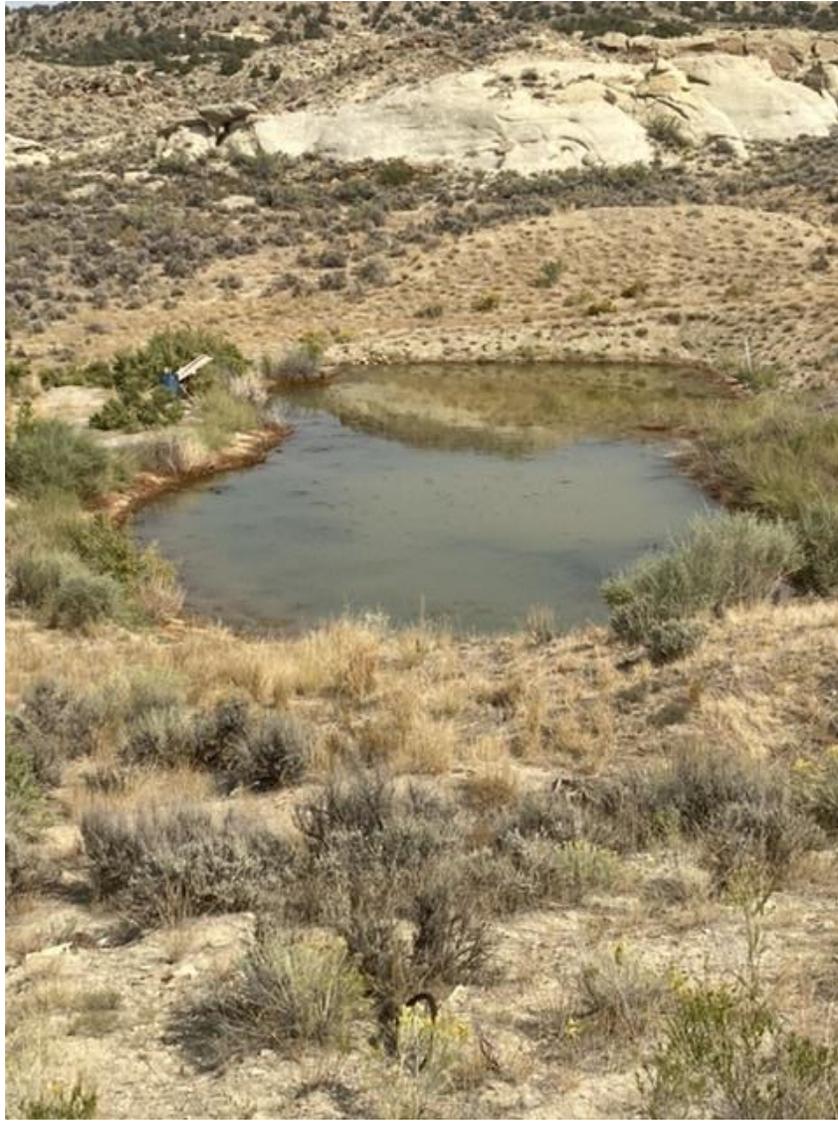
The SDH-3 Dewatering System was holding water during the inspection (Photo 6). The pond was discharging through the primary spillway. The embankments of the pond were vegetated and stable. There were no indications of erosion.

**Photo 6:** The SDH-3 Dewatering System Pond.

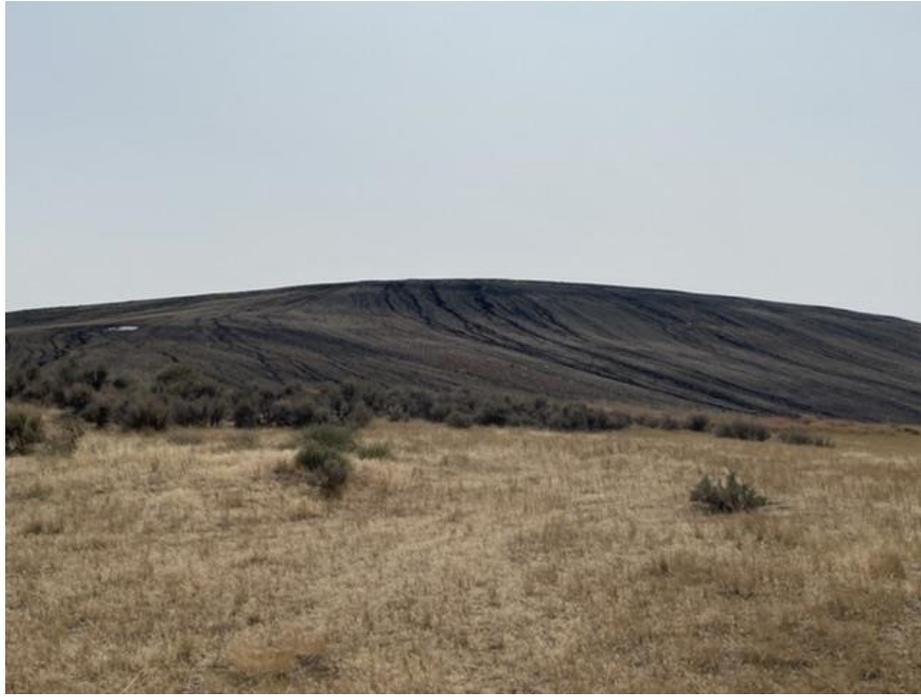
The Refuse on the RP-2/3/4 Pile and RP-5a Pile was spread out and compacted. No new refuse had been stockpiled on top of the piles. The outslopes of the piles were stable with some localized erosion (Photo 7). The rills on the slopes of the piles have been noted in previous inspection reports. The rills do not appear to affect the stability of the piles. The slopes will be included on the list of spring maintenance items for 2021 or sooner if the rills increase in size.

**Photo 7:** The RP-5a Refuse Pile.
