| Permit Number: C-1981-041 Mine Name: Roadside Portals Operator: Snowcap Coal Company, Inc. Operator Address: MS Tonya Hammond P.O. Box 1430 Palisade, CO 81526 | County: Mesa Operation Type: Underground Permit Status: Active Ownership: Private |

| Inspection Start Date: September 17, 2020 Inspection Start Time: 09:07 Inspection End Date: September 17, 2020 Inspection End Time: 09:25 | | Inspection Type: Aerial Inspection Inspection Reason: Normal I&E Program Weather: Clear | |

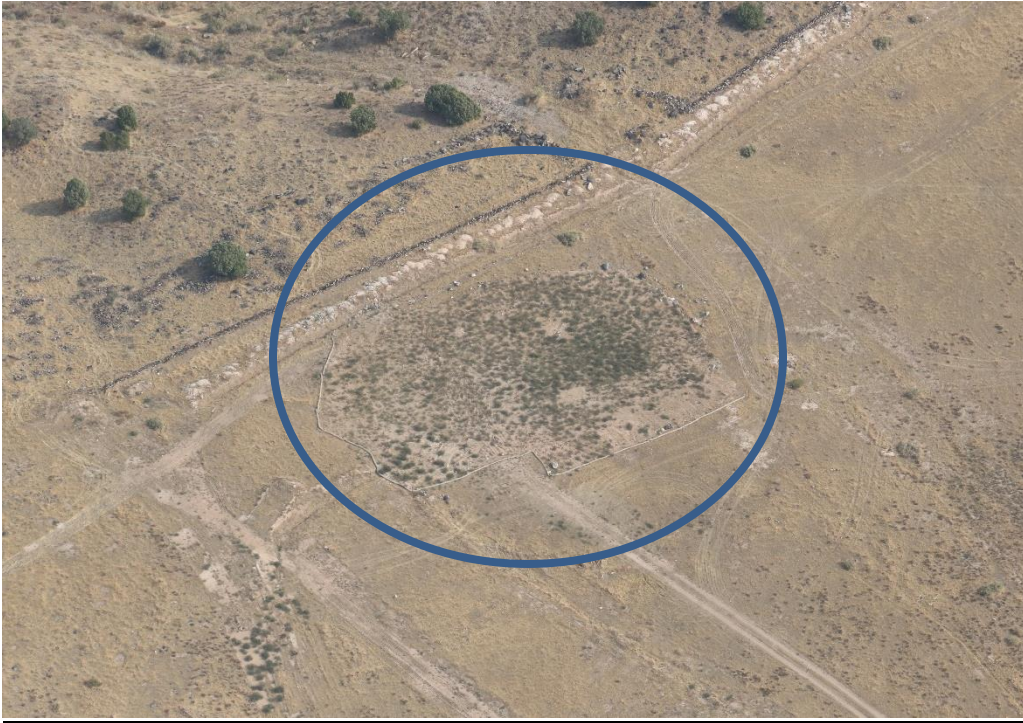
The TR-69 repair area was in good condition at the time of the inspection (Photo 1). The boundary of the disturbance was marked by T-posts. The sediment logs placed on the down-gradient portions of the area were in stable and in good condition. There were no indications of off-site impacts. The site was stable and no indications of surface settling were identified. Vegetation at the site had begun to grow in and appeared to be helping stabilize the site.

Photo 1: The TR-69 repair area outlined in the blue circle.

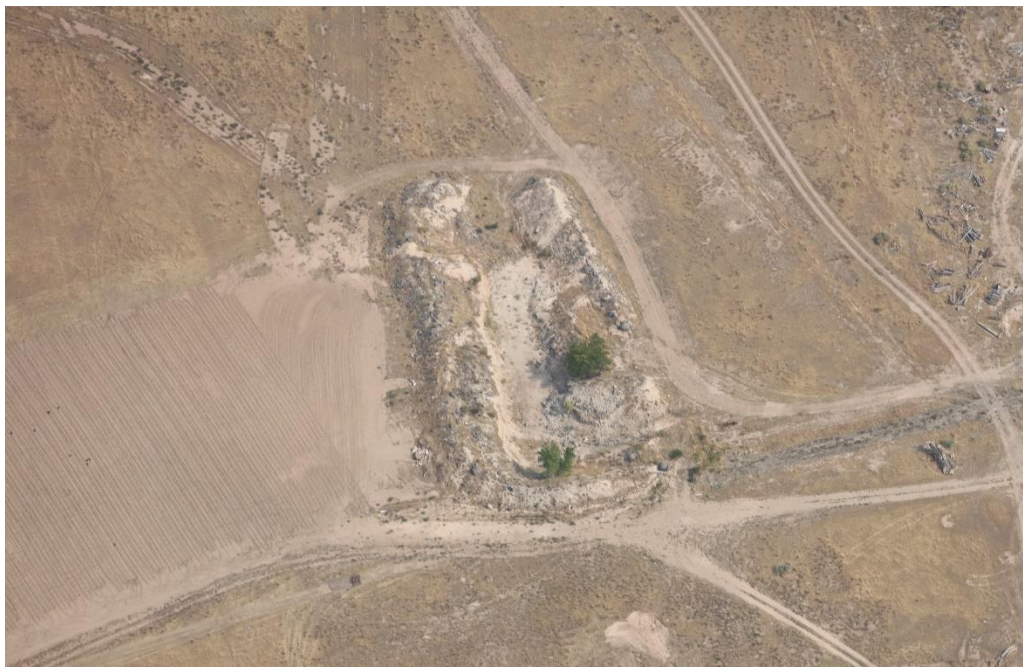
There is 0.4 acres of bonded disturbance left at the Roadside Mine. These 0.4 acres are associated with the work conducted under Technical Revision No. 69 (TR-69). The ground at the TR-69 repair area was dry during the inspection. There were no indications of erosional features at the site. The Carey Pond, located to the south of the TR-69 repair area was dry (Photo 2). There was no evidence of recent water impoundment in the pond. The trenches created by the landowner on top of the Tract 70 were dry during the inspection (Photo 3). There was no evidence of recent flow in the trenches. Trenches on Tract 71 near the TR-69 repair area were observed to be dry. There was no evidence of recent flow in the trenches.

Photo 2: The Carey Pond.

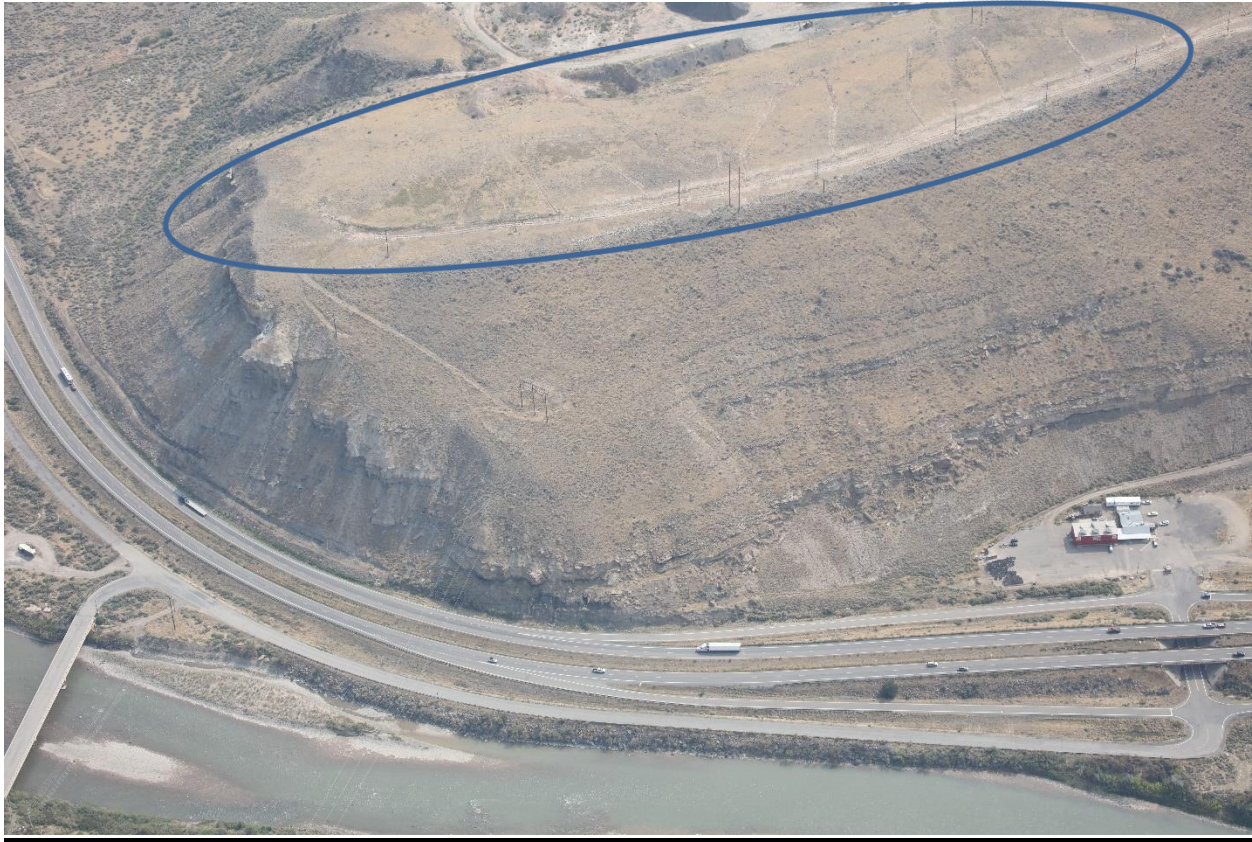
Photo 3: The trenches on top of tract 70 are outlined by a blue oval in the photo above.
