MINERALS PROGRAM INSPECTION REPORT
PHONE: (303) 866-3567

MINE NAME: Ravenkamp Pit No 1	MINE/PROSPECTING ID#: M-1991-060	MINERAL: Gravel	COUNTY: Lincoln
INSPECTION TYPE: Monitoring	INSPECTOR(S): Daniel Cunningham	INSP. DATE: September 9, 2020	INSP. TIME: 11:00
OPERATOR: Lincoln County	OPERATOR REPRESENTATIVE: Fred Lundy	TYPE OF OPERATION: 112c - Construction Regular Operation	
REASON FOR INSPECTION: Normal I&E Program	BOND CALCULATION TYPE: None	BOND AMOUNT: \$0.00	
DATE OF COMPLAINT: NA	POST INSP. CONTACTS: None	JOINT INSP. AGENCY: None	
WEATHER: Clear	INSPECTOR'S SIGNATURE:

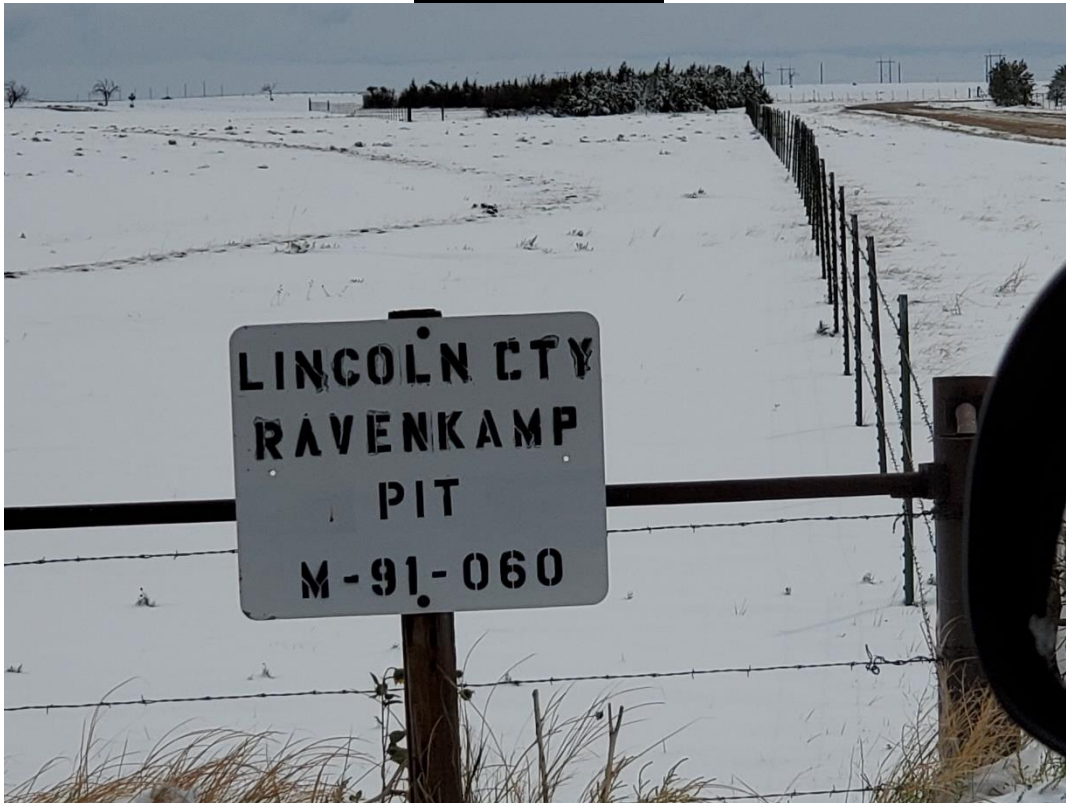
The site identification sign was posted at the mine entrance and the boundary was marked. A large stockpile of overburden was located at the site entrance. A 15 ft. high by 300 ft. long highwall was located around the active mine pit. Topsoil was being stored on the western edge of the pit floor. No major issues were noted in the active mine.

Mine Site Entrance

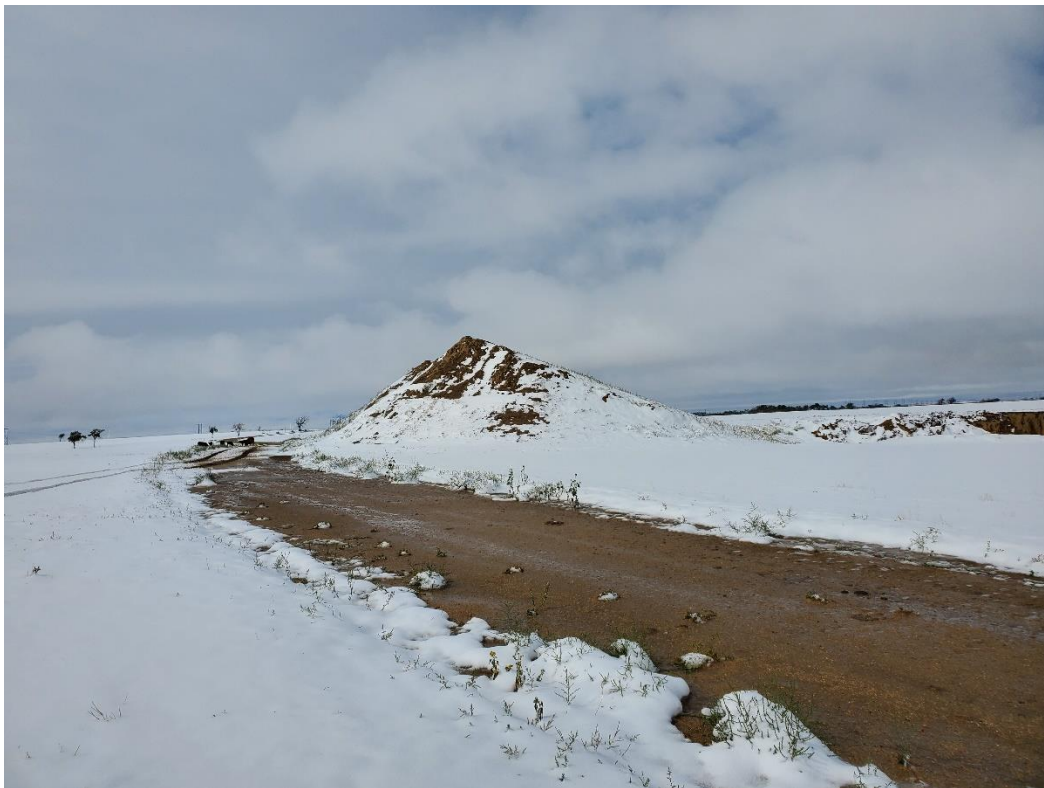
Overburden Stockpile

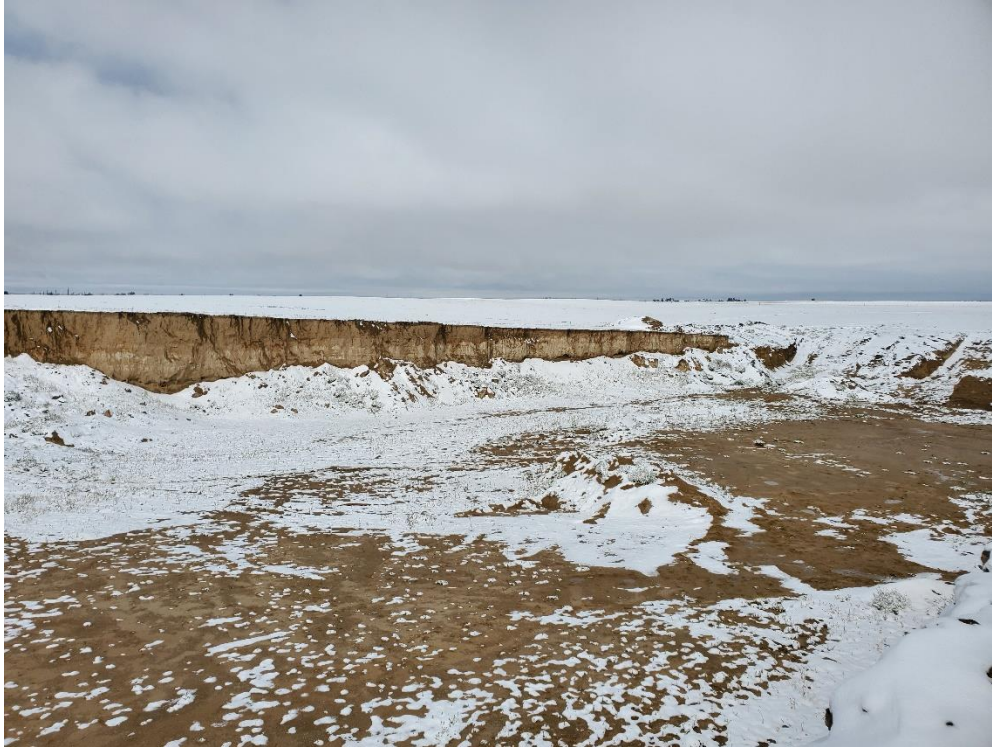
Pit floor facing West

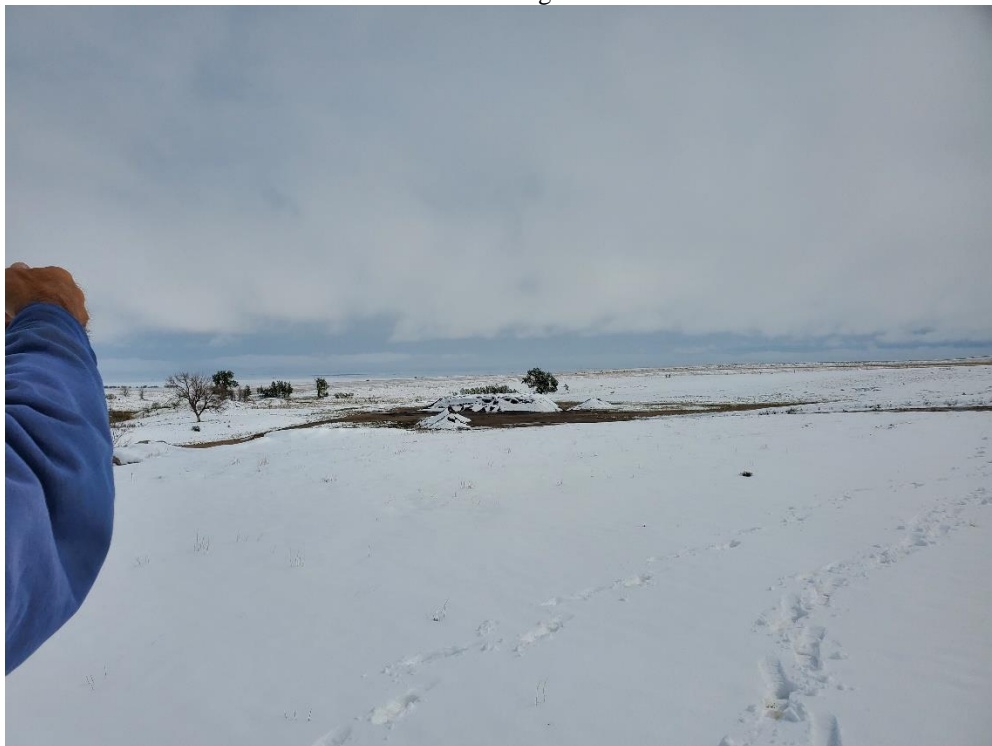
A stockpile of rotomillings and crushed concrete was located near the edge of the reclaimed section of the permit. This was approved through Technical Revision 03.

The eastern side of the permit area is the process of being reclaimed. The slopes have been graded to 3H:1V ratio or greater and topsoil has been spread throughout much of the area.

Rotomillings and Reclaimed Area of the Permit
