MINERALS PROGRAM INSPECTION REPORT
PHONE: (303) 866-3567

MINE NAME: Brent Pit	MINE/PROSPECTING ID#: M-2019-032	MINERAL: Borrow material for	COUNTY: Lincoln
INSPECTION TYPE: Monitoring	INSPECTOR(S): Daniel Cunningham	INSP. DATE: September 11, 2020	INSP. TIME: 09:00
OPERATOR: Castle Rock Construction Company of Colorado	OPERATOR REPRESENTATIVE: Darren Janssen	TYPE OF OPERATION: 111 - Construction by Government Agency	
REASON FOR INSPECTION: Normal I&E Program	BOND CALCULATION TYPE: None	BOND AMOUNT: \$44,750.00	
DATE OF COMPLAINT: NA	POST INSP. CONTACTS: None	JOINT INSP. AGENCY: None	
WEATHER: Clear	INSPECTOR'S SIGNATURE:

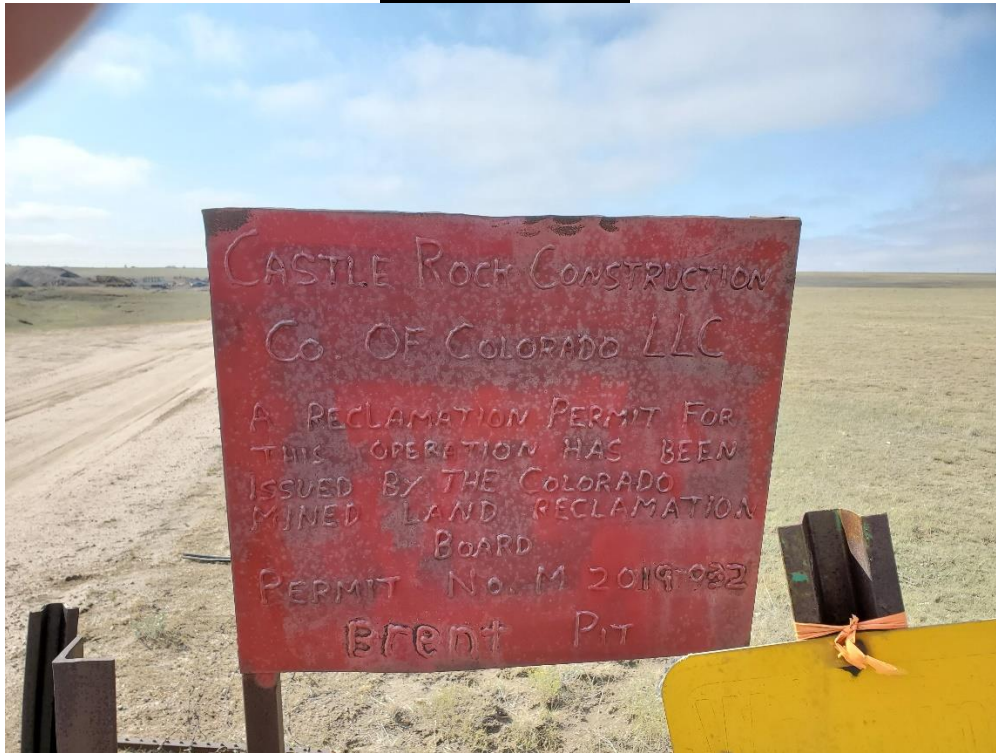
Mine Site Entrance

The site identification sign was posted at the mine entrance and the permit boundary were marked with T post and an orange covering to help prevent cattle from rubbing on them. .

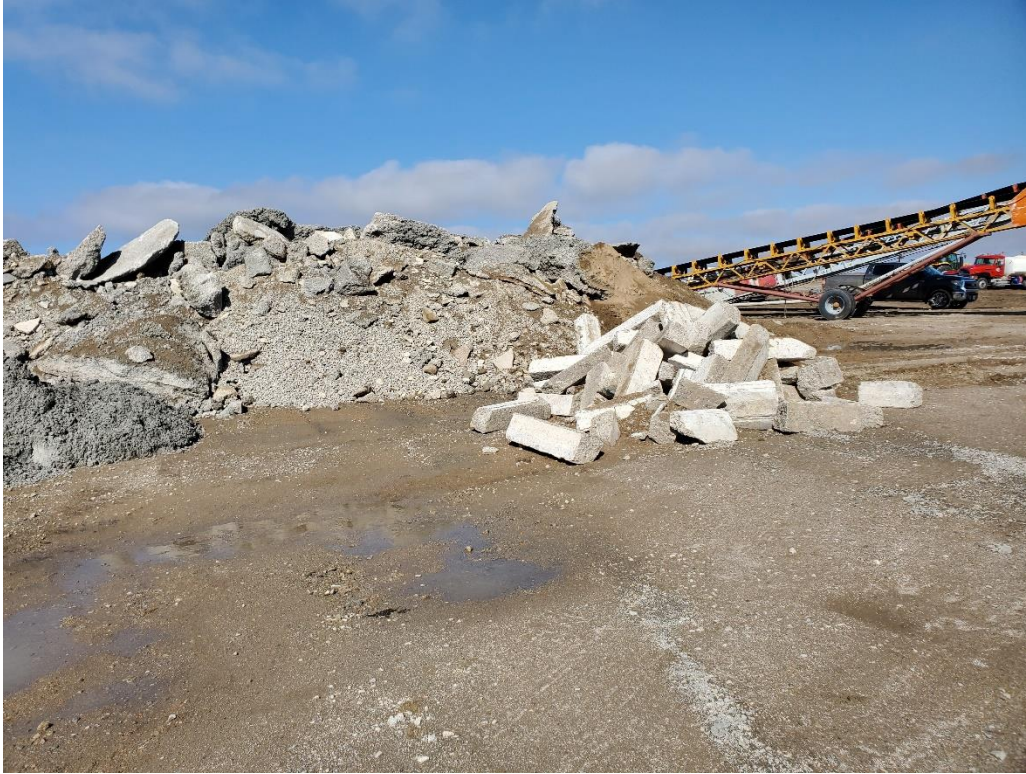
Crushed Concrete

A stockpile of broken up concrete was located in the middle of the permit. The Operator stated the material was going to be removed before reclamation work would begin. The Operator was also informed that if they wanted to use the material as backfill they would need to submit a Technical Revision to address using inert fill per Rule 3.1.5(9).

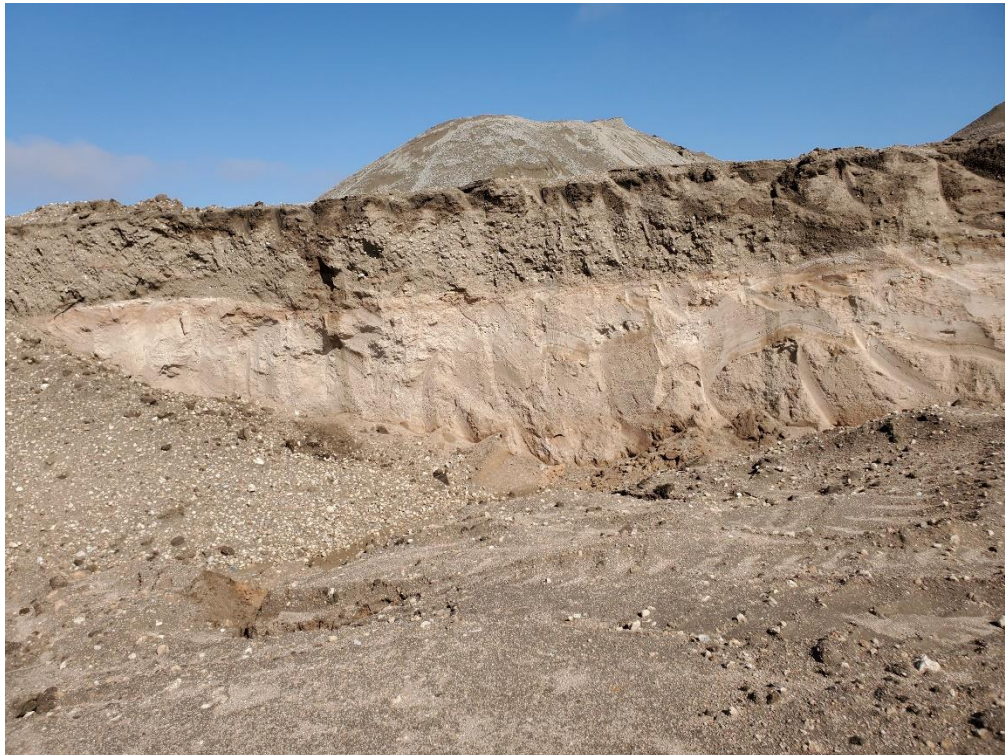
Highwall

A berm was noted around the haul road to prevent water runoff down the slope. A weight scale was located near the mine entrance. Several large stockpiles were located throughout the area. A 10 ft. high by 300 ft. long highwall was located in the center of the permit. A berm, consisting of topsoil, was located around the permit to help prevent offsite damage. A large topsoil pile was also located adjacent to the excavation area.

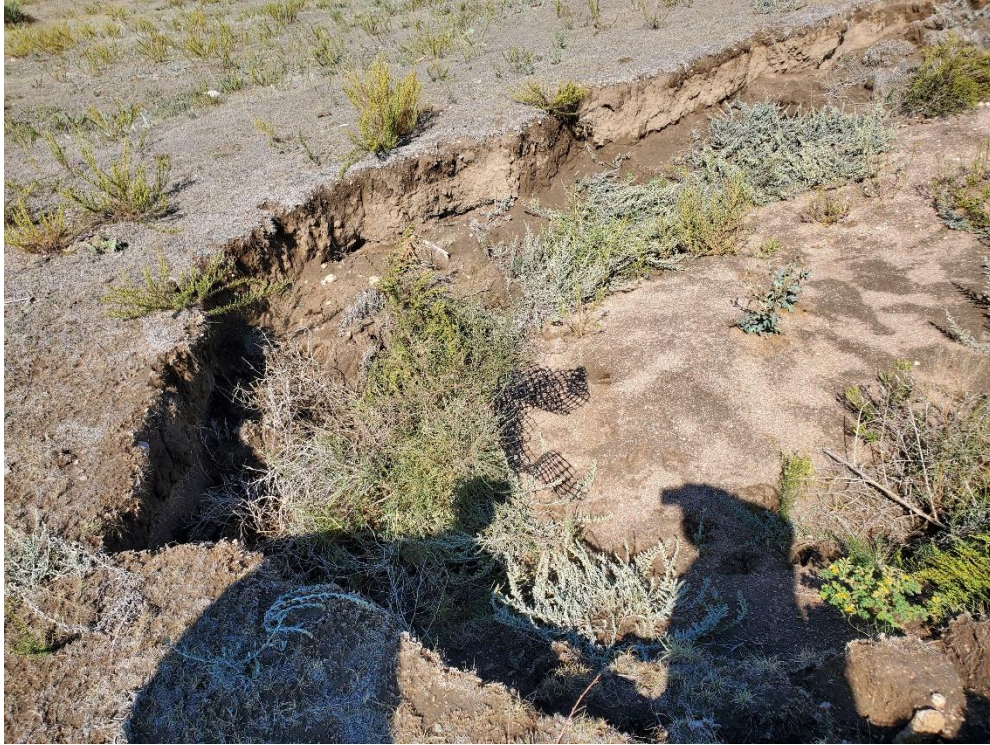
Natural Erosional Feature

A small naturally occurring erosional issue was located near the north eastern corner of the permit. In addition to the naturally occurring erosional issue, a pile of trash was located just outside the Northern permit boundary. This material appeared to have been located here for quite some time based on the amount of vegetation that has grown in the area.

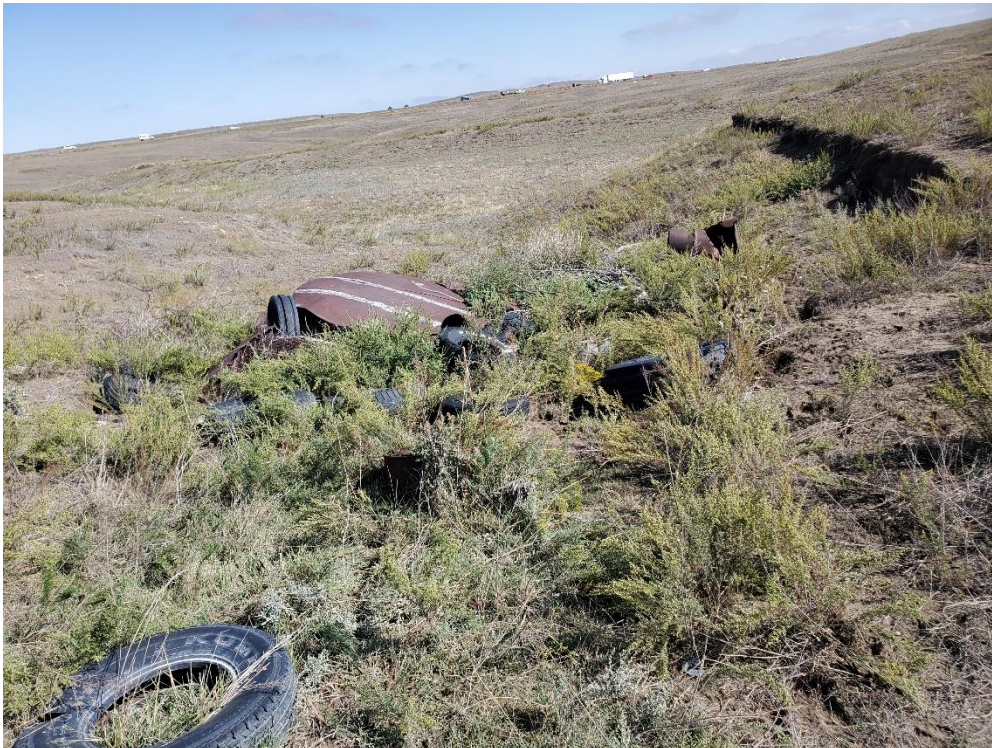
Trash just outside Northern Boundary
