MINERALS PROGRAM INSPECTION REPORT
PHONE: (303) 866-3567

MINE NAME: Vick Borrow Pit	MINE/PROSPECTING ID#: M-2010-048	MINERAL: Borrow material for	COUNTY: Lincoln
INSPECTION TYPE: Aerial Inspection	INSPECTOR(S): Daniel Cunningham	INSP. DATE: September 11, 2020	INSP. TIME: 11:00
OPERATOR: Castle Rock Construction Company of Colorado	OPERATOR REPRESENTATIVE: Darren Janssen	TYPE OF OPERATION: 111 - Construction by Government Agency	
REASON FOR INSPECTION: Normal I&E Program	BOND CALCULATION TYPE: Partial Bond	BOND AMOUNT: \$25,375.00	
DATE OF COMPLAINT: NA	POST INSP. CONTACTS: None	JOINT INSP. AGENCY: None	
WEATHER: Clear	INSPECTOR'S SIGNATURE:

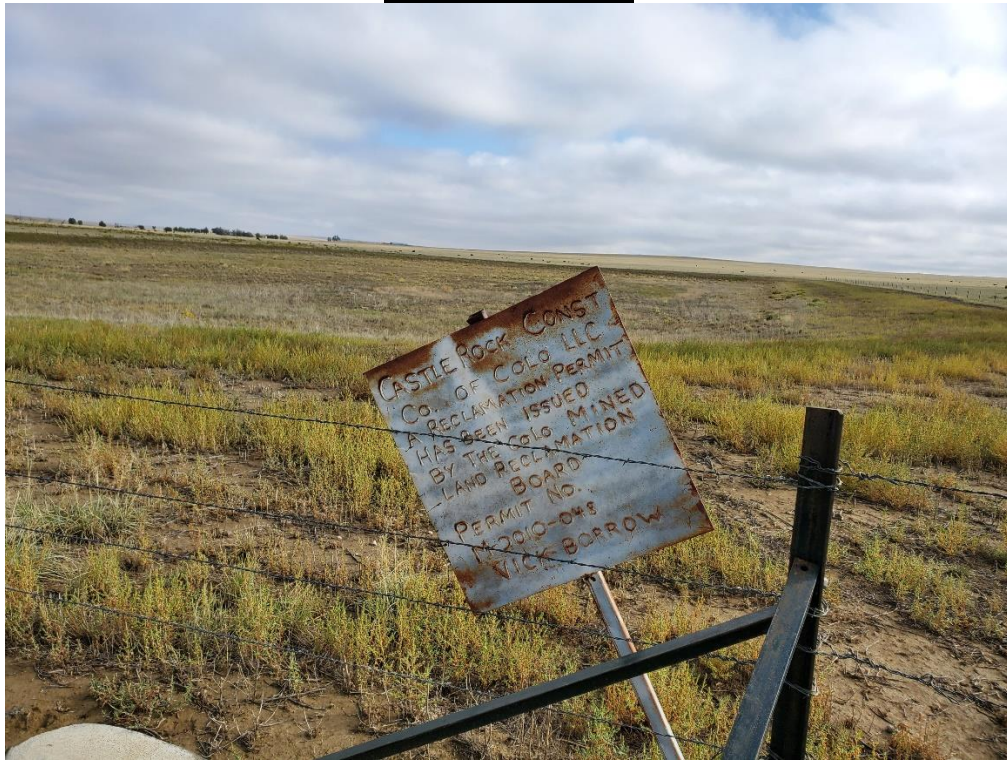
Mine Site Entrance

The site identification sign was posted at the mine entrance and the boundary was marked with a fence. Vegetation of the site has improved, however it is not ready for release at this time. In a previous inspection, Canadian thistle, a state listed noxious weed, was seen throughout the permit and was noted as a problem at the time. However, during this inspection the noxious weed has been treated and dozens of dead or dying plants were seen throughout the site.

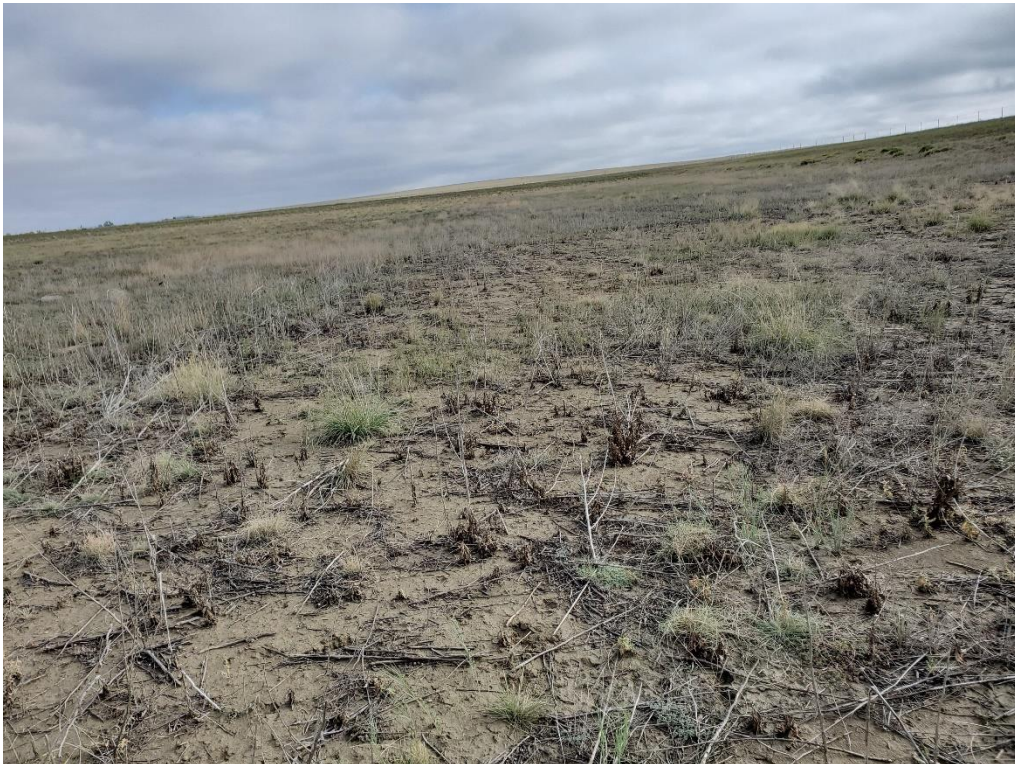
Treated Weeds

The Division is hopeful about the site and feels that another good fall or early spring seeding may provide enough vegetation cover to allow the site to be recommended for release by the next inspection.
