**MINERALS PROGRAM INSPECTION REPORT**  
**PHONE: (303) 866-3567**

<b>MINE NAME:</b> Ellis Allen Pit	<b>MINE/PROSPECTING ID#:</b> M-1984-185	<b>MINERAL:</b> Sand and gravel	<b>COUNTY:</b> Lincoln
<b>INSPECTION TYPE:</b> Monitoring	<b>INSPECTOR(S):</b> Daniel Cunningham	<b>INSP. DATE:</b> September 9, 2020	<b>INSP. TIME:</b> 12:00
<b>OPERATOR:</b> Lincoln County	<b>OPERATOR REPRESENTATIVE:</b> Fred Lundy	<b>TYPE OF OPERATION:</b> 110c - Construction Limited Impact	
<b>REASON FOR INSPECTION:</b> Normal I&E Program	<b>BOND CALCULATION TYPE:</b> None	<b>BOND AMOUNT:</b> \$0.00	
<b>DATE OF COMPLAINT:</b> NA	<b>POST INSP. CONTACTS:</b> None	<b>JOINT INSP. AGENCY:</b> None	
<b>WEATHER:</b> Clear	<b>INSPECTOR'S SIGNATURE:</b>

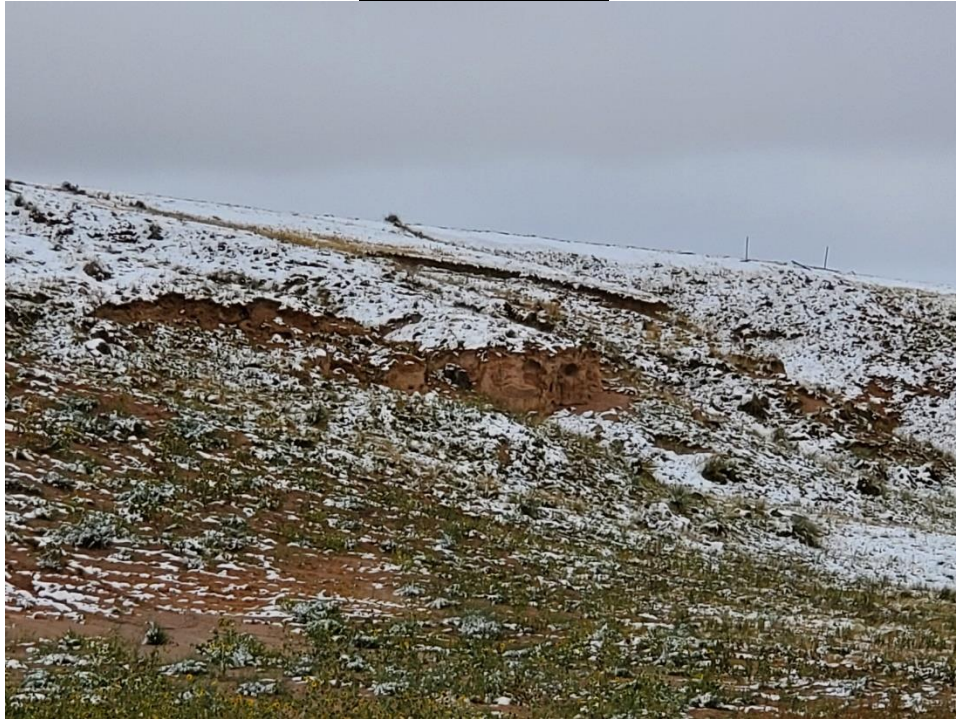
A minor issues was seen on the east side of the permit area where a slope has not been graded to a 3H:1V ratio. This area will need to be sloped to a 3H:1V and reseeded before the site can be considered for release.

Area that needs to be sloped to 3H:1V
