**MINERALS PROGRAM INSPECTION REPORT**  
**PHONE: (303) 866-3567**

<b>MINE NAME:</b> Hoffman Pit	<b>MINE/PROSPECTING ID#:</b> M-2005-044	<b>MINERAL:</b> Sand and gravel	<b>COUNTY:</b> Lincoln
<b>INSPECTION TYPE:</b> Monitoring	<b>INSPECTOR(S):</b> Daniel Cunningham	<b>INSP. DATE:</b> September 9, 2020	<b>INSP. TIME:</b> 10:00
<b>OPERATOR:</b> Lincoln County	<b>OPERATOR REPRESENTATIVE:</b> Fred Lundy	<b>TYPE OF OPERATION:</b> 112c - Construction Regular Operation

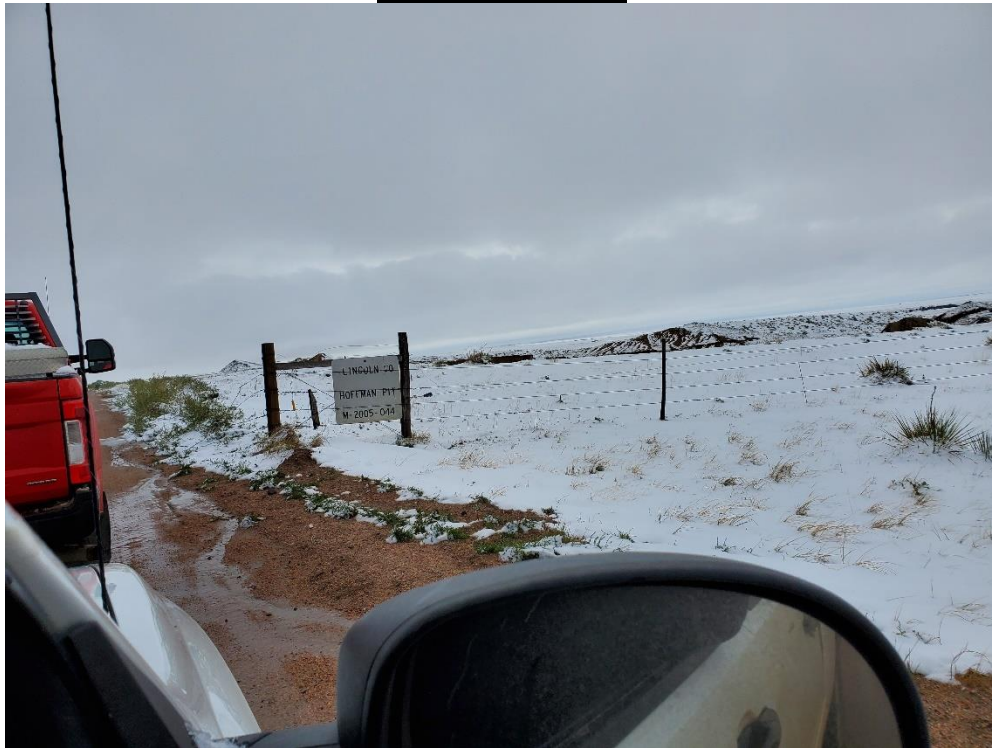
Mine Site Entrance

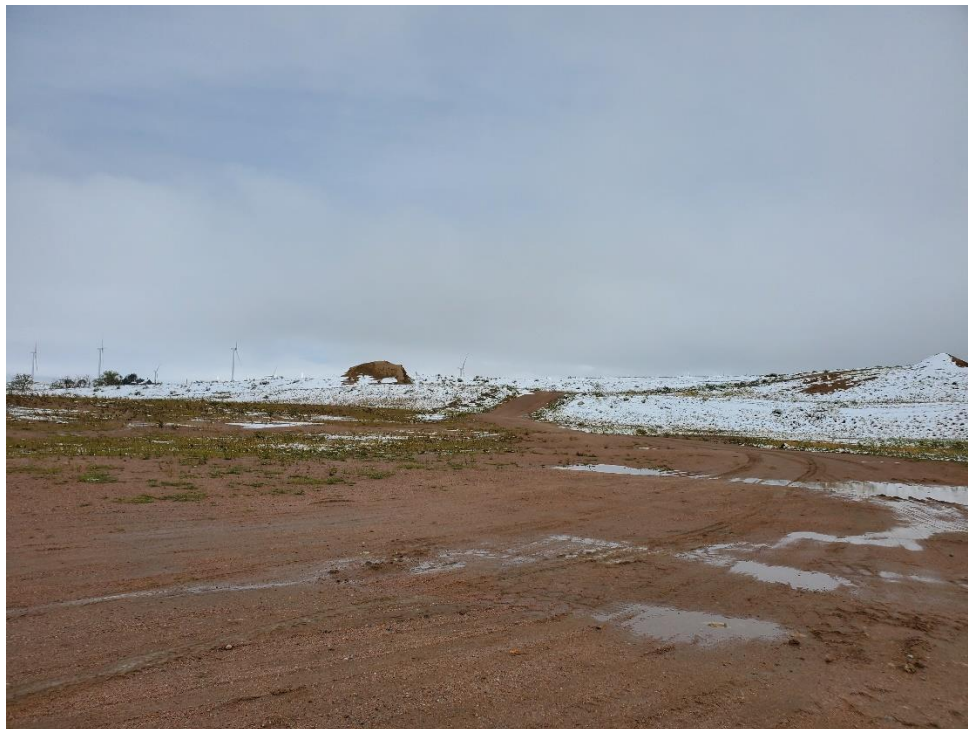
Pit Floor

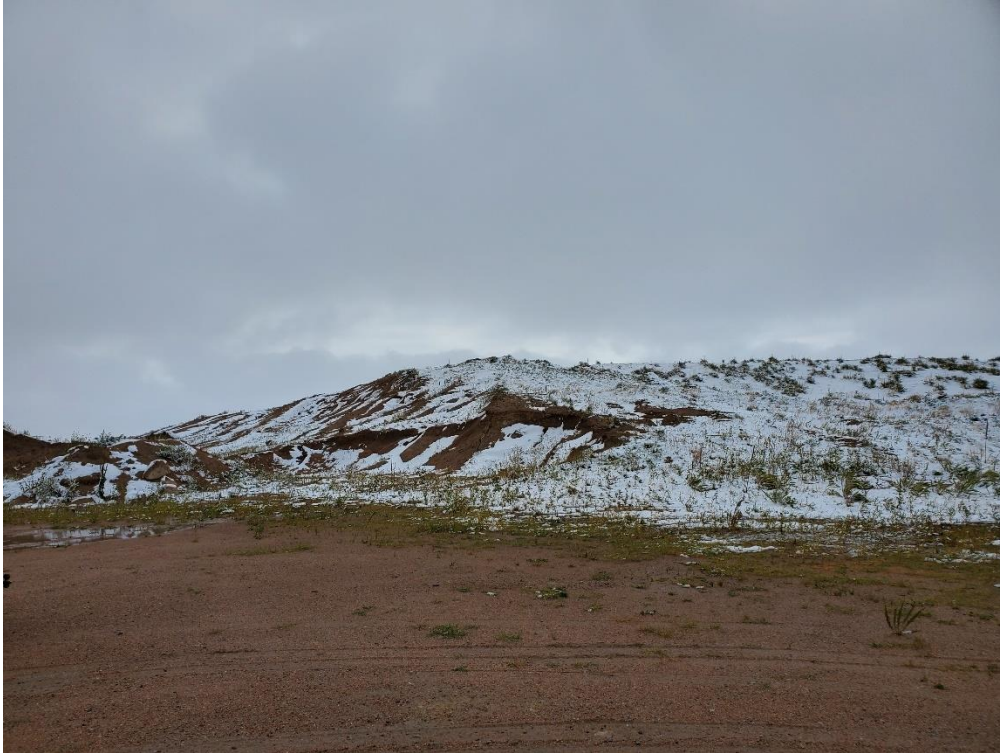
Overburden

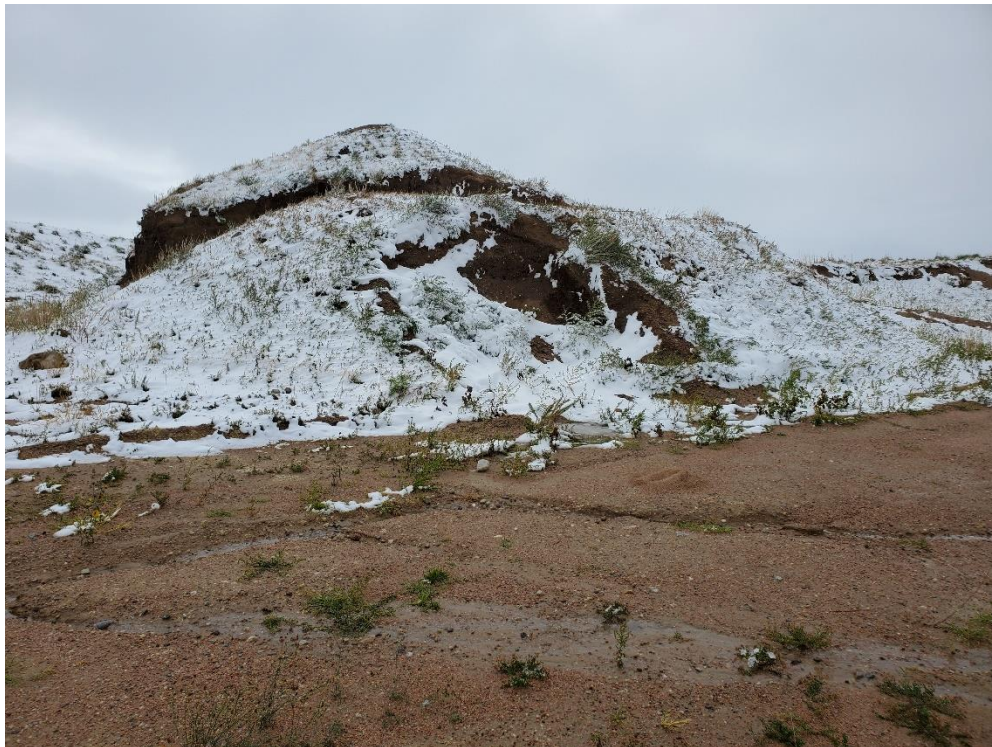
**PROBLEM:** Topsoil stockpiles were not configured and stabilized with vegetation to protect against wind and water erosion in accordance with Rule 3.1.9.

Existing topsoil stockpiles were not stabilized to help prevent erosion in accordance with Rule 3.1.9. This is cited as a problem at the beginning of this report. The Operator will need to submit proof the topsoil stockpile has been reshaped and is stable.

Topsoil Pile with Erosional Issue

**CORRECTIVE ACTIONS:** Submit evidence the topsoil stockpiles have been reconfigured and seeded with an appropriate seed mixture to stabilize them from erosion.
