PERMIT INFORMATION

Permit Number: C-1981-018 Mine Name: Deserado Mine Operator: Blue Mountain Energy, Inc. Operator Address: Mr. Kurtis Blunt 3607 County Road 65 Rangely, CO, 81648	County: Moffat, Rio Blanco Operation Type: Underground Permit Status: Active Ownership: Private
	Operator Representative Present: NA
Operator Representative Signature: (Field Issuance Only)

Inspection Start Date: September 17, 2020 Inspection Start Time: 09:41 Inspection End Date: September 17, 2020 Inspection End Time: 09:44		Inspection Type: Aerial Inspection Inspection Reason: Normal I&E Program Weather: Clear	
Joint Inspection Agency: None		Joint Inspection Contacts: None	
Post Inspection Agency: None		Post Inspection Contacts: None	
Inspector(s): Clayton Wein Brock Bowles	Inspector's Signature: <i>Clayton Wein</i>		Signature Date: 9/23/2020

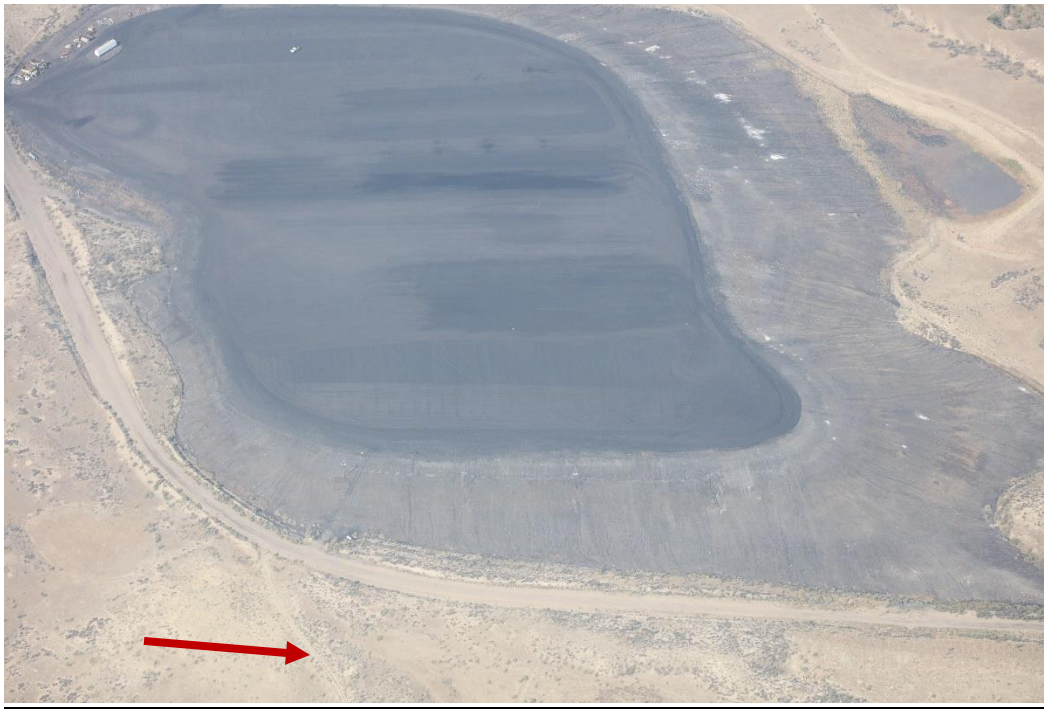
The RP-2/3/4 Refuse Pile was stable during the inspection (Photo 1). The refuse on top of the pile had been spread out and compacted. The slopes of the pile showed localized erosion in the form of rills. These rills have been documented in previous Division inspection reports. The slopes of the pile will be included in the spring maintenance list in 2021. The rills do not appear to affect the stability of the refuse pile. The perimeter ditches for the pile were dry. The ditches were clear from obstructions and stable.

Photo 1: The RP-2/3/4 Refuse Pile.

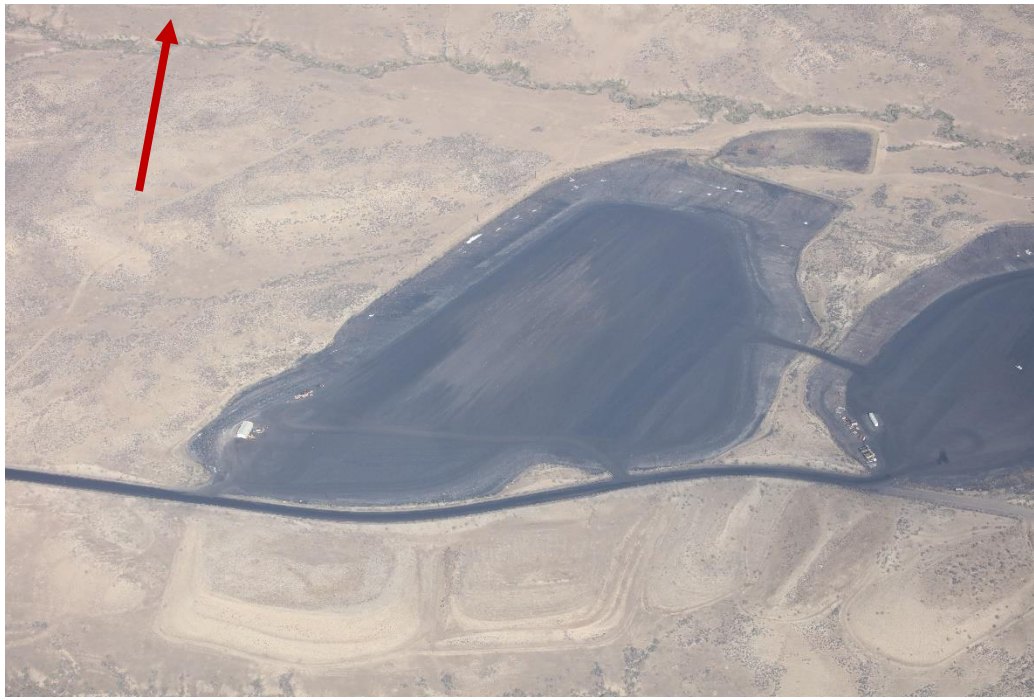
The RP-5a Refuse Pile was stable (Photo 2). The refuse on top of the pile had been spread out and compacted. The slopes of the pile have localized erosion on them in the form of rills. The rills do not appear to be deep enough to affect the stability of the pile. The rills on the slopes have been documented in previous Division inspection reports. The rills will be included on the spring maintenance list for 2021. The perimeter ditches for the pile were dry and stable. There were no indications of erosional issues.

Photo 2: The RP-5a Refuse Pile.

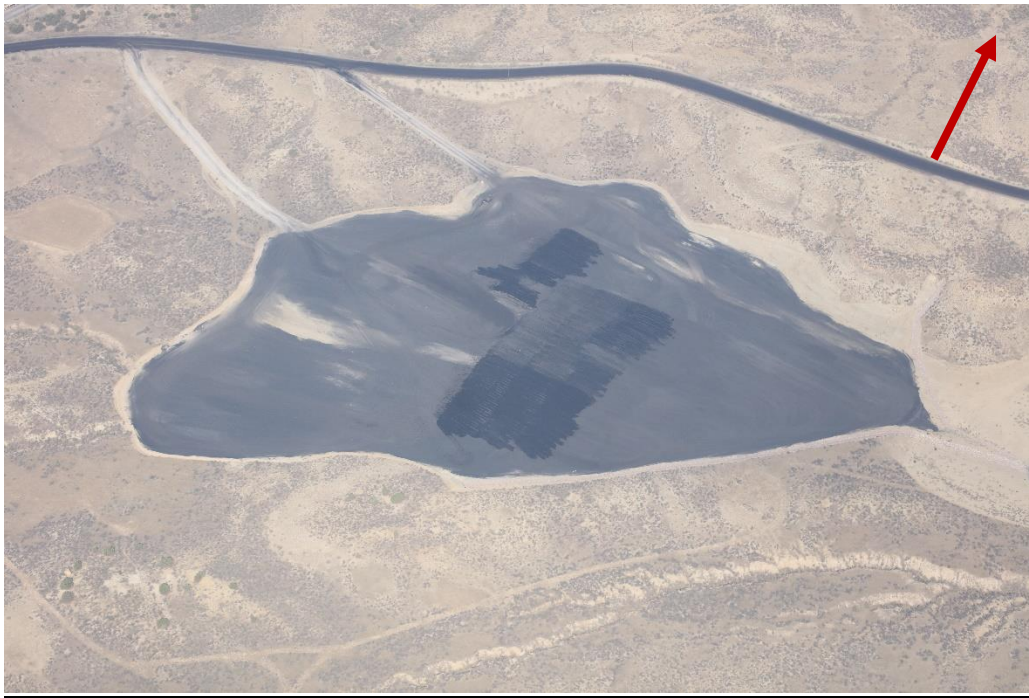
The placement of refuse material on the new RP-A Refuse Pile has progressed over the last few months. Material has been added to the pile to help create the first lifts of the base of the pile (Photo 3). Material placed on the pile has remained in place and no visible slumping was identified. The perimeter ditches for the pile were stable and clear of debris. There were no indications of erosional features at the site.

Photo 3: The RP-A Refuse Pile.

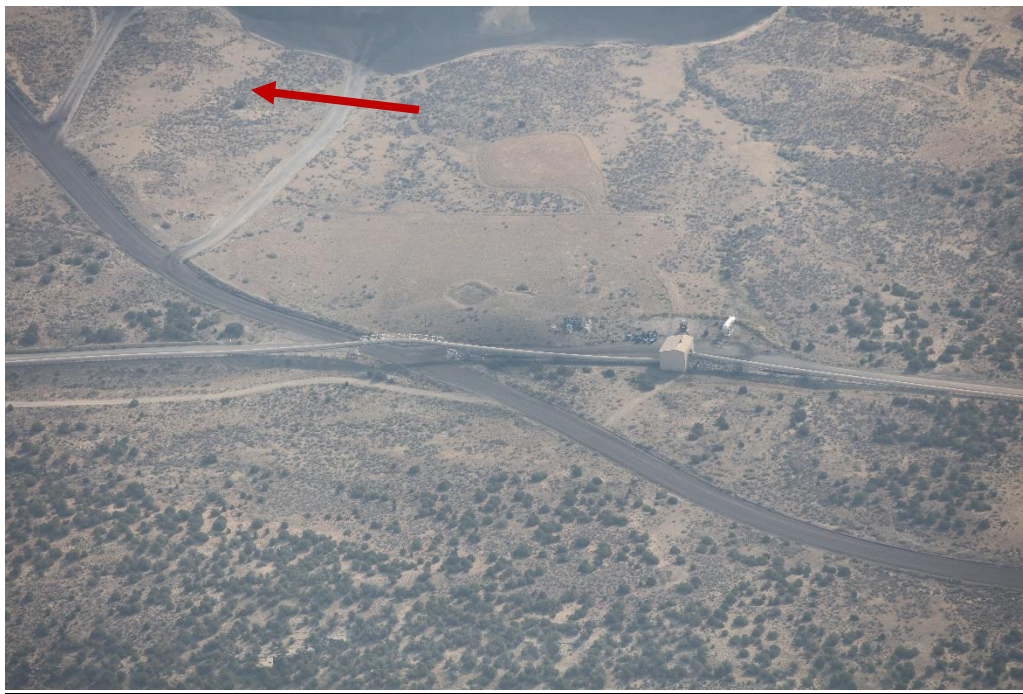
The Haul Road was in good condition at the time of the inspection (Photo 4). The road had no indications

of erosional features or instability. The ditches for the Haul Road were clear of debris and dry. Access roads throughout the site appeared to be well kept. There were no erosional concerns identified or indications of instability.

Photo 4: The intersection between the Haul Road and the Conveyor Corridor.

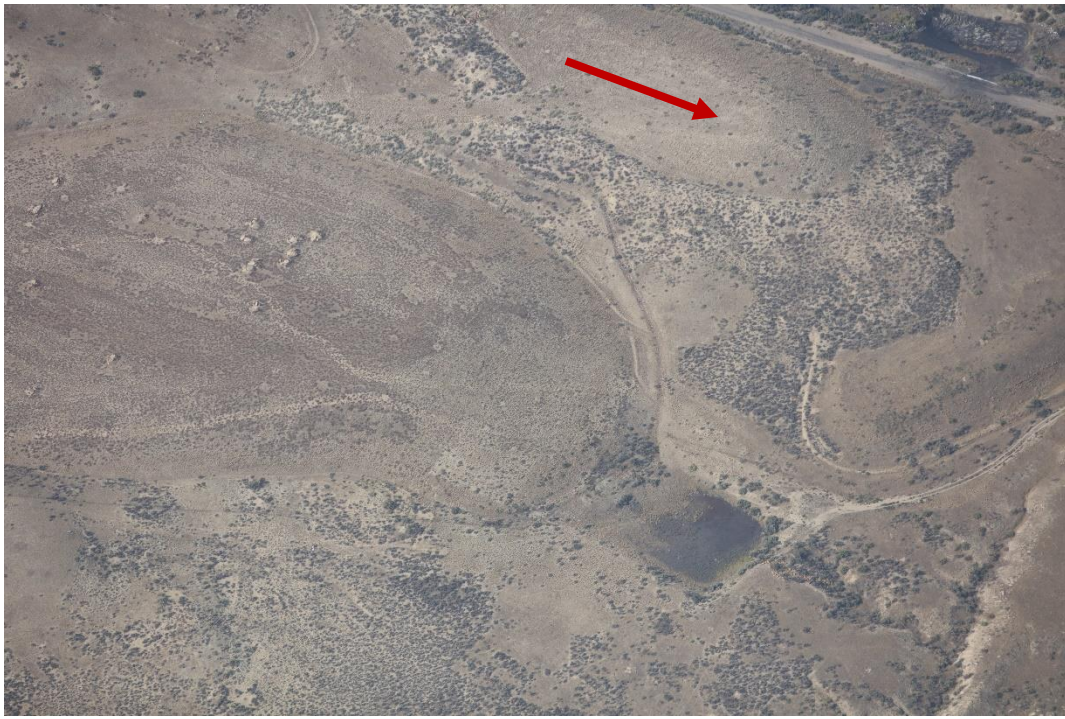
The RP-1 Refuse Pile is the only reclaimed pile at the mine site (Photo 5). The pile has been reclaimed for several years. The pile was vegetated and stable. There were no erosional features identified. The perimeter ditches were clear of debris and dry during the inspection. Several large rocks can be seen on top of the reclaimed pile. These rocks were placed there to create wildlife habitat.

Photo 5: The RP-1 Reclaimed Refuse Pile.

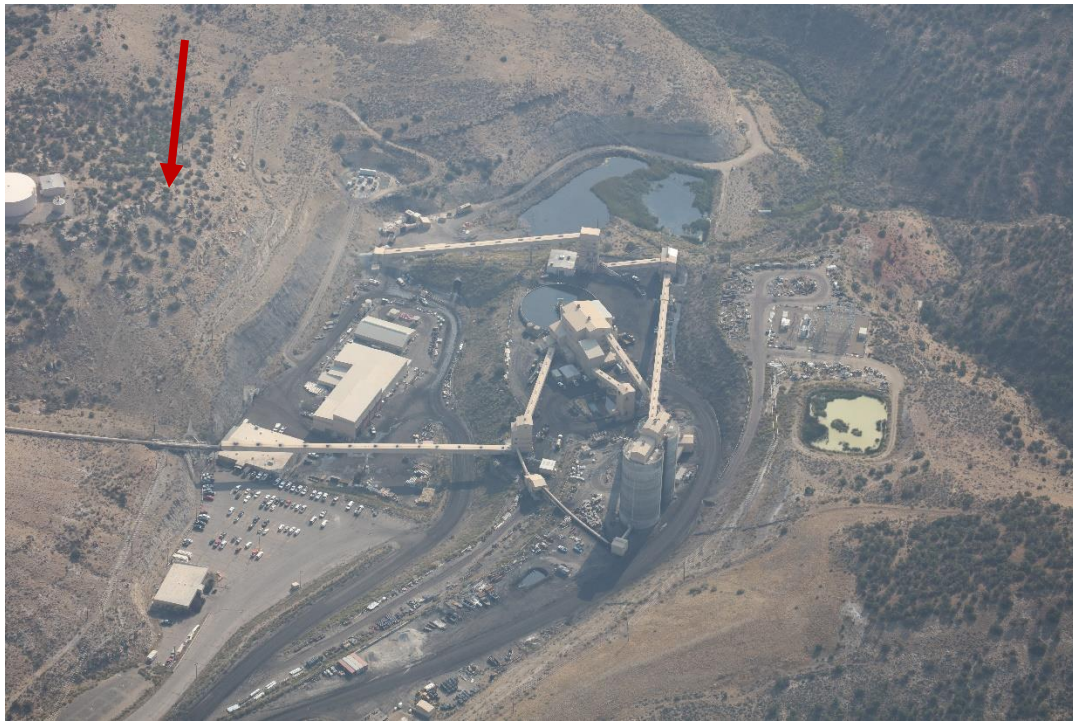
The pads for the above mentioned facilities were in good condition. There was no evidence of erosional features. Berms for the pads were well vegetated and stable. Cut-slopes for the pads were stable and no sloughing was observed.

Photo 6: The Main Facilities and Portals Area.

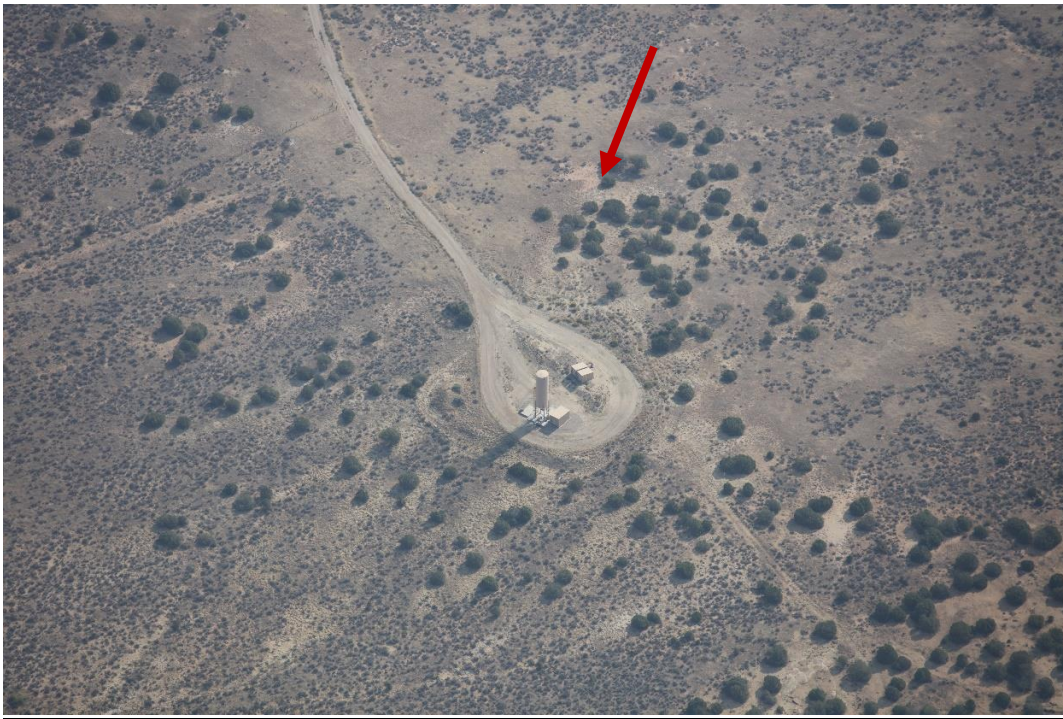
Photo 7: The RDH-2 (Rock Dust Hole) Pad.

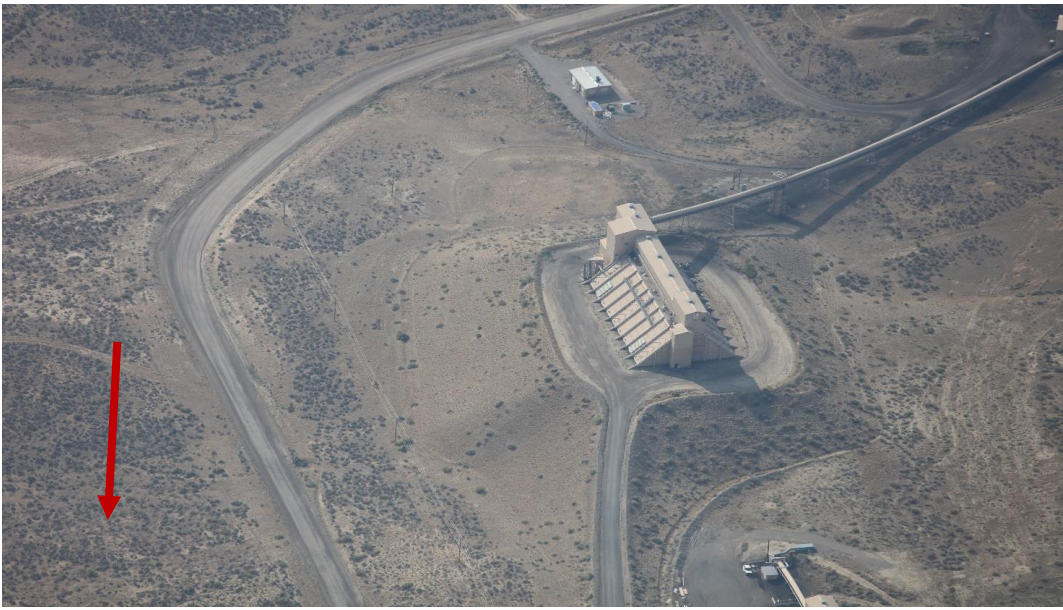
Photo 8: The Slot Storage Facility.
