COLORADO
Division of Reclamation,
Mining and Safety
Department of Natural Resources

Permit Number: C-2010-088 Mine Name: Fruita Loadout Operator: CAM-Colorado, LLC Operator Address: Ronald Hull 424 Lewis Hargett Circle Suite 250 Lexington, KY 40503	County: Mesa Operation Type: Loadout Permit Status: Temporary Cessation Ownership: Private
	Operator Representative Present: NA
Operator Representative Signature: (Field Issuance Only)

Inspection Start Date: September 15, 2020 Inspection Start Time: 11:25 Inspection End Date: September 15, 2020 Inspection End Time: 11:55		Inspection Type: Coal Complete Inspection Inspection Reason: Normal I&E Program Weather: Clear	
Joint Inspection Agency: None		Joint Inspection Contacts: None	
Post Inspection Agency: None		Post Inspection Contacts: None	
Inspector(s): Clayton Wein	Inspector's Signature: <i>Clayton Wein</i>		Signature Date: 9/23/2020

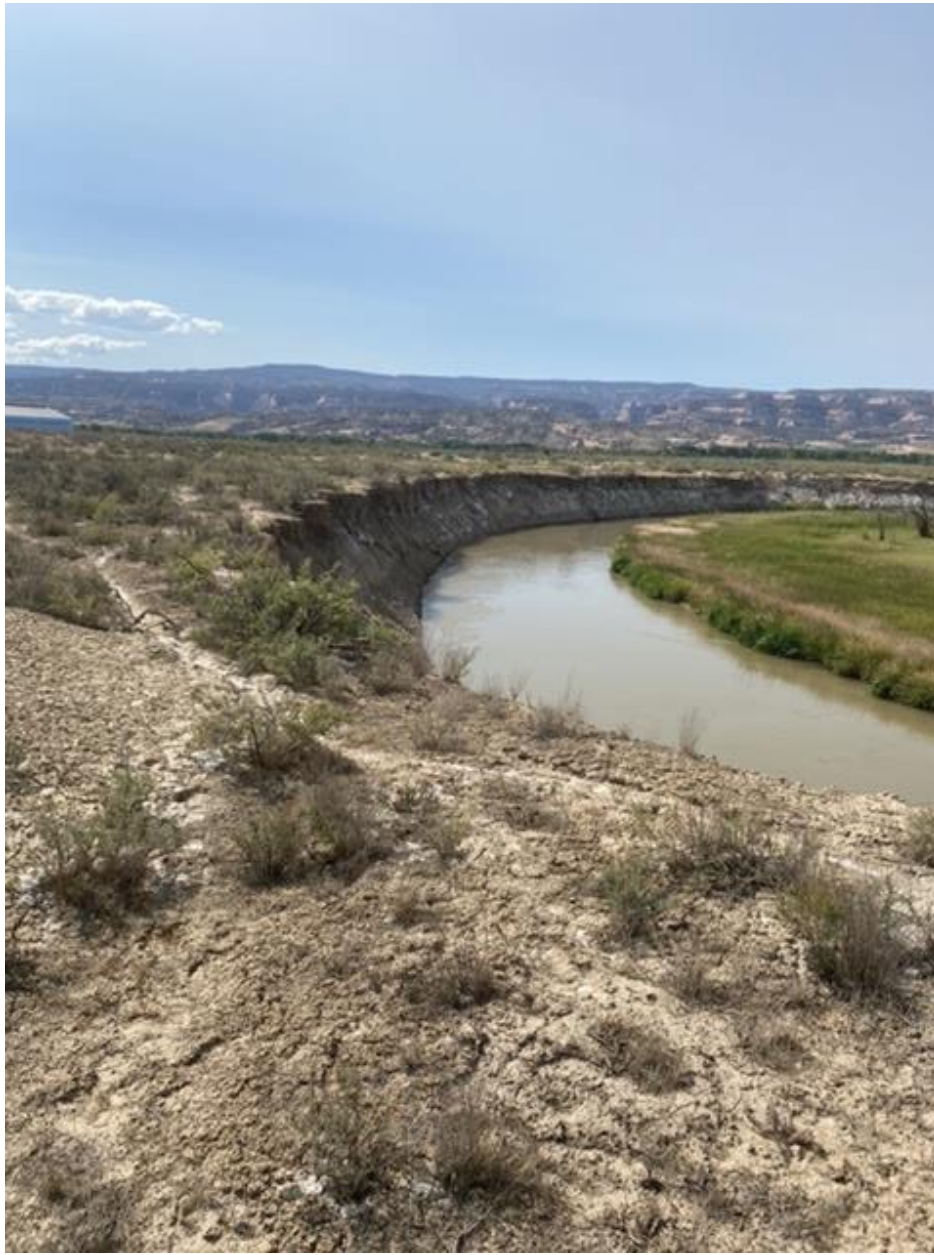
Reed Wash was flowing at the time of the inspection (Photo 1). The wash bisects the permit area by entering the north side of the site and the exiting at the south side of the permit. The Site has had no construction activities occur at it since it was permitted (Photo 2). No disturbances were identified during the inspection. There were no indications of instability or erosion observed.

Photo 1: Reed Wash. The photo was taken looking to the south.

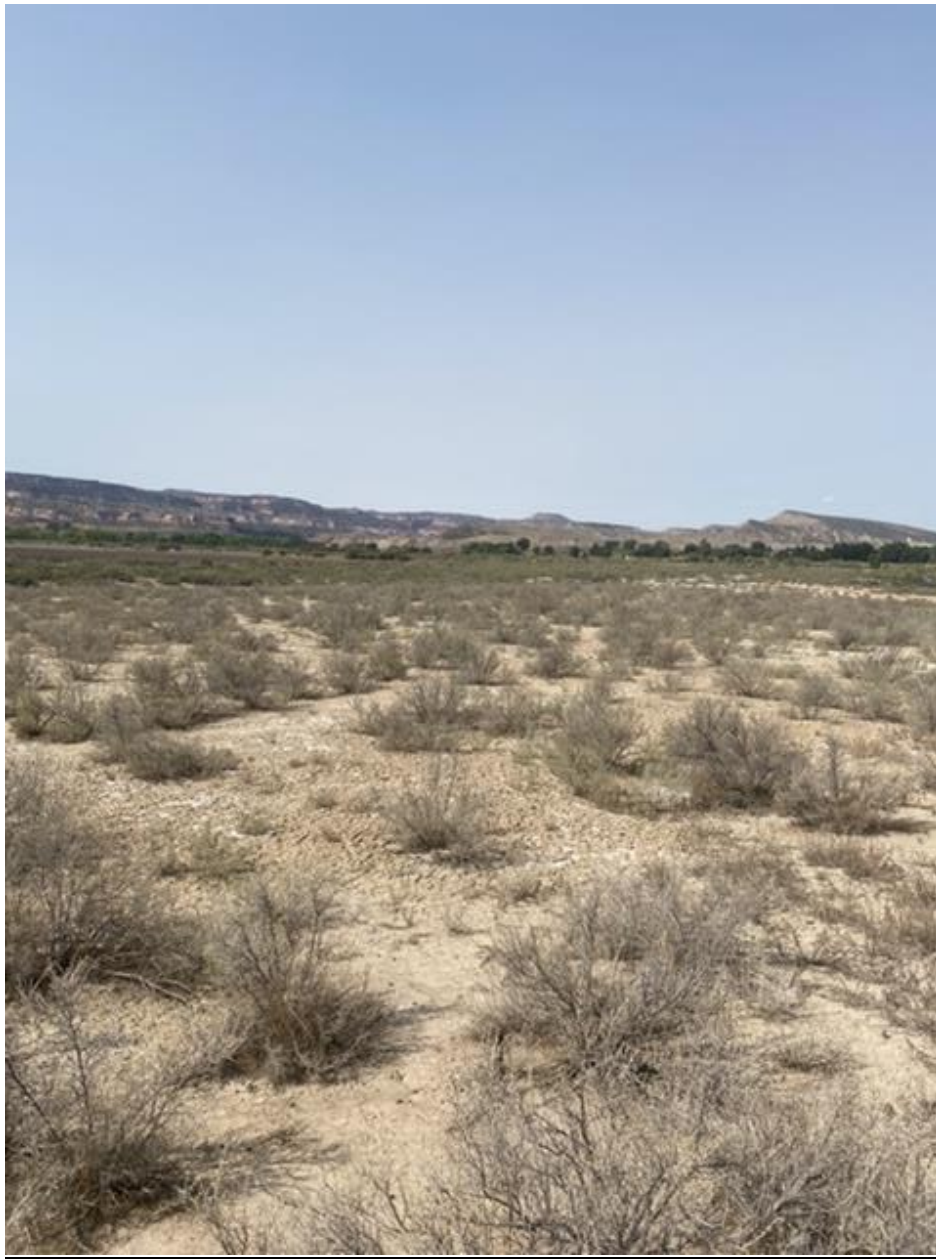
Photo 2: The loadout site, the photo was taken looking to the southwest.

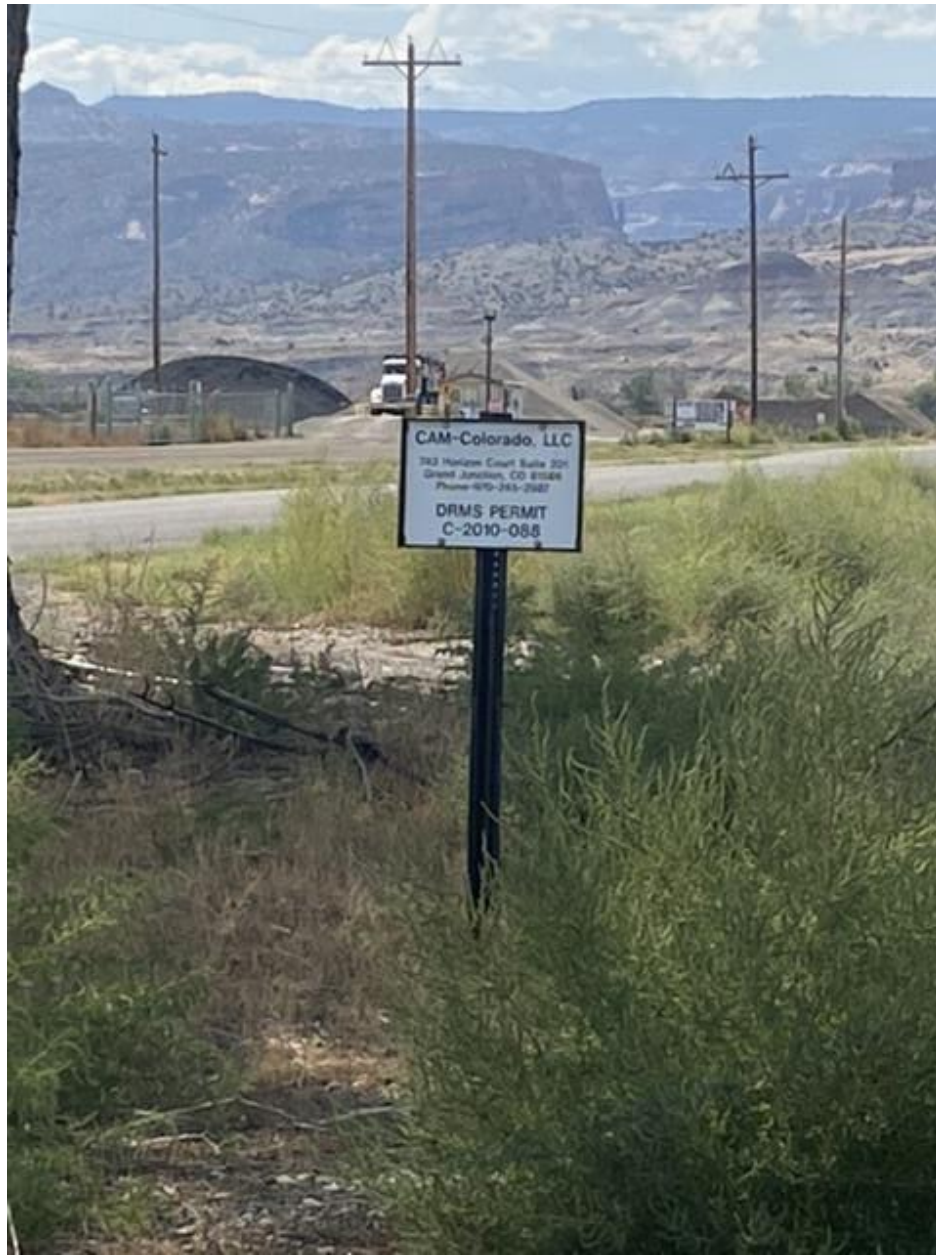
The mine identification sign was posted at the entrance to the site (Photo 3). The sign displayed the current contact information about the operator, the Division and the permit. The sign was in good condition and easy to locate.

Photo 3: The mine identification sign, located to the left of the entrance of the site.
