**MINERALS PROGRAM INSPECTION REPORT**  
**PHONE: (303) 866-3567**

<b>MINE NAME:</b> Strode Pit	<b>MINE/PROSPECTING ID#:</b> M-2019-002	<b>MINERAL:</b> Sand	<b>COUNTY:</b> Kit Carson
<b>INSPECTION TYPE:</b> Monitoring	<b>INSPECTOR(S):</b> Elliott Russell	<b>INSP. DATE:</b> September 4, 2020	<b>INSP. TIME:</b> 10:45
<b>OPERATOR:</b> Castle Rock Construction Company of Colorado, LLC	<b>OPERATOR REPRESENTATIVE:</b> Matt Fonte	<b>TYPE OF OPERATION:</b> 111 - Government Contract Related

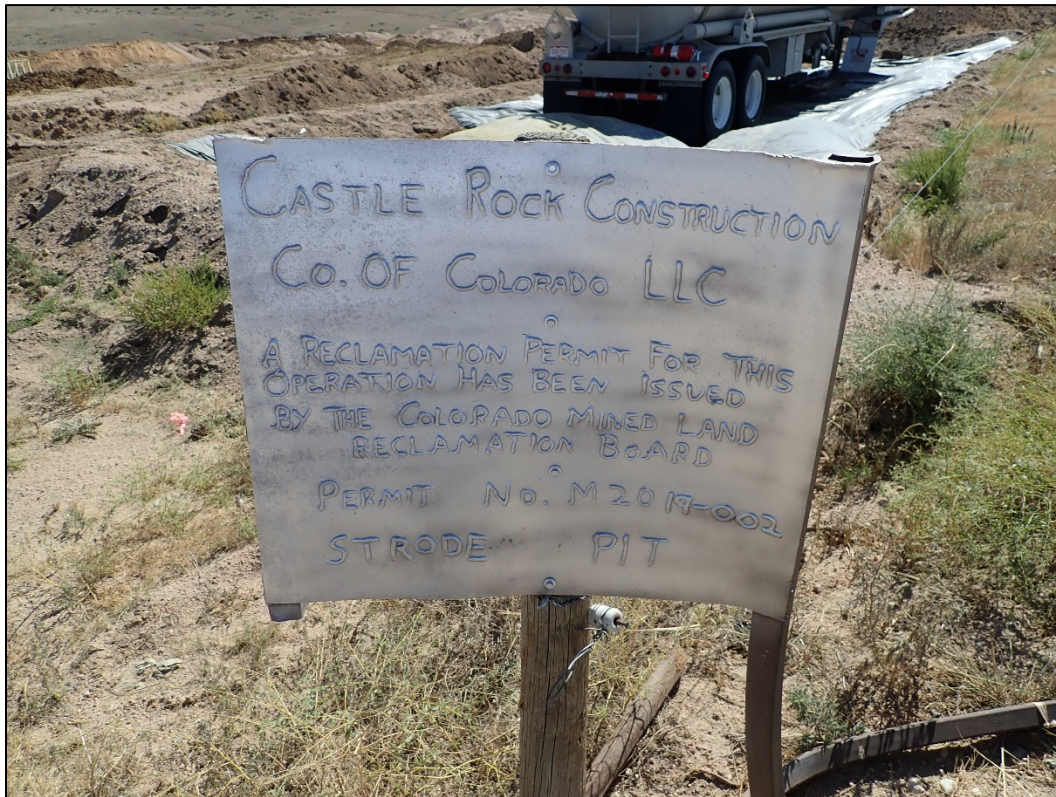
**Photo 1.** Permit identification sign; looking east.

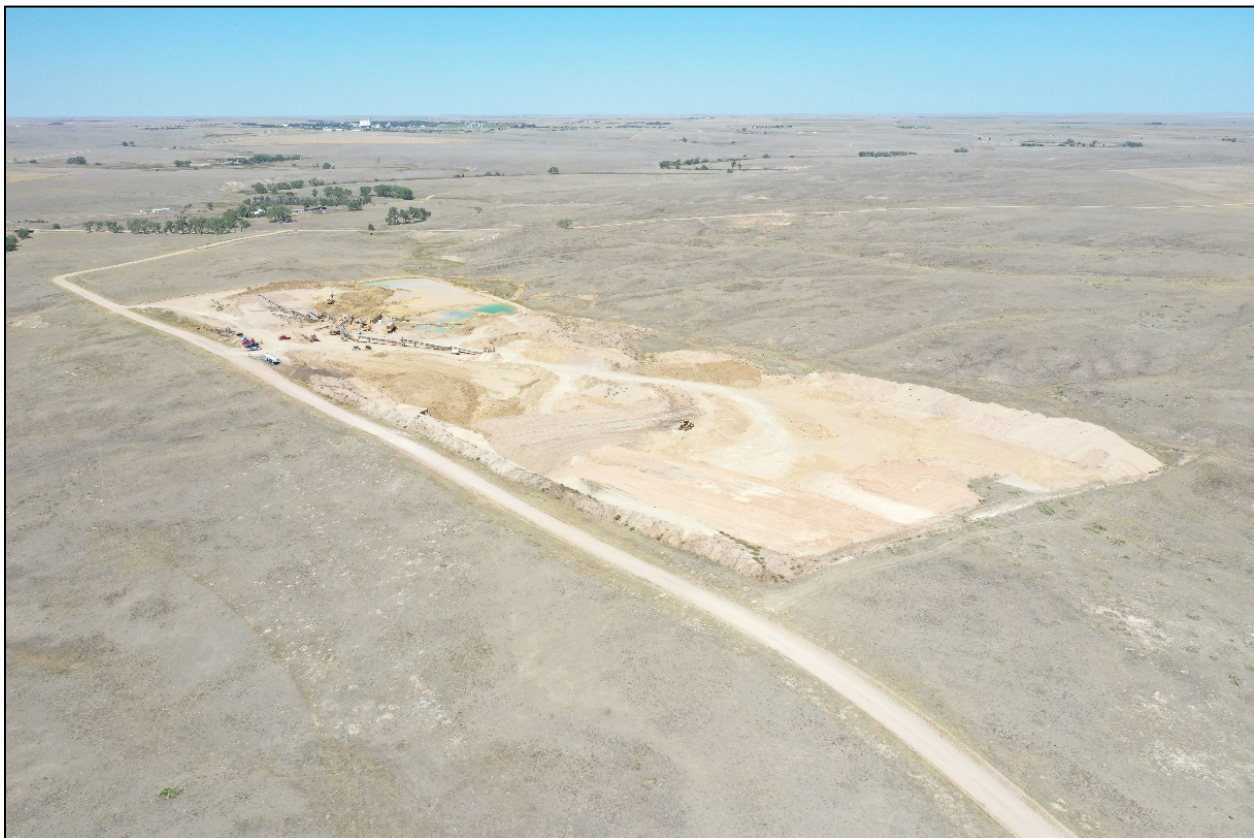
**Photo 2.** Mine site overview, CR 6 located west of the mine site; looking north.

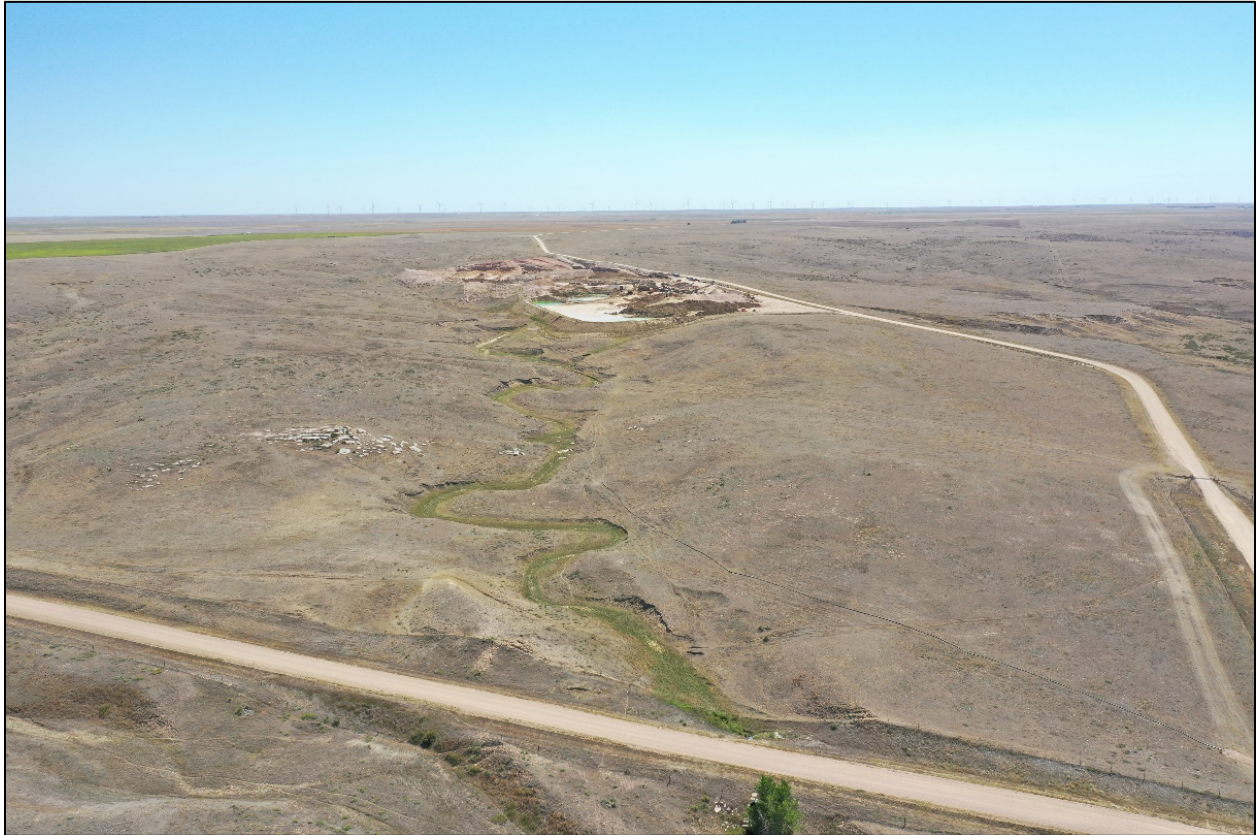
**Photo 3.** Mine site overview, CR R in foreground; looking south.

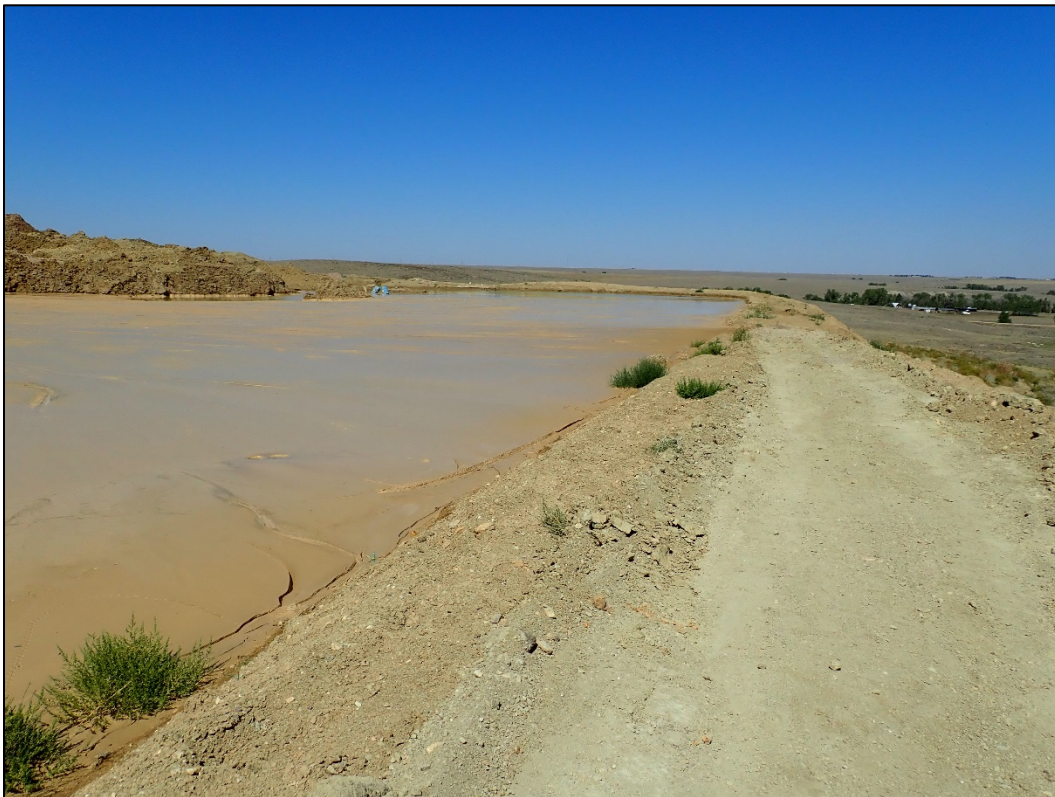
Mr. Fonte led the Division to the northern portion of the permit to the embankment of the sediment retaining area. This retaining area mainly consisted of mud/sediment with two small portions of standing water on the north and south side from the slurry decanting. The Division approximates the height of the embankment to be 30 feet at the highest point. Mr. Fonte stated that on Wednesday night (September 2<sup>nd</sup>) the capacity of the retaining area was reached and overtopped the embankment, causing wash water and fines to be discharged into the adjacent unnamed drainage. This drainage reports to the South Fork of the Republican River, which was dry at the time of the inspection, approximately 1/3 of a mile north.

**Photo 4.** Embankment of sediment storage area; looking northwest.

Immediately following the inspection, the Operator formally committed to ceasing mining and processing operations until the sediment storage embankment had been repaired, the embankment reinforced and increased in height by at least 1 foot, and moving forward, the Operator committed to utilizing the newly excavated forebay for the remaining processing needed to complete the sand requirements of the Interstate 70 reconstruction project. The Operator committed to providing the Division with photographic evidence of the repairs. On Tuesday, September 8, 2020, the Operator provided the Division with the repair work photos. The Division accepted the repair work and allowed the Operator to finish mining and processing at the site with the understanding that all waste from the processing plant needed to be contained in the forebay and under no circumstance was the Operator permitted to discharge any further sediment laden waters outside of the permit area.

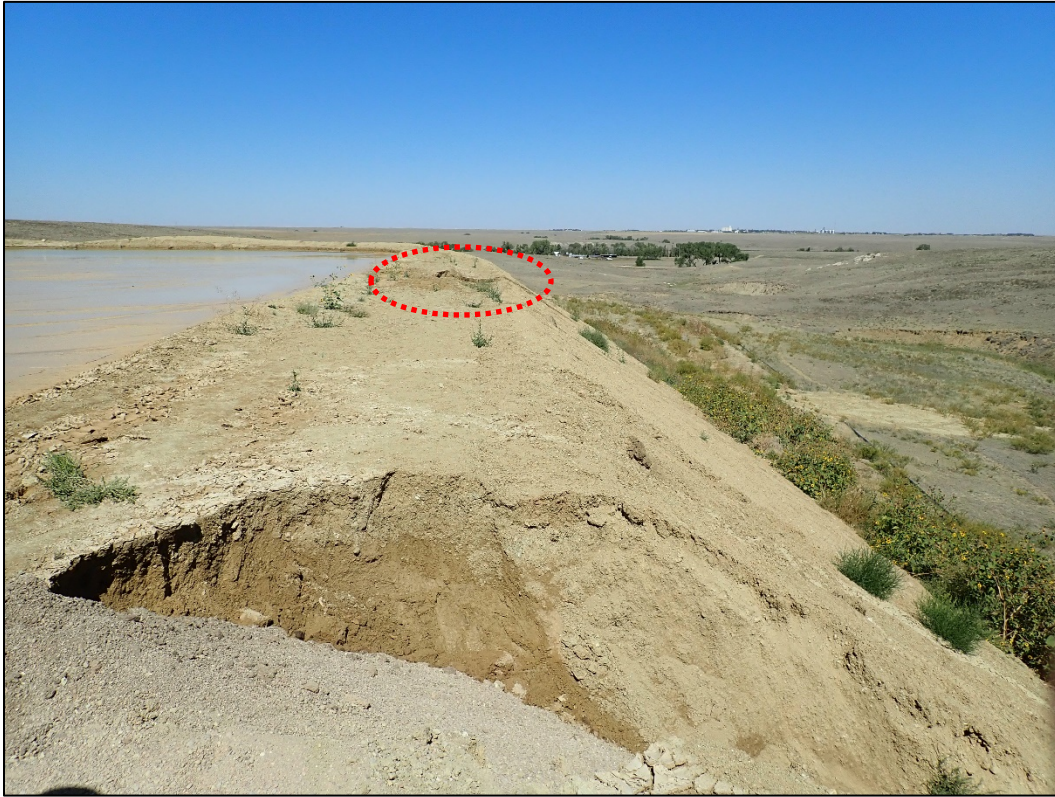
The overtopping caused a head cut erosional feature in the outside face of the embankment, approximately 10 feet by 10 feet and 5 feet deep. It appears the Operator placed material in the head cut to prevent further discharge. The Operator stated that the following morning (Thursday, September 3<sup>rd</sup>) a second overtopping occurred, approximately 100 feet north of the first event. This created an additional head cut in the outside face of the embankment, approximately 10 feet by 15 feet and 4 feet deep. To stop the overtopping and potential failure of the embankment, the Operator rerouted the pump used to pump decanted water to the cleaned water pond, and discharged water north of the northern permit boundary directly into the unnamed drainage. The Division has identified this as the Pump Discharge Point on the attached Inspection Report Map. The pump and associated hoses had been moved by the time the Division inspected the site. To prevent further overtopping, the Operator also created a new forebay well within the mud retaining area where future mud and process water could be contained without reaching the embankment. Upon review of the permit file after the inspection, and confirmation from the Colorado Department of Health and Environment, the site has a storm water discharge permit, however this permit does not allow the discharge of process waters.

**Photo 5.** First overtopping head cut, second is circled in the background; looking northwest.

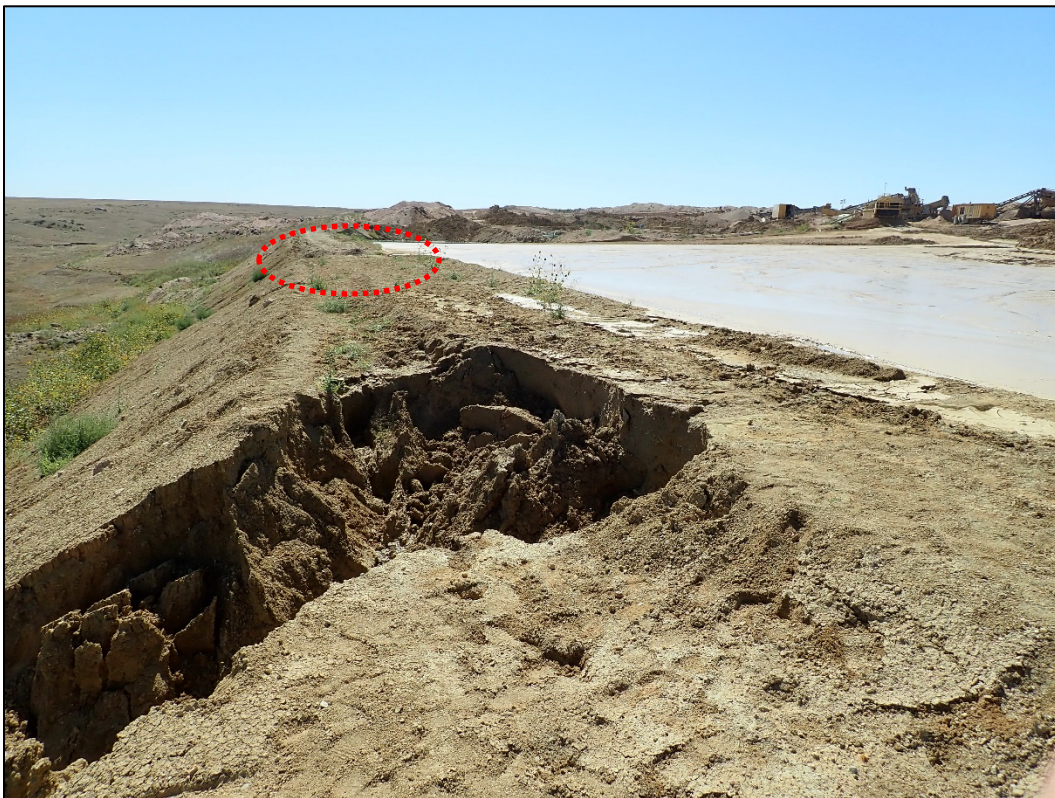
**Photo 6.** Second overtopping head cut, first is circled in the background; looking southeast.

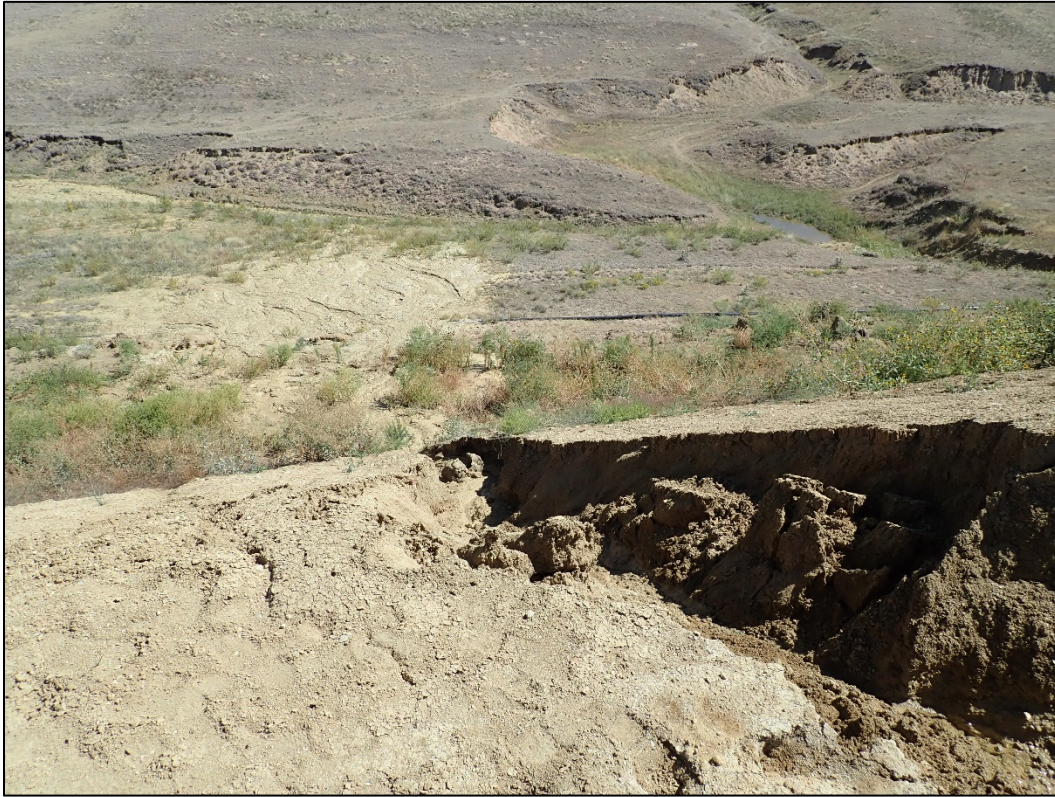
**Photo 7.** Second overtopping head cut; looking east toward the unnamed drainage.

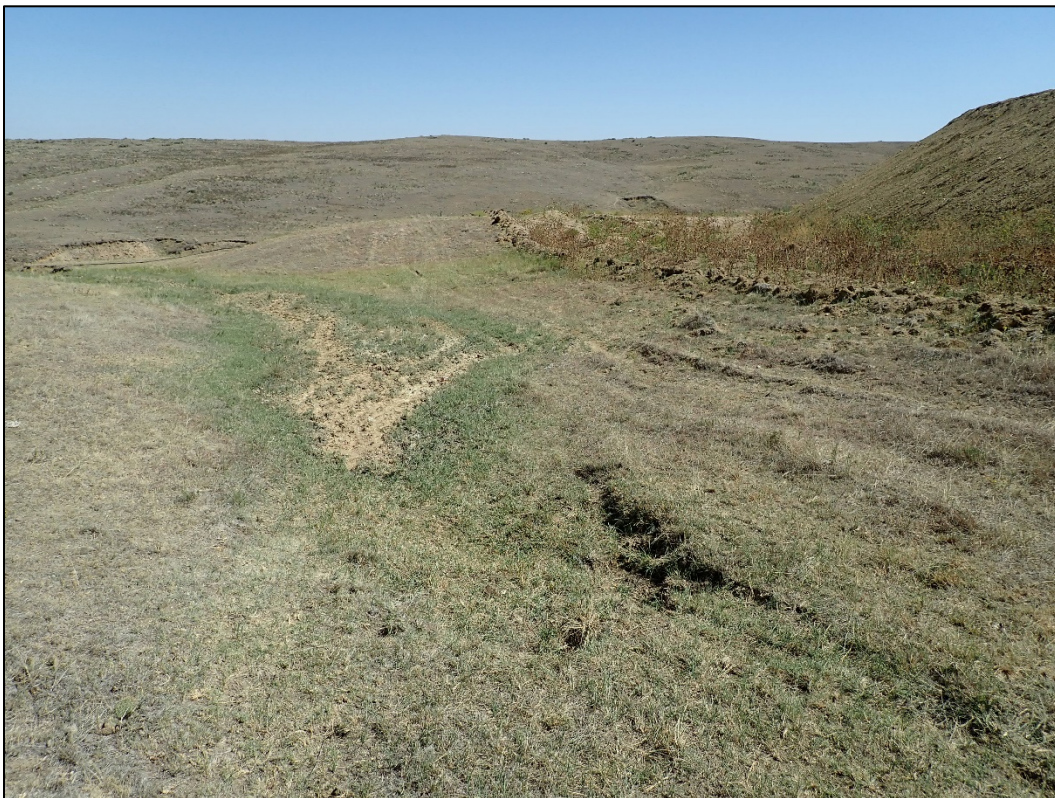
**Photo 8.** Pump discharge point; looking east.

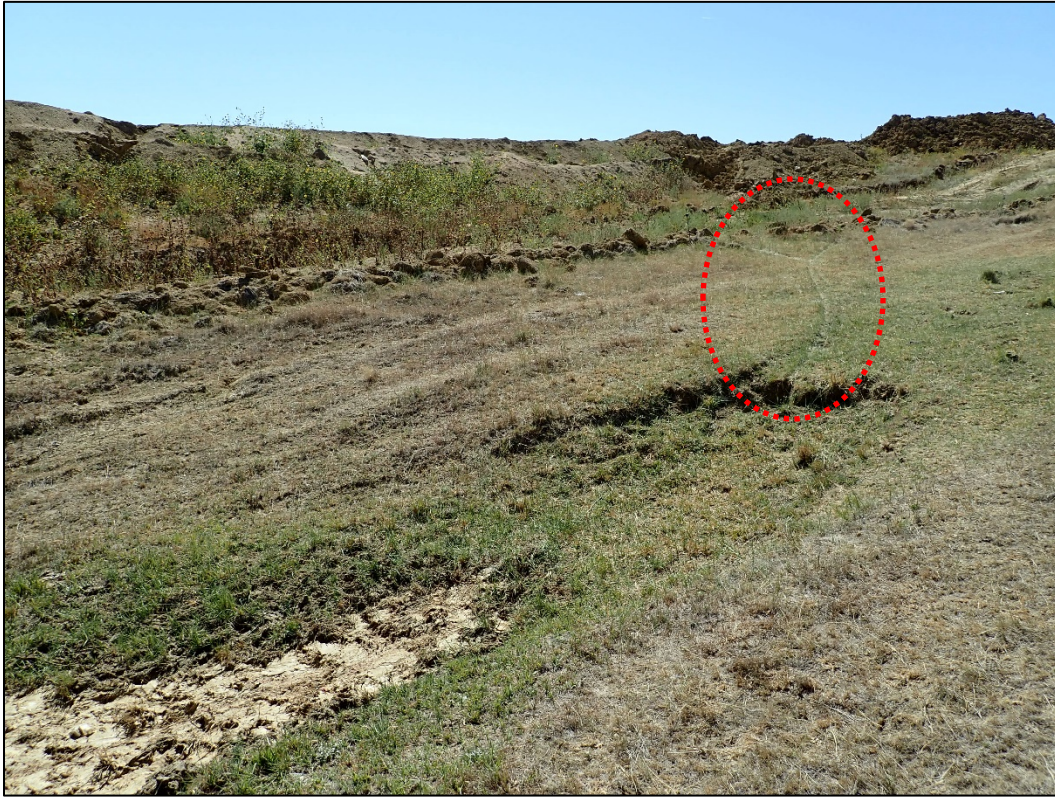
**Photo 9.** Pump Discharge Point, hose impression circled; looking south.

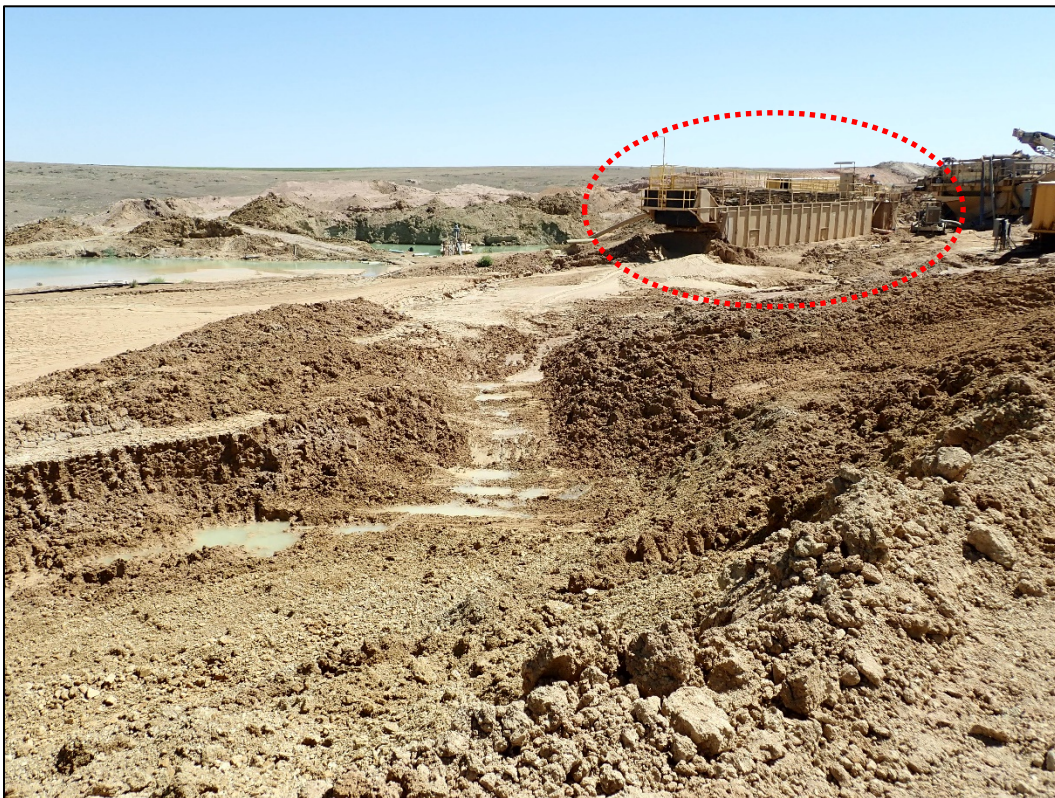
**Photo 10.** Newly excavated forebay within sediment storage area, Jadair Water Clarifier circled; looking southeast.

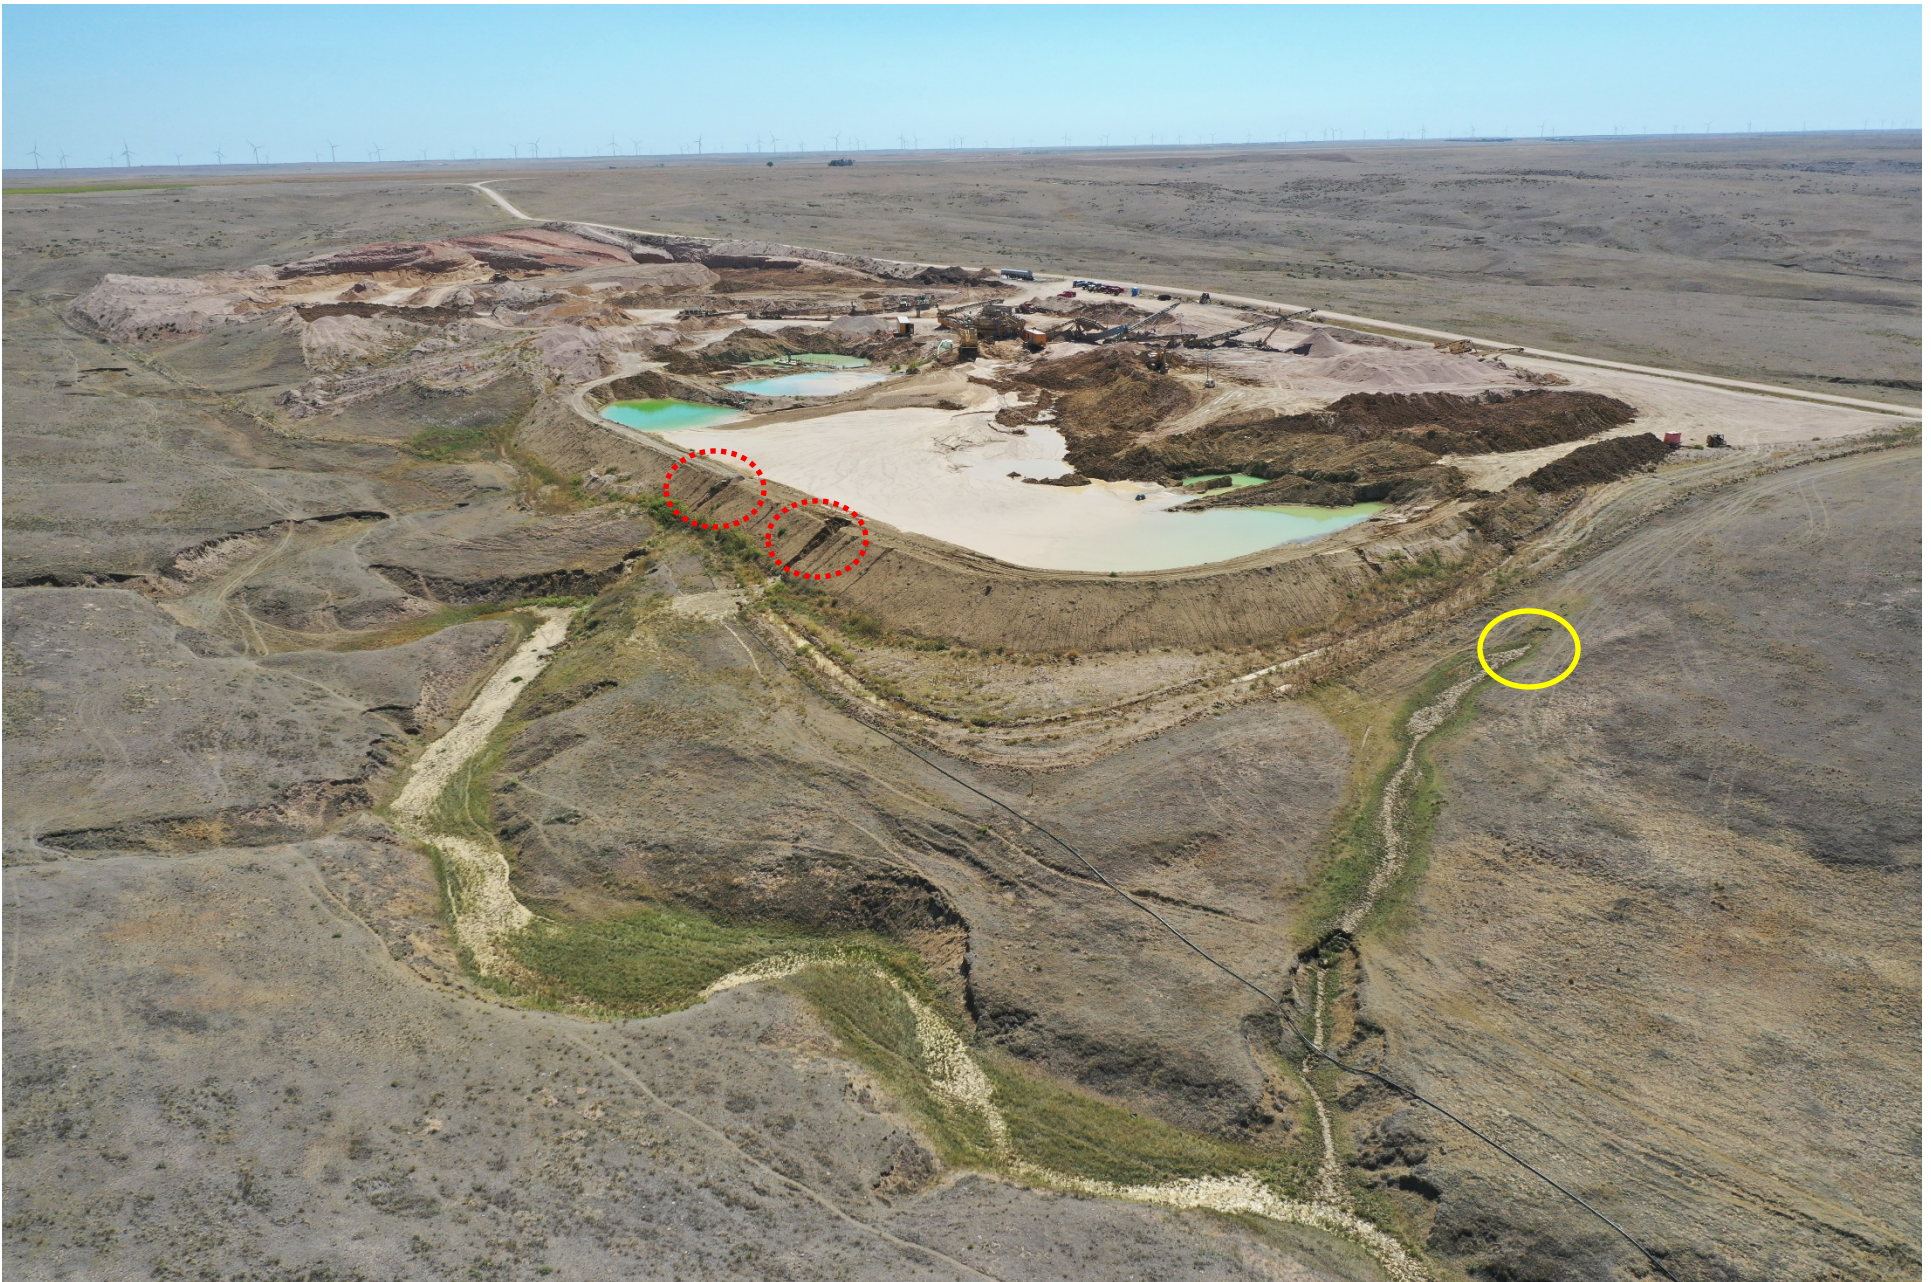
**Photo 11.** Aerial over discharge area, overtopping circled in dashed red, Pump Discharge Point circled in solid yellow; looking south.

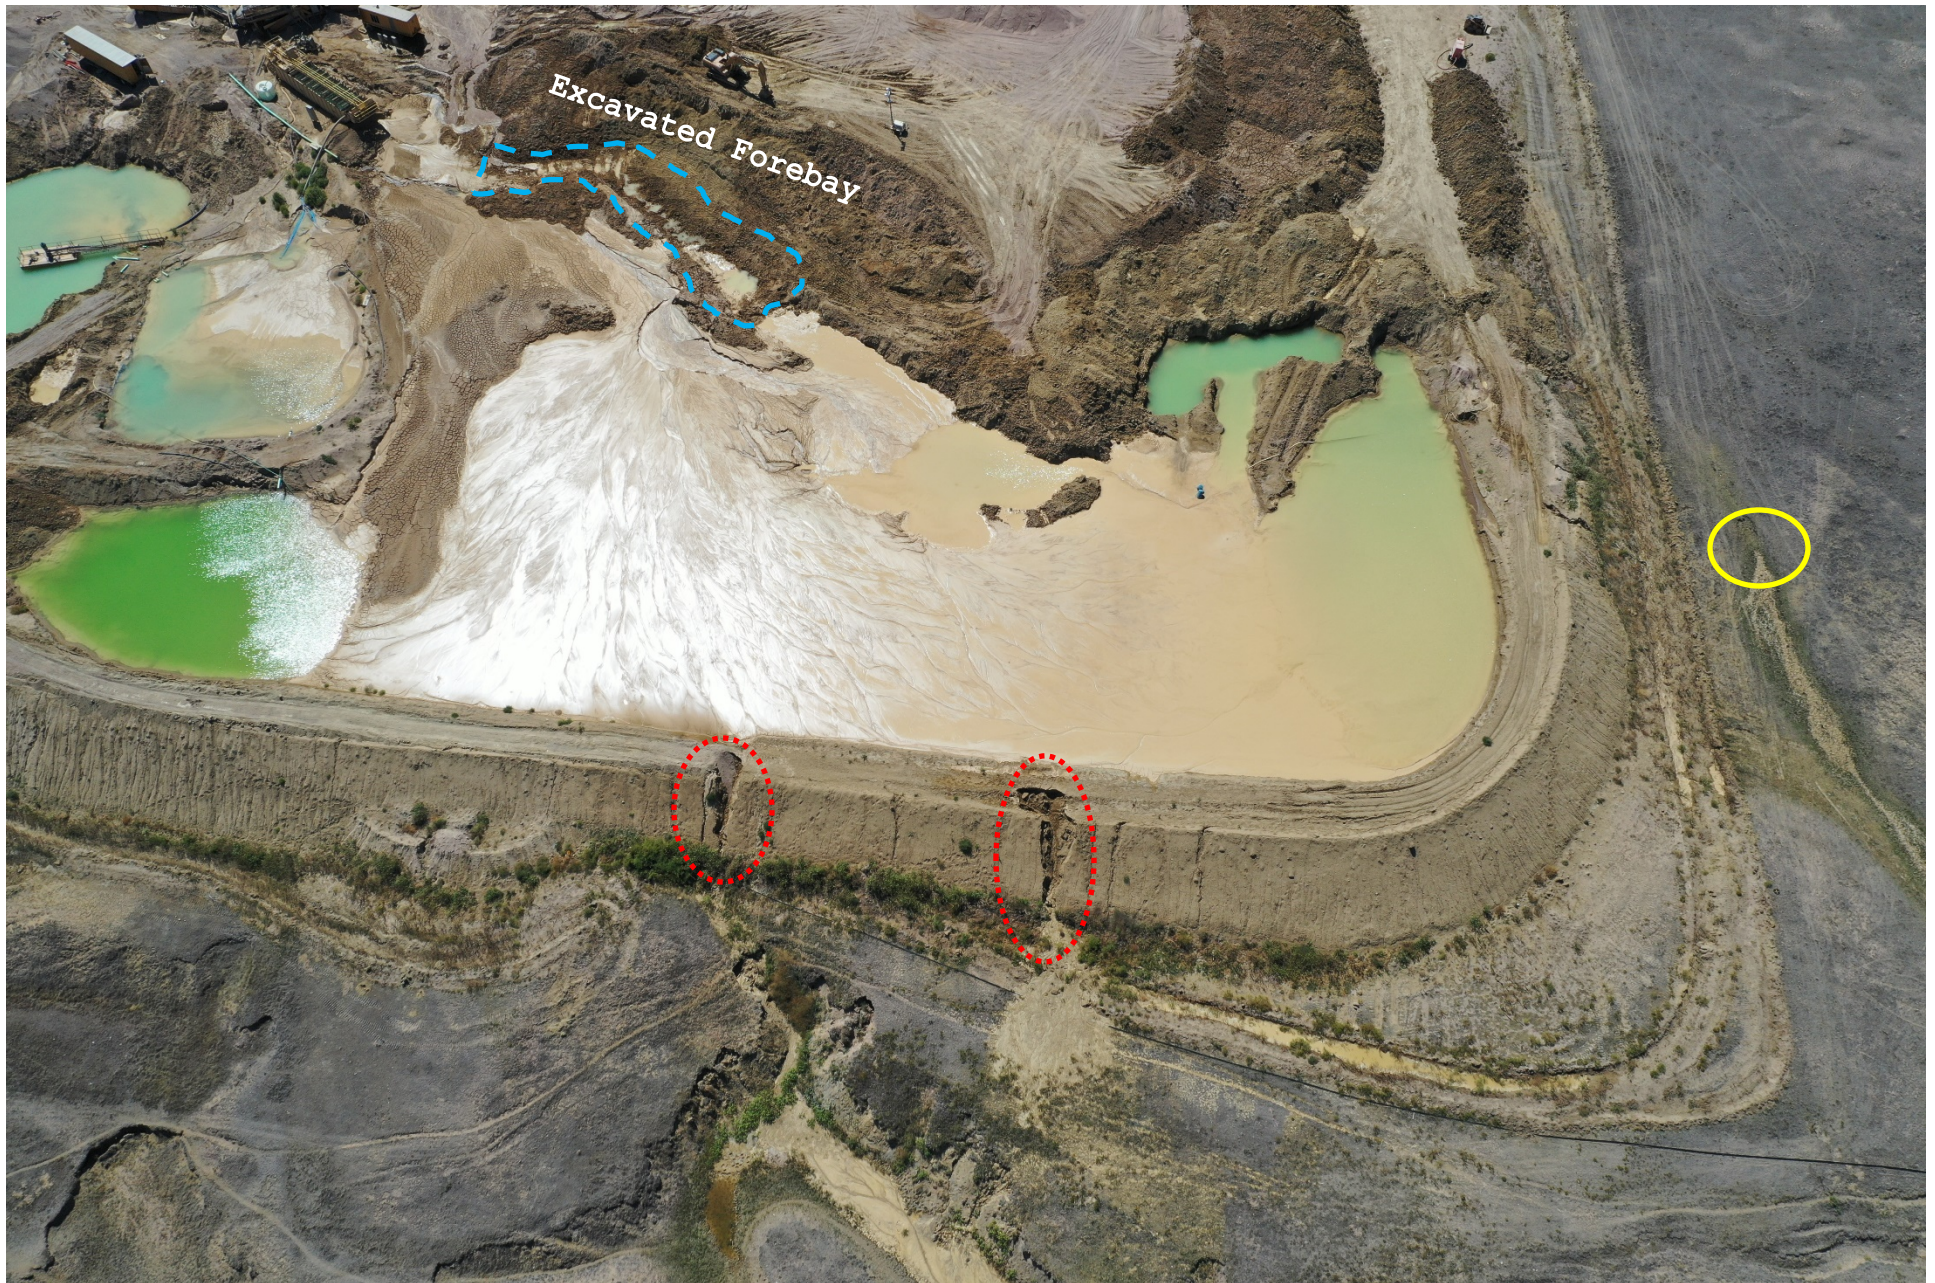
**Photo 12.** Aerial overview of sediment storage area overtopping circled in dashed red, Pump Discharge Point circled in solid yellow; looking southwest.

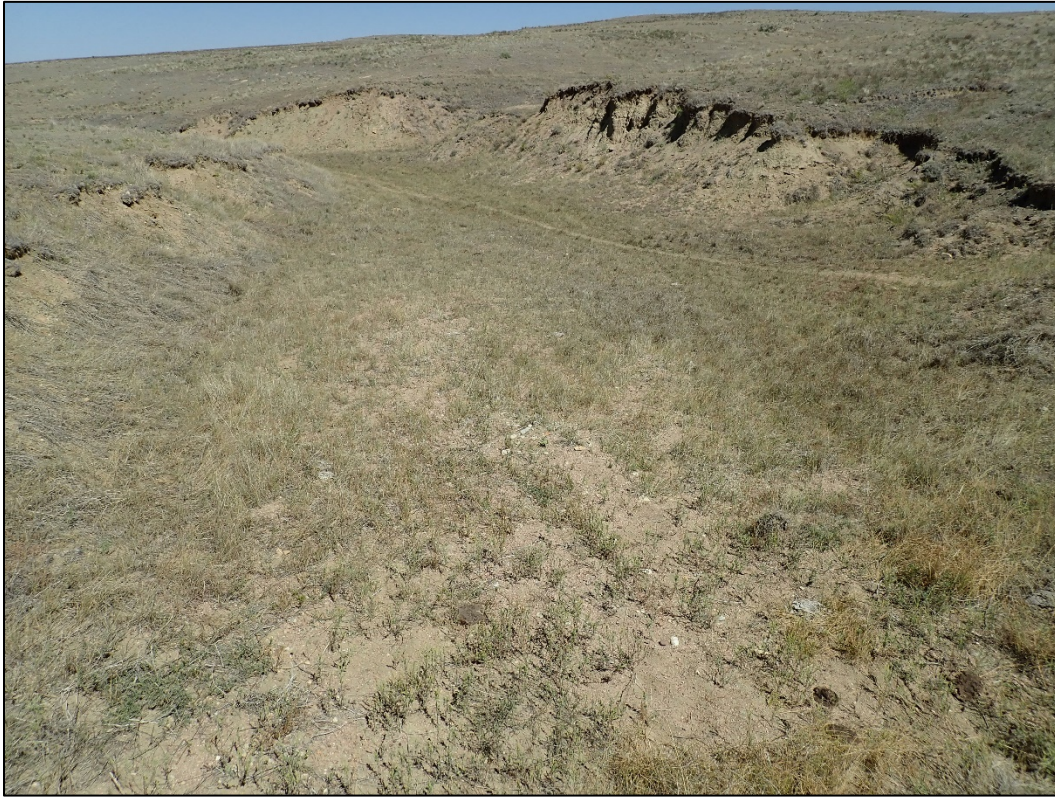
**Photo 13.** Unnamed drainage upstream from overtopping; looking northeast.

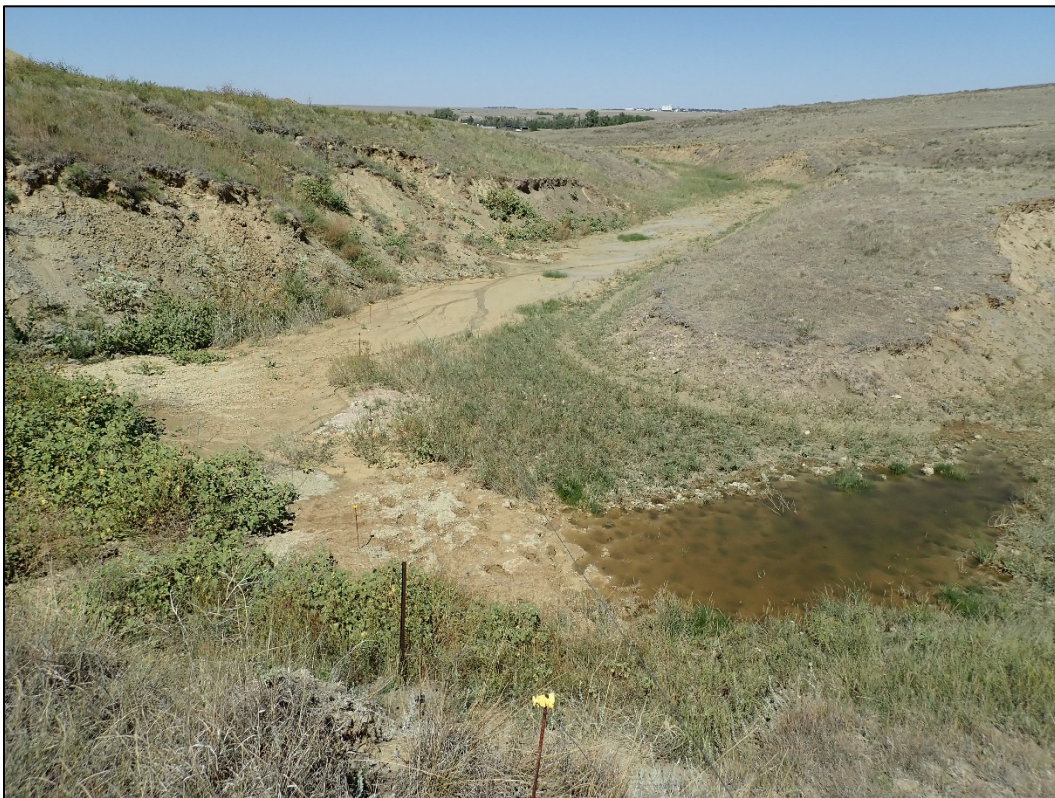
The Division walked the unnamed drainage from the southeast permit boundary corner to CR R. The Division observed significant fines from the drainage adjacent the first overtopping downstream approximately 1,100 feet. The Division has identified this area as the Off-site Discharge Disturbance on the attached Inspection Report Map. This area was determined from collected GPS data and site observations and is estimated to be 0.34 acres in size. When discussing the fines and sediment within this area, the Operator stated they wanted to repair and reclaim the damage to the drainage by excavating and hauling the fines back to the mining area, likely using a skid steer. The Division also observed evidence of light brown colored staining on vegetation just before the culvert under CR R. This observation indicates the discharge traveled at least 2,600 feet down the unnamed drainage toward the South Fork of the Republican River, which is 330 feet north of CR R. Based on the evidence observed, the majority of fines dropped out within the first 1,100 feet of the unnamed drainage and discolored water likely reached the South Fork of the Republican River. This has been cited as a possible violation requiring a hearing before the Mined Land Reclamation Board.

**Photo 14.** Unnamed drainage at the first overtopping; looking north.

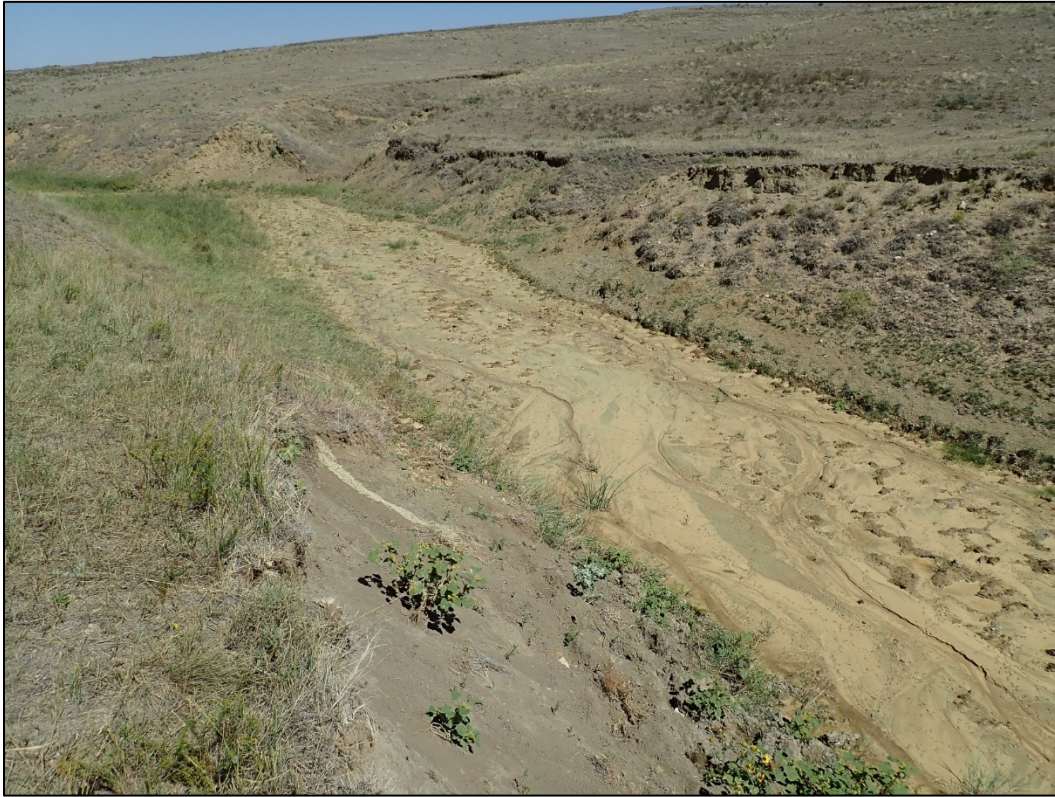
**Photo 15.** Unnamed drainage downstream from overtopping; looking northeast.

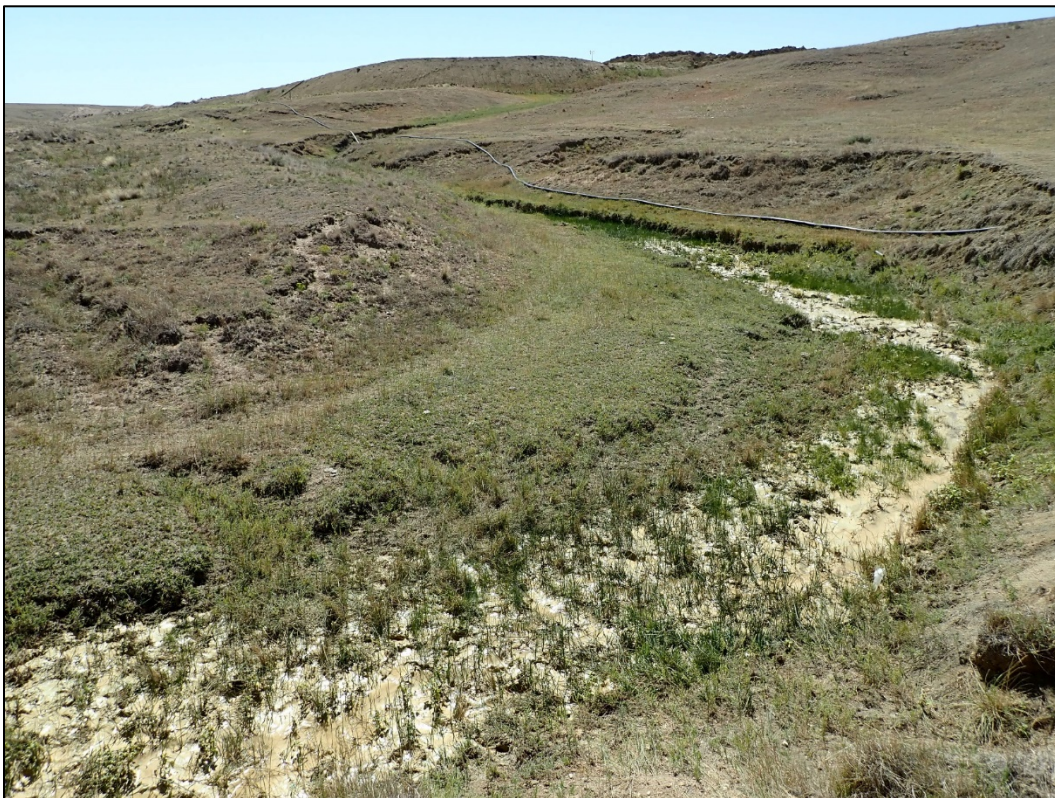
**Photo 16.** Unnamed drainage downstream from overtopping and Pump Discharge Point; looking south back toward the mine site.

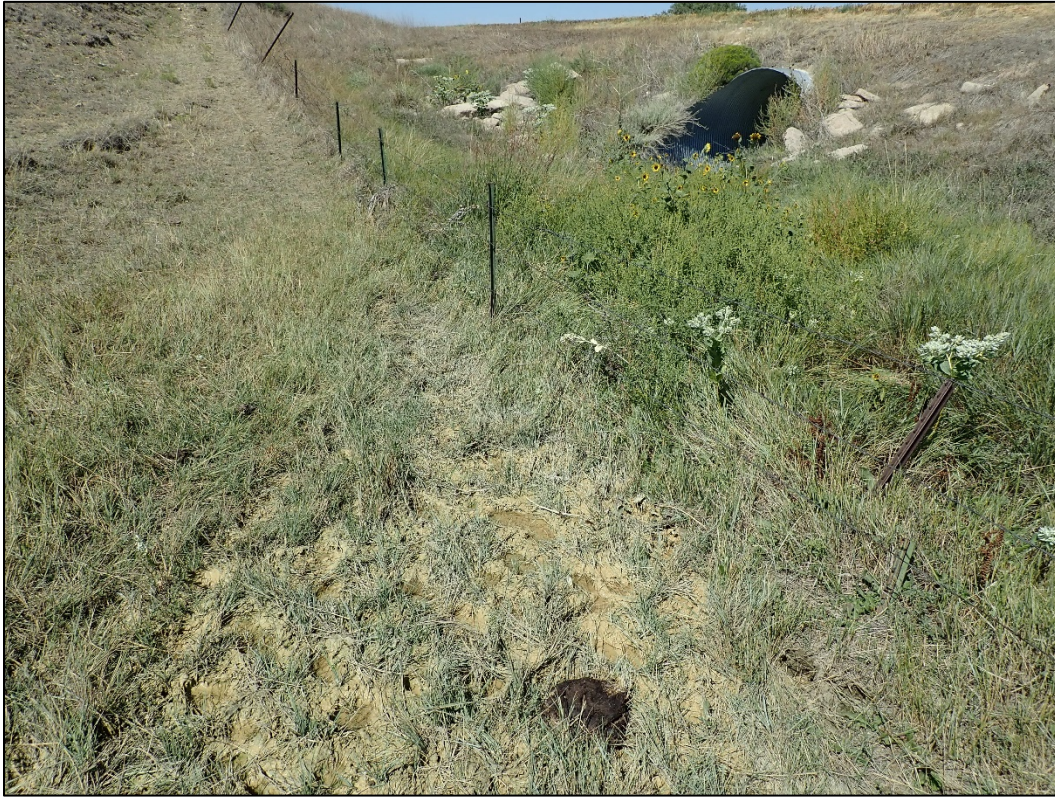
**Photo 17.** ROW fence along the south side of CR 6, not stained vegetation from flowing water; looking west.

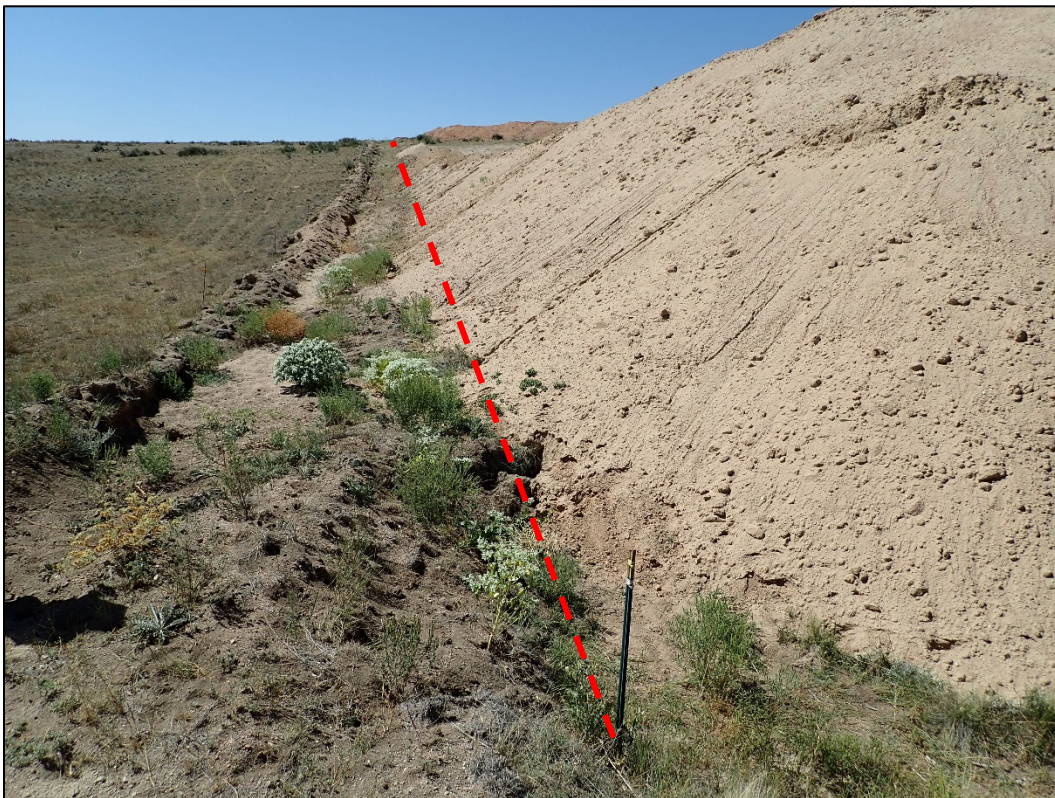
After inspecting the discharge area, the Division inspected the permit boundary markers. While inspecting the southeast permit boundary, the Division observed topsoil and overburden and been piled across the southern and eastern delineated permit boundaries. The Division used a Trimble Juno 3B to acquire GPS data of the permit boundary markers and the entire disturbance footprint. Upon review of the permit file after the inspection, and based on the collected GPS data, the Division determined the permit boundary markers are likely not in the correct locations, however, the Operator has still affected approximately 1.51 acres of land outside of the approved northern, western, and southern permit boundaries. The Division has identified this area as the Off-site Mining Disturbance on the attached Inspection Report Map. The majority of the off-site disturbance falls between the permit boundary and CR 6 where there is a permitted 50-foot offset from the road. This has been cited as a possible violation requiring a hearing before the Mined Land Reclamation Board.

**Photo 18.** Southeast permit boundary corner, approximate southern permit boundary depicted; looking southwest.

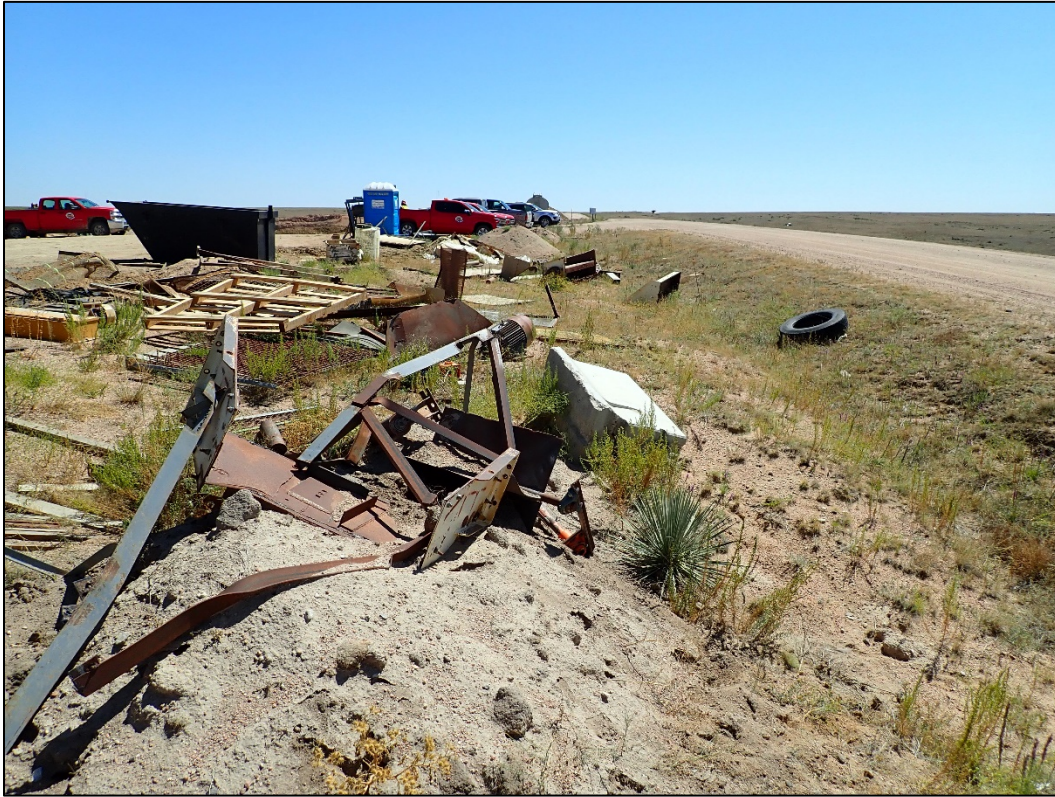
**Photo 19.** Mine site disturbance and debris along CR 6 within the permitted 50-foot offset from road; looking southeast.
