**MINERALS PROGRAM INSPECTION REPORT**  
**PHONE: (303) 866-3567**

<b>MINE NAME:</b> Strode Pit	<b>MINE/PROSPECTING ID#:</b> M-2019-002	<b>MINERAL:</b> Sand	<b>COUNTY:</b> Kit Carson
<b>INSPECTION TYPE:</b> Monitoring	<b>INSPECTOR(S):</b> Elliott Russell	<b>INSP. DATE:</b> September 4, 2020	<b>INSP. TIME:</b> 10:45
<b>OPERATOR:</b> Castle Rock Construction Company of Colorado, LLC	<b>OPERATOR REPRESENTATIVE:</b> Matt Fonte	<b>TYPE OF OPERATION:</b> 111 - Government Contract Related

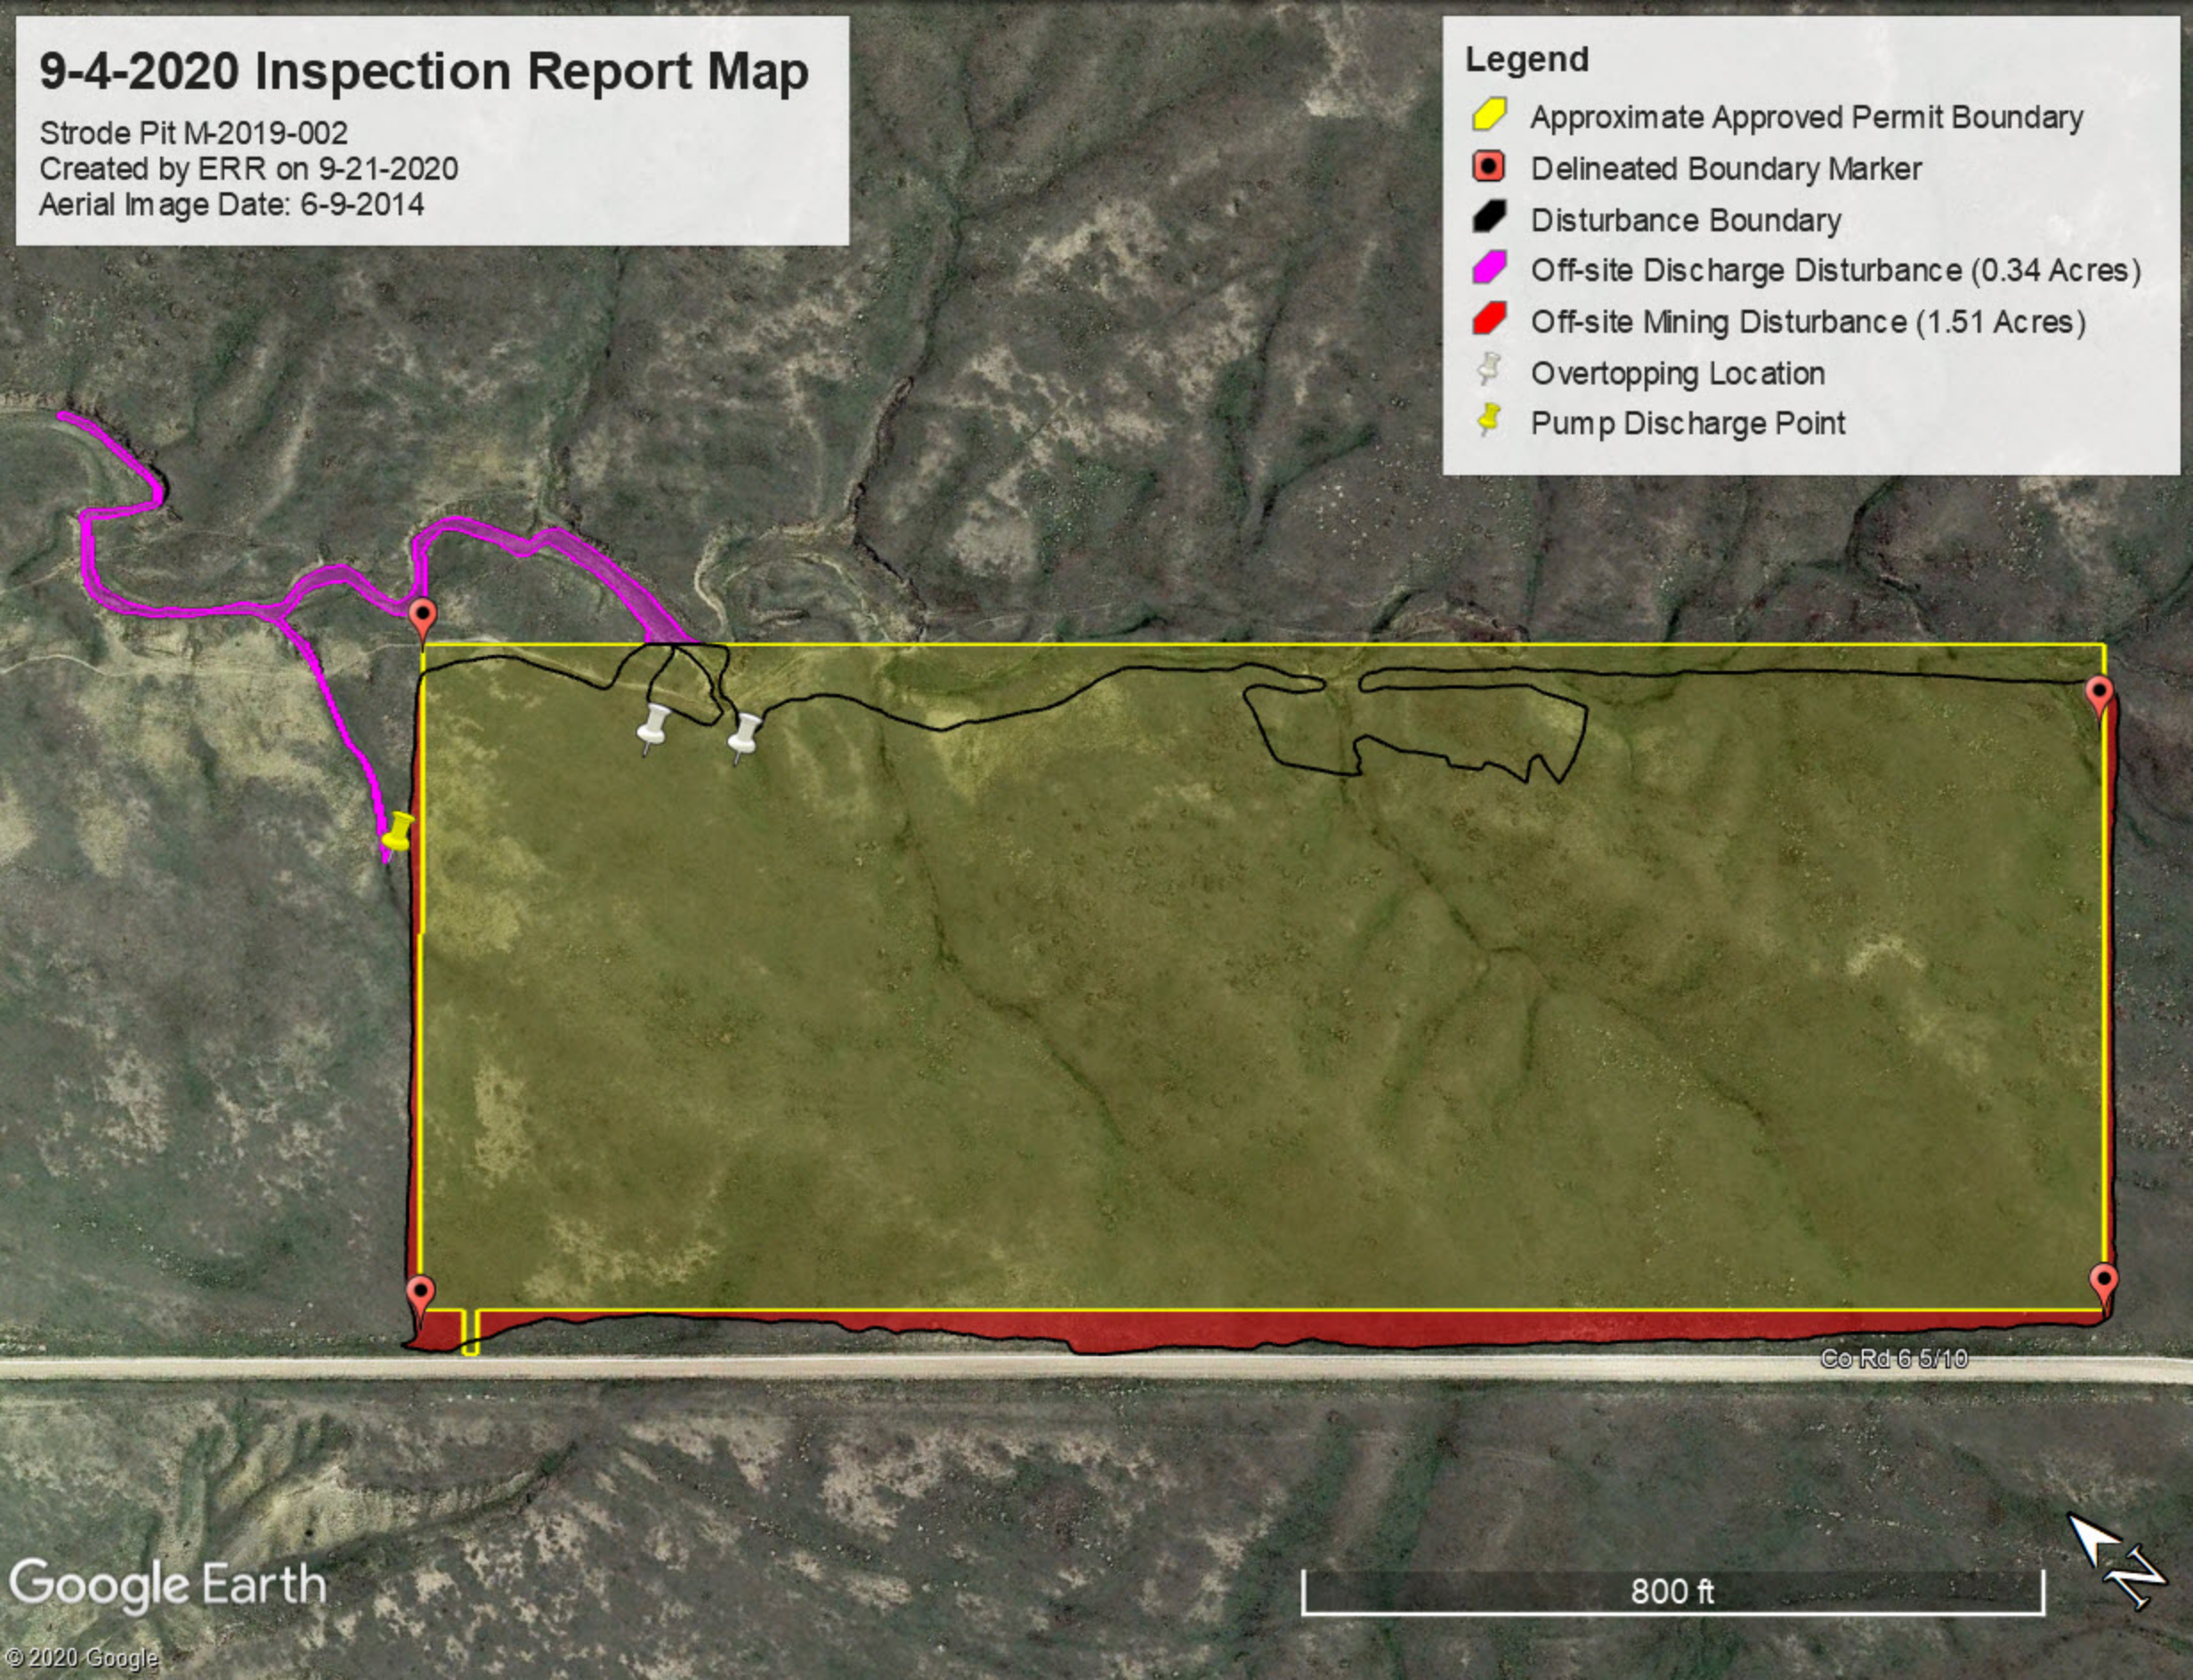
# 9-4-2020 Inspection Report Map

The Division walked the unnamed drainage from the southeast permit boundary corner to CR R. The Division observed significant fines from the drainage adjacent the first overtopping downstream approximately 1,100 feet. The Division has identified this area as the Off-site Discharge Disturbance on the attached Inspection Report Map. This area was determined from collected GPS data and site observations and is estimated to be 0.34 acres in size. When discussing the fines and sediment within this area, the Operator stated they wanted to repair and reclaim the damage to the drainage by excavating and hauling the fines back to the mining area, likely using a skid steer. The Division also observed evidence of light brown colored staining on vegetation just before the culvert under CR R. This observation indicates the discharge traveled at least 2,600 feet down the unnamed drainage toward the South Fork of the Republican River, which is 330 feet north of CR R. Based on the evidence observed, the majority of fines dropped out within the first 1,100 feet of the unnamed drainage and discolored water likely reached the South Fork of the Republican River. This has been cited as a possible violation requiring a hearing before the Mined Land Reclamation Board.

After inspecting the discharge area, the Division inspected the permit boundary markers. While inspecting the southeast permit boundary, the Division observed topsoil and overburden and been piled across the southern and eastern delineated permit boundaries. The Division used a Trimble Juno 3B to acquire GPS data of the permit boundary markers and the entire disturbance footprint. Upon review of the permit file after the inspection, and based on the collected GPS data, the Division determined the permit boundary markers are likely not in the correct locations, however, the Operator has still affected approximately 1.51 acres of land outside of the approved northern, western, and southern permit boundaries. The Division has identified this area as the Off-site Mining Disturbance on the attached Inspection Report Map. The majority of the off-site disturbance falls between the permit boundary and CR 6 where there is a permitted 50-foot offset from the road. This has been cited as a possible violation requiring a hearing before the Mined Land Reclamation Board.
