COLORADO
Division of Reclamation,
Mining and Safety
Department of Natural Resources

Permit Number: C-1980-004 Mine Name: McClane Canyon Mine Operator: McClane Canyon Mining, LLC Operator Address: Ronald Hull 424 Lewis Hargett Circle Suite 250 Lexington, KY 40503	County: Garfield Operation Type: Underground Permit Status: Temporary Cessation Ownership: Private
	Operator Representative Present: Chuck Selingo
Operator Representative Signature: (Field Issuance Only)

Inspection Start Date: September 15, 2020 Inspection Start Time: 09:50 Inspection End Date: September 15, 2020 Inspection End Time: 11:05		Inspection Type: Coal Complete Inspection Inspection Reason: Normal I&E Program Weather: Clear	
Joint Inspection Agency: None		Joint Inspection Contacts: None	
Post Inspection Agency: None		Post Inspection Contacts: None	
Inspector(s): Clayton Wein	Inspector's Signature: <i>Clayton Wein</i>		Signature Date: 9/23/2020

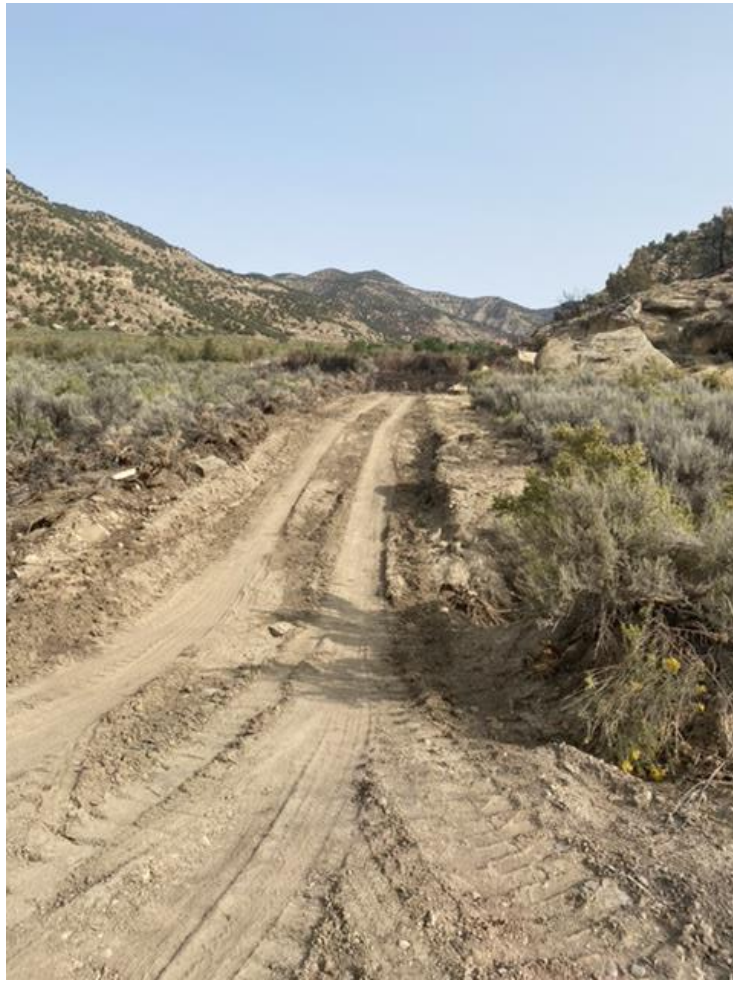
Photo 1: Fire break extending north from the haul road.

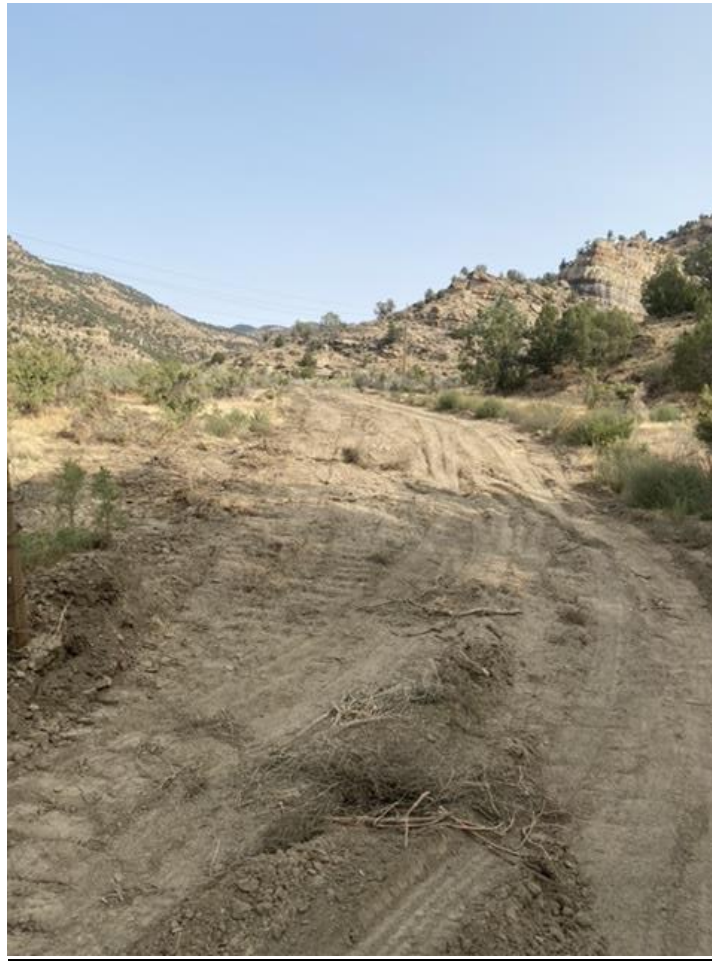
Photo 2: The fire break extending south from the haul road. The photo was taken looking to the north.

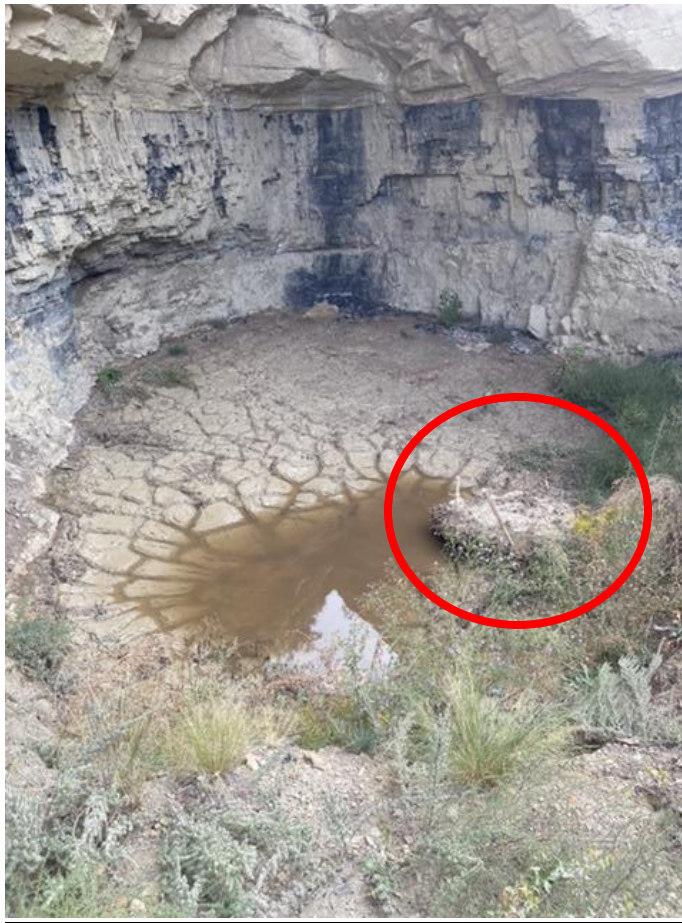
There are two sumps located at the portals area of the mine. The east sump and the northeast sump. The east sump was holding a small amount of water in it. The level of the water was not at the discharge spillway. The trash rack on the spillway had become mostly covered with debris and sediment (Photo 4). Please clean the outlet to prevent blockage. The sump was stable at the time of the inspection. There were no erosional concerns. The northeast sump was also holding a small amount of water in it. There was no discharge from the sump. The trash rack on the outlet was clear of debris. The sump was stable and there were no erosional concerns identified. There was a slump located just up the drainage next to the sump. The slumped material was not blocking the inlet to the sump.

Photo 4: The sump east of the portals bench. The red circle outlines the trash rack that requires cleaning.

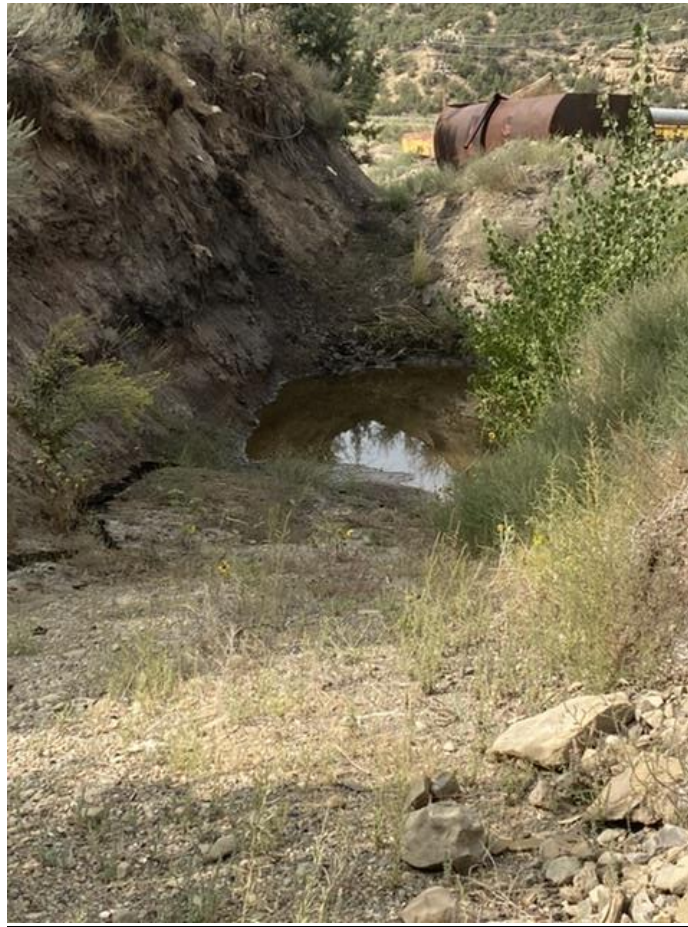
There are sumps located along the north and south sides of the haul road in the portion that extends from the portals area to the sediment pond. These sumps are designed to control the flow of water as it makes its way along the haul road ditches to the pond. The haul road sumps were stable with no erosional feature (Photo 5). There was a small amount of water impounded in the sumps. No discharge was observed from any of the sumps. The discharge outlets were observed to be unobstructed.

Photo 5: One of the lower haul road sumps.

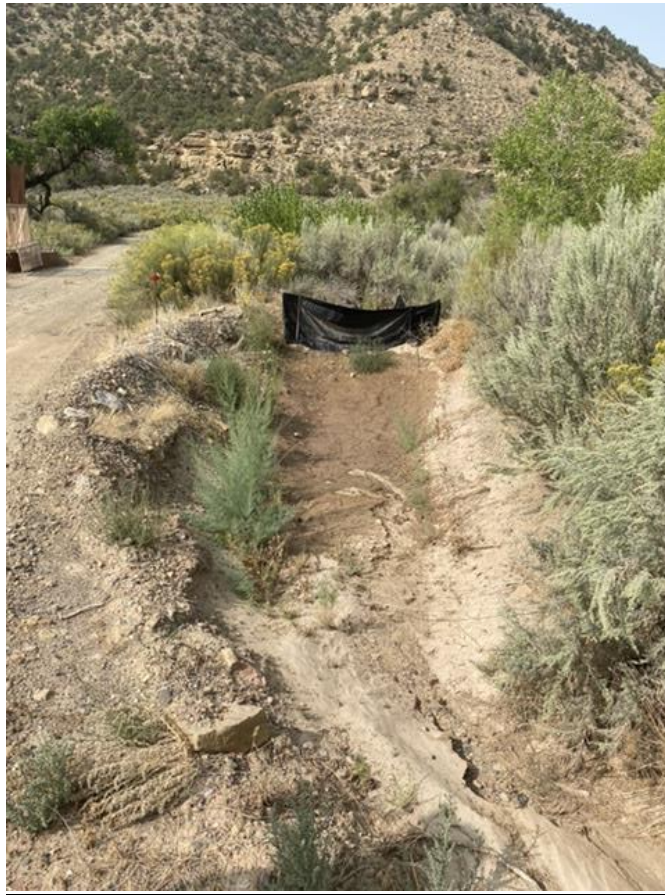
Two sumps are located on the west side of the mine office pad. One on the north side (Photo 6) of the haul road and the other on the south side of the haul road. Both sumps were holding water in them but neither was discharging during the inspection. The outlets for the sumps had silt fencing on them. The silt fences were in good repair. There were no erosional features identified or indications of instability observed.

Photo 6: The sump located on the north side of the office pad and haul road.
