PERMIT INFORMATION

Permit Number: C-1981-015 Mine Name: Fruita No 1 & 2 Operator: Dorchester Coal Company Operator Address: Greg Lewicki 9054 South Forrest Drive Highlands Ranch, CO 80126	County: Mesa Operation Type: Underground Permit Status: Revoked Ownership: Private
	Operator Representative Present: NA
Operator Representative Signature: (Field Issuance Only)

INSPECTION INFORMATION

This was a complete inspection of the Fruita No. 1 and 2 Mine conducted on September 15, 2020. The inspection was completed by Clayton Wein of the Division. The Fruita No. 1 and 2 Mine is a revoked site. The weather was clear with a high temperature of 87 degrees F. The ground conditions were dry.

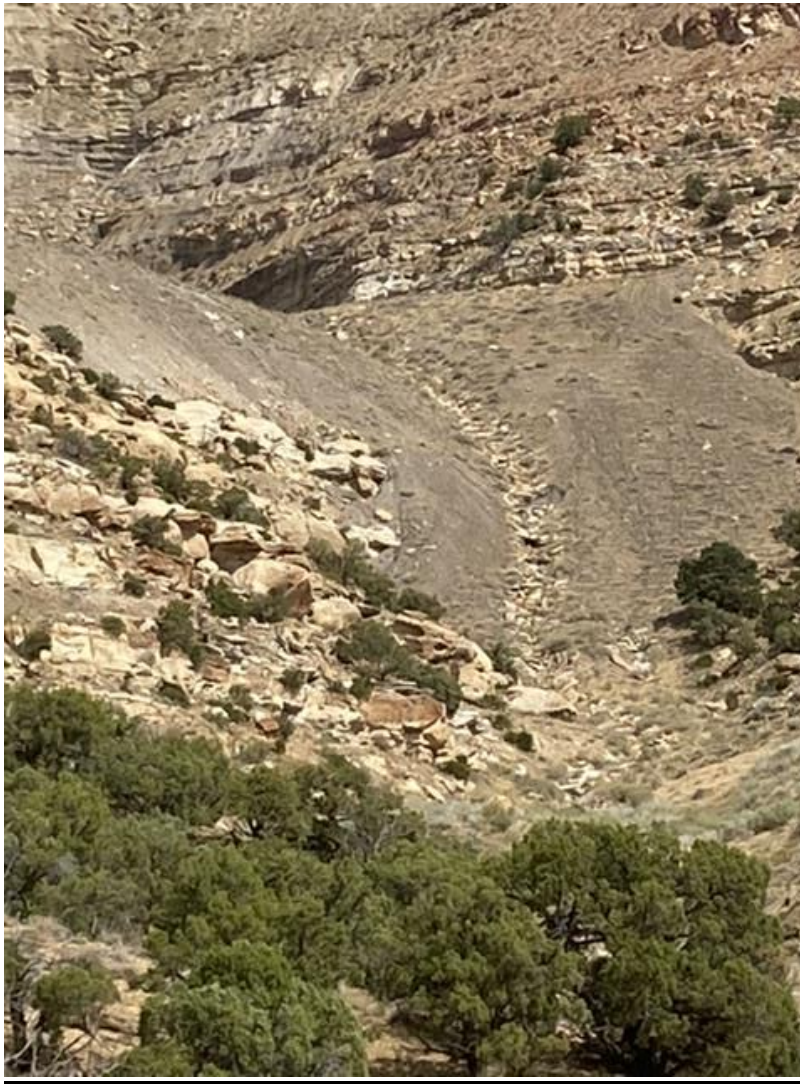
The reclaimed mine bench has a riprap lined channel extending from the bench to the drainage below. The riprap channel was stable and dry (Photo 2).

Photo 1: The riprap channel extending down from the reclaimed mine bench.

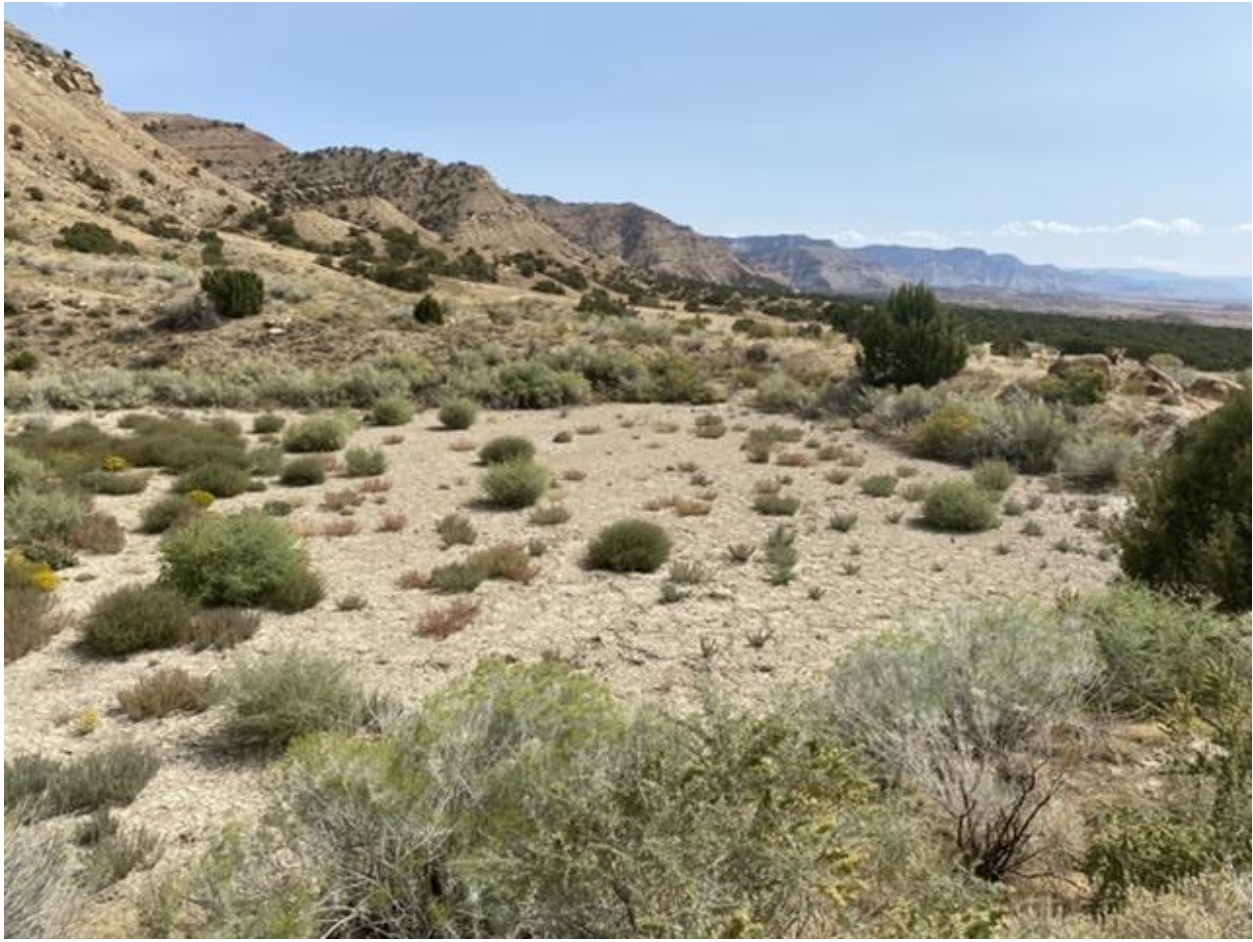
There is a sediment pond at the site that will remain as a permanent feature. At the time of the inspection the pond was dry (Photo 1). The spillway was stable with no evidence of side cutting or down cutting. The embankment was stable with vegetative cover. There were no indications of erosional features.

Photo 2: The dry sediment pond.

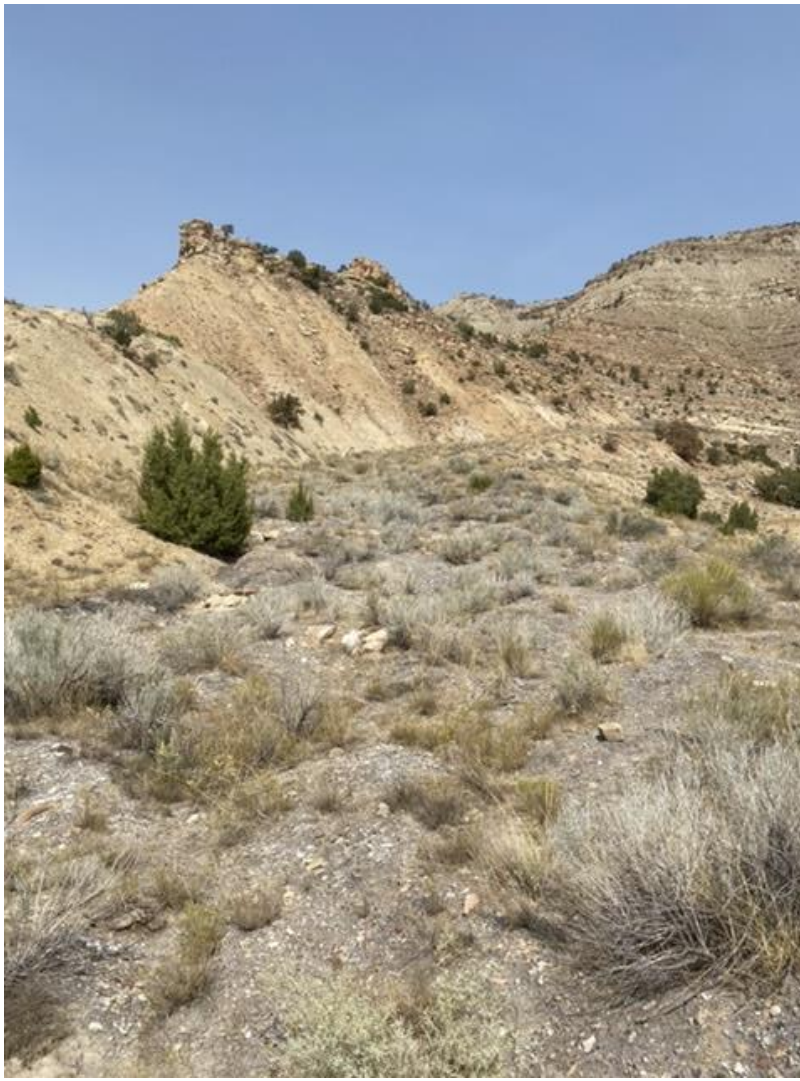
The reclaimed haul road was stable with vegetative cover (Photo 3). There are some areas with erosional features in the form of gullies and rills. These features have been identified during previous Division inspections. The rills and gullies have stabilized and not enlarged since the previous inspection. The rills and gullies start on the haul road and end in the natural drainage that leads to the sediment pond. The rills and gullies do not appear to affect the stability of the reclamation.

Photo 3: The reclaimed haul road vegetated with shrubs and other smaller plant species.
