MINERALS PROGRAM INSPECTION REPORT
PHONE: (303) 866-3567

MINE NAME: Bivens Pit	MINE/PROSPECTING ID#: M-1985-184	MINERAL: Sand and gravel	COUNTY: Larimer
INSPECTION TYPE: Monitoring	INSPECTOR(S): Amy Eschberger	INSP. DATE: September 2, 2020	INSP. TIME: 13:30
OPERATOR: Bivens Trucking & Excavating, Inc.	OPERATOR REPRESENTATIVE: Aaron Bivens	TYPE OF OPERATION: 112c - Construction Regular Operation	
REASON FOR INSPECTION: Normal I&E Program	BOND CALCULATION TYPE: Complete Bond	BOND AMOUNT: \$40,000.00	
DATE OF COMPLAINT: NA	POST INSP. CONTACTS: None	JOINT INSP. AGENCY: None	
WEATHER: Clear	INSPECTOR'S SIGNATURE:

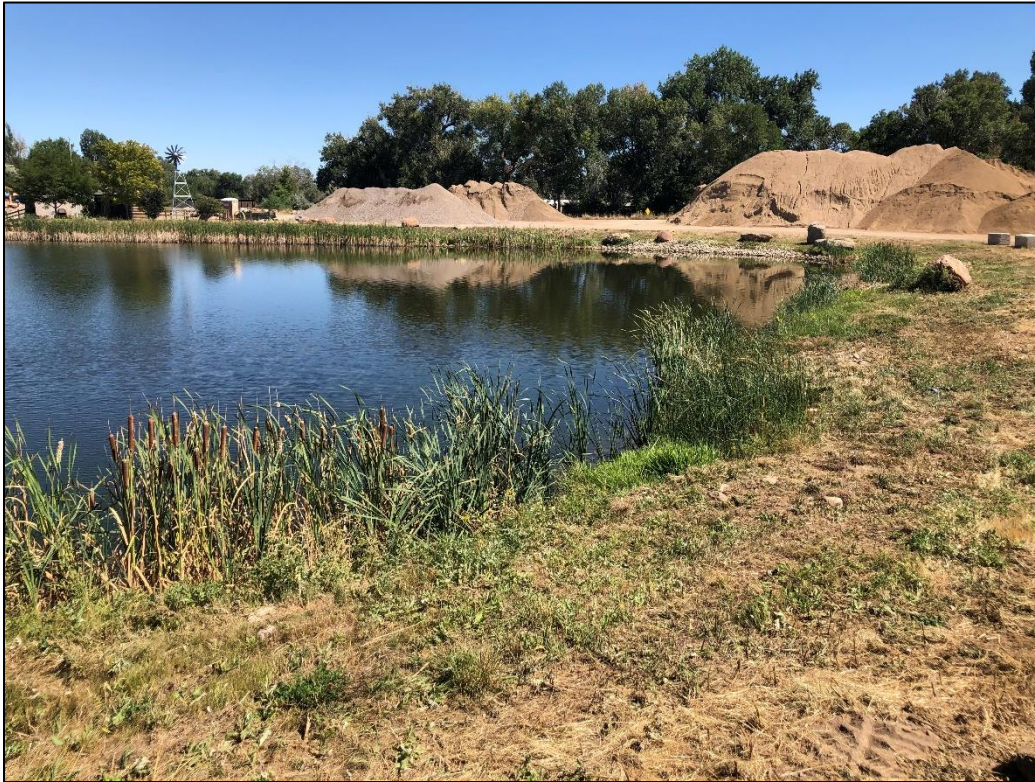
Photo 1. View looking east across southern pond shoreline, showing slopes graded to 3H:1V or flatter and stable with good vegetative cover.

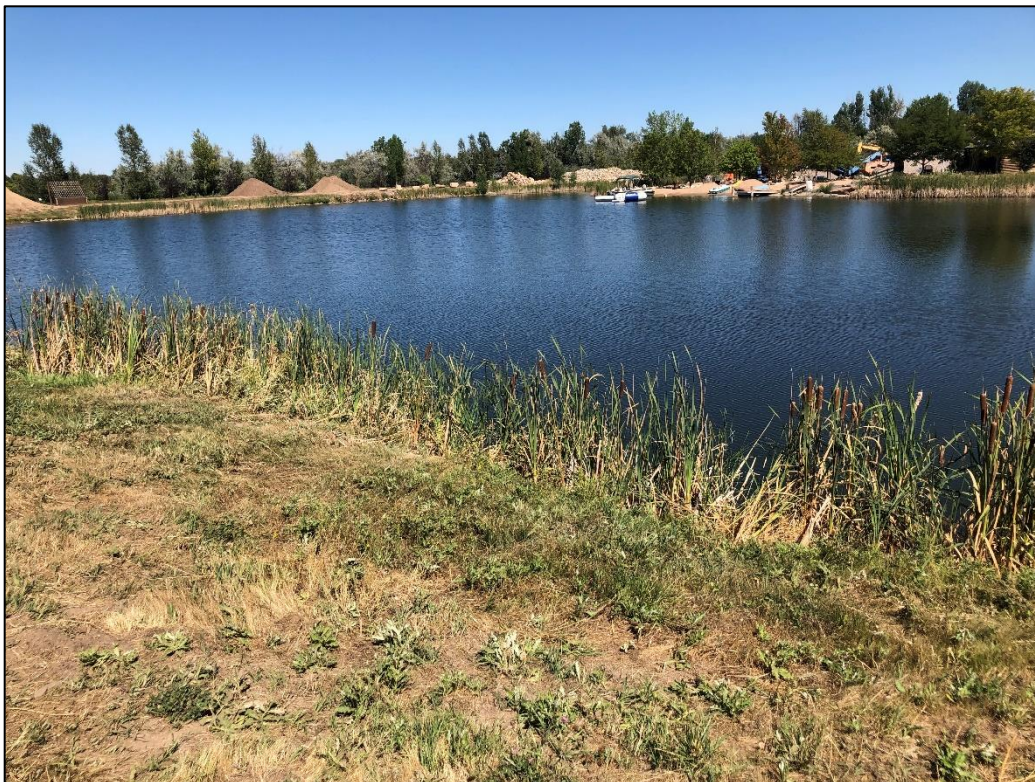
Photo 2. View looking northeast across western pond shoreline, showing slopes graded to 3H:1V or flatter and stable with good vegetative cover.

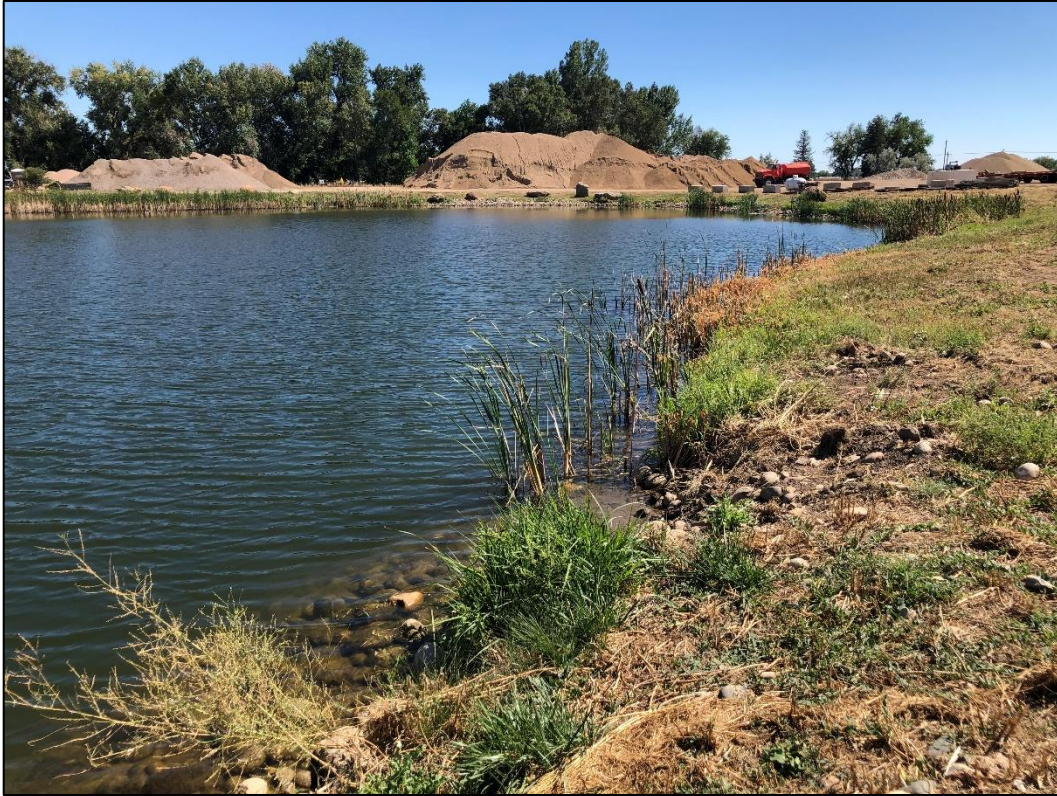
Photo 3. View looking southeast across western pond shoreline, showing slopes graded to 3H:1V or flatter and stable with good vegetative cover.

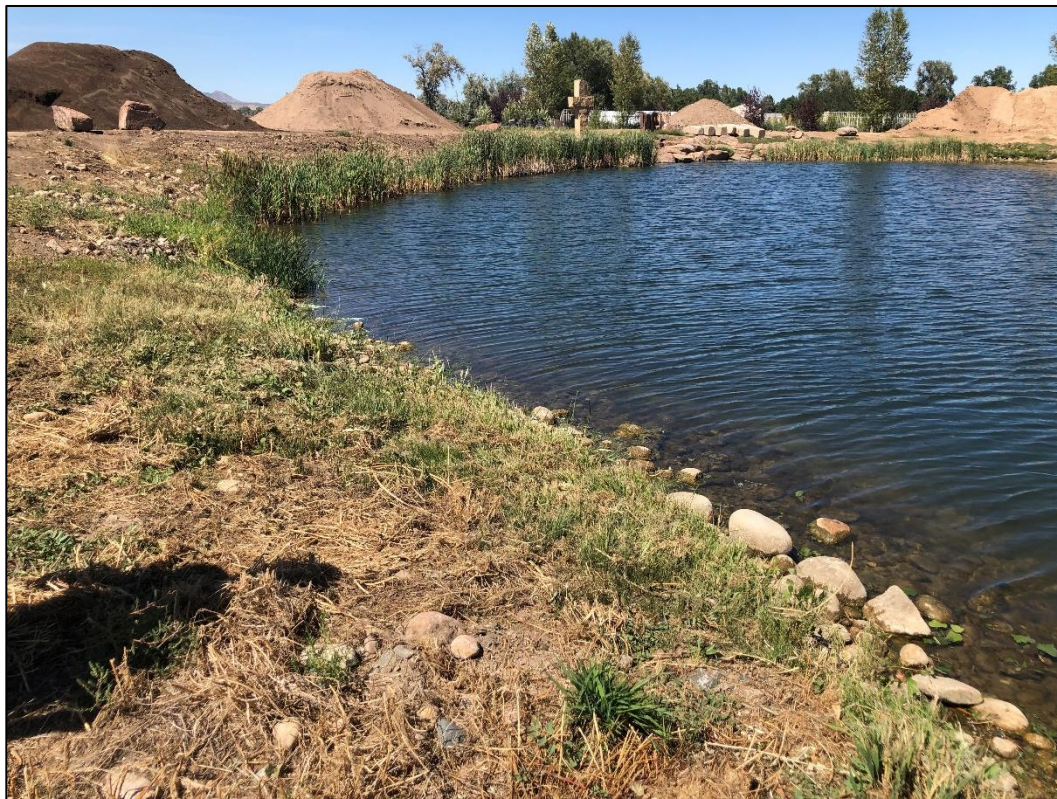
Photo 4. View looking north across northwestern pond shoreline, showing slopes graded to 3H:1V or flatter and stable with good vegetative cover.

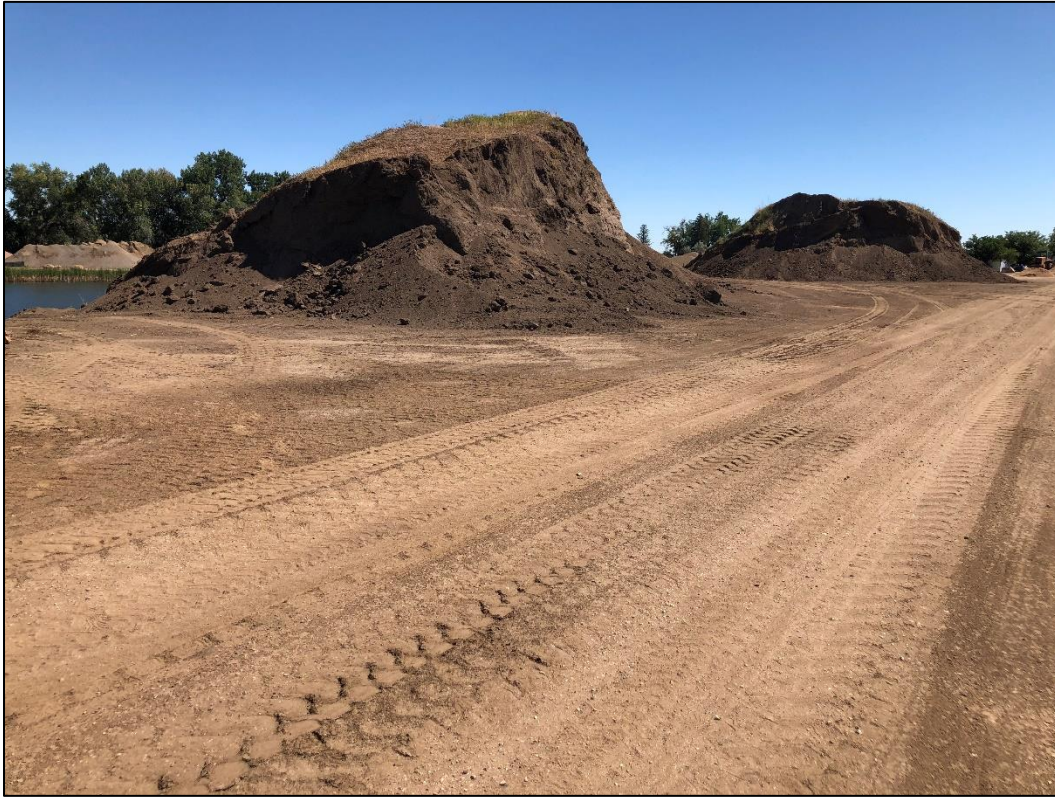
Photo 5. View looking south, showing topsoil stockpiles stored west of pond. These stockpiles should be graded to a stable configuration and seeded with a fast-growing vegetative cover.

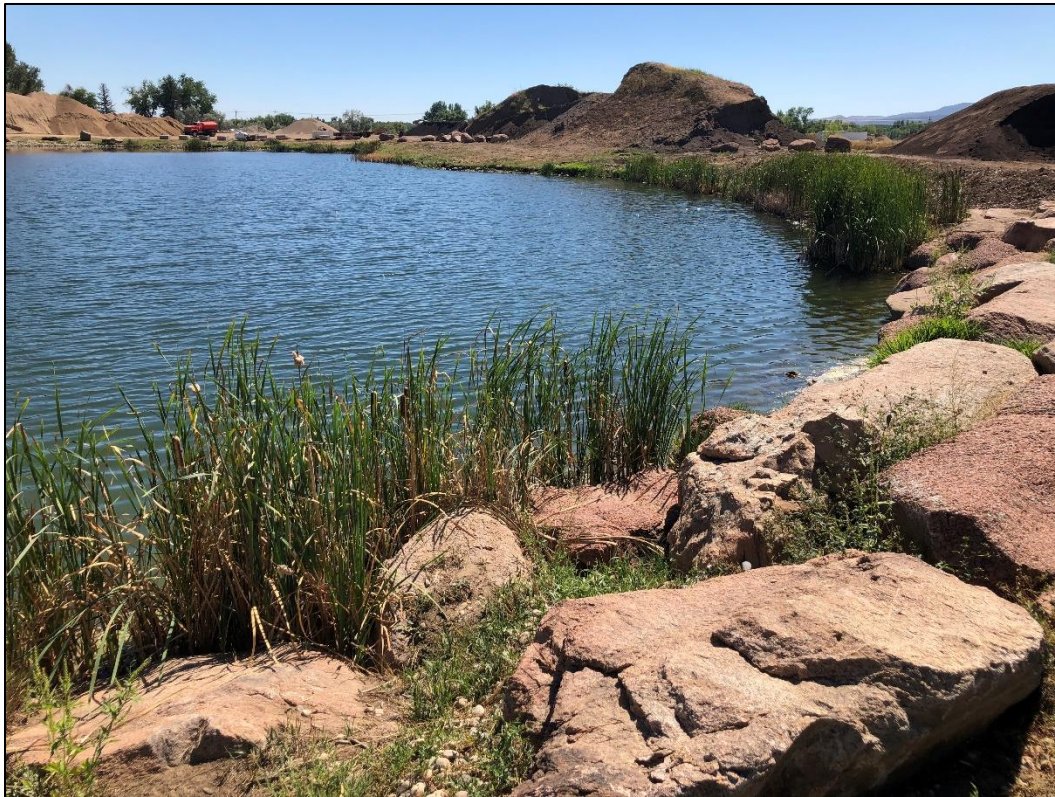
Photo 6. View looking south across northwestern pond shoreline, showing slopes graded to 3H:1V or flatter and stabilized with boulders.

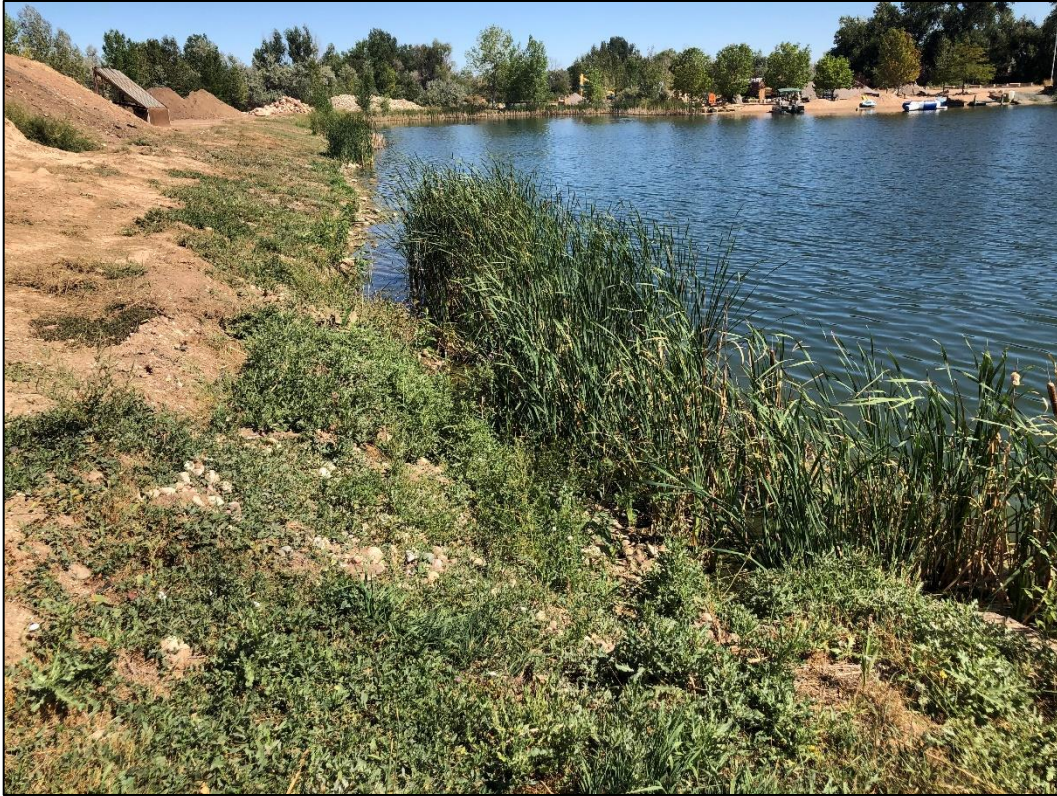
Photo 7. View looking east across northern pond shoreline, showing slopes graded to 3H:1V or flatter and stable with good vegetative cover.

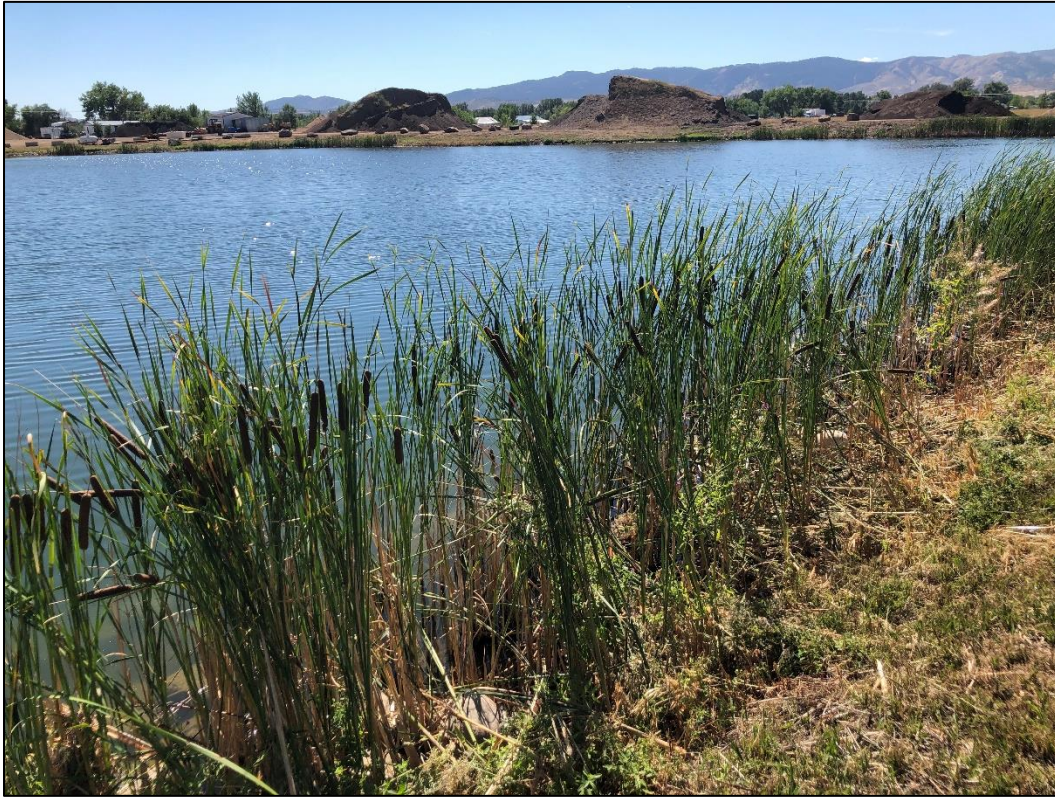
Photo 9. View looking southwest across northern pond shoreline, showing slopes graded to 3H:1V or flatter and stable with good vegetative cover.

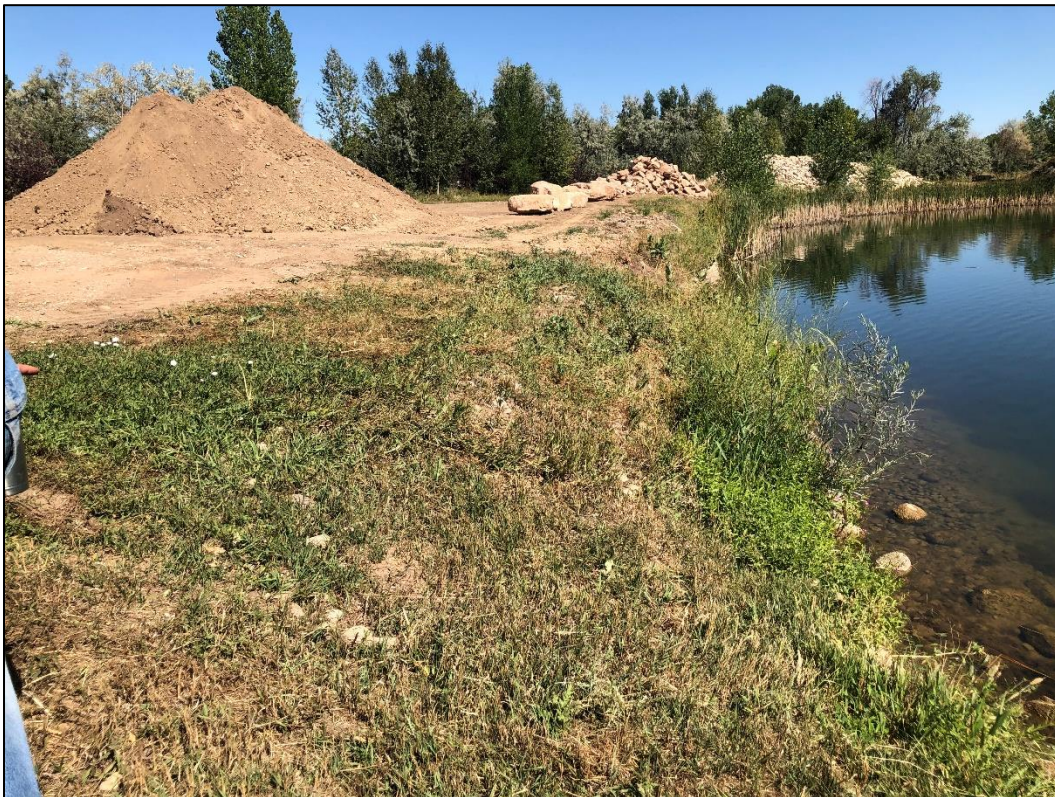
Photo 10. View looking east across northeastern pond shoreline, showing slopes graded to 3H:1V or flatter and stable with good vegetative cover.

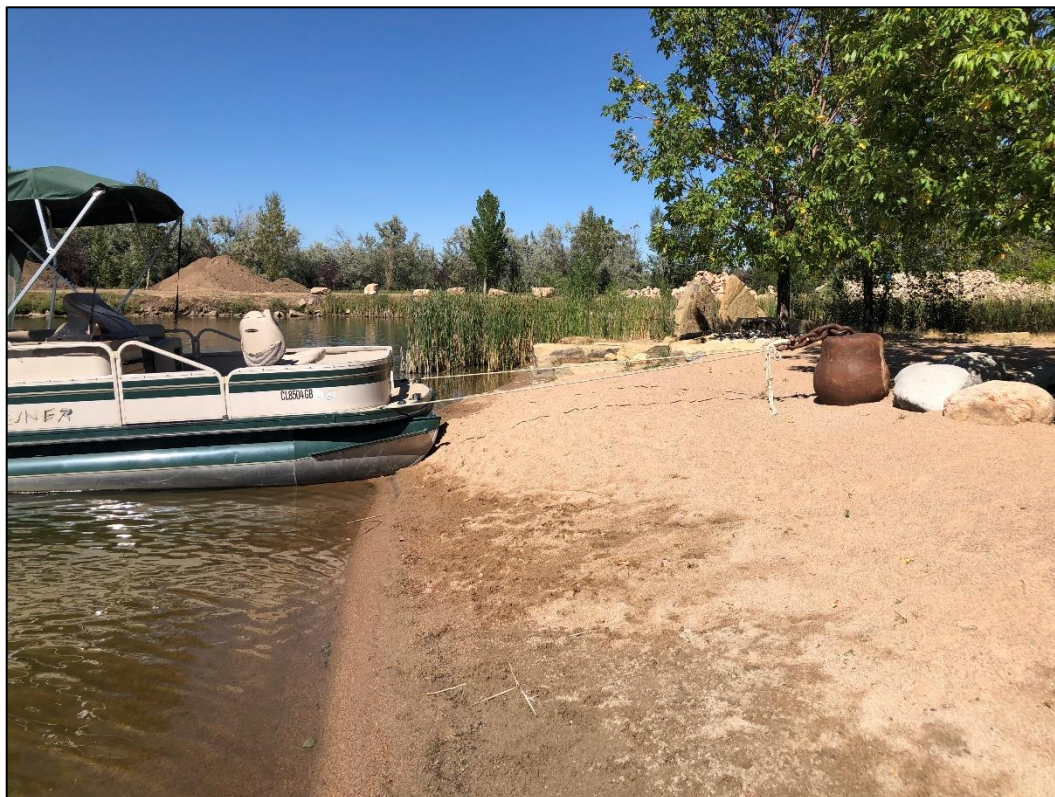
The approved reclamation plan does not address the recreational area and associated structures/features created at the eastern edge of the pond or the residential area and associated structures located in the southern portion of the permit area. Therefore, unless the reclamation plan is updated to show these areas will remain as-is for final reclamation, the Division will need to update the required financial warranty to include costs for reclaiming these areas and their associated structures/features. **A problem is cited in this report (see page 1) requiring the operator to submit a Technical Revision to update the reclamation plan and reclamation plan map to reflect, at a minimum, existing conditions at the site.** The revised reclamation plan map should specify all features and structures to remain on site for final reclamation, show final slope gradients of the pond shorelines (including the swimming area which was graded flatter than 3H:1V for swimming), indicate the post-mining

Photo 16. View looking northeast across eastern pond shoreline in recreational area, with slopes graded to 5H:1V or flatter for swimming.

CORRECTIVE ACTIONS: By the corrective action date, the operator shall submit a Technical Revision, with the required \$216 revision fee, to update and clarify the current approved reclamation plan to reflect existing and proposed activities. This revision should include an updated reclamation plan and reclamation plan map that, at a minimum, addresses existing conditions at the site, including the residential and recreational areas (and associated structures) located within the permit area.

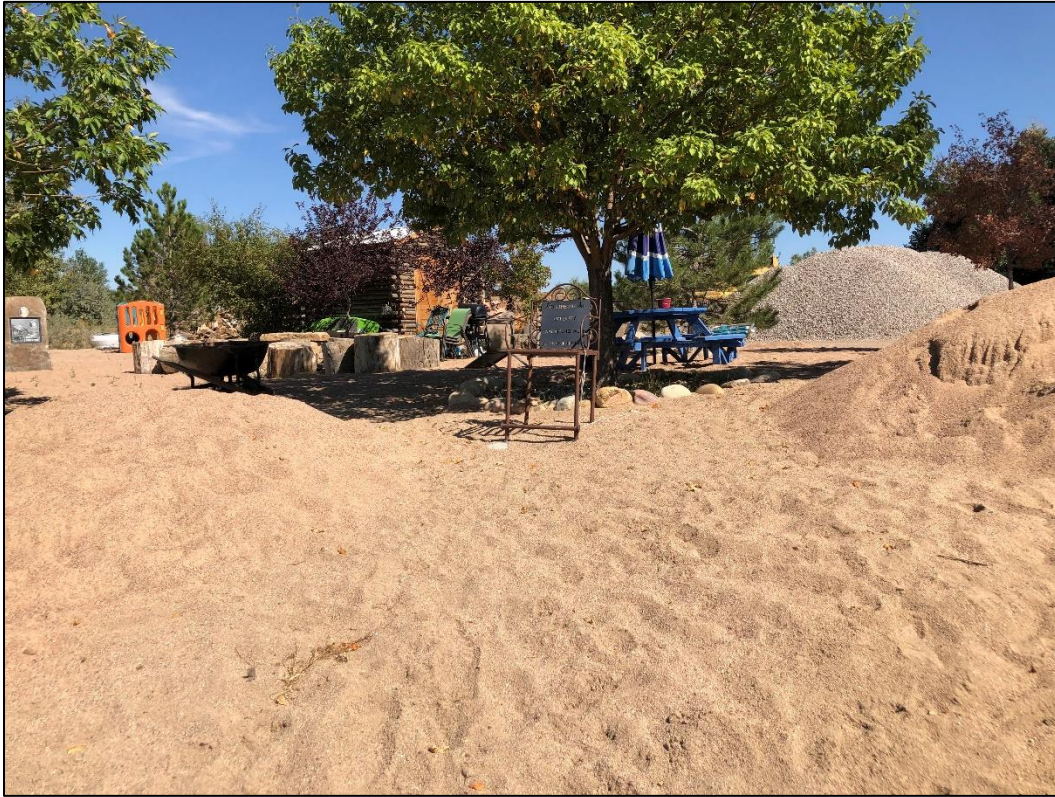
Photo 17. View looking east across recreational area along eastern edge of pond.

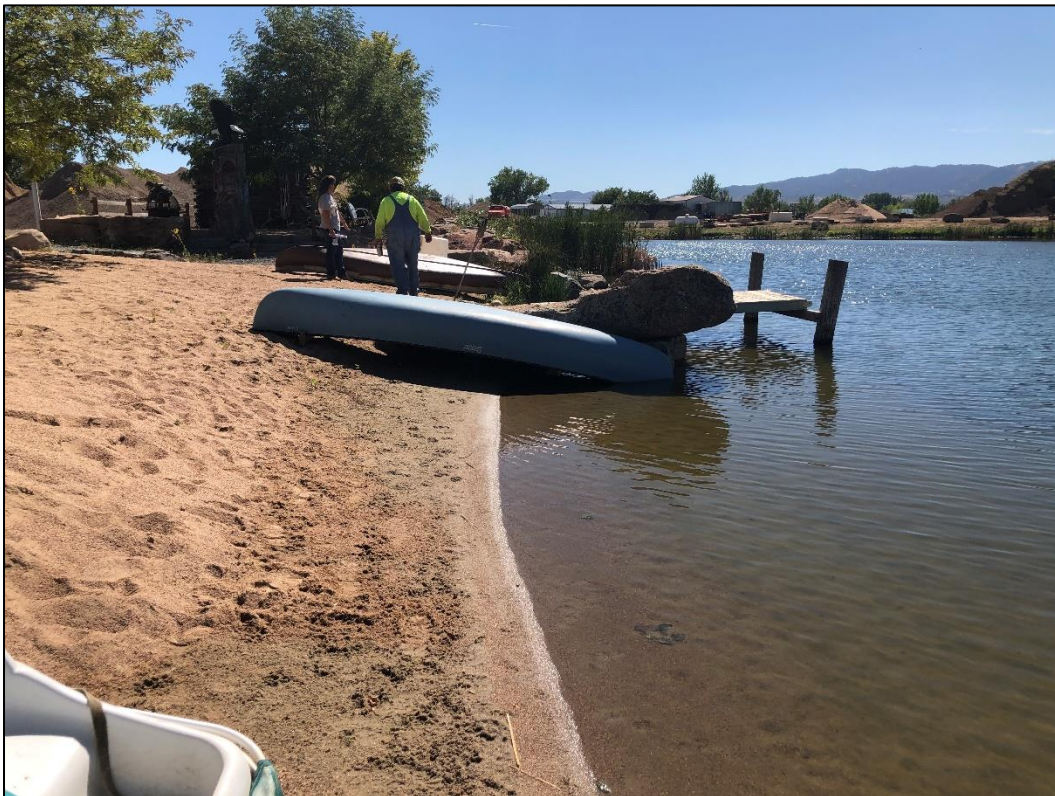
Photo 18. View looking southwest across eastern pond shoreline in recreational area, with slopes graded to 5H:1V or flatter for swimming.

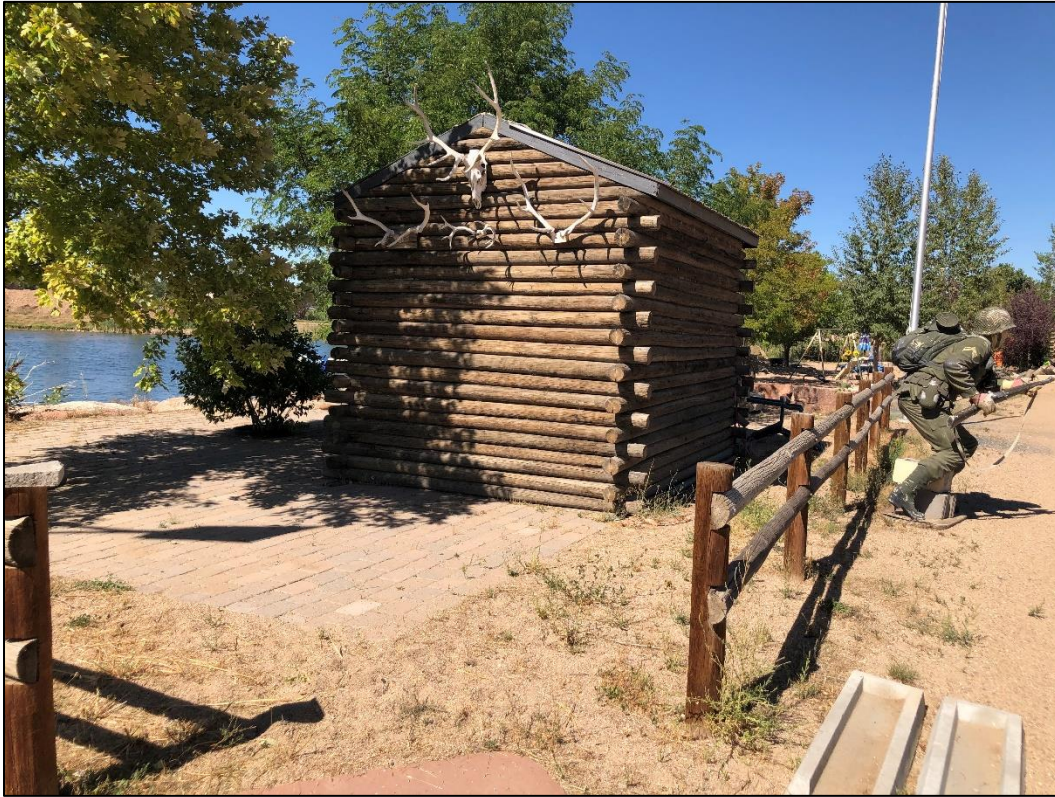
Photo 21. View looking northeast across recreational area along eastern pond shoreline, showing small building, fencing, and art structures present in this area.

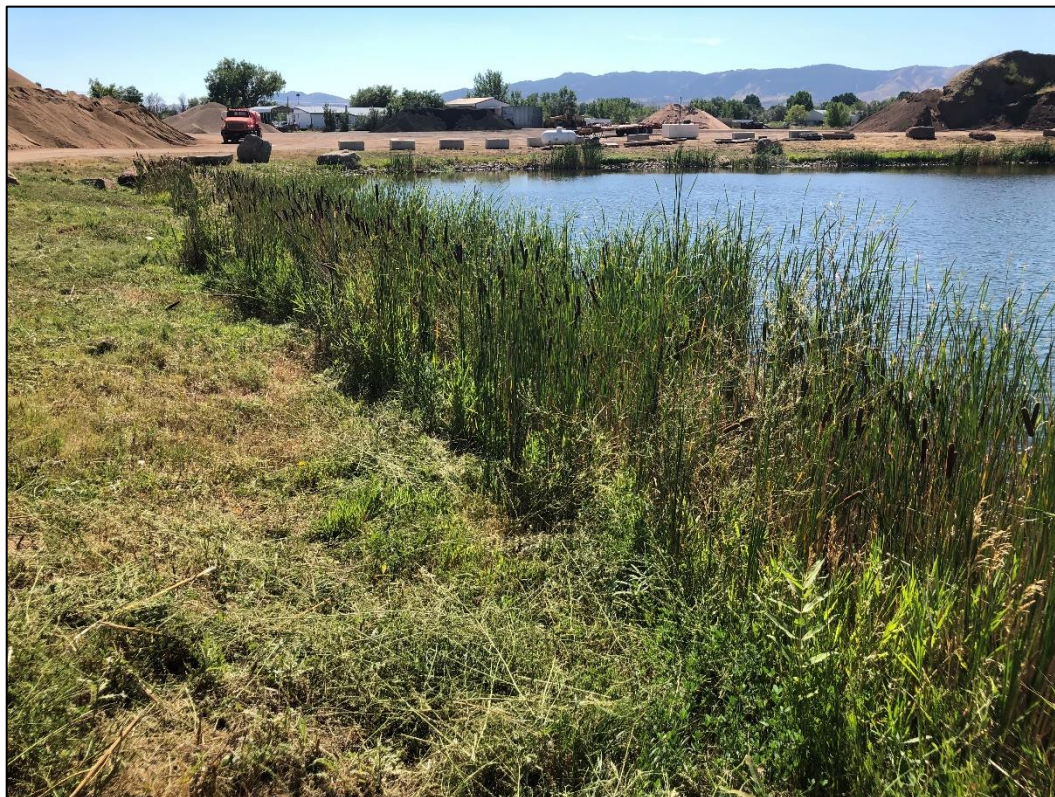
Photo 22. View looking southwest across eastern pond shoreline (south of recreational area), showing slopes graded to 3H:1V or flatter and stable with good vegetative cover.

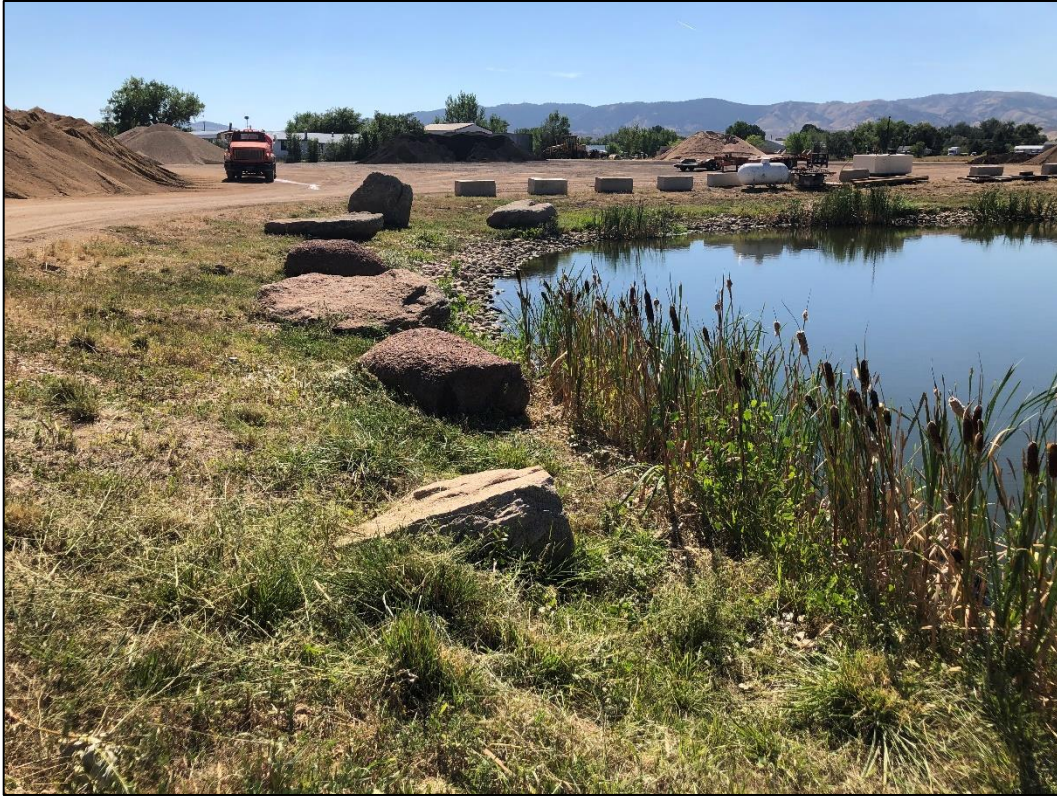
Photo 25. View looking south across southeastern pond shoreline, showing slopes graded to 3H:1V or flatter and stable with good vegetative cover.

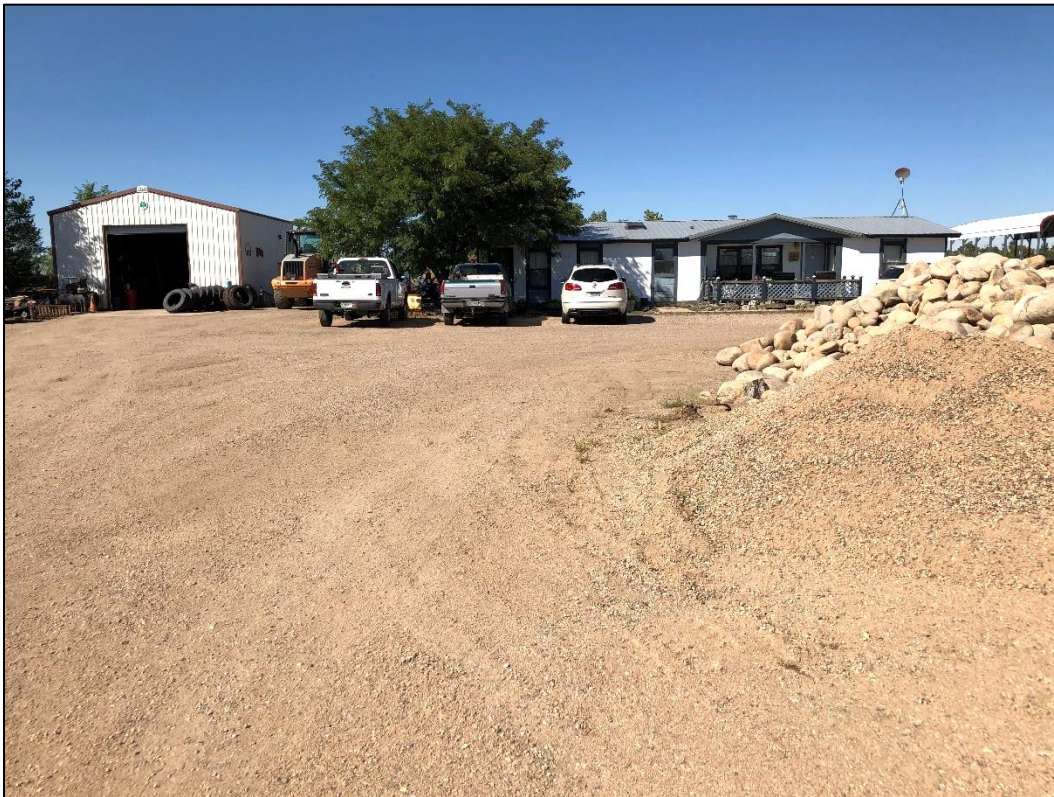
A residential area is located at the southern end of the site, where a house, carport, and chainlink fencing are located within the permit area, a large garage is located partially within the permit area, and a row of rock bins are located outside of the permit area. The rock bins and material stockpiles located in the residential area are associated with the operator's construction material recycling business, and not with the mine permit. None of the construction material stored outside of the permit area was extracted from the mine. Because the approved permit boundary no longer aligns with the property boundary, the mine operation will need to be very careful not to disturb land outside the permit boundary, particularly along the western edge of the site.

Photo 30. View looking north, showing residential buildings (in background) present in southern portion of permit area. Garage (at left) is located partially outside permit area.

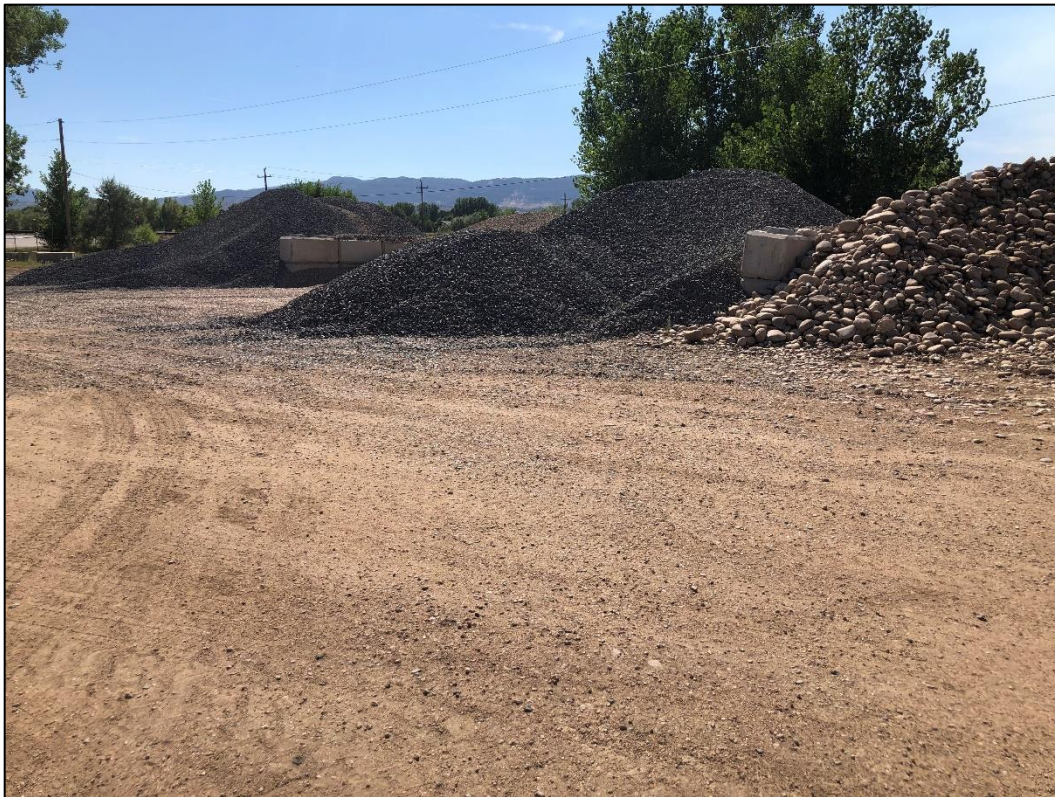
Photo 32. View looking southwest, showing row of rock bins present along western edge of property (outside permit area), utilized for operator's construction material recycling business.
