Attachment 1: Photos

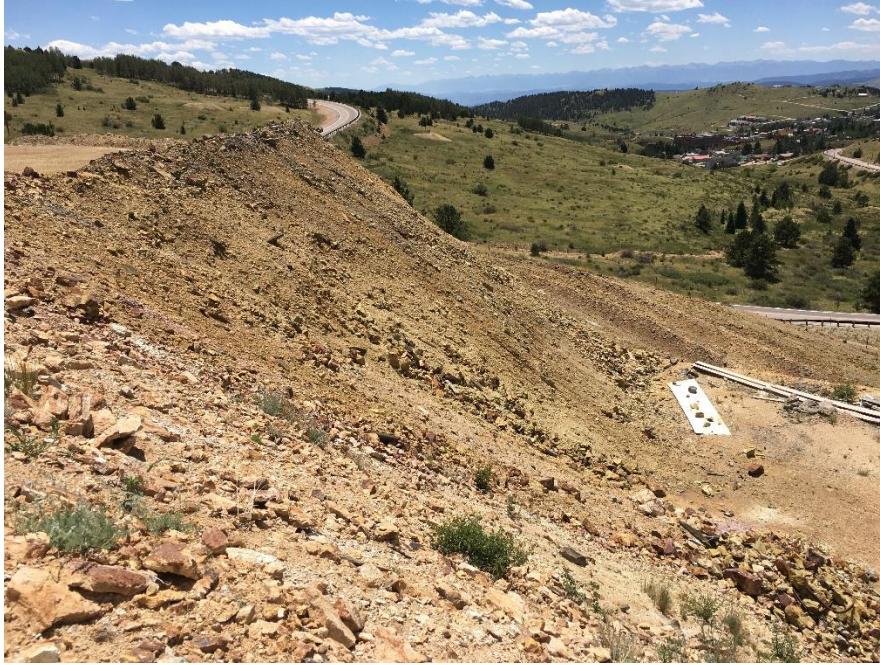
Photo 1: Stormwater controls are adequate, very little erosion from side slope

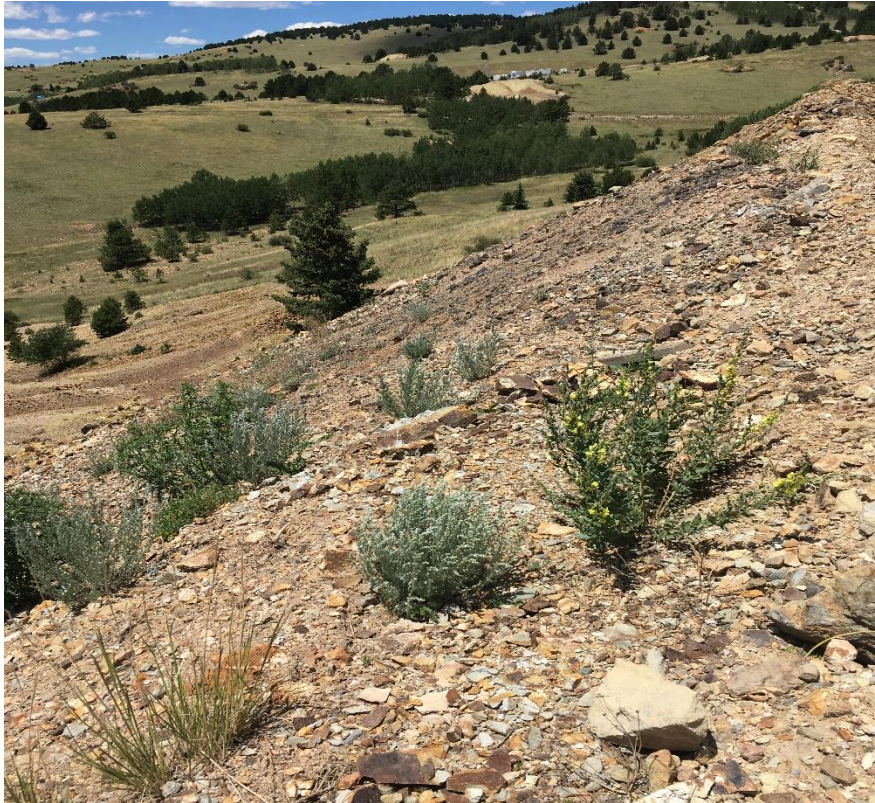
Photo 4: Some noxious weeds present, mitigated (sprayed) after site visit

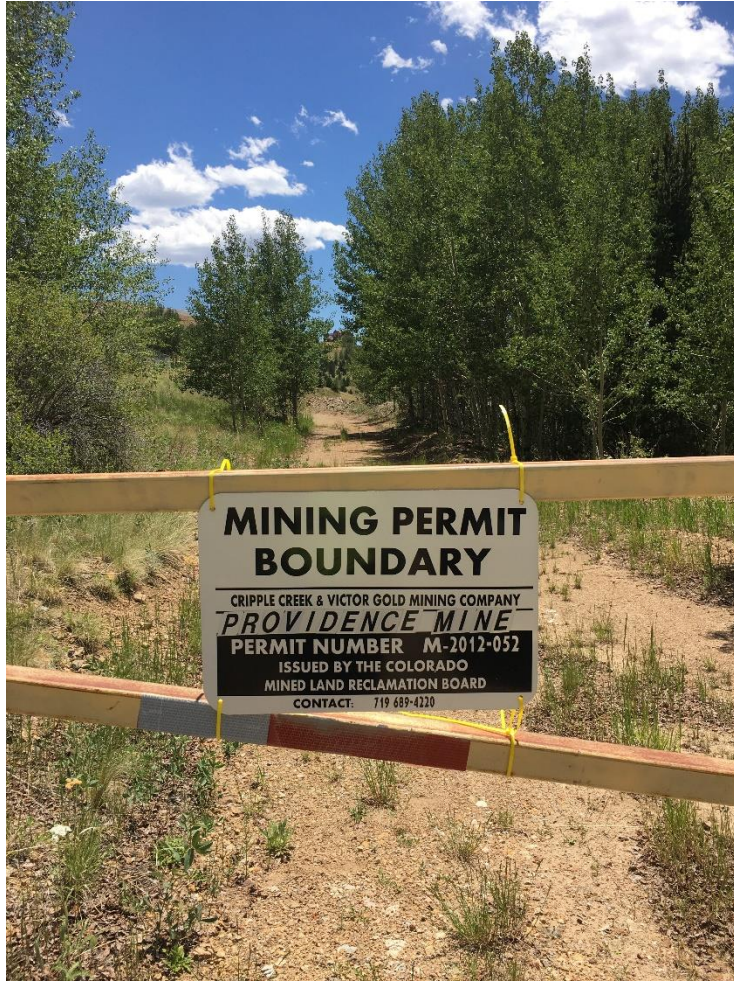
Photo 5: Main gate signage, also found along mine perimeter
