**NEW ELK MINE**  
**Permit No. C-1981-012**

**QUARTERLY COAL WASTE BANK INSPECTION REPORT**  
**July 31, 2020**

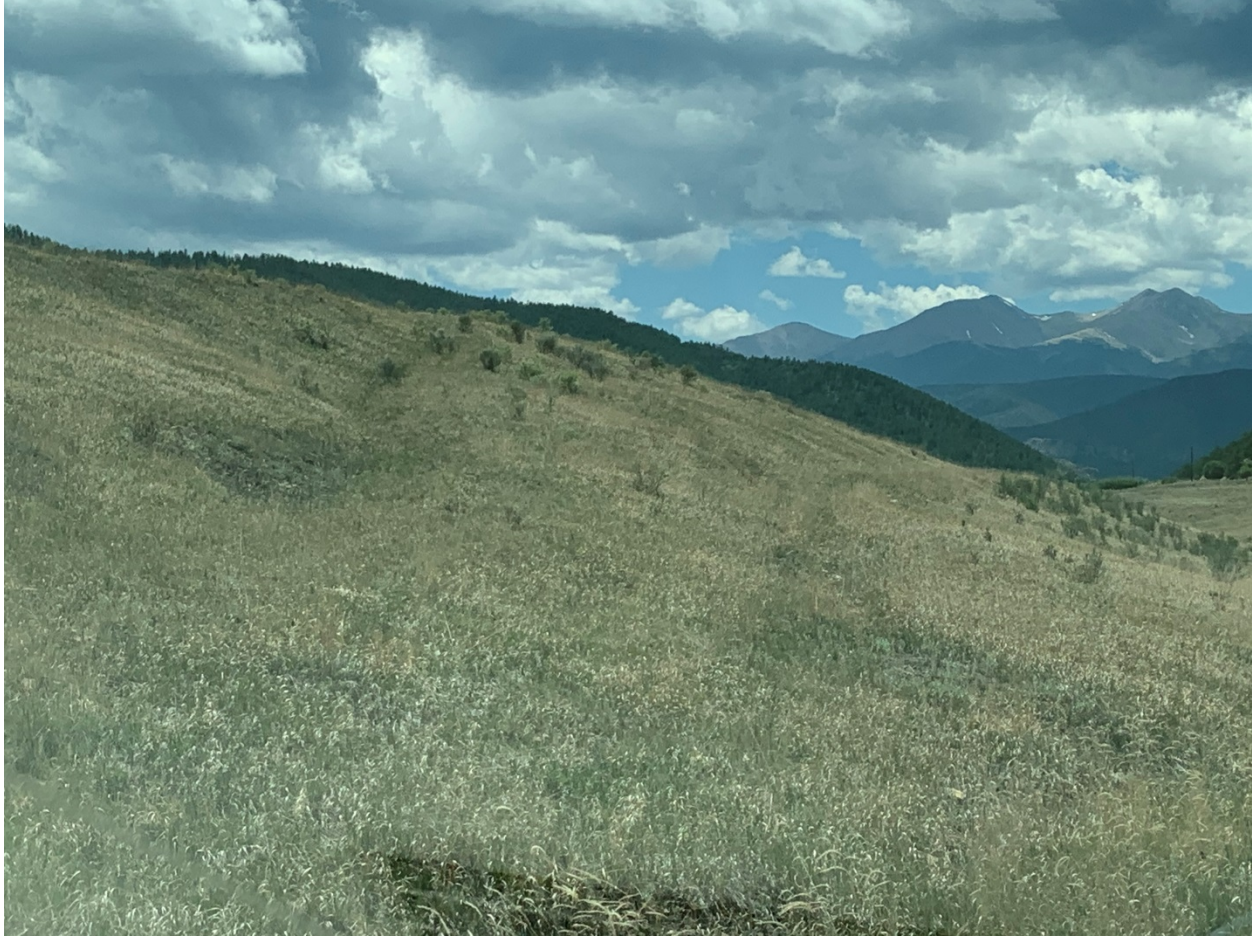
**DWDA #1 – North Facing Slope**

Overall the disposal area is in good condition. Vegetation is overall good for the lack of moisture in recent months.

None at this time.

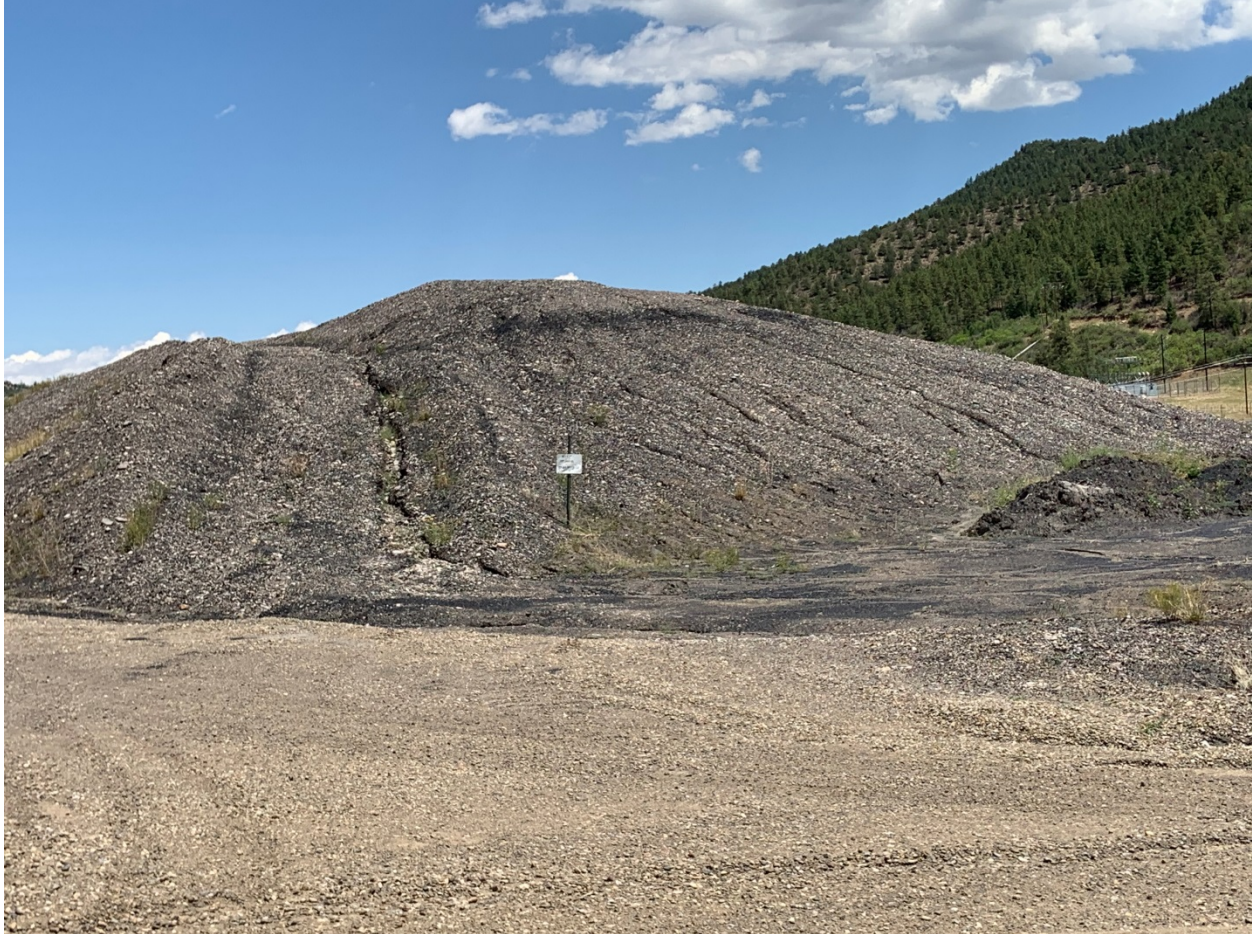
**DWDA #2 – South and West Facing Slopes**

Surface and out slopes of the pile were inspected for visible signs of potential failure or instability. There was some surface erosion but not enough to make the area unstable. In all no signs of failure or instability were observed.

Overall the disposal area is in good condition.

The ditch around the area has been cleaned within the past quarter as part of annual maintenance. The Rills are being monitored and have not gotten any bigger and there is no sediment loading. Operator is evaluating either reclamation of the area or permitting alternative uses of the land north of the Purgatoire River and south of Highway 12.

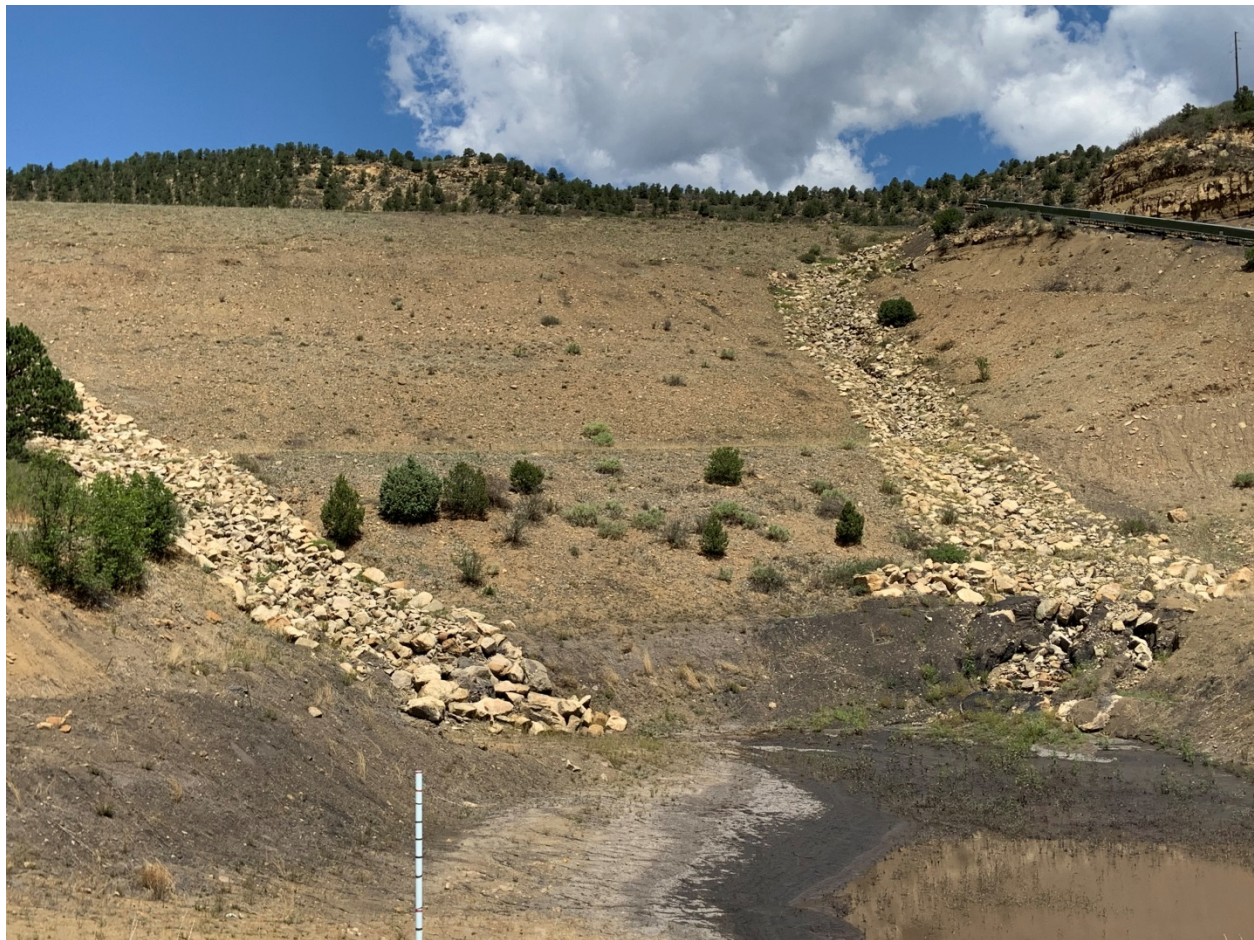
**Refuse Disposal Area – Reclaimed Benches and Armored Drainage**

Overall the site is in good condition.

None required at this time.
