## QUARTERLY SEDIMENTATION POND INSPECTION REPORT

Mine: New Elk  
NPDES ID. No.: Pond #1  
Inspection Period: Third Quarter 2020  
Inspection Date: 7/31/2020

**QUARTERLY SEDIMENTATION POND INSPECTION REPORT**  
**New Elk Mine- July 31, 2020**

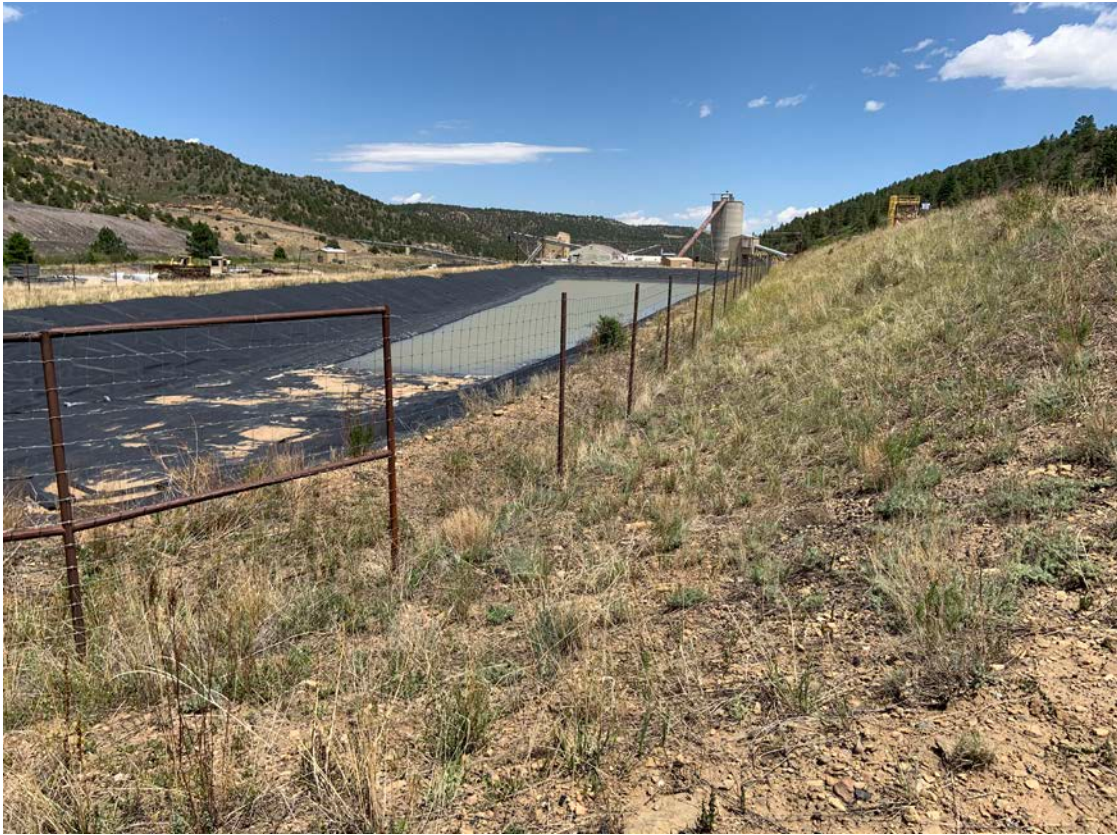
**Pond 1**

Pond liner is in good condition at time of inspection. Pond was holding water at time of inspection.

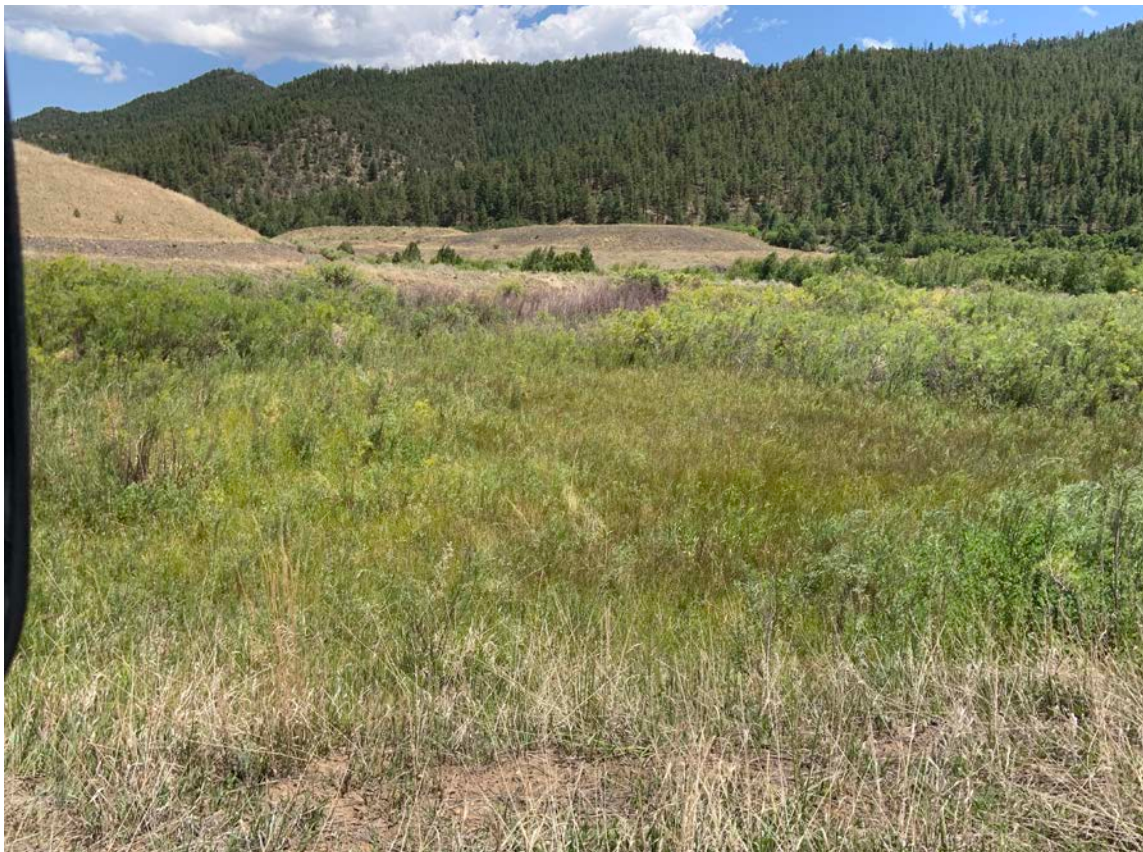
**Pond 4**

Pond was holding a small amount of water.

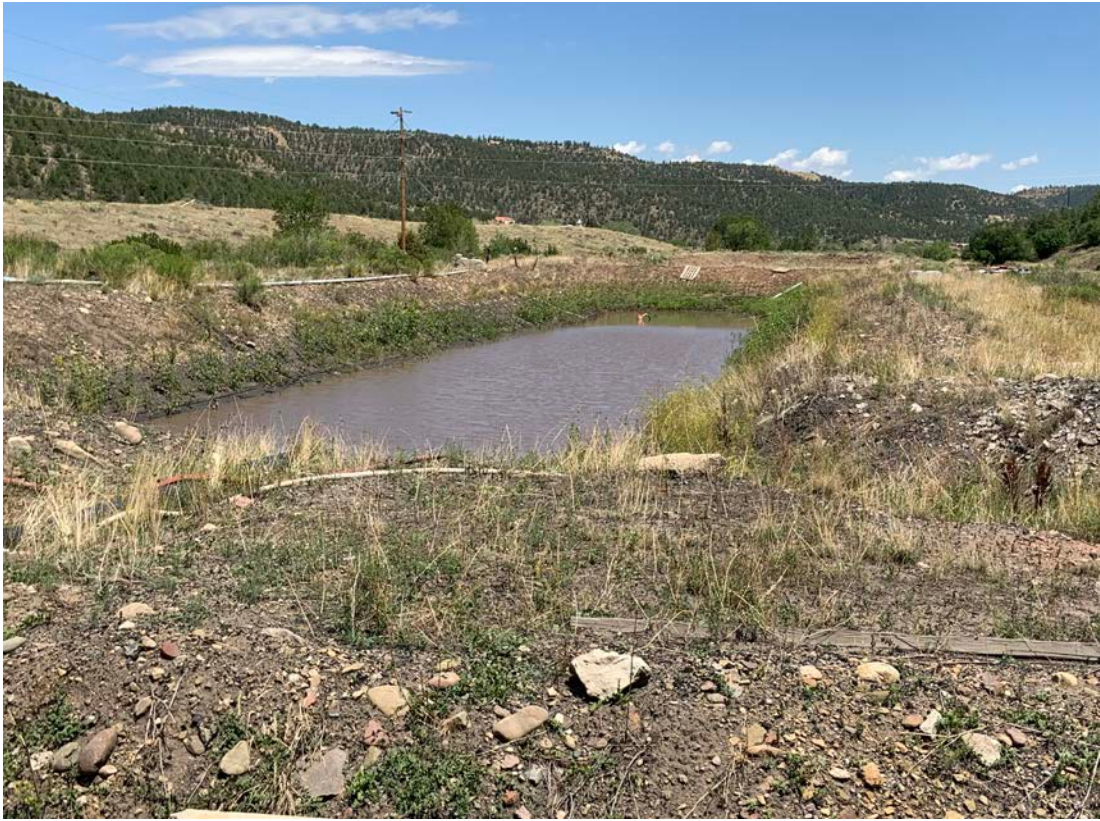
**Pond 6**

Pond is holding water, not close to full.

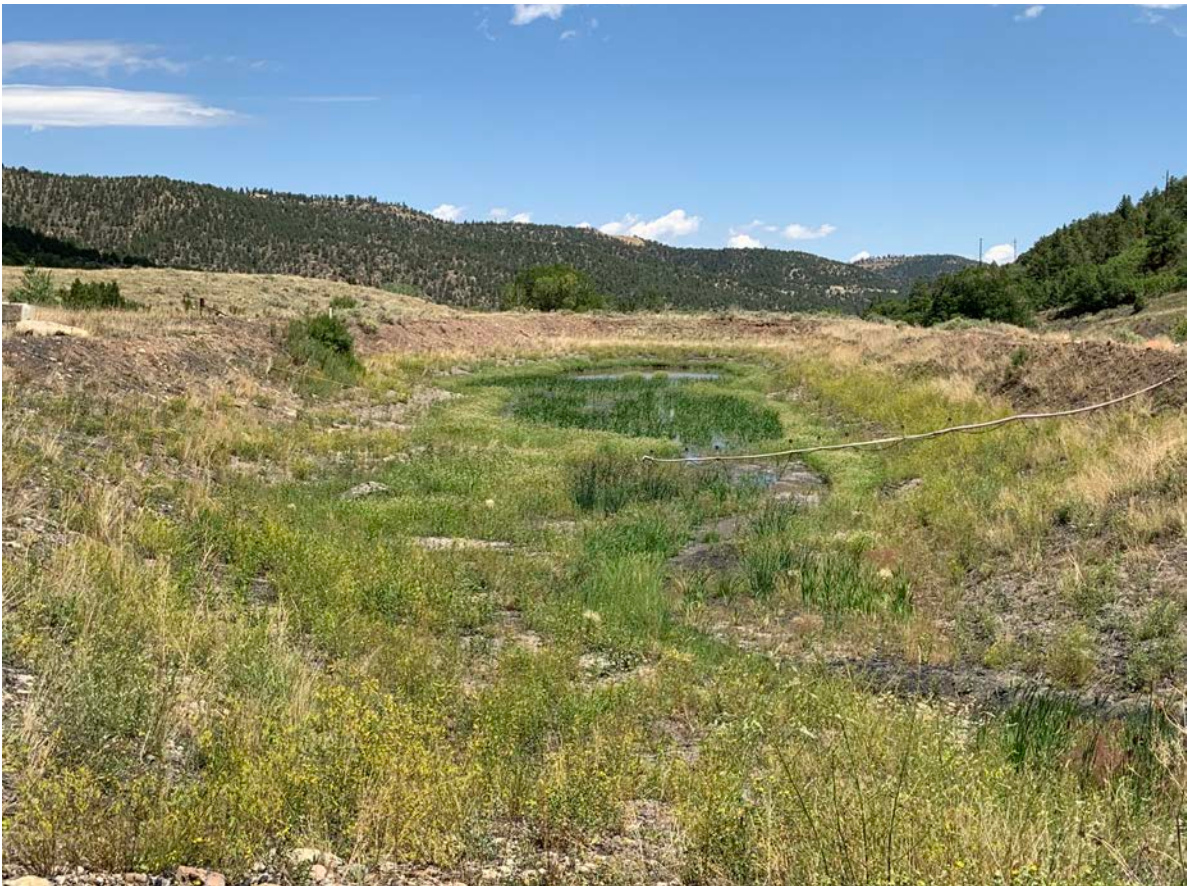
**Pond 7**

Pond is holding water, not near the level of the decant.

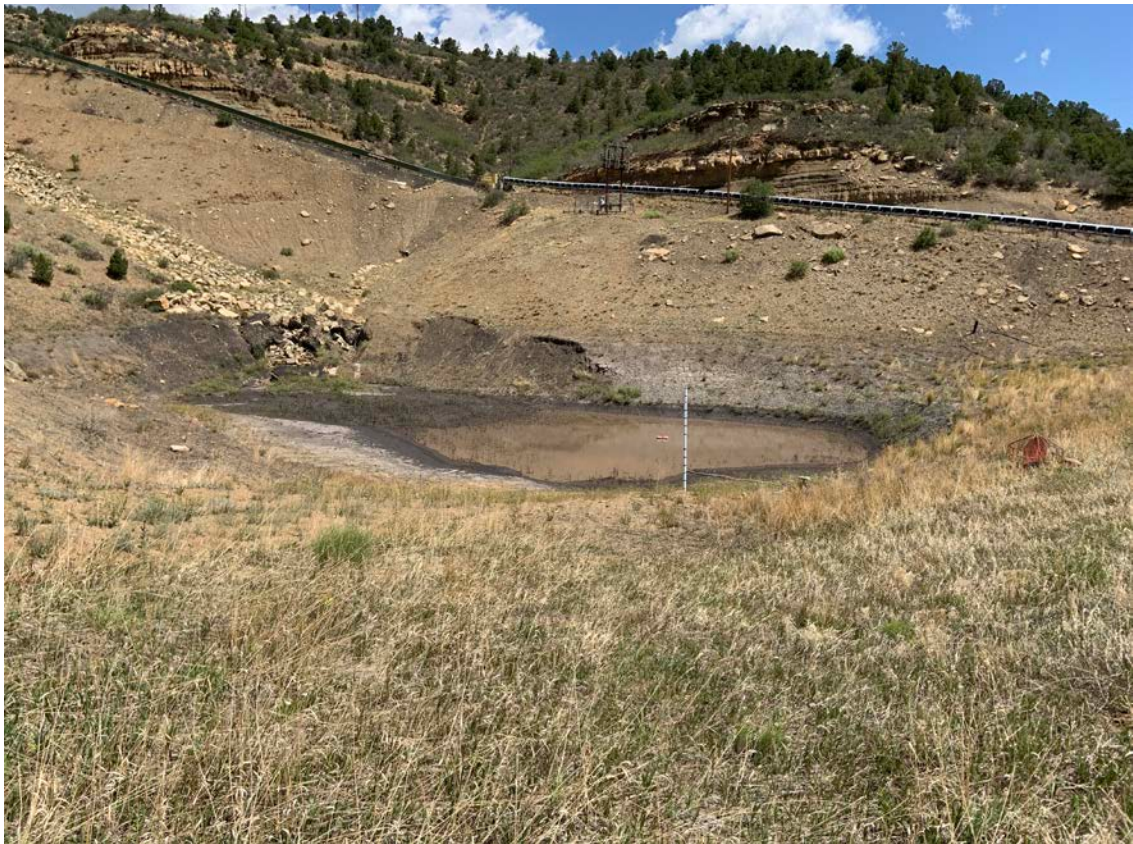
**Pond 8**

Pond was holding water at the time of inspection. No new sediment has been deposited and there is very little sediment in the pond.

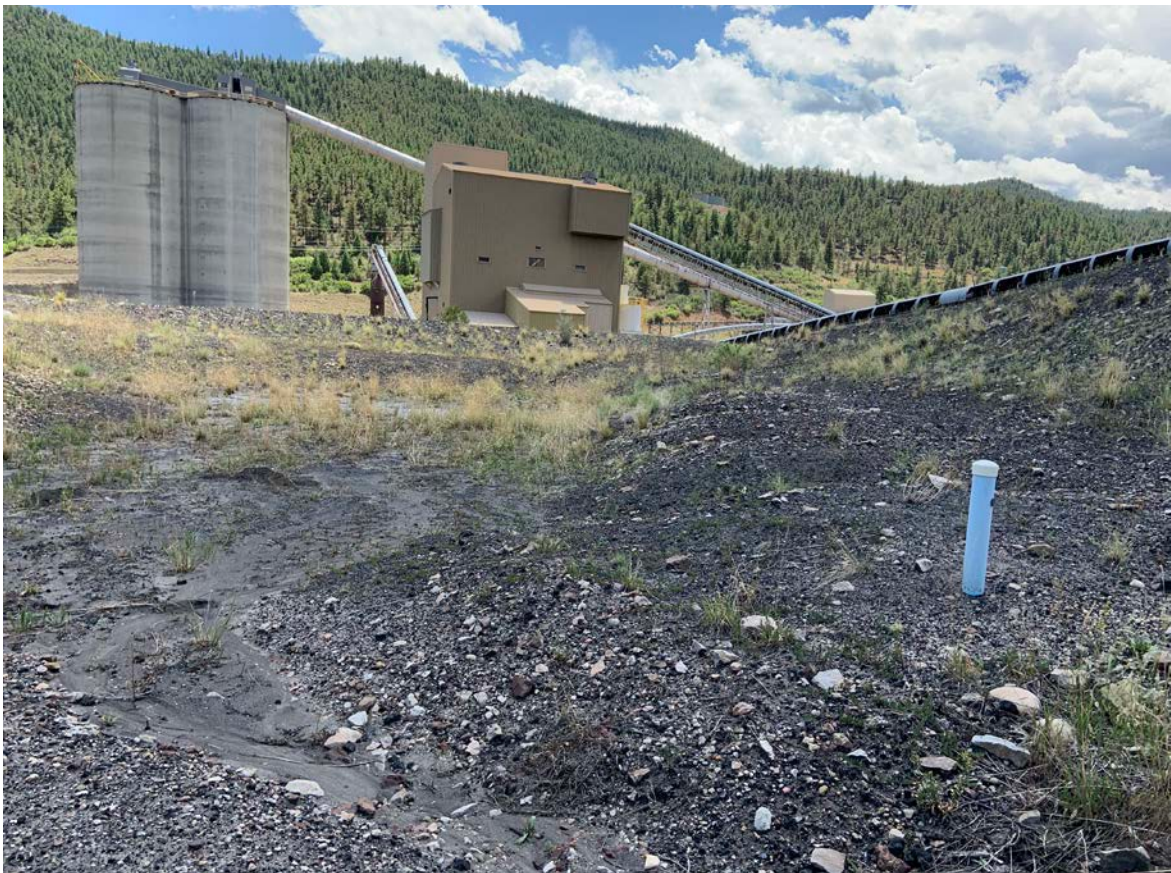
**Containment Area #3**

Containment Area is dry at time of inspection.

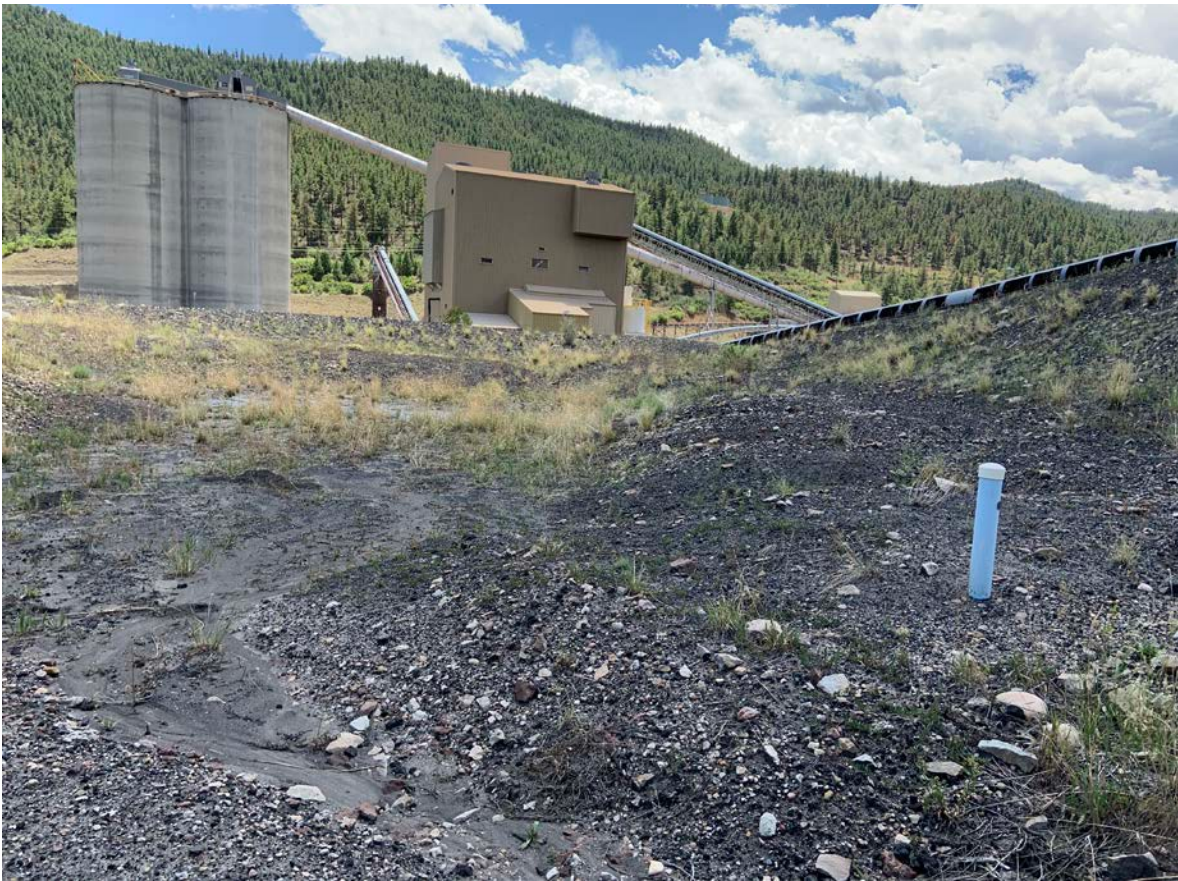
**Containment Area #4**

Containment Area was dry at time of inspection.

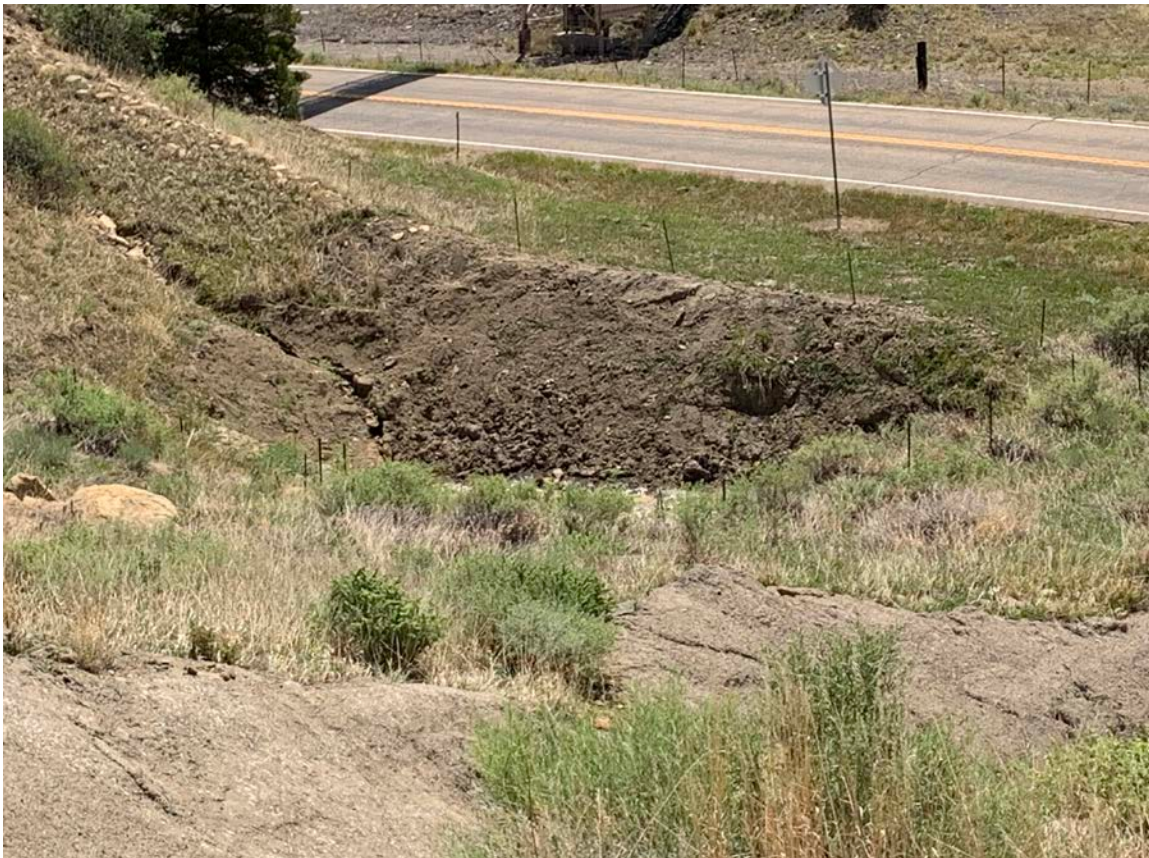
**Containment Area #5**

Containment Area is empty. Containment Area was cleaned in the first quarter of 2020 and about 70 percent of the sediment in the containment area was removed.
