QUARTERLY SEDIMENTATION POND INSPECTION REPORT

Mine: Lorencito

Inspection Period: Third Quarter 2020

QUARTERLY SEDIMENTATION POND INSPECTION REPORT
Lorencito Canyon Mine- July 31, 2020

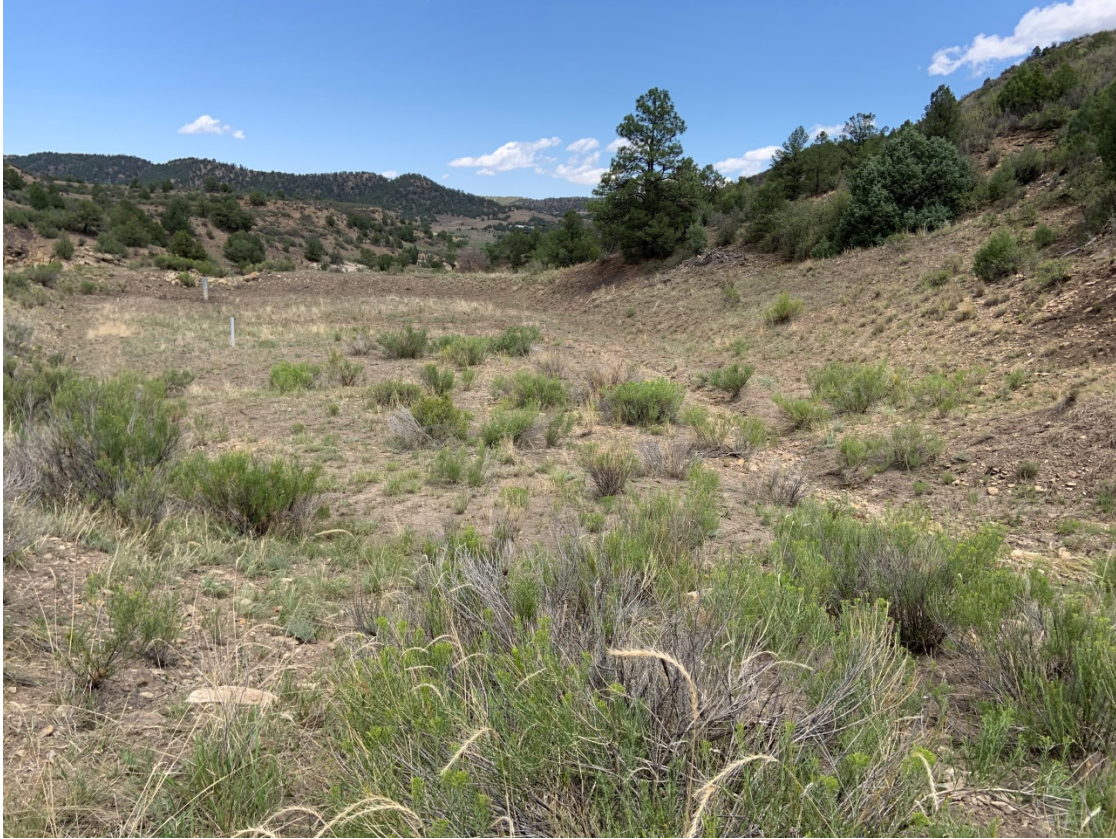
Pond 5

Pond empty at time of inspection

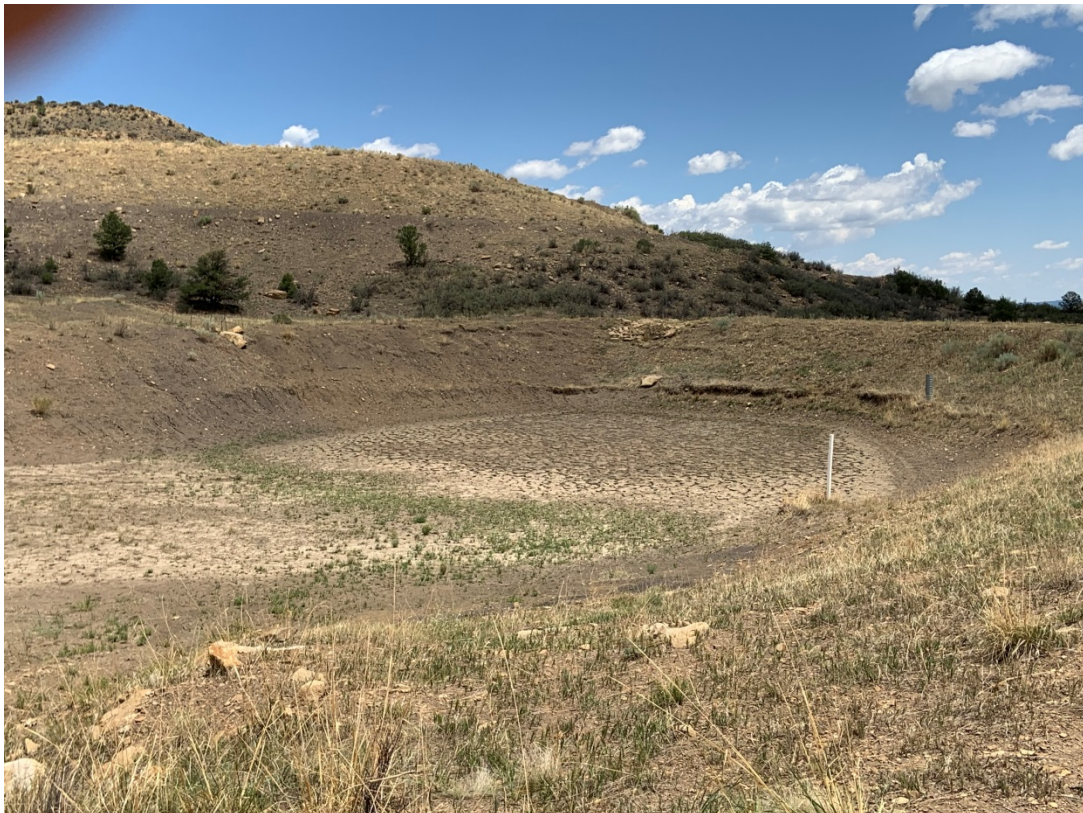
Pond 6

Pond empty at time of inspection.

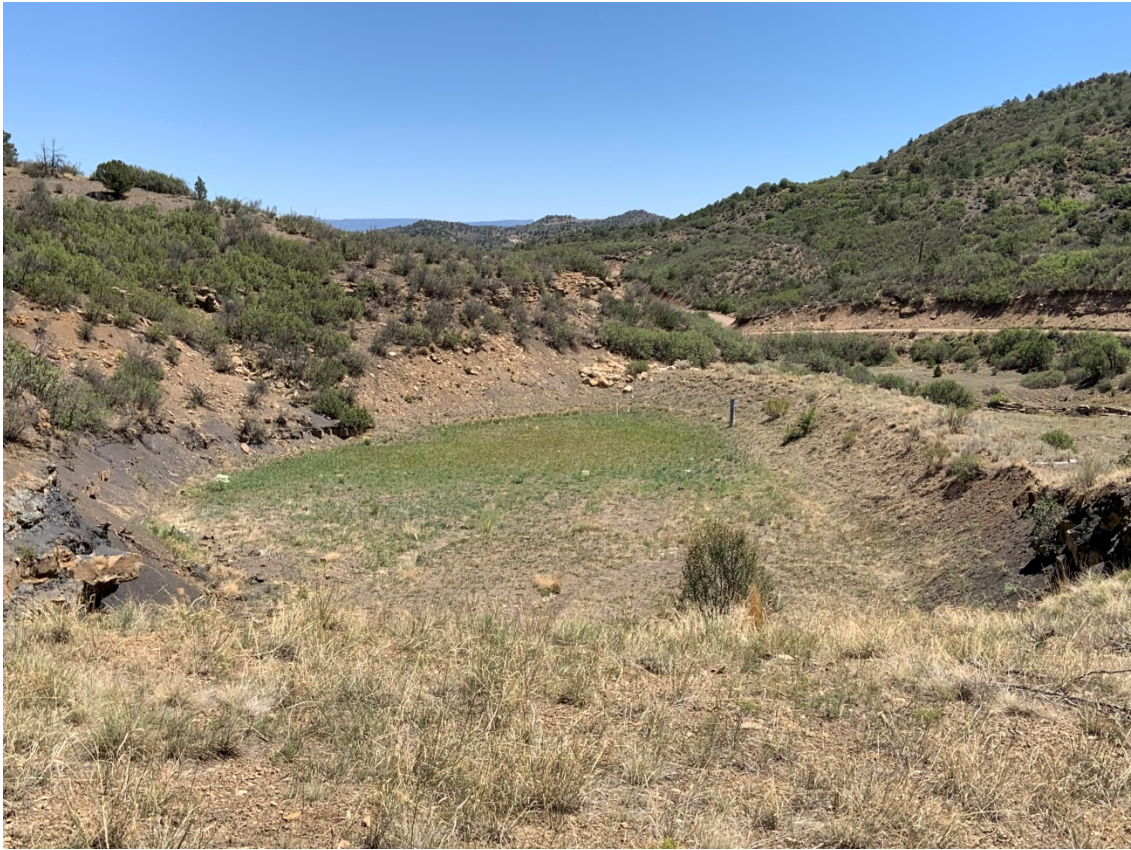
Pond 7

Pond empty at time of inspection.

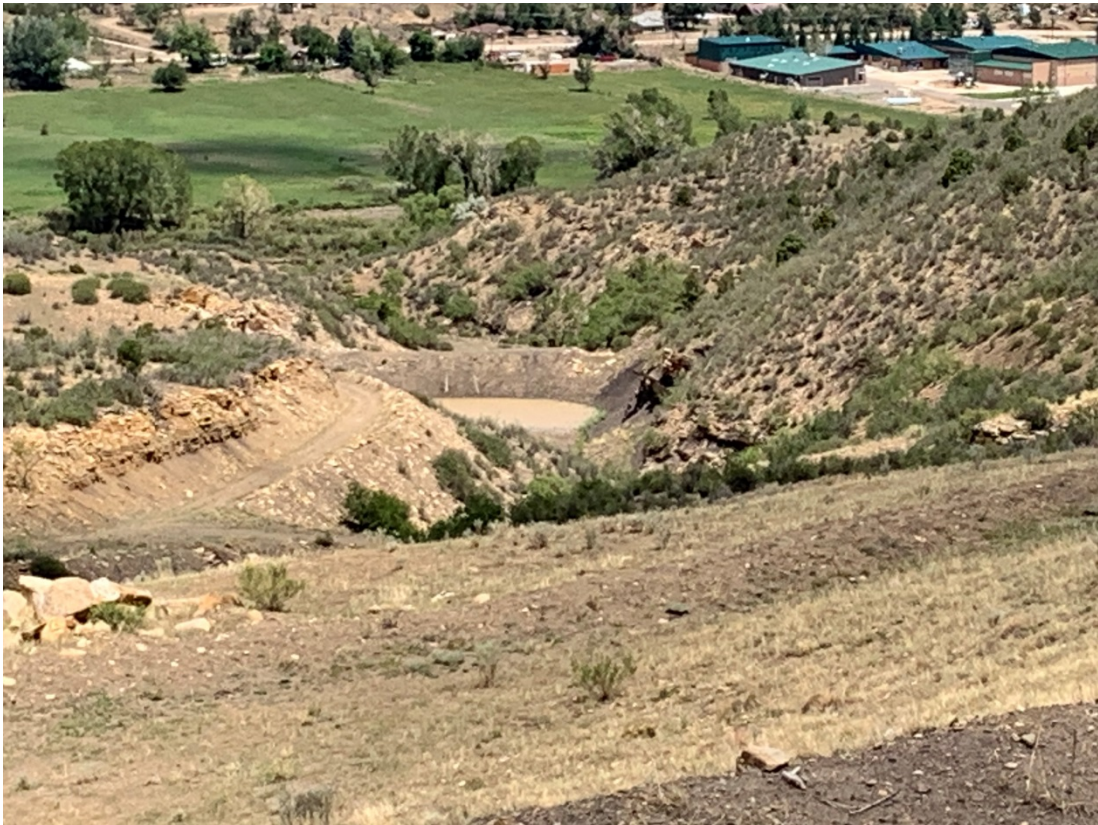
Pond 8

Pond holding about 6 inches of water at time of inspection.

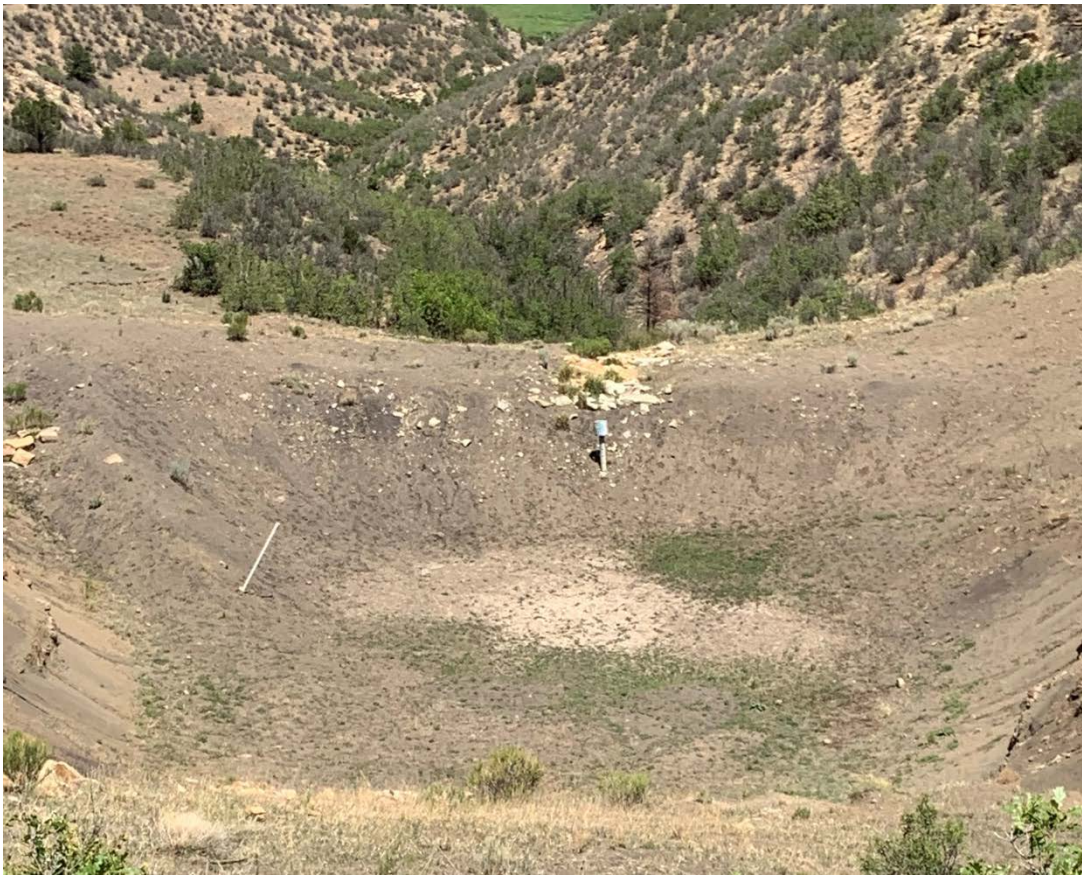
Pond 9

Pond not holding water at time of inspection.

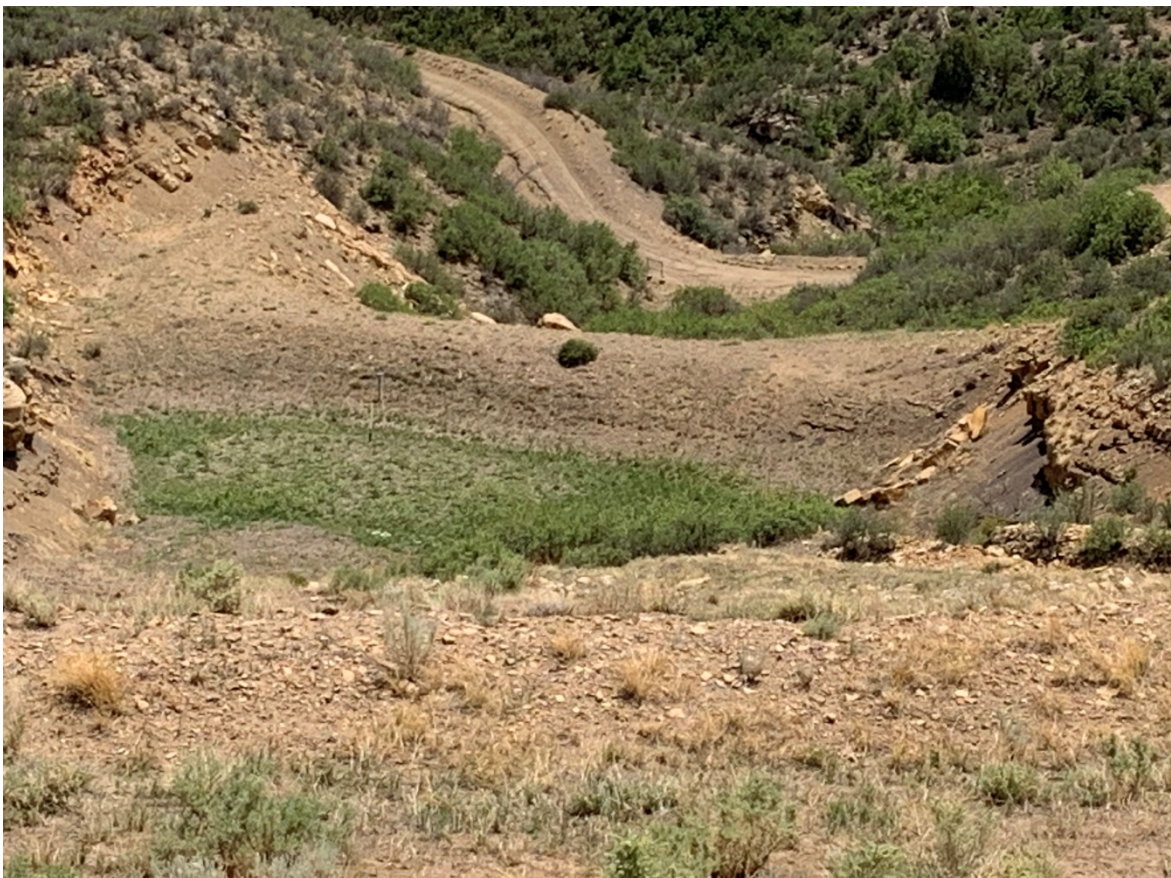
Pond 9a

Pond was empty at time of inspection.
