**LORENCITO CANYON MINE**  
**Permit No. C-1996-084**

**INSPECTION OF EXCESS SPOIL-FILLS 7, 8, & 9**  
**July 31, 2020**

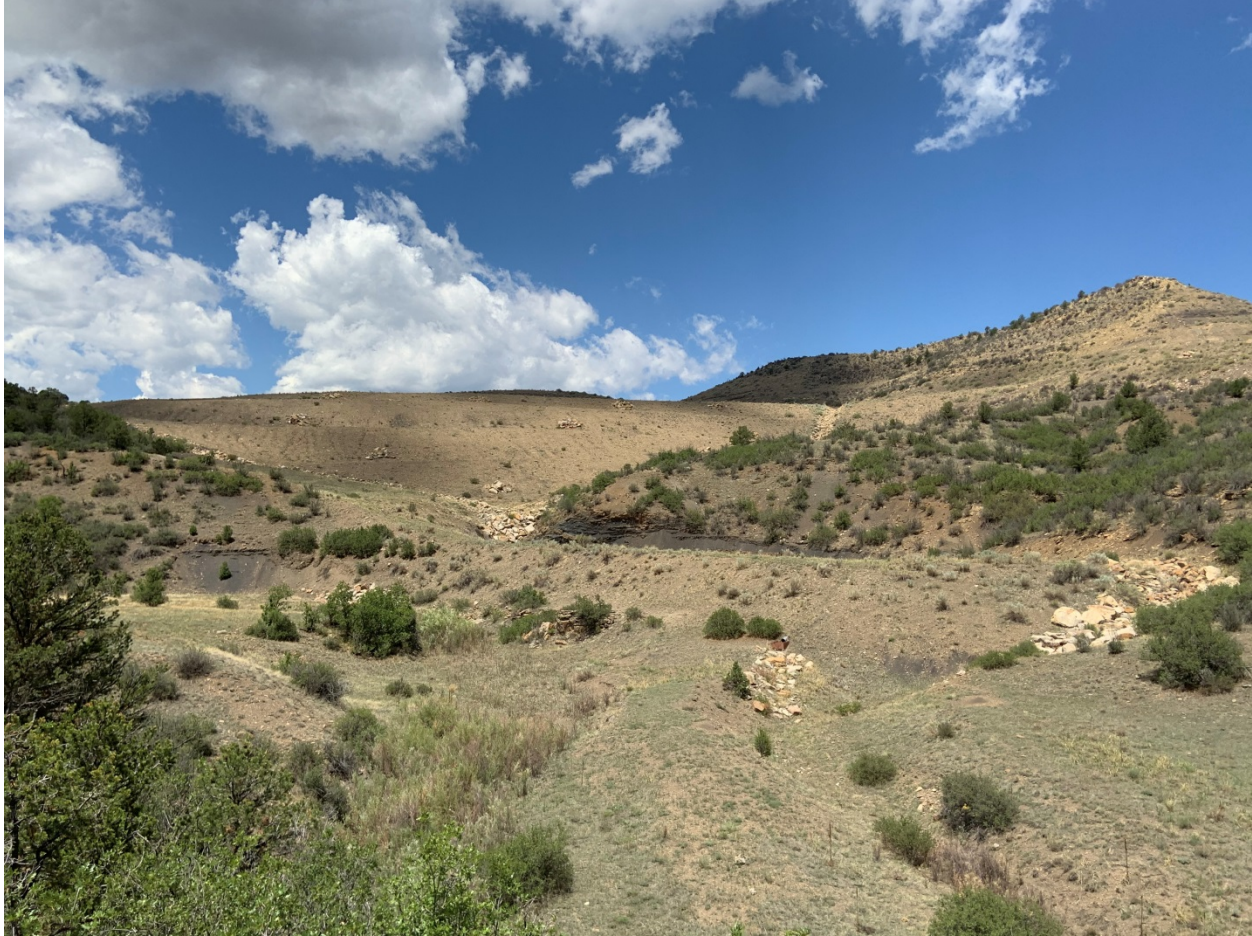
**Fill #7**

The entire excess spoil fill facility was examined for signs of failure and instability such as tension cracks, ground movement, springs and seeps, and standing water. There was no indication of potential instability at time of inspection.

Overall the site is in good condition. The vegetation on the fill is encouraging.

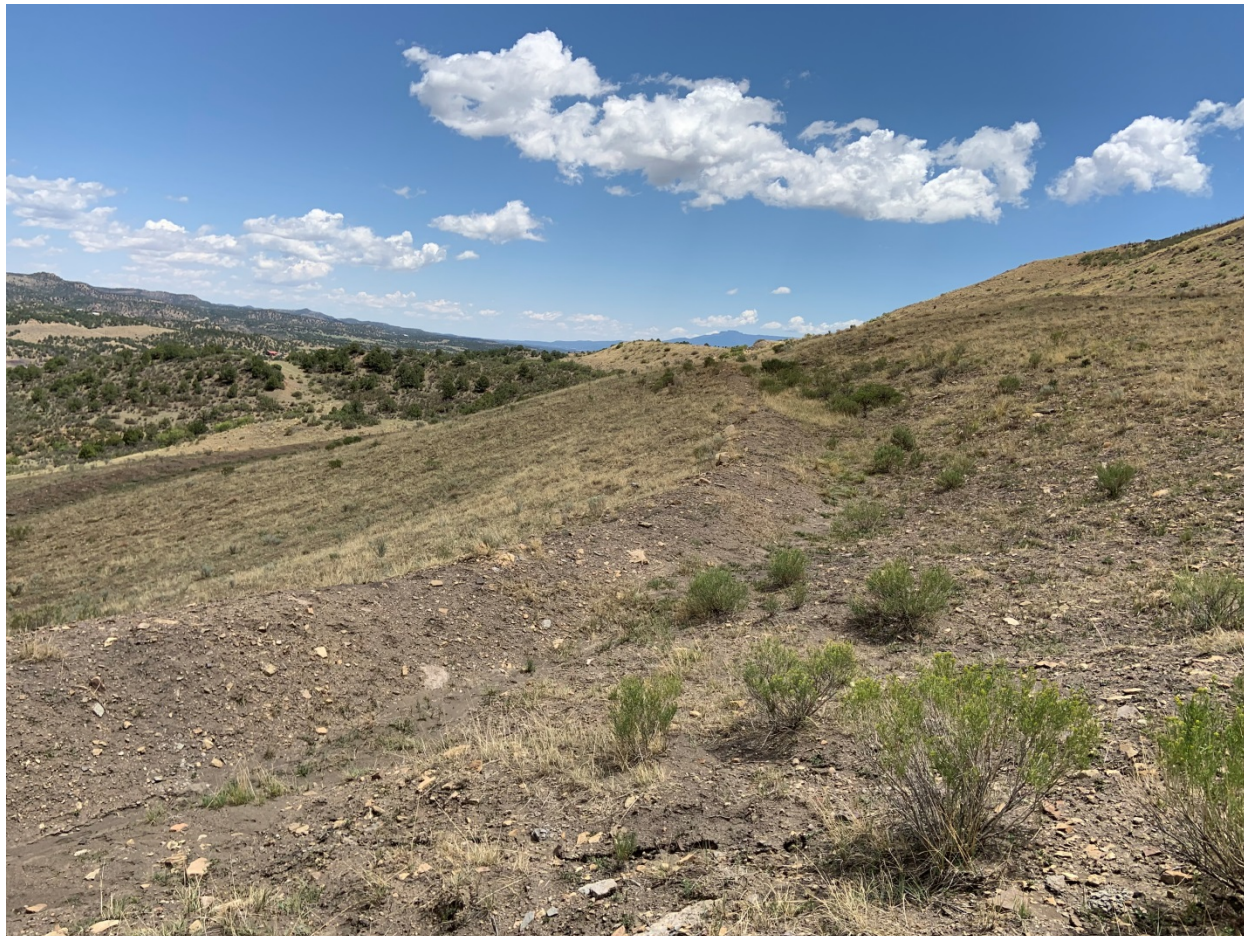
**Fill #8**

The entire excess spoil fill facility was examined for signs of failure and instability such as tension cracks, ground movement, springs and seeps, and standing water. There was no indication of potential instability at time of inspection.

Overall the site is in good condition. Vegetation is very good on the fill.

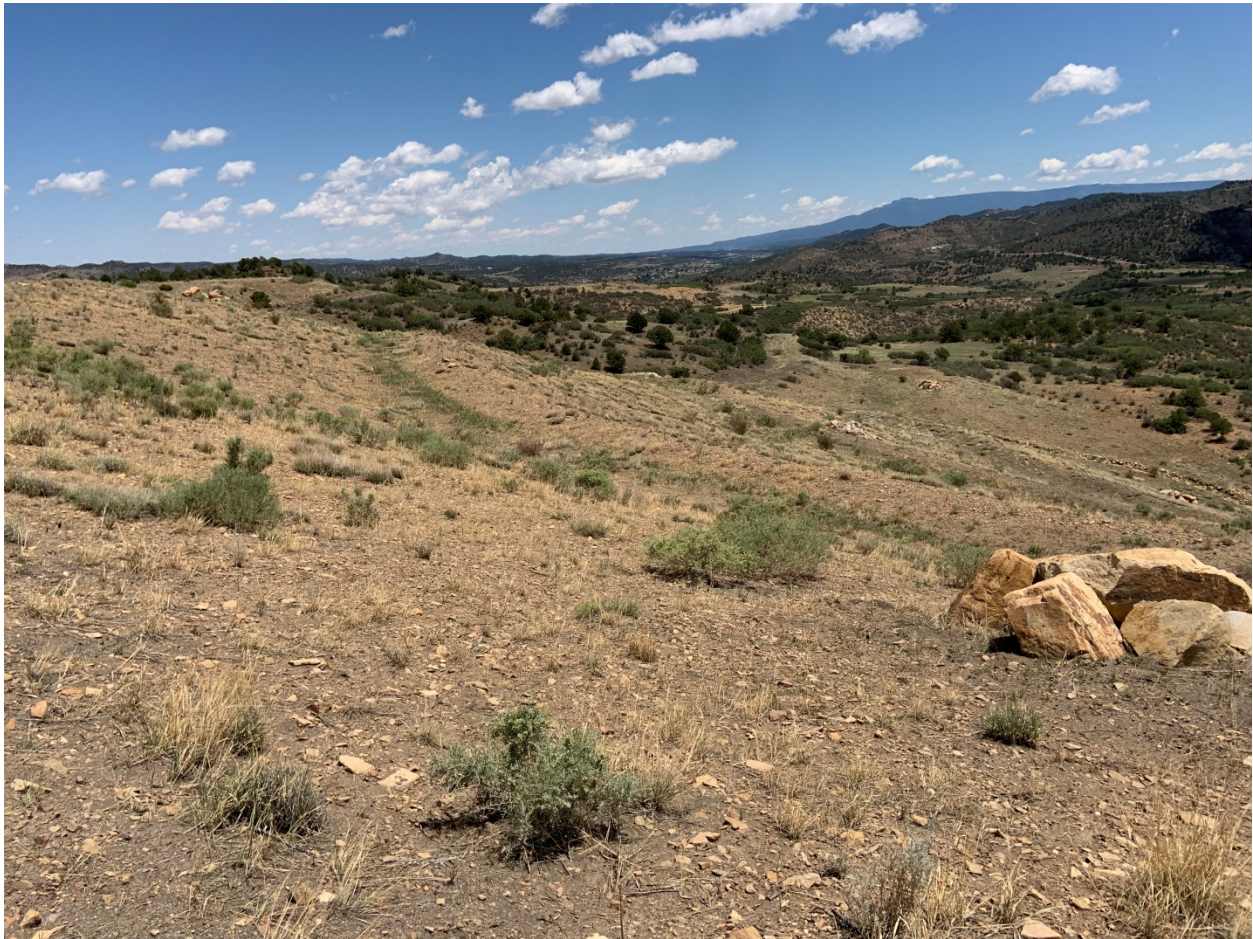
**Fill #9**

The entire excess spoil fill facility was examined for signs of failure and instability such as tension cracks, ground movement, springs and seeps, and standing water. There was no indication of potential instability at time of inspection.

Overall the site is in good condition. Vegetation is fine for this time of year.
