MINERALS PROGRAM INSPECTION REPORT
PHONE: (303) 866-3567

MINE NAME: Headley	MINE/PROSPECTING ID#: M-1980-135	MINERAL: Sand and gravel	COUNTY: Morgan
INSPECTION TYPE: Monitoring	INSPECTOR(S): Brock Bowles	INSP. DATE: September 15, 2020	INSP. TIME: 13:00
OPERATOR: Pinneo Feedlot, LTD. Liability Company	OPERATOR REPRESENTATIVE: Dan Timmerman	TYPE OF OPERATION: 112c - Construction Regular Operation	
REASON FOR INSPECTION: Normal I&E Program	BOND CALCULATION TYPE: None	BOND AMOUNT: \$20,000.00	
DATE OF COMPLAINT: NA	POST INSP. CONTACTS: None	JOINT INSP. AGENCY: None	
WEATHER: Clear	INSPECTOR'S SIGNATURE:

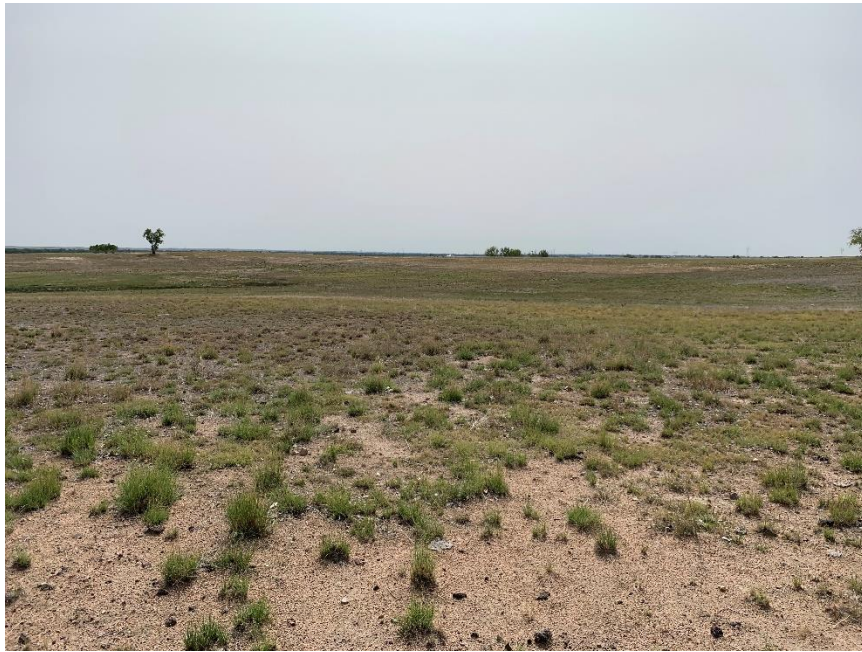
Pit #2 facing southwest

Pit #2 has been backfilled and graded to 3h:1v slopes or flatter. The graded slopes blend well with the surrounding landscape. The vegetation is well established and is equal in extent of cover to the surrounding areas, based on observation. The slopes appeared to be stable as there was no evidence of erosion, rills or gullies.

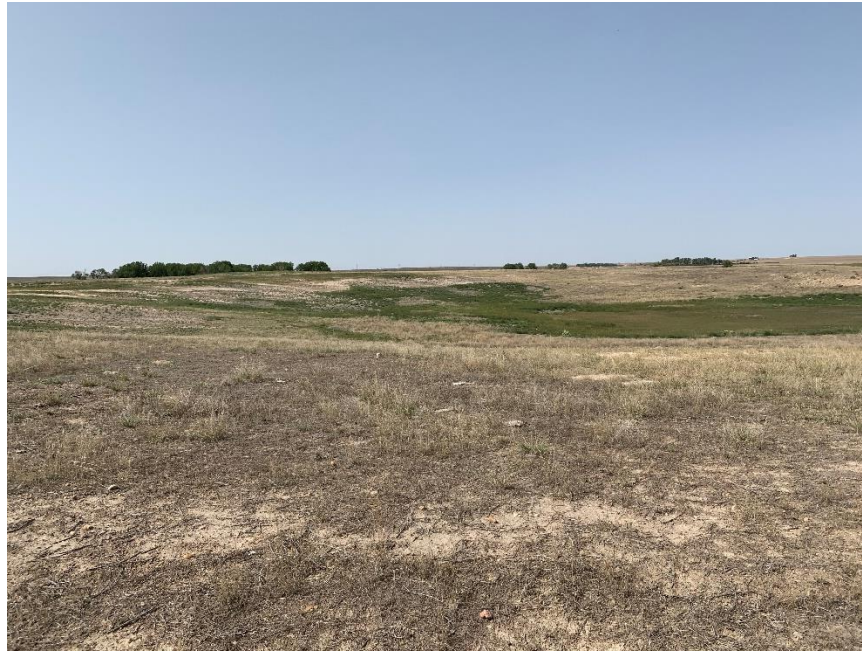
Pit #1 facing west

Pit #1 has been backfilled and graded to 3h:1v slopes or flatter. The graded slopes blend well with the surrounding landscape. The vegetation is well established and is equal in extent of cover to the surrounding areas, based on observation. The slopes appeared to be stable as there was no evidence of erosion, rills or gullies. The vegetation in the low areas of the pit and on the western slope were greener than other areas of the pit, indicating some available moisture. There was no standing water in the pit.
