**MINERALS PROGRAM INSPECTION REPORT**  
**PHONE: (303) 866-3567**

<b>MINE NAME:</b> Yocam Borrow Pit	<b>MINE/PROSPECTING ID#:</b> M-2018-020	<b>MINERAL:</b> Borrow material for	<b>COUNTY:</b> Morgan
<b>INSPECTION TYPE:</b> Monitoring	<b>INSPECTOR(S):</b> Brock Bowles	<b>INSP. DATE:</b> September 15, 2020	<b>INSP. TIME:</b> 10:00
<b>OPERATOR:</b> Castle Rock Construction Company of Colora	<b>OPERATOR REPRESENTATIVE:</b> Darren Janssen	<b>TYPE OF OPERATION:</b> 111 - Construction by Government Agency	
<b>REASON FOR INSPECTION:</b> Normal I&E Program	<b>BOND CALCULATION TYPE:</b>	<b>BOND AMOUNT:</b> \$42,500.00	
<b>DATE OF COMPLAINT:</b> NA	<b>POST INSP. CONTACTS:</b> None	<b>JOINT INSP. AGENCY:</b> None	
<b>WEATHER:</b> Clear	<b>INSPECTOR'S SIGNATURE:</b>

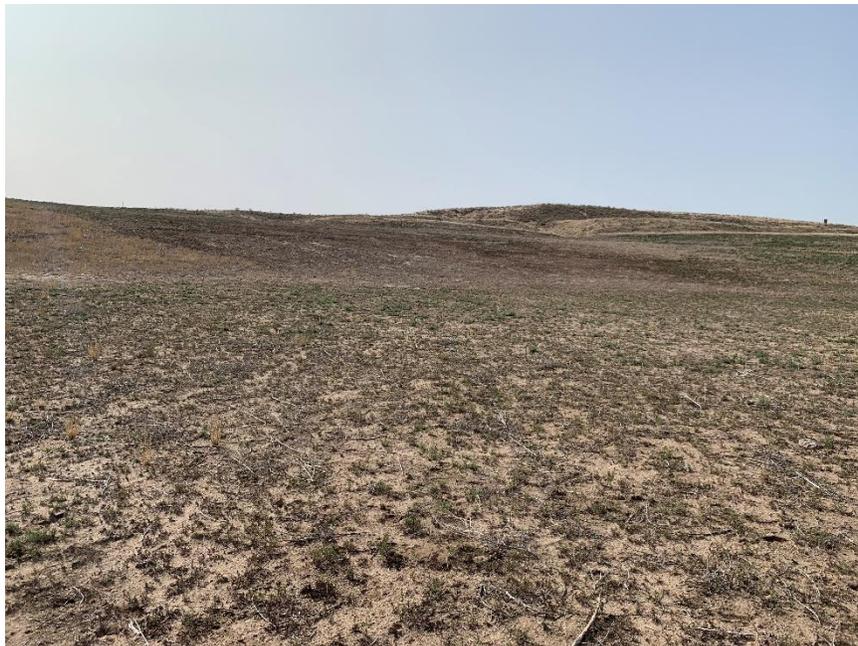
Pit area looking southeast

The entire site is in reclamation. There was no equipment on-site. The slopes of the pit area were graded to approximately 4h:1v and the soil appears to be stable. There were no signs of erosion, rills or gullies.

The vegetation on the site mostly consisted of consisted of kochia and Russian thistle, both non-desirable annuals but not Colorado Dept. of Agriculture listed noxious weeds. No other native grasses or desirable species were seen. This is most likely due to the fact that the gate was open upon arrival and there was evidence that cattle had recently grazed the area. The Operator should consider re-seeding the site and keep the cattle off the reclaimed area for at least 2-4 years to give the plants time to get established. The length of time is dependent on the amount of precipitation received over the next couple of years and keeping cattle off the reclamation.
