**MINERALS PROGRAM INSPECTION REPORT**  
**PHONE: (303) 866-3567**

<b>MINE NAME:</b> Kula Gravel Pit	<b>MINE/PROSPECTING ID#:</b> M-1985-200	<b>MINERAL:</b> Sand and gravel	<b>COUNTY:</b> Morgan
<b>INSPECTION TYPE:</b> Monitoring	<b>INSPECTOR(S):</b> Brock Bowles	<b>INSP. DATE:</b> September 15, 2020	<b>INSP. TIME:</b> 11:00
<b>OPERATOR:</b> Erker Estates Ltd.	<b>OPERATOR REPRESENTATIVE:</b> Nick Erker	<b>TYPE OF OPERATION:</b> 110c - Construction Limited Impact	
<b>REASON FOR INSPECTION:</b> Normal I&E Program	<b>BOND CALCULATION TYPE:</b>	<b>BOND AMOUNT:</b> \$11,891.00	
<b>DATE OF COMPLAINT:</b> NA	<b>POST INSP. CONTACTS:</b> None	<b>JOINT INSP. AGENCY:</b> None	
<b>WEATHER:</b> Clear	<b>INSPECTOR'S SIGNATURE:</b>

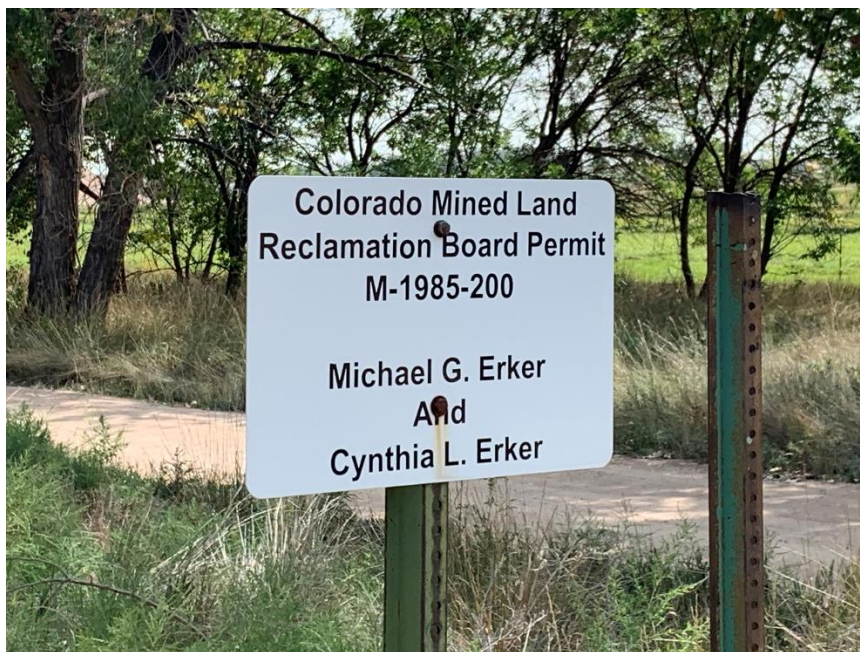
No mining activity was being conducted and no equipment was on site at the time of the inspection. The mine identification sign was in place and was legible. The permit boundary corners were marked with markers painted orange. The entrance gate was closed upon arrival.

Mine entrance sign

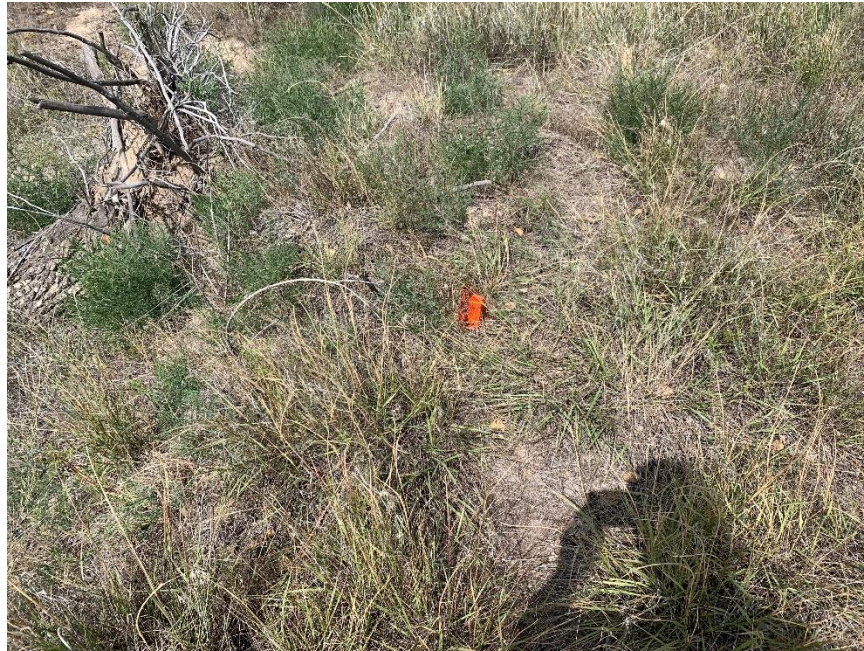
Boundary marker on northwest corner

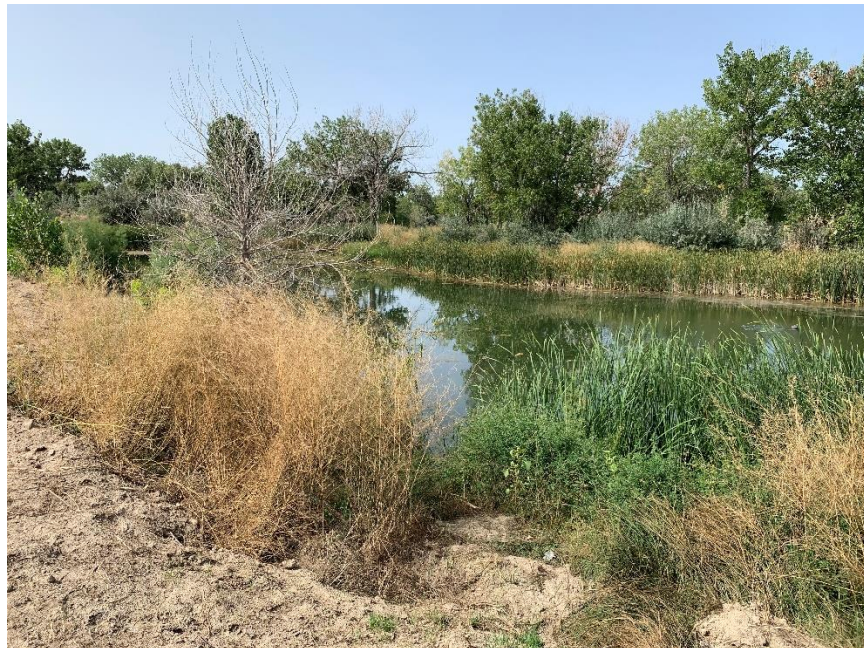
The west and north banks of the pond were well vegetated and appeared to be stable. No more mining is planned for the north and west banks. Material had been removed from the south bank and mining is planned to continue to the south and east.

Southwest bank of pond facing southwest

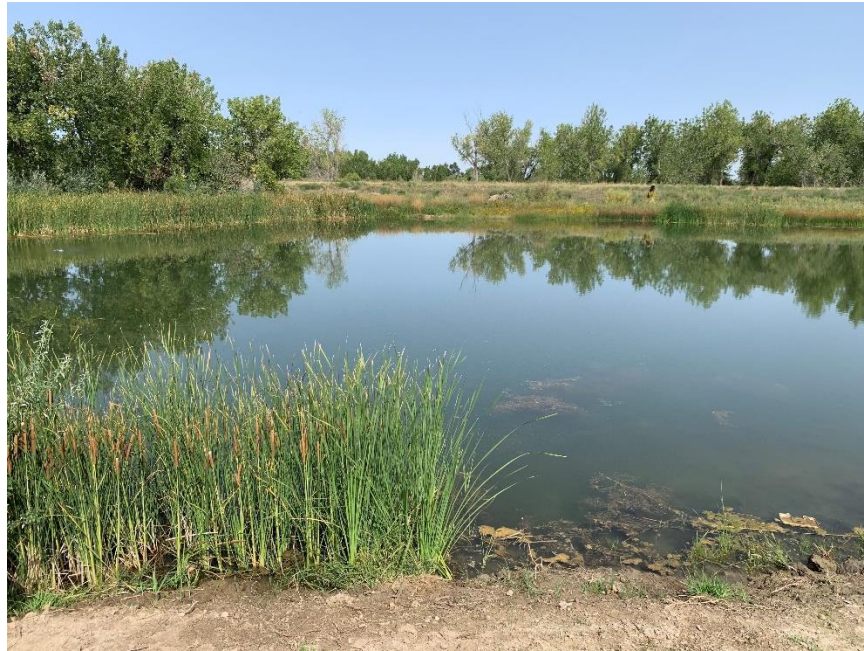
Northwest corner of pond
