**MINERALS PROGRAM INSPECTION REPORT**  
**PHONE: (303) 866-3567**

| <b>MINE NAME:</b><br>Henderson Mine | <b>MINE/PROSPECTING ID#:</b><br>M-1977-342 | <b>MINERAL:</b><br>Molybdenum | <b>COUNTY:</b><br>Clear Creek, Grand |
| <b>INSPECTION TYPE:</b><br>Monitoring | <b>INSPECTOR(S):</b><br>Peter Hays | <b>INSP. DATE:</b><br>September 10, 2020 | <b>INSP. TIME:</b><br>10:00 |

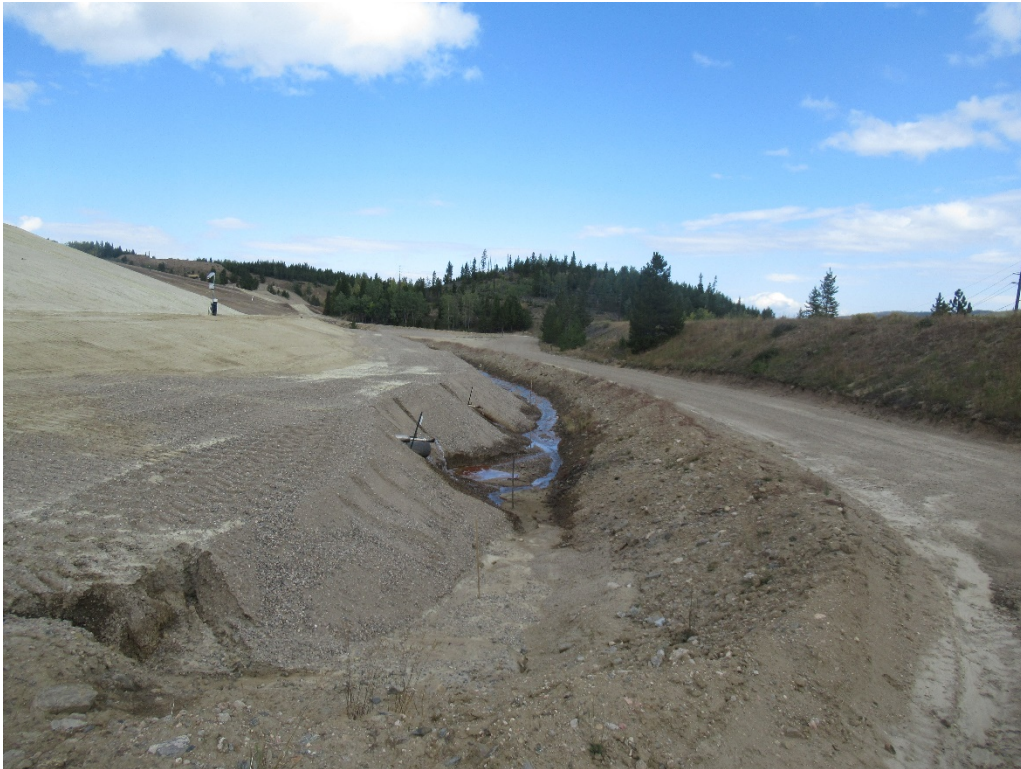
The placement of the rock fill at the toe of the south area of 3-Dam is complete and was observed during the inspection. The placement and compaction of the buttress material was observed on the lower face of the south area of 3-Dam during the inspection. The buttress material was delivered by haul trucks and placed with a GPS controlled dozer. The tailings material was being placed and compacted from north to south in 1 foot lifts. Compaction was achieved by the haul trucks and a sheepsfoot compactor. The buttress material is required to be compacted to 95% maximum density with a moisture content within a range of the optimal moisture. The compaction and moisture content are verified by AECOM with nuclear density tests every lift.

View of the rock fill at the toe of the south area of 3-Dam from the south end looking north

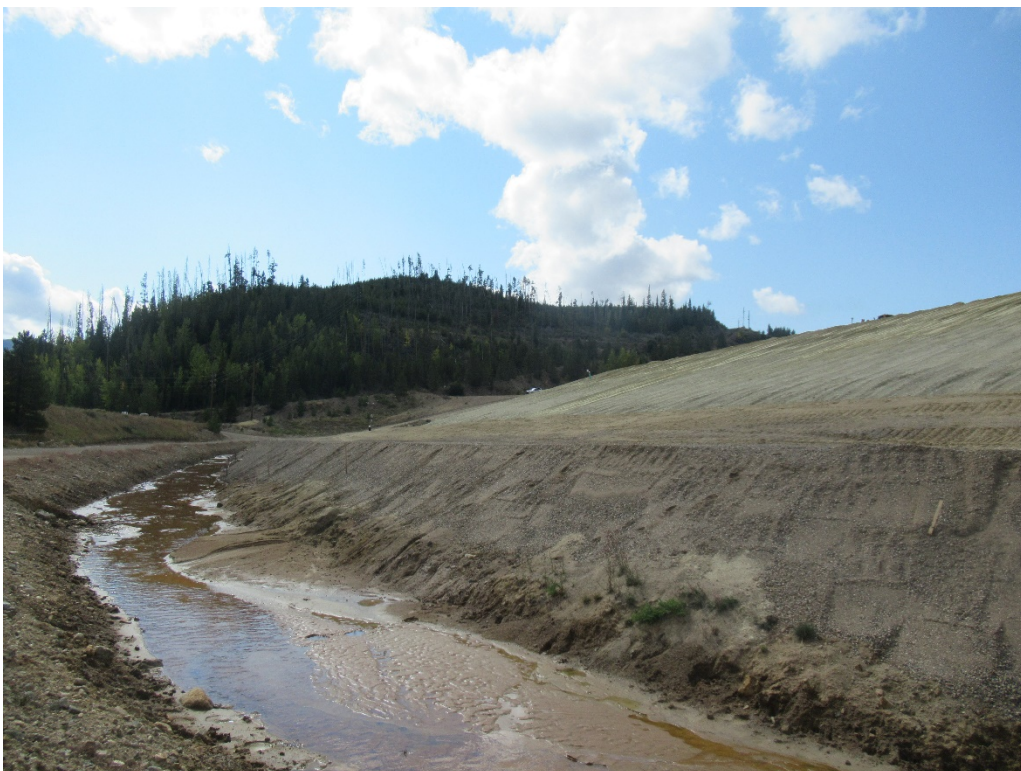
View of the rock fill at the toe of the south area of 3-Dam from the north end looking south

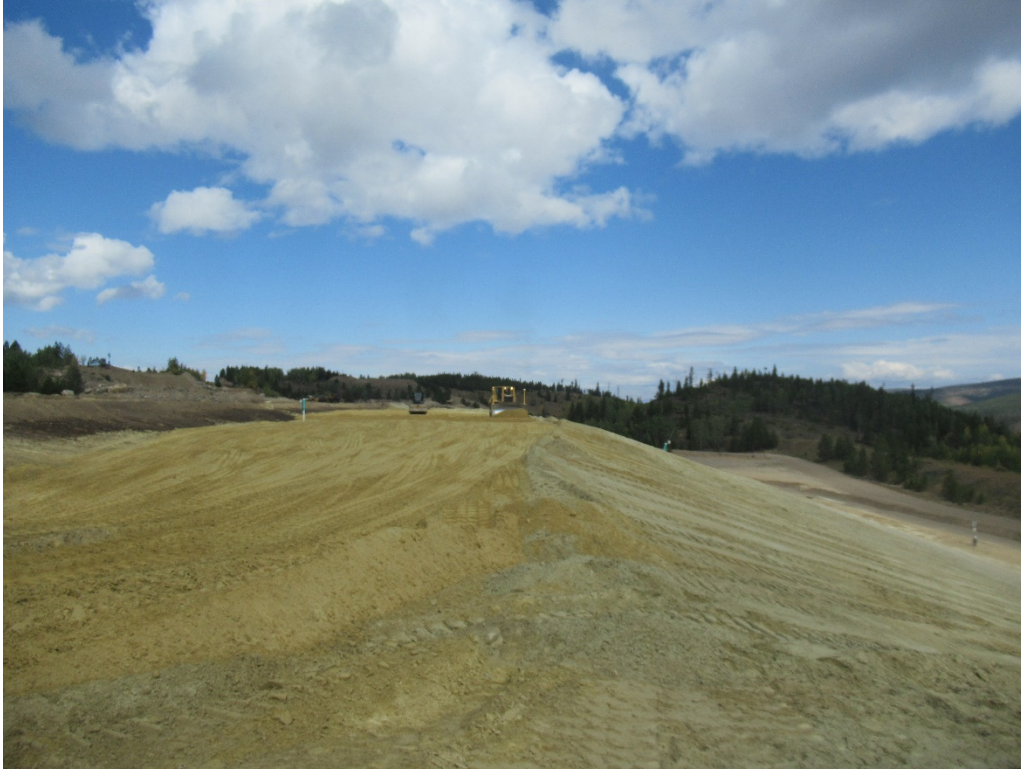
Approximately, three (3) feet of buttress material remained to be placed on the lower face of the south area of 3-Dam at the time of the inspection. The placement and compaction of the buttress material will continue up the face of the south area to the stepback bench and the upper face following completion of the lower face. The filter material required to be placed on the stepback bench buttress was complete and protected from erosion by a lift of buttress material. The location of the buttress for the upper face of the south area was indicated by survey lathes.

View of the placement and compaction of buttress material on the lower face of the south area of 3-Dam

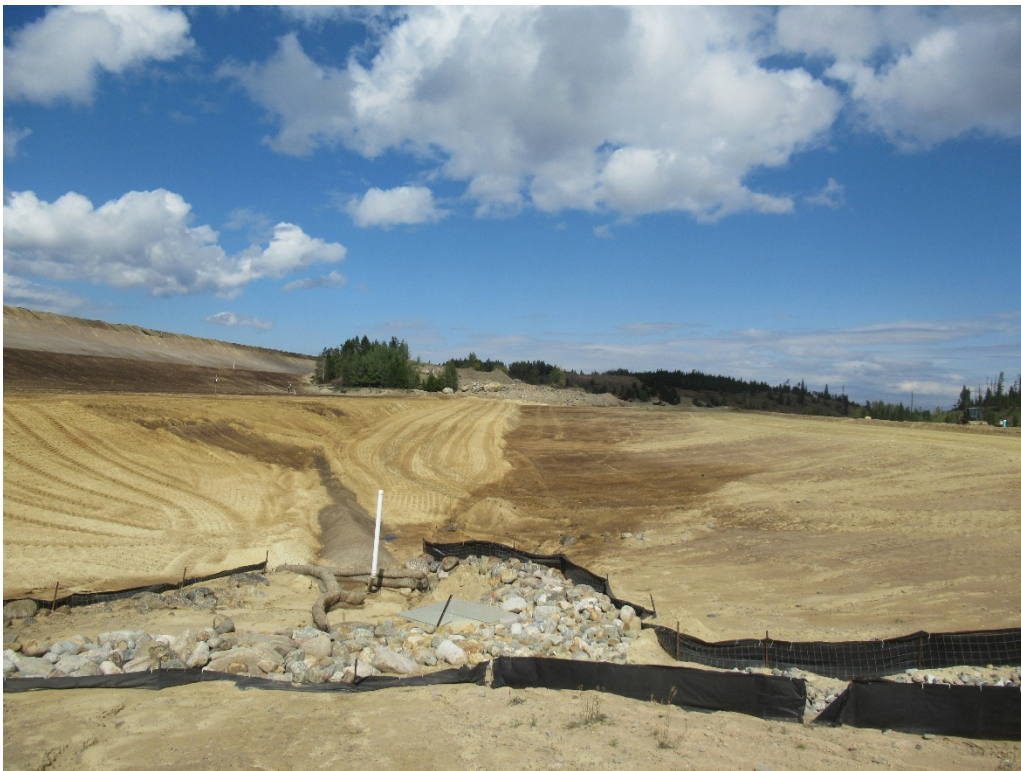
View of the stepback bench on the south area of 3-Dam, filter material placed and covered with buttress material

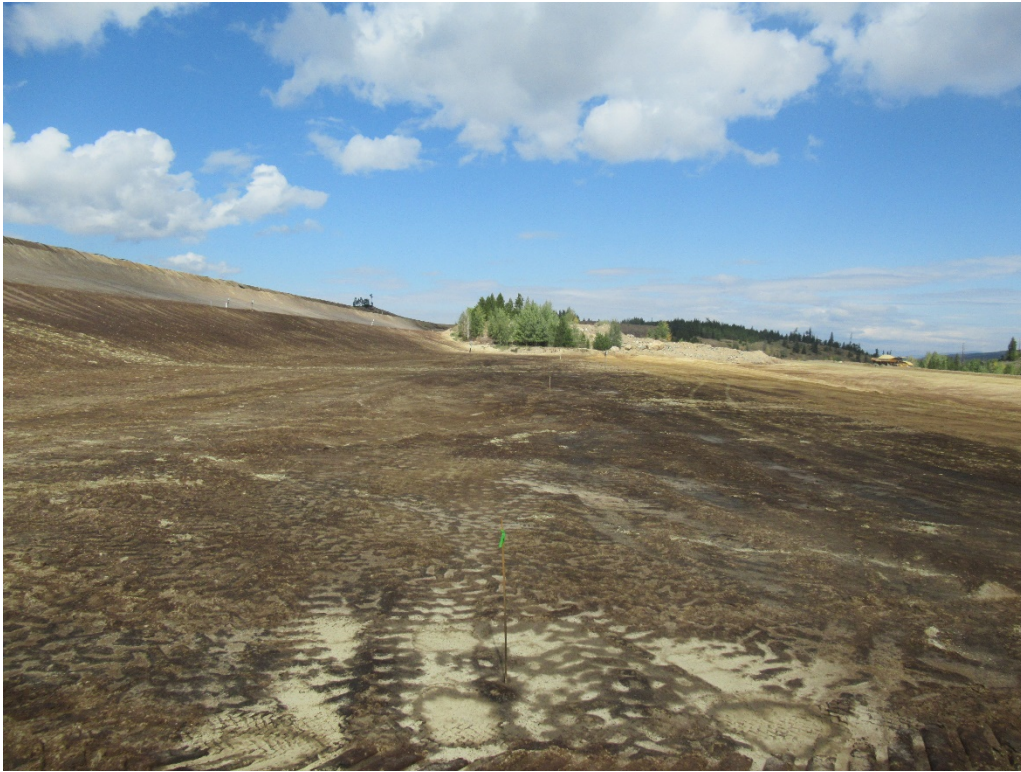
View of the upper face on the south area of 3-Dam, stakes indicate toe of buttress material placement for Phase 2

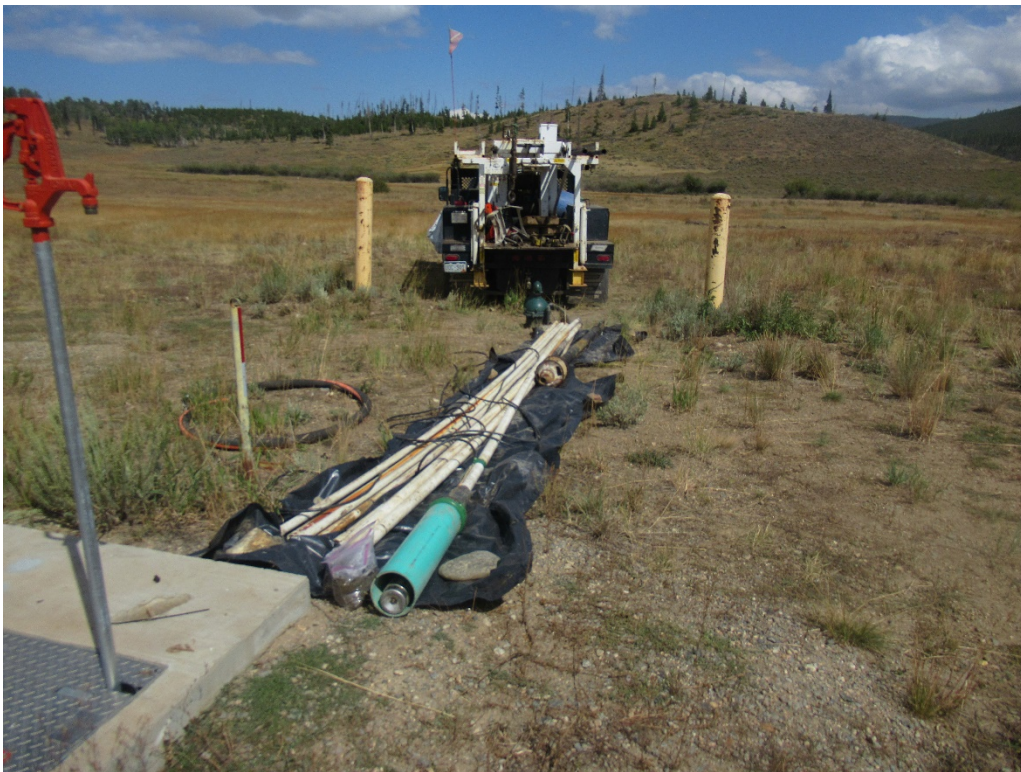
Extraction wells MLEX-1 and MLEX-4 were being rehabilitated by Henderson. The pitless adaptors, pumps and PVC pipes were removed from the wells. The wells were treated with acid to eliminate iron reducing bacteria, swabbed with a brush and bailed to remove sediment in the wells. The wells will be videoed prior to reinstalling the well components. MLEX-1 will be operated on a pump rate rather than based on the water level to reduce sand being pulled through the screen into the well.

View of MLEX-1 during rehabilitation

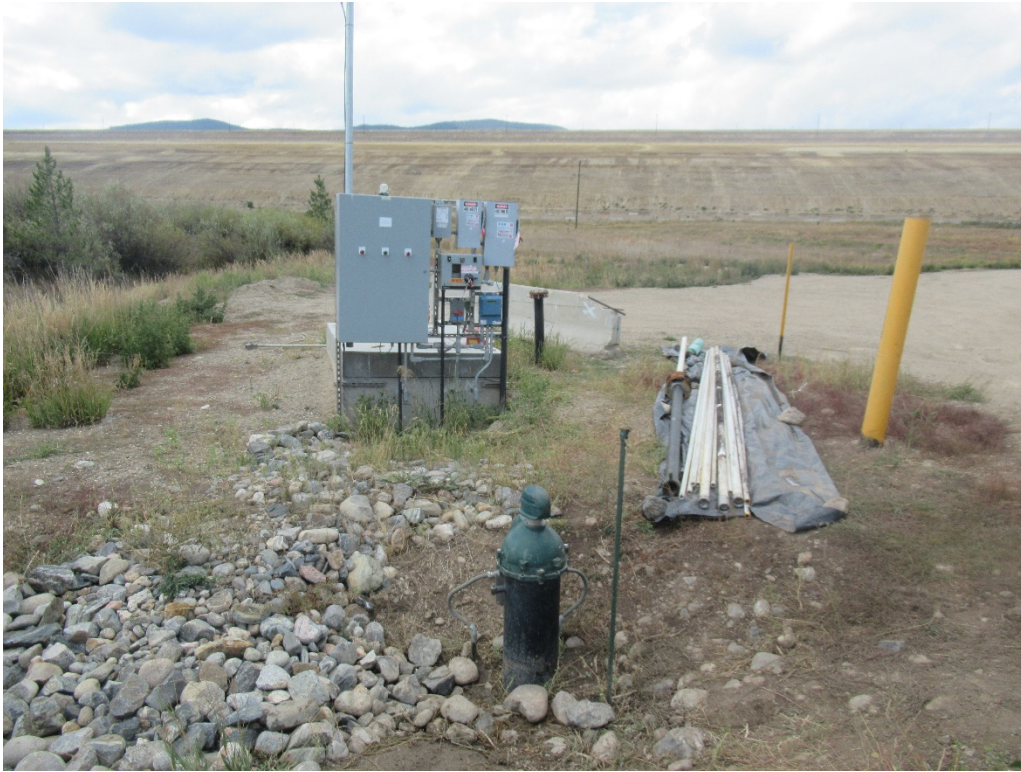
View of MLEX-4 during rehabilitation

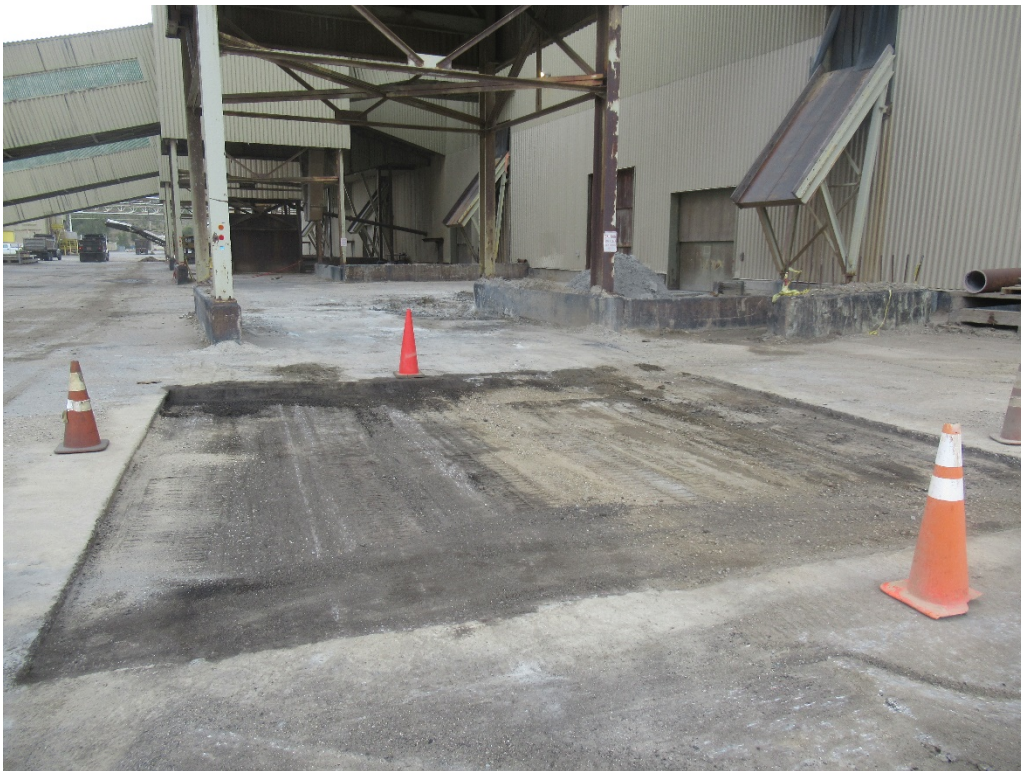
On November 5, 2019, the Division received written follow-up notice of a release of process water from the fire water line from the Mill Process Water Storage Tanks to the fire water distribution and suppression systems. The repair of the fire water line near hydrant #7 was observed during the June inspection. During the repair the Operator discovered another possible leak near fire hydrant #6 located west of the first repair area. The Operator later determined two leaks were located near hydrant #6. The repair of one of the leaks located east of hydrant #6 is complete and the surface of the repair area was prepared for asphalt paving. The second leak area located south of hydrant #6 is scheduled to be repaired soon.

View of fire water repair area located east of hydrant #6
