MINERALS PROGRAM INSPECTION REPORT
PHONE: (303) 866-3567

MINE NAME: Cresson Project	MINE/PROSPECTING ID#: M-1980-244	MINERAL: Gold	COUNTY: Teller
INSPECTION TYPE: Monitoring	INSPECTOR(S): Brock Bowles	INSP. DATE: June 30, 2020	INSP. TIME: 09:00
OPERATOR: Cripple Creek & Victor Gold Mining Company	OPERATOR REPRESENTATIVE: Justin Bills and Jeana Ratcliff	TYPE OF OPERATION: 112d-3 - Designated Mining Operation	
REASON FOR INSPECTION: Normal I&E Program	BOND CALCULATION TYPE:	BOND AMOUNT: \$209,491,188.00	
DATE OF COMPLAINT: NA	POST INSP. CONTACTS: None	JOINT INSP. AGENCY: None	
WEATHER: Clear	INSPECTOR'S SIGNATURE:

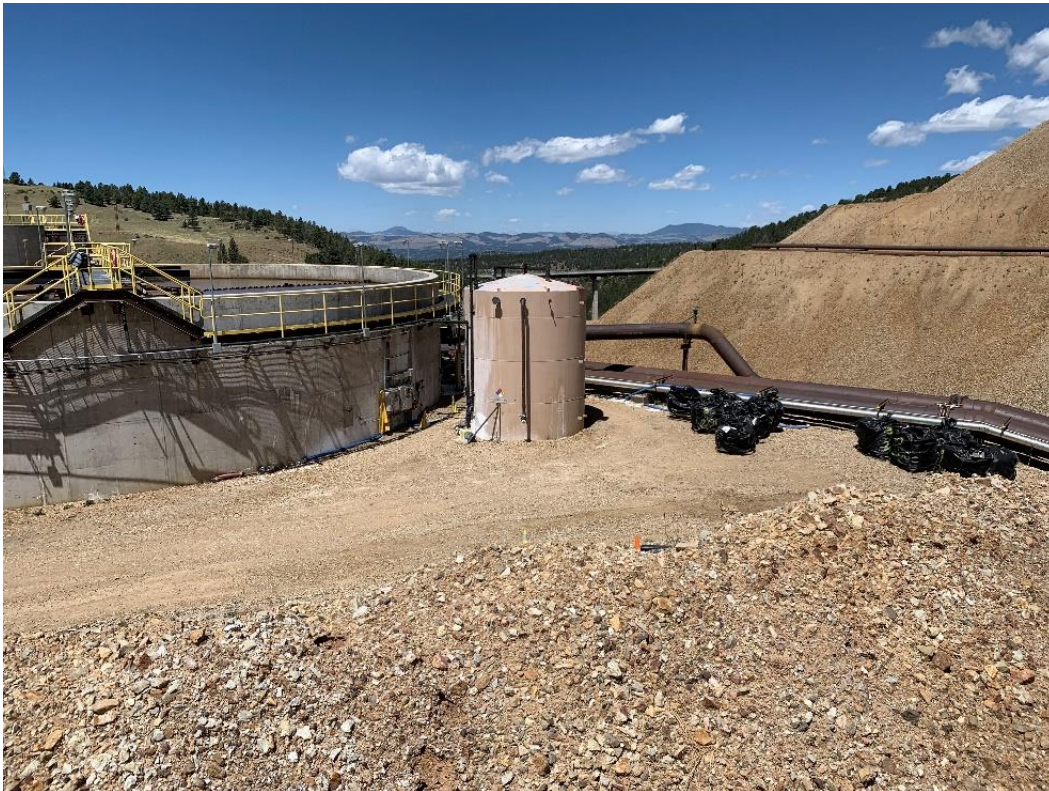
PROBLEM/POSSIBLE VIOLATION: Problem: The lime holding tank located north of the PSES needs to be added to the cost estimate through a SA revision or verified that it has been included in the cost estimate in a previous revision.

The area to the west of the PSES facility was inspected to follow-up on the plume of white substance documented in the May 18, 2020 aerial inspection report. Dylan Noble of CC&V explained that the plume was the result of lime solution being released from the lime holding tank located north of the PSES facility (see photo 1). The lime holding tank was installed sometime between January 2019 and June 2019 according to aerial photos of those respective months. A records search does not show that the lime holding tank was added to the reclamation cost estimate. **The lime holding tank needs to be added to the cost estimate through a SA revision or shown that it was included in a previous cost estimate.**

Photo 1 - Lime holding tank located north of the PSES

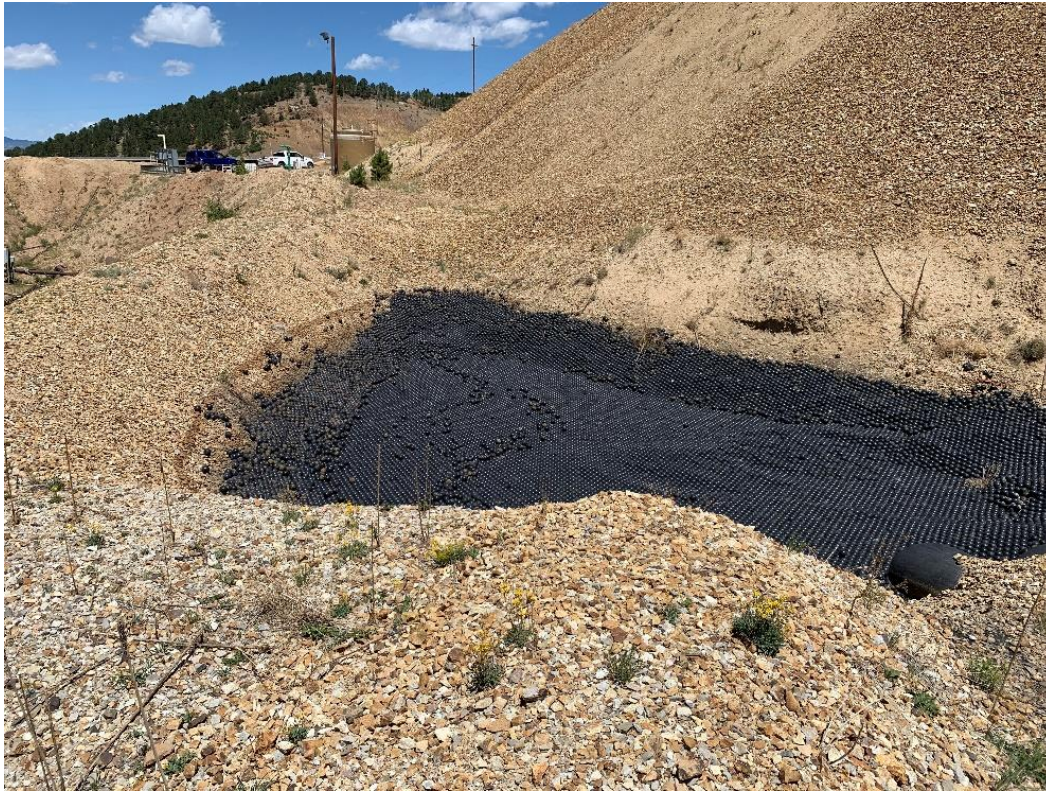
The lime solution noted in the May 18 photo, flowed in a westerly direction, downhill into a small holding pond (see photo 2). The pond appeared to contain the lime solution. The holding pond is located over the liner, is full of bird balls to protect wildlife and does not have a designed spillway. It appears that ADR1 and the PSES areas also drain to this small pond.

Photo 2 - Small holding pond west of PSES

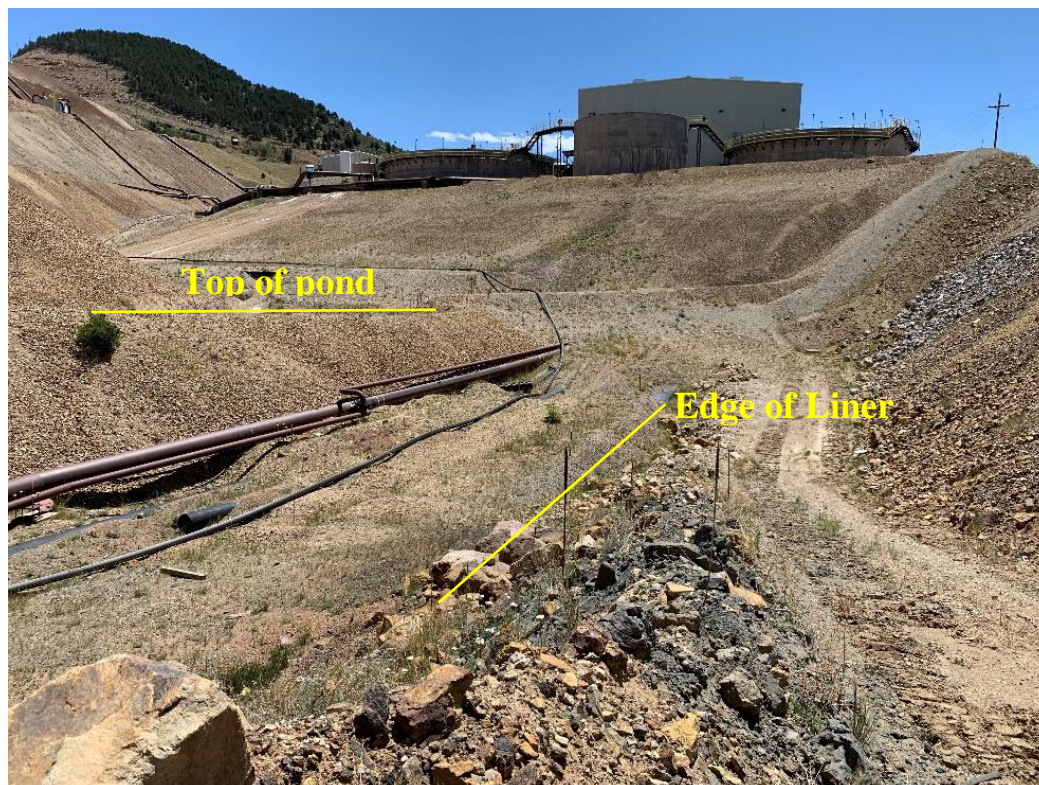
PROBLEM/POSSIBLE VIOLATION: Problem: A demonstration must to be submitted to the Division showing that the impacted water observed in the holding pond west of the PSES will be contained within the lined primary containment system area in the event that the pond capacity is exceeded.

The pond's south embankment is less than 50 feet from the edge of liner and it is perched higher than the edge of liner (photo 3). The outslope of the south embankment is graded towards the edge of liner. There is not a notable berm or secondary containment structure between the embankment and the edge of liner. Data as to the pond's design and its capacity have not been submitted to the Division. In the event that the pond's capacity is exceeded or there is an embankment failure, contents of the pond would appear to flow off liner, and thereby be released from the liner's primary containment system. **A demonstration must be submitted to the Division showing that the pond's impacted water contents observed as part of the May 18, 2020 aerial inspection in of the holding pond west of the PSES will be contained within the lined, primary containment system area in the event that the pond capacity is exceeded.**

Photo 3 - Pond location in relation to edge of liner

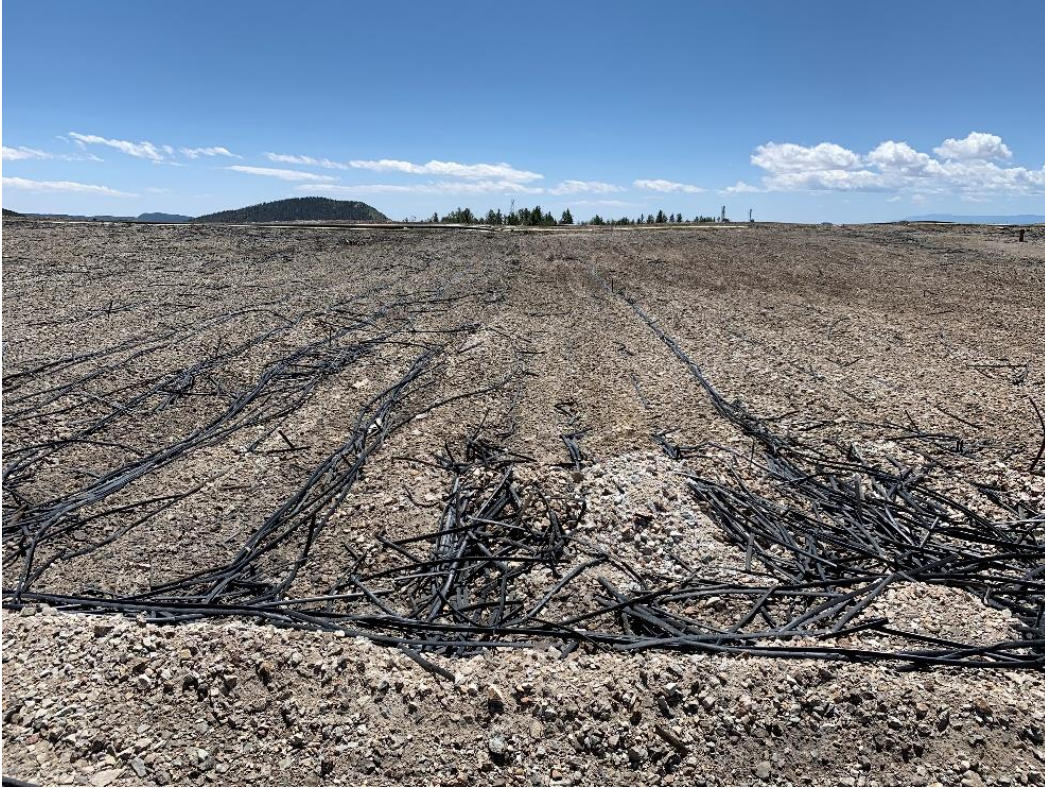
The 10,400 foot level was inspected (photo 4). The area was dry and solution was not being applied to the top via the drip system. Process solution was being applied via large sprinklers on the outslopes on the south side of VLF1.

Photo 4 - VLF-1, 10,400 foot level

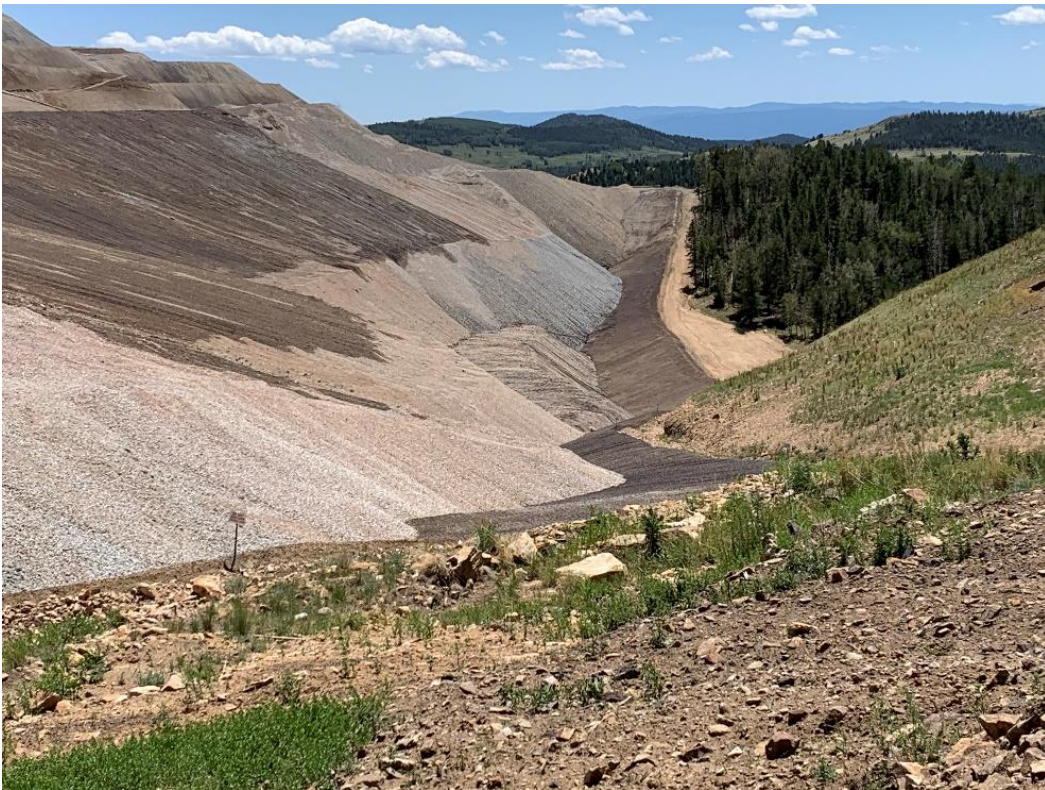
The edge of liner markers along the west side of the VLF2 were in place (photo 5). Solutions was being applied to the new flatter outcrops with the drip irrigation system.

Photo 5 - VLF-2, western side with edge of liner markers in place

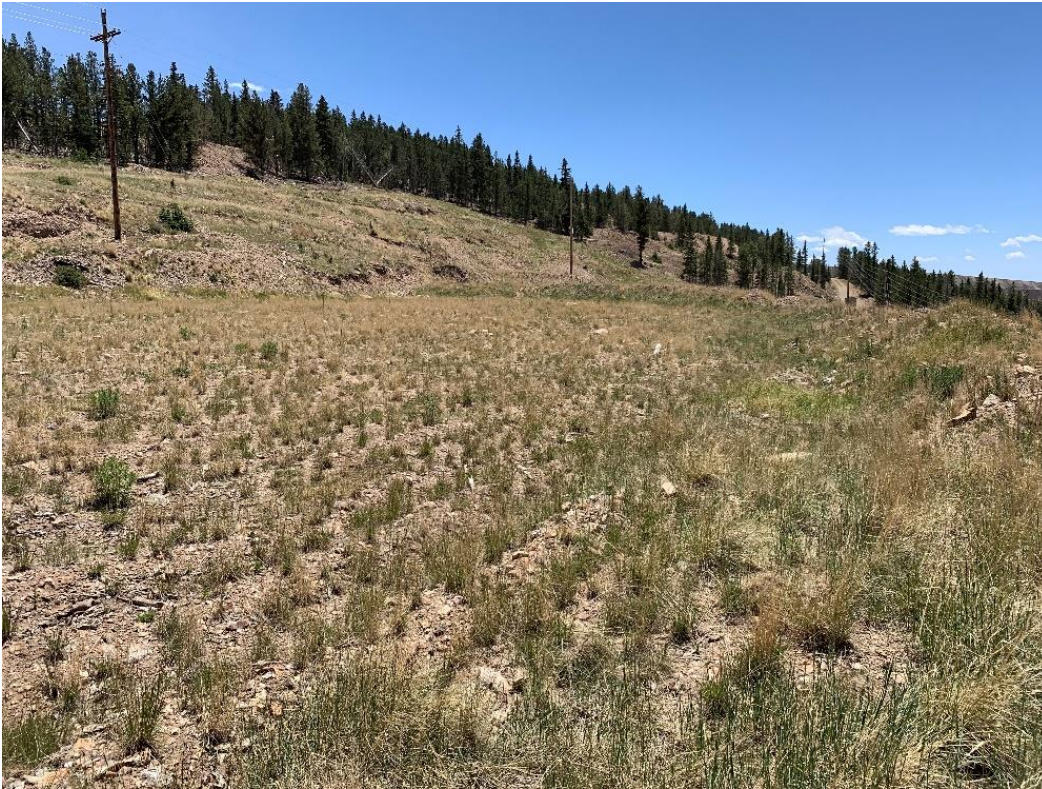
Stockpile #27 is located northeast of the high grade mill. The footprint of the pile depicted on Drawing C-4b submitted in AM-13 is inaccurate and needs to be updated. **This item will be addressed through the AM-13 review process.** The vegetation on the stockpile appeared to be adequate for the purpose of stabilizing the topsoil and controlling erosion (photo 6). Noxious weeds were not seen on the stockpile.

Photo 6 - Topsoil stockpile #27

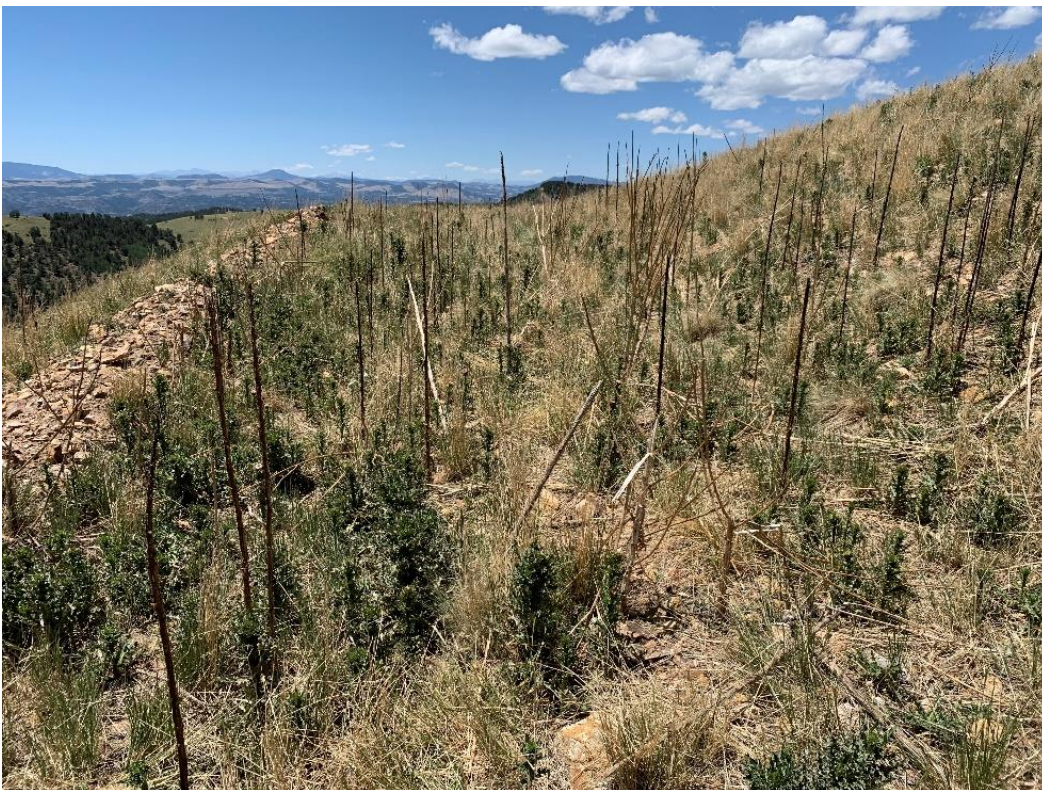
Stockpile #34 is located north of the ADR2 and west of the VLF-2. The footprint of the pile depicted on Drawing C-4b submitted in AM-13 appeared to be accurate. The vegetation on the west side of the pile appeared to be adequate for the purpose of stabilizing the topsoil and controlling erosion. Many musk thistle plants were noted on the south side of the pile (photo 7). Musk thistle is a CO B-List noxious species and needs to be treated. Justin Bills explained that a contractor is scheduled to treat the thistles. **Please submit evidence that the thistles have been treated during this growing season.**

Photo 7 - Topsoil stockpile #37 with musk thistle plants

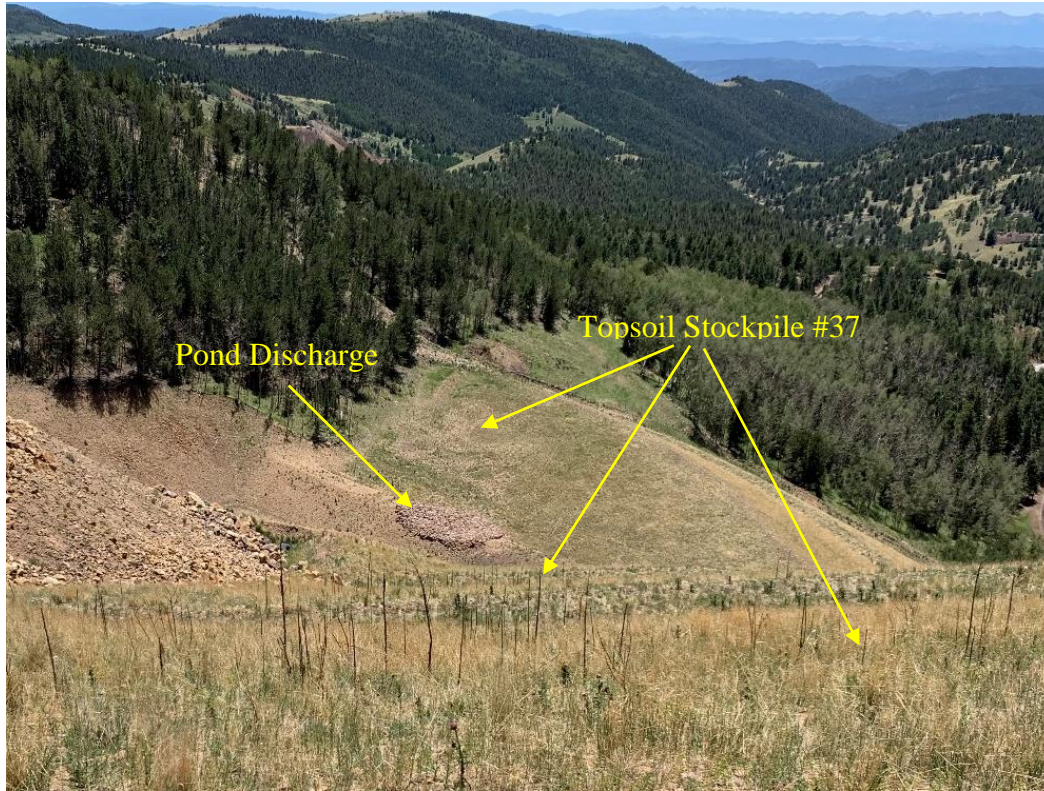
According to Drawing C-4b, the south side of stockpile #34 extends below a sediment pond which has a rock lined spillway. A visual inspection of the pond verified that the spillway directs any pond overflow onto the lower portions of the topsoil stockpile (photo 8). Rule 3.1.9(3) states that topsoil stockpiles will be stored in locations and configurations to minimize erosion and disturbance of ongoing mining operations will be minimized. **This item will be addressed through the AM-13 review process.**

Photo 8 – Pond discharge above topsoil pile
