MINERALS PROGRAM INSPECTION REPORT PHONE: (303) 866-3567

MINE NAME:		MINE/PROSPECTING ID#:	MINERAL:	COUNTY:
Tomahawk Mine		M-1991-003	Clay (general)	Pueblo
INSPECTION TYPE:		INSPECTOR(S):	INSP. DATE:	INSP. TIME:
Monitoring		Patrick Lennberg	September 24, 2020	12:00
OPERATOR:		OPERATOR REPRESENTATIVE:	TYPE OF OPERATION:	
General Shale Brick, Inc.		Jason McGraw	112c - Construction Regular Operation	
REASON FOR INSPECTION:		BOND CALCULATION TYPE:	BOND AMOUNT:	
Normal I&E Program		Complete Bond	\$70,685.00	
DATE OF COMPLAINT:		POST INSP. CONTACTS:	JOINT INSP. AGENCY:	
NA		None	None	
WEATHER:	INSPECTOR'S SIGNATURE:		SIGNATURE DAT	E:
Clear	Part	truck Lg	September 30, 2020

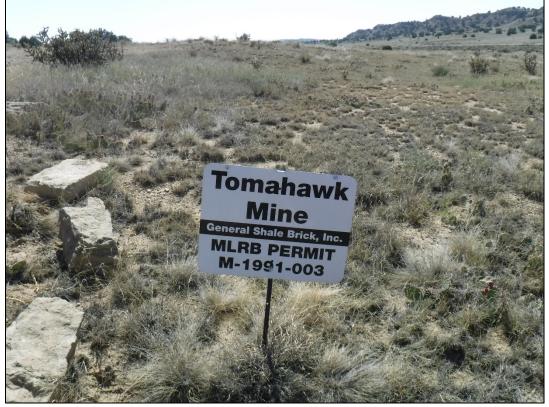
The Stone City Mine is located in Pueblo County approximately 18 miles northwest of Pueblo, Colorado on the Fort Carson Army Base. The mine is a 112 construction materials permit for 240 acres. The primary commodity being mined at the site is clay. The approved post-mining land use is rangeland. A mine sign was observed as required by Rule 3.1.12.

Photo 1: Mine sign near entrance to mine site

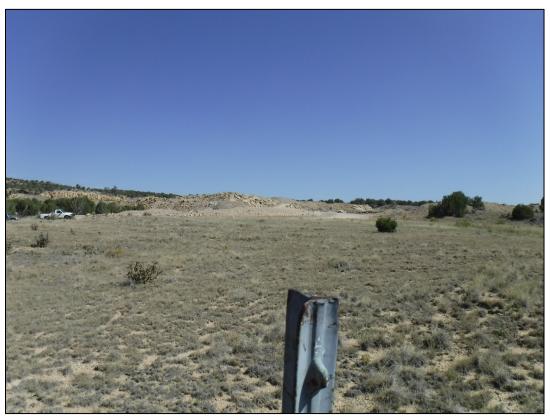
Photo 2: Typical permit boundary marker

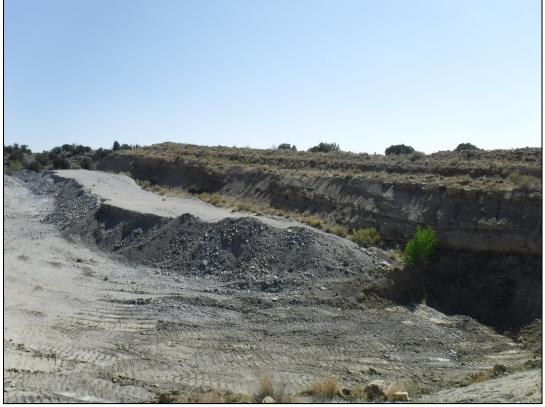
Photo 3: Highwall with an associated product stockpile

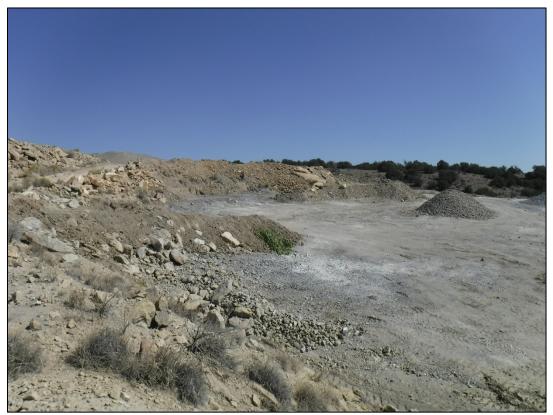
Photo 4: Pit area associated with the highwall, to the right of picture

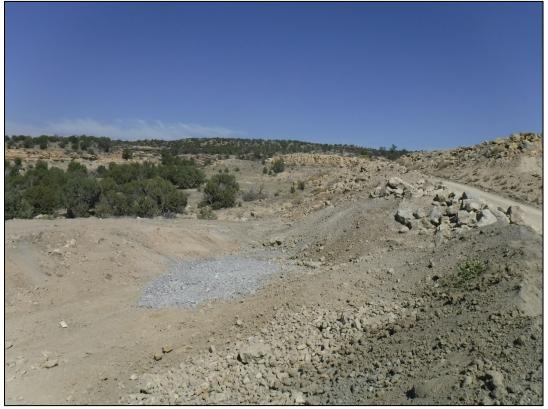
Photo 5: Recently mined area that has been reclaimed to a 3H:1V slope or shallower, looking northeast

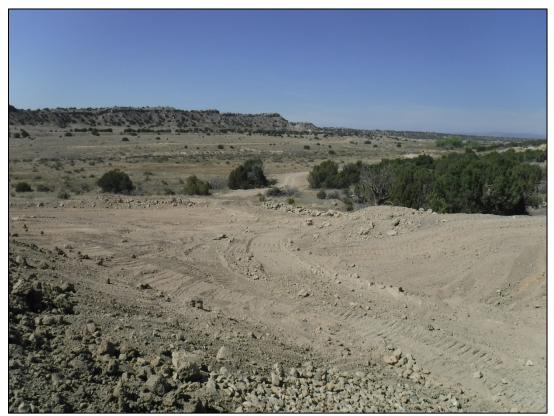
Photo 6: Recently mined area that has been reclaimed to a 3H:1V slope or shallower, looking southwest

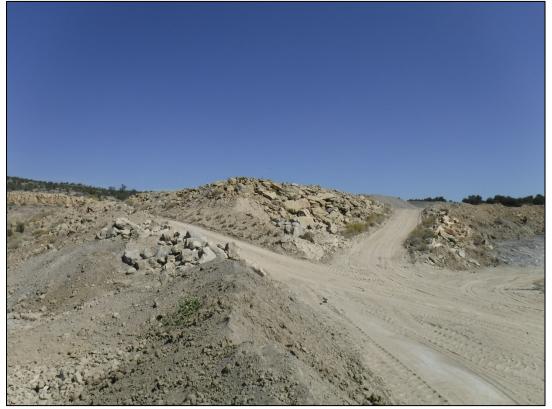
Photo 7: Typical haul road conditions in the disturbed area

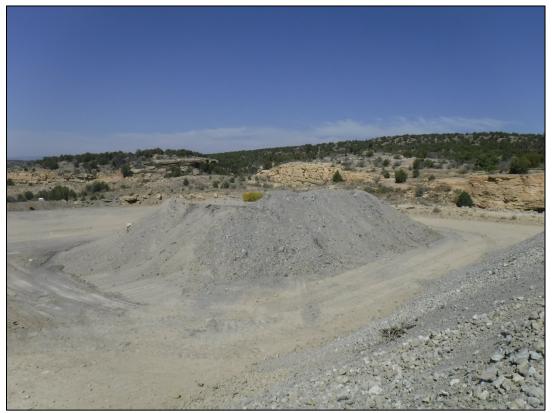
Photo 8: Another product stockpile

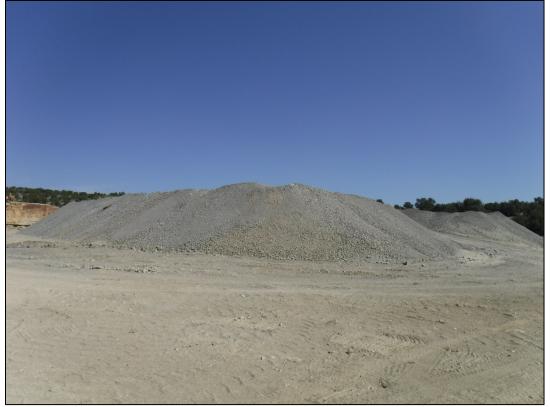
Photo 9: Largest product stockpile

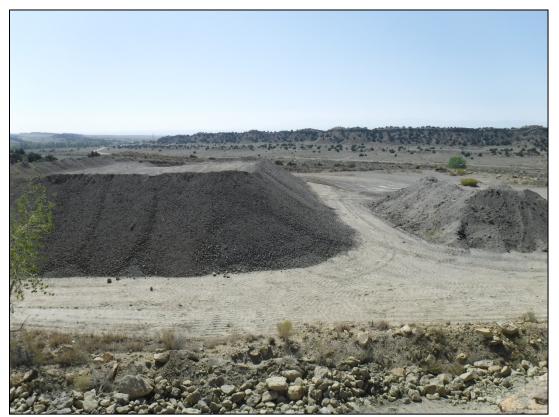
Photo 10: Perspective of stockpiles
