Spring 2020 Subsidence and Geologic Field Observations

Southern Panels Mining Areas

September 30, 2020

Re: Spring 2020 Subsidence Monitoring Report Preparation – Mountain Coal Company, LLC.

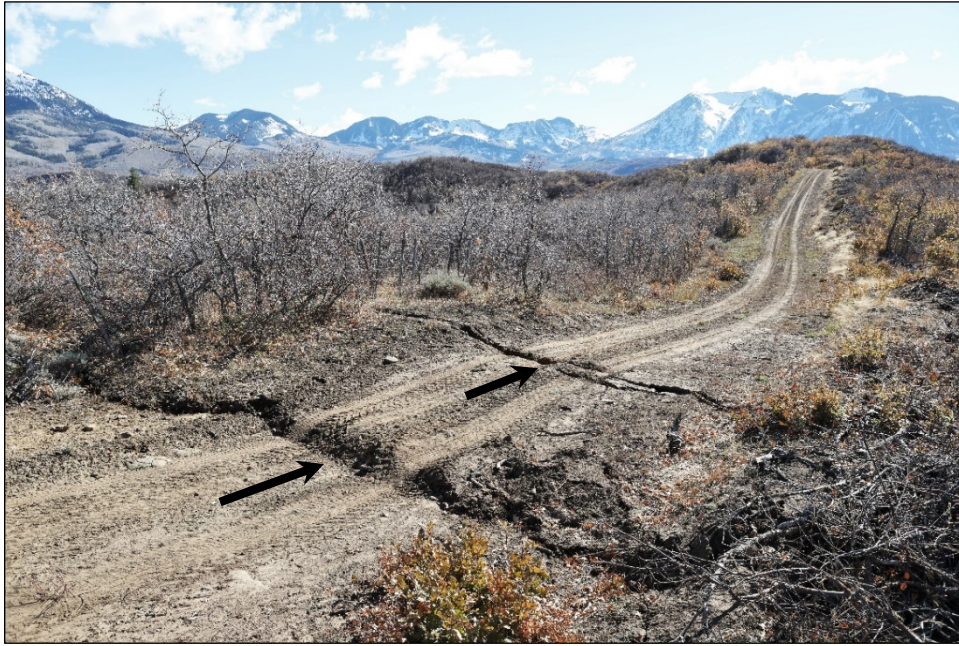
Two parallel subsidence cracks were observed approximately 300 feet south of the E7-12 MVB pad during WWE's fall 2018 field work (Figure 1). These cracks had a N60°W orientation and an offset of about 13 feet. Observational evidence at that time (i.e., sharpness of crack edges) suggested that the cracks had not formed at the same time. The northern crack had rounded edges

while the southern crack had sharp edges. E-seam overburden thickness at this location is about 800 feet.

Figure 1. Southeastward view during the fall 2018 field visit of two parallel subsidence cracks that appeared as a result of recent longwall mining beneath the area. The closer crack showed more rounded edges than the farther crack, suggesting the latter had most recently formed at the time of the observation.

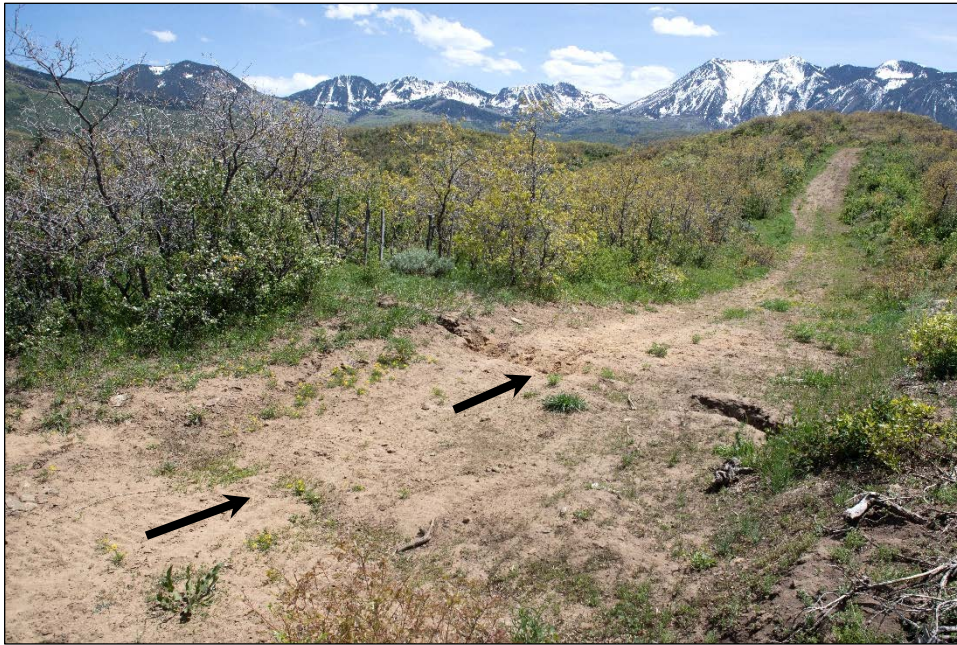
Observations made during the spring 2020 field visit were somewhat similar. The northern crack was nearly completely filled while the southern crack still presented with a measurable width and depth. Both cracks showed signs of healing and weathering (Figure 2). Maximum measurements of the southern crack were 6 inches in width and 36 inches in depth.

Figure 2. Southeastward view during the spring 2020 field visit of the same area shown in Figure 1.

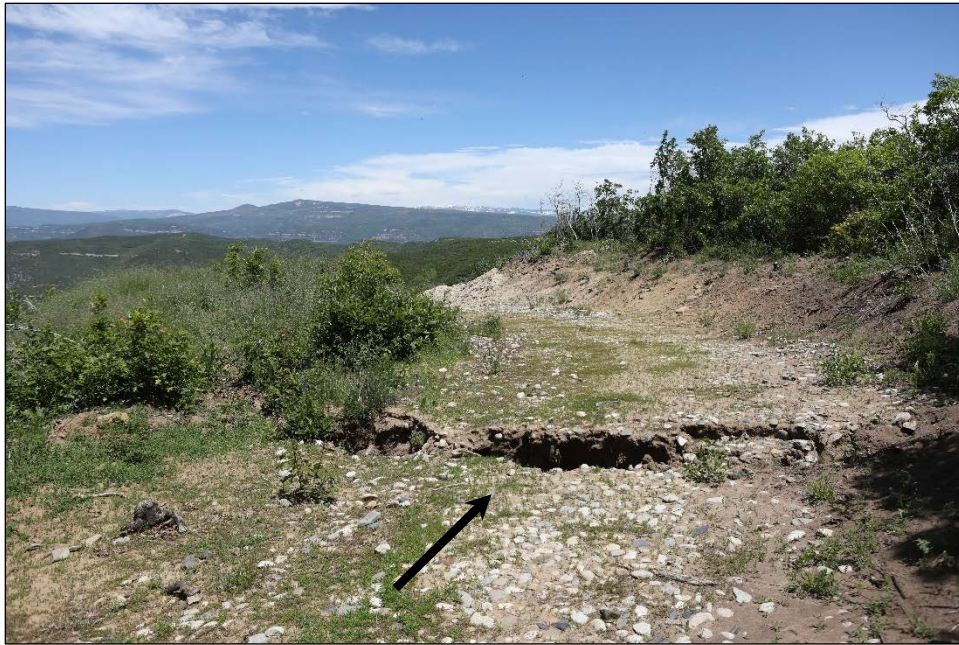
During the spring 2019 field visit, a new subsidence crack was observed approximately 1,000 feet north of the E6-14 MVB pad (Figure 3). This crack had a pronounced elevation offset of 6 inches from north to south and extended completely across the road and beyond (20+ feet in length) in a N70°W orientation. The maximum dimensions were observed to be 24 inches both in width and depth. This location is over the tailgate entries of E-seam Longwall Panel E7 where tensional stresses are somewhat greater. E-seam overburden thickness at this location is about 800 feet.

Figure 3. Northward view during the spring 2019 field visit of a new subsidence crack with 6-inch elevation from north to south observed approximately 1,000 feet north of the MVB E6-14 pad.

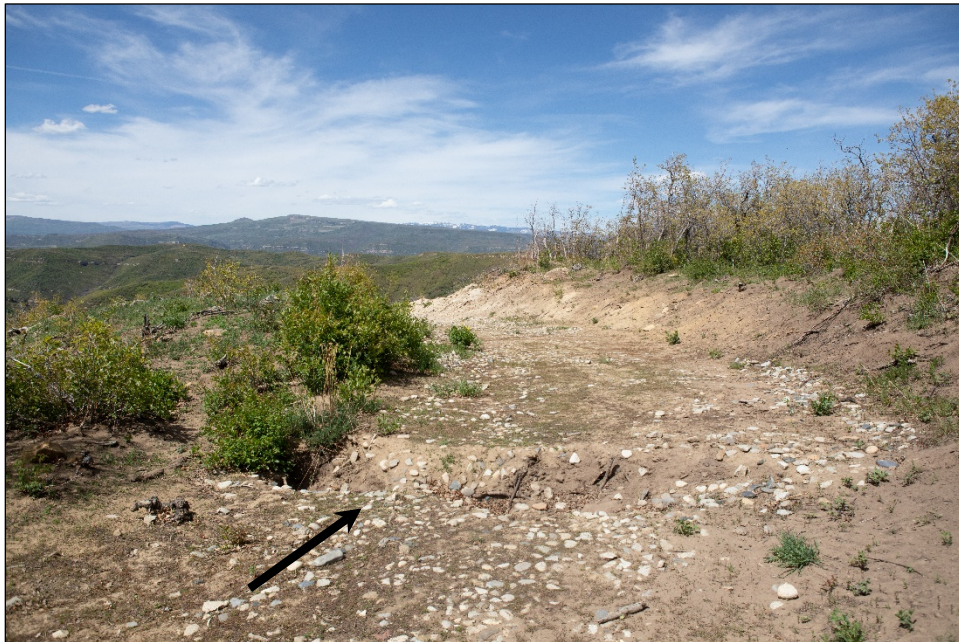
Observations made during the spring 2020 field visit found that the crack was still evident with signs of weathering (Figure 4). The maximum dimensions observed during the fall 2019 field visit had not changed and neither had the elevation offset of about 6 inches from south to north across the crack.

Figure 4. Northward view during the spring 2020 field visit of the same subsidence crack shown in Figure 3.

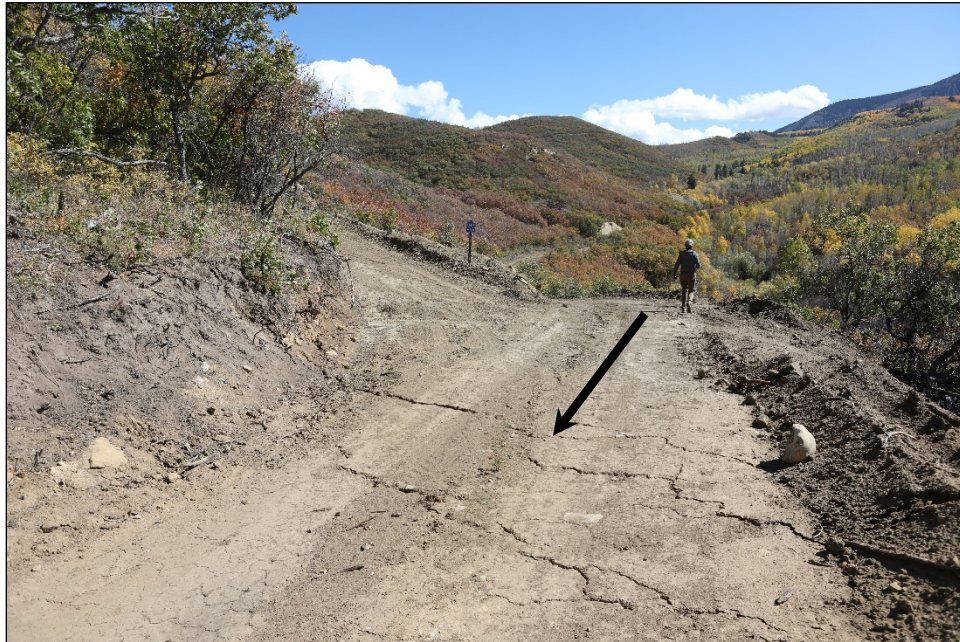
Beginning approximately 60 feet west of the fork in the road leading to either the MVB E8-7 or MVB E8-8 pad and continuing eastward is a series of six sets of parallel subsidence cracks that appeared between spring and fall 2019 in response to longwall mining activities that passed beneath the area. These crack sets were comprised of 2 to 4 individual cracks with a general orientation of N10°E and an offset of about 20 to 25 feet from each other. The largest and most continuous of the crack sets was located at the fork. Figures 5 and 7 show these features as observed during WWE's fall 2019 field visit. Figures 6 and 8 are from approximately the same location and with the same orientation. Note the lack of readily identifiable subsidence cracks in just a few months.

Figure 5. Fall 2019 view looking east of subsidence cracks west of the intersection leading to either the MVB E8-7 or E8-8 pads

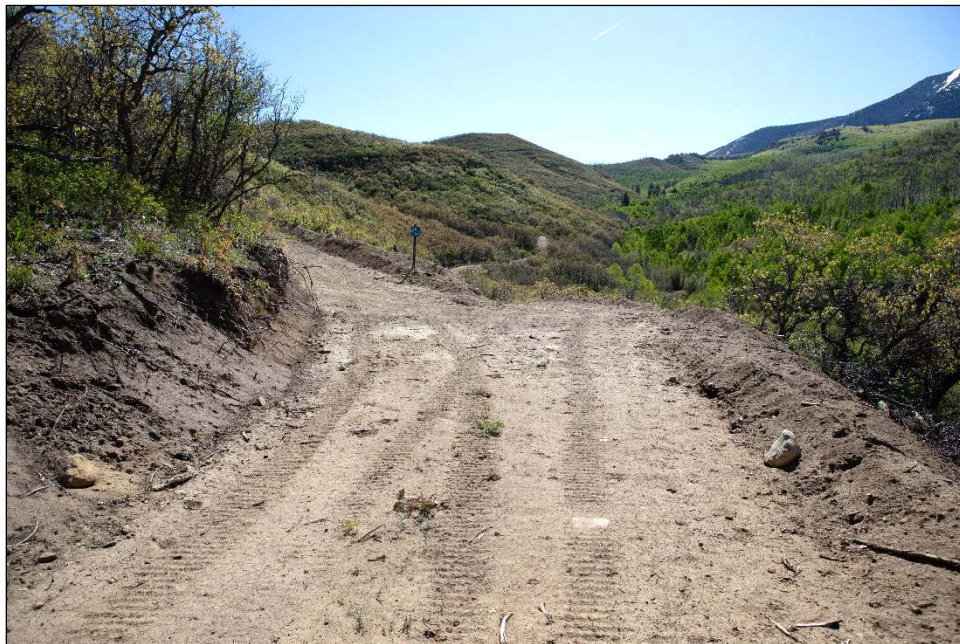
Figure 6. Spring 2020 view of approximately the same location and orientation as provided in Figure 5.

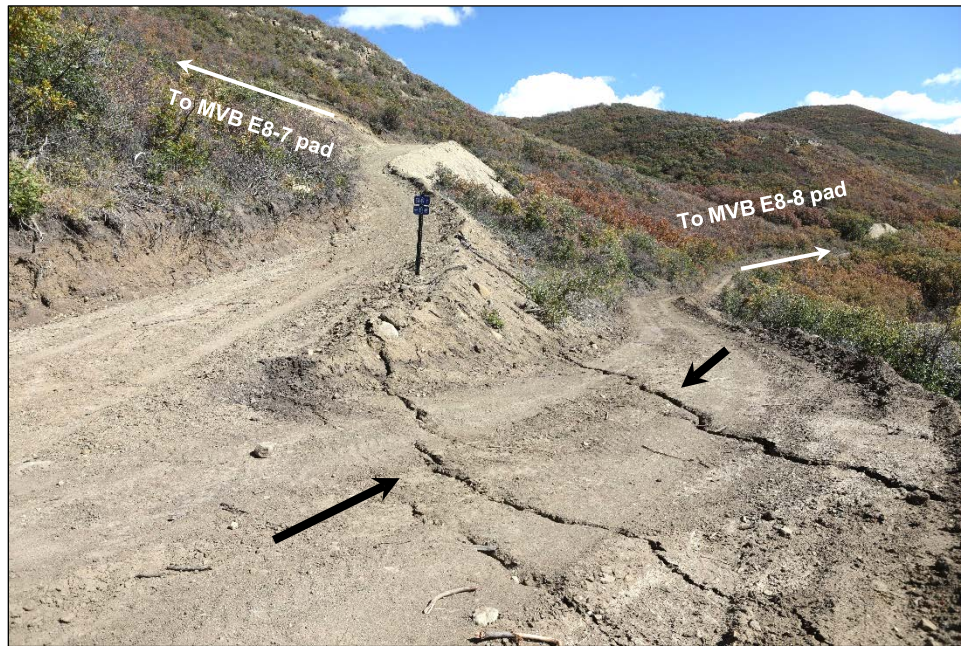
Figure 8. Northeastward view during fall 2019 of the largest subsidence crack sets located at the fork in the road leading to either MVB E8-7 or E8-8 pads.

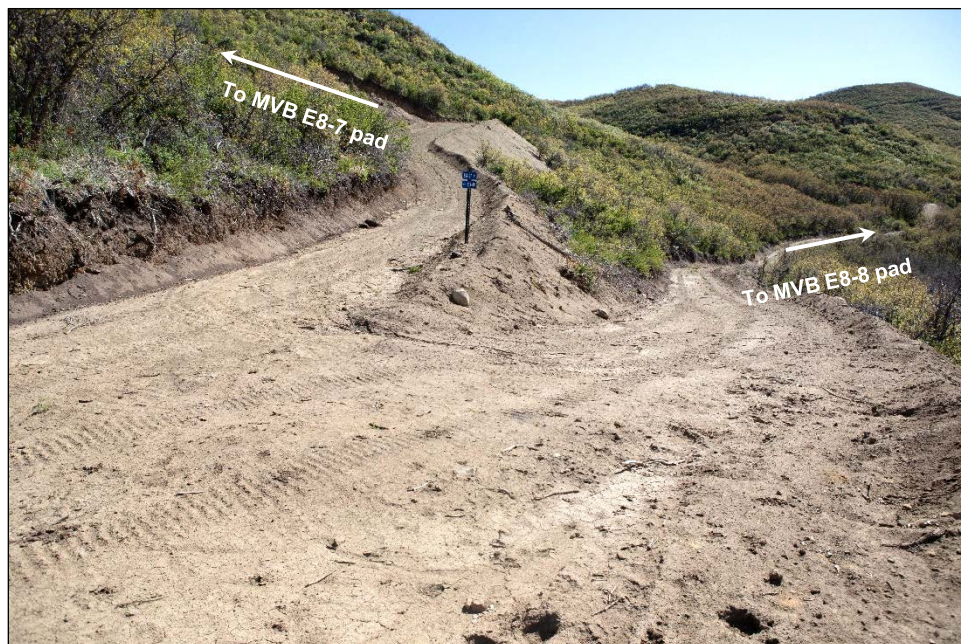
Figure 8. Northeastward view during spring 2020 of the same area and orientation as shown in Figure 7.

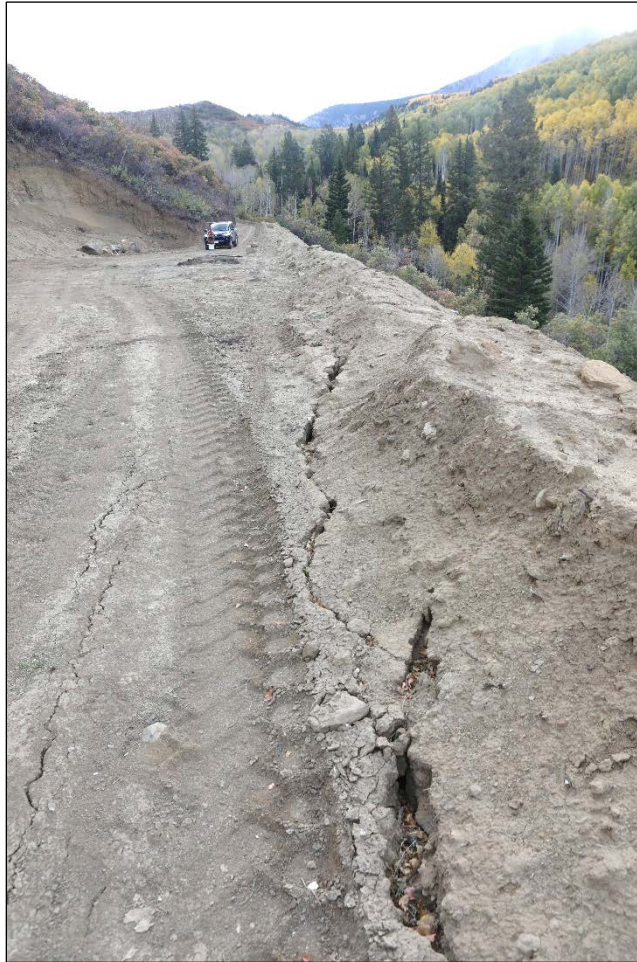
Numerous differential settlement cracks were observed during the fall 2019 field visit along the south side of the road leaving the southwest side of the pad (i.e., areas of greatest fill placement). This road connects this pad with the MVB E8-4 pad. The largest of these cracks measured about 45 feet in length, had a maximum width of 6 inches, and a maximum depth of 18 inches (Figure 9). Observations made during WWE's spring 2020 field visit found these differential settlement

Figure 9. Eastward view during the fall 2019 field visit of a relatively continuous differential settlement crack along the south side of the road connecting the MVB E8-3 pad with the MVB E8-4 pad.

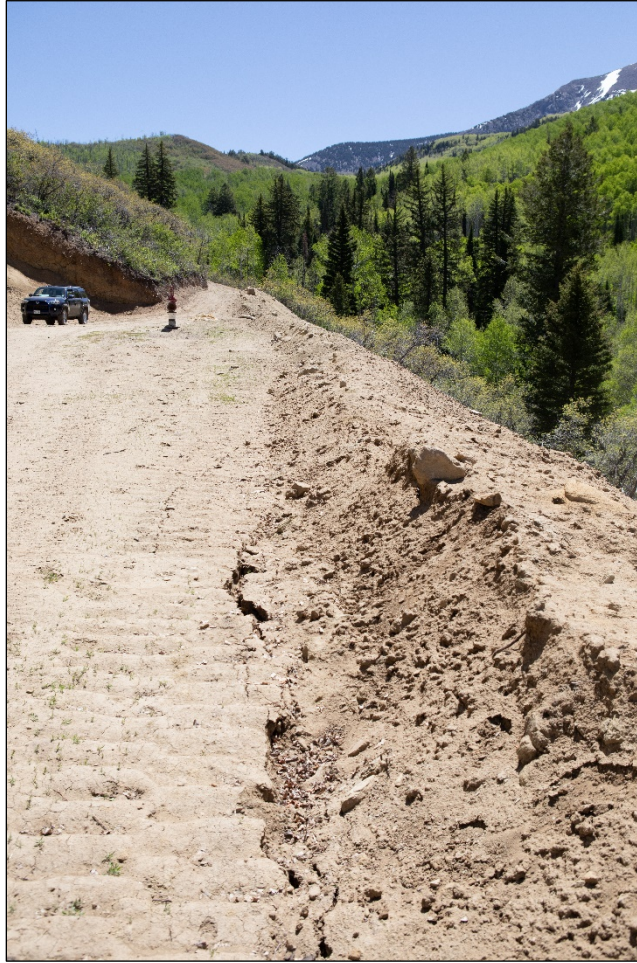
cracks were still present as shown in Figure 10. The various dimensions of the largest crack appear to be similar to those observed during our fall 2019 field visit.

Figure 10. Eastward view during the spring 2020 field visit of the same relatively continuous differential settlement crack shown in Figure 9. The length, maximum width, and maximum depth dimensions appeared to be similar to those observed previously.

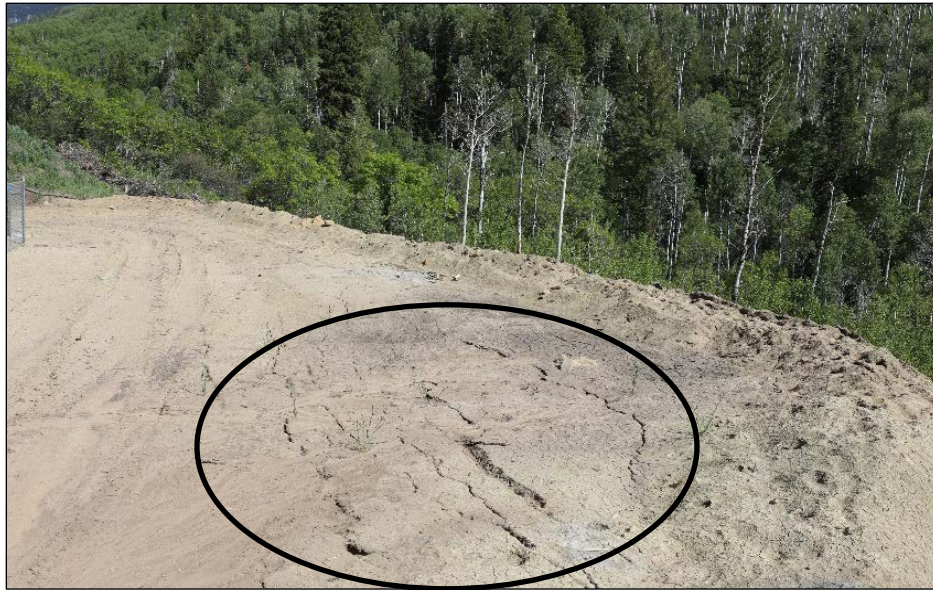
Figure 11 shows the differential settlement cracks first observed on the southwest corner of the MVB E8-4 pad during WWE's spring 2019 field work. A comparison photo obtained during our spring 2020 field visit found that some of the cracks had healed while others had expanded (Figure 12). The largest of the remaining cracks denoted by a black arrow in Figure 12 measured 45 feet in length with a maximum width of 6 inches and a maximum depth of 18 inches. These cracks are represented in the photograph labeled Figure 13. The E-seam overburden thickness at this location is approximately 1,000 feet. There are no other subsidence features associated with this pad.

Figure 11. Eastward view during the spring 2019 field visit of a series of differential settlement cracks (designated by the oval) located on the largest fill portion of MVB E8-4 pad.

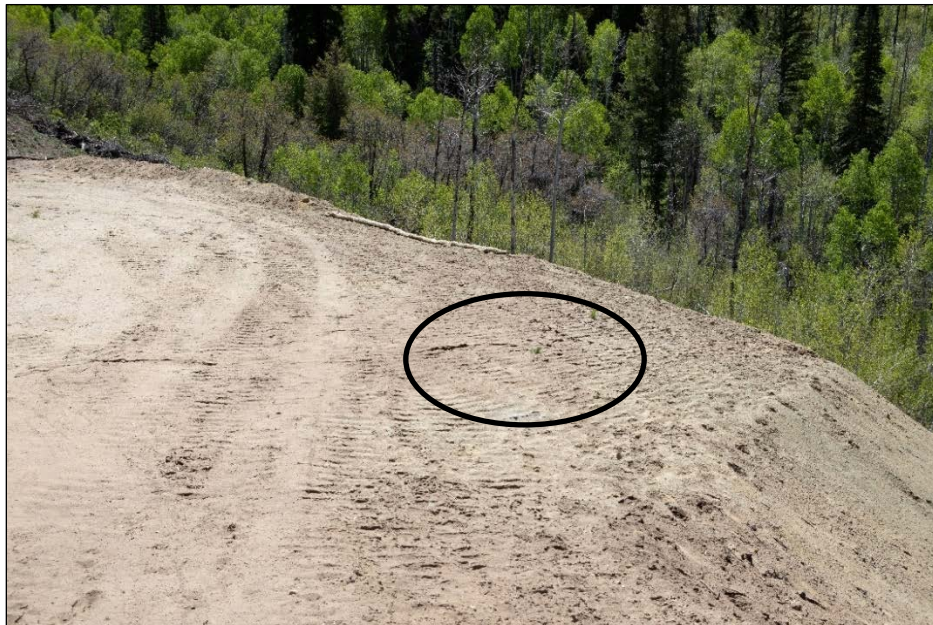
Figure 12. Eastward view during the spring 2020 field visit of the same area depicted in Figure 11. Many previous differential settlement cracks had healed since our last visit while others had remained and even widened. The area within the black oval was one of the areas that had widened, as further represented in Figure 13.

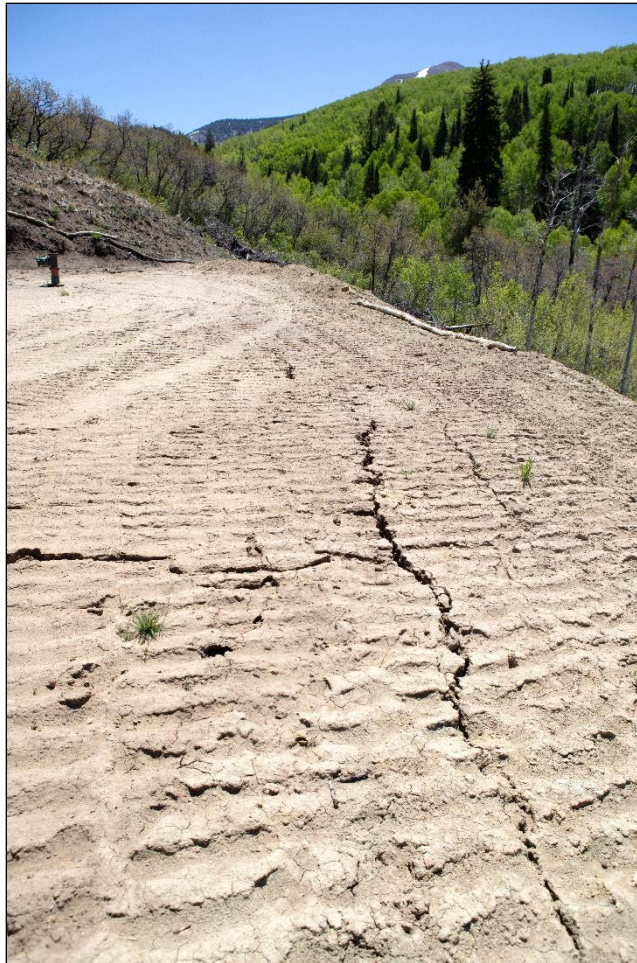
Figure 12. Eastward view during the spring 2020 field visit of differential settlement cracks on the southwest portion of the MVB E8-4 pad.

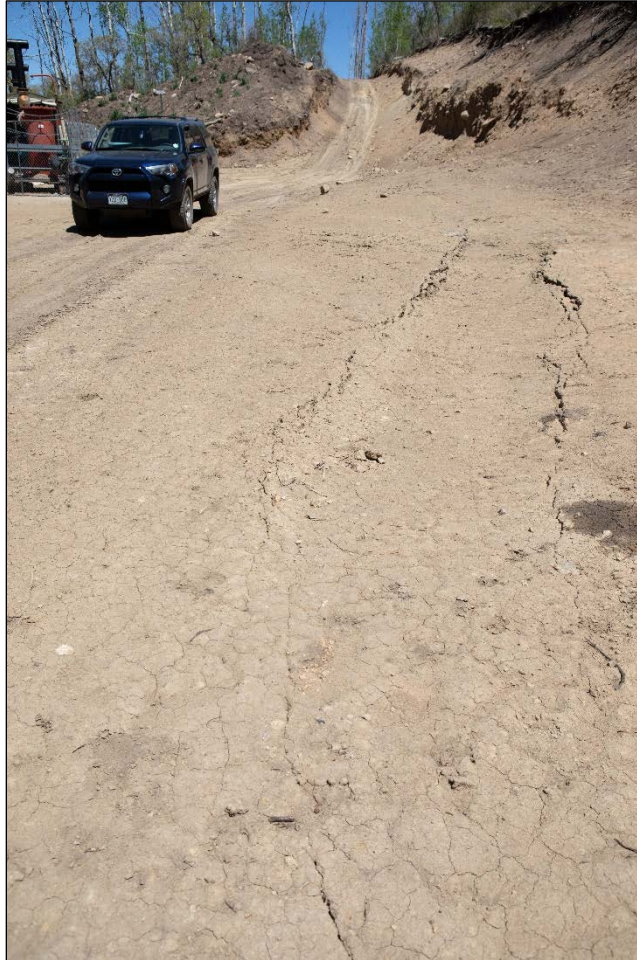
A pair of parallel cracks were observed during WWE's spring 2020 field work on the southeast portion of the MVB SS1-1 pad (Figure 13). The separation between the cracks was a consistent 3 feet with an orientation that was nearly due north to south. The easternmost crack extended approximately 30 feet in length with maximum width dimensions of 3 inches and maximum depth dimensions of 5 inches. The westernmost crack was about 57 feet in length with maximum width and depth dimensions of 2 inches and 3 inches, respectively.

The amount of fill material placed during pad construction was relatively small and on the western portion of the pad. The observations of cracks on the southeast portion of this pad led to an initial assumption that the cracks may be the result of settlement of backfill placed over the mud pit or a trench associated with the mud pit as used in the drilling process for the methane drainage borehole into the target E-seam coal. Later observations of parallel cracks on multiple MVB pads over mined and unmined E-seam Longwall Panel SS1 demonstrated that similarly observed features were not longwall mining related but rather the edge of a poorly compacted and subsiding track-

hoe trench used in the reclamation of the mud pits. Further evidence that the Location 6 cracks are due to a poorly compacted and subsiding track-hoe trench is the depressed nature of the trough between the two cracks, as visible in Figure 13.

Figure 13. Northward view during the spring 2020 field visit of a parallel set of cracks on the southeast portion of the MVB SS1-1 pad.

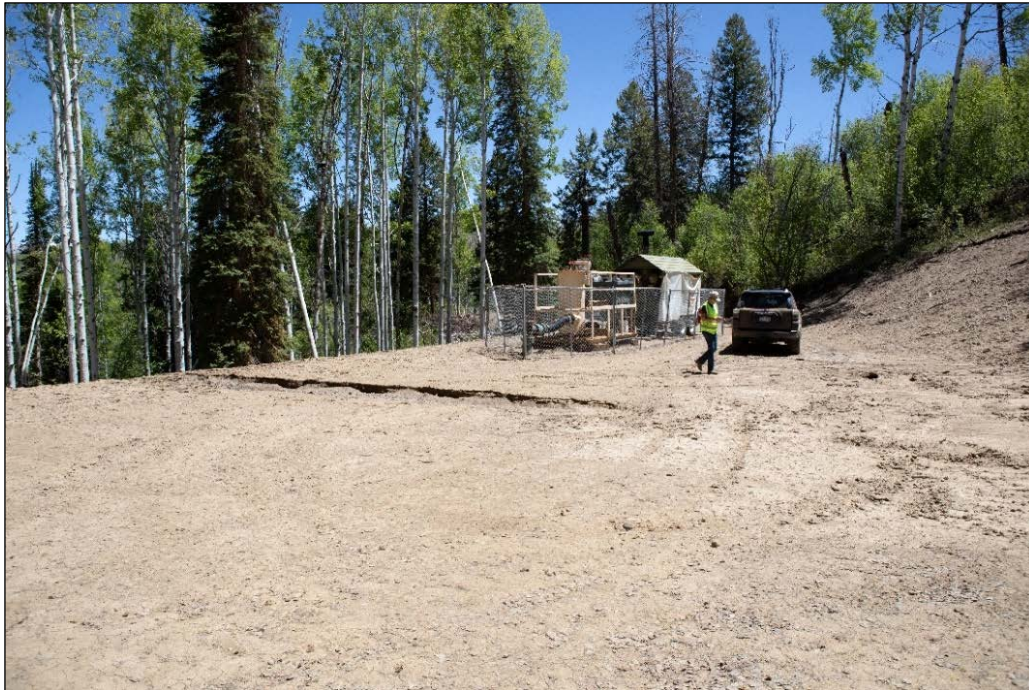
A 3-foot-wide trough of approximately 27 feet in length was observed on the MVB SS1-3 pad during WWE's spring 2020 field visit (Figures 14 and 15). This feature originates near the middle of the pad and continues to the northern edge. The elevation difference between the edges and middle of the settlement trough is as much as 8 inches. This feature is similar to that described at MVB SS1-1 (Location 6) and similar in appearance to features observed on the remainder of the

MVB pads west of this location above unmined E-seam Longwall Panel SS1. The consistency in width confirms an anthropogenic origin. The appearance of these settlement features necessitated their inclusion in this report even though they are not the result of longwall mining in the area.

Figure 14. Northeastward view of the MVB SS1-3 pad with a 3-foot-wide settlement trough extending from near the middle of the pad to the northern edge.

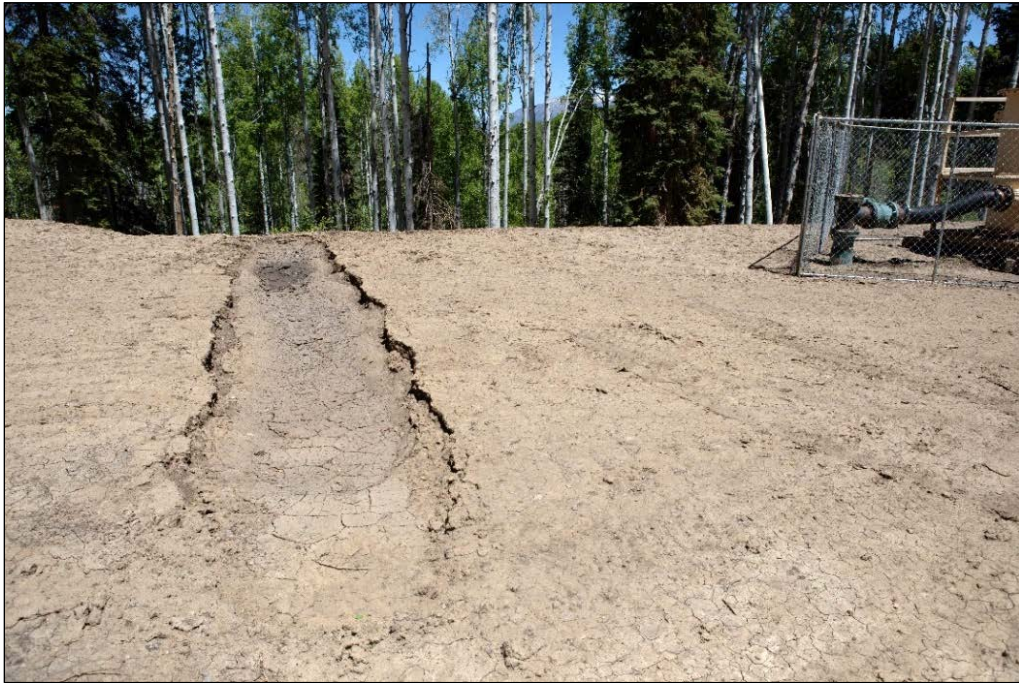
Figure 15. Northern view of the same settlement trough shown in Figure 14. This feature has the same width and consistent linear features to those on other pads over unmined E-seam Longwall Panel SS1.
