MINERALS PROGRAM INSPECTION REPORT
PHONE: (303) 866-3567

MINE NAME: Ordway Pit	MINE/PROSPECTING ID#: M-2006-054	MINERAL: Sand and gravel	COUNTY: Crowley
INSPECTION TYPE: Preoperation Inspection	INSPECTOR(S): Patrick Lennberg	INSP. DATE: September 23, 2020	INSP. TIME: 10:30
OPERATOR: Arkansas Valley Ranch, LLC	OPERATOR REPRESENTATIVE: Peter Hurt & Dr. Angela Bellantoni	TYPE OF OPERATION: 112c - Construction Regular Operation	
REASON FOR INSPECTION: Preoperation Inspection	BOND CALCULATION TYPE: None	BOND AMOUNT: \$60,882.77	
DATE OF COMPLAINT: NA	POST INSP. CONTACTS: None	JOINT INSP. AGENCY: None	
WEATHER: Clear	INSPECTOR'S SIGNATURE:

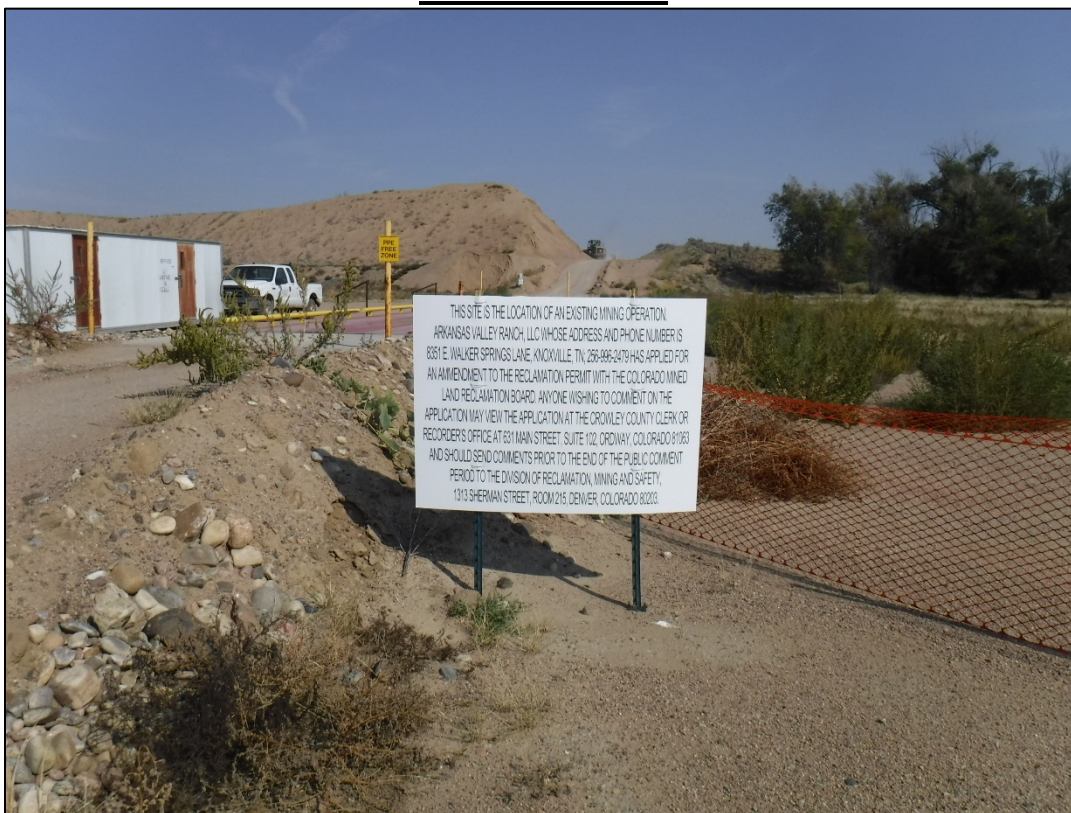
Photo 1: Notice sign posted at the mine entrance

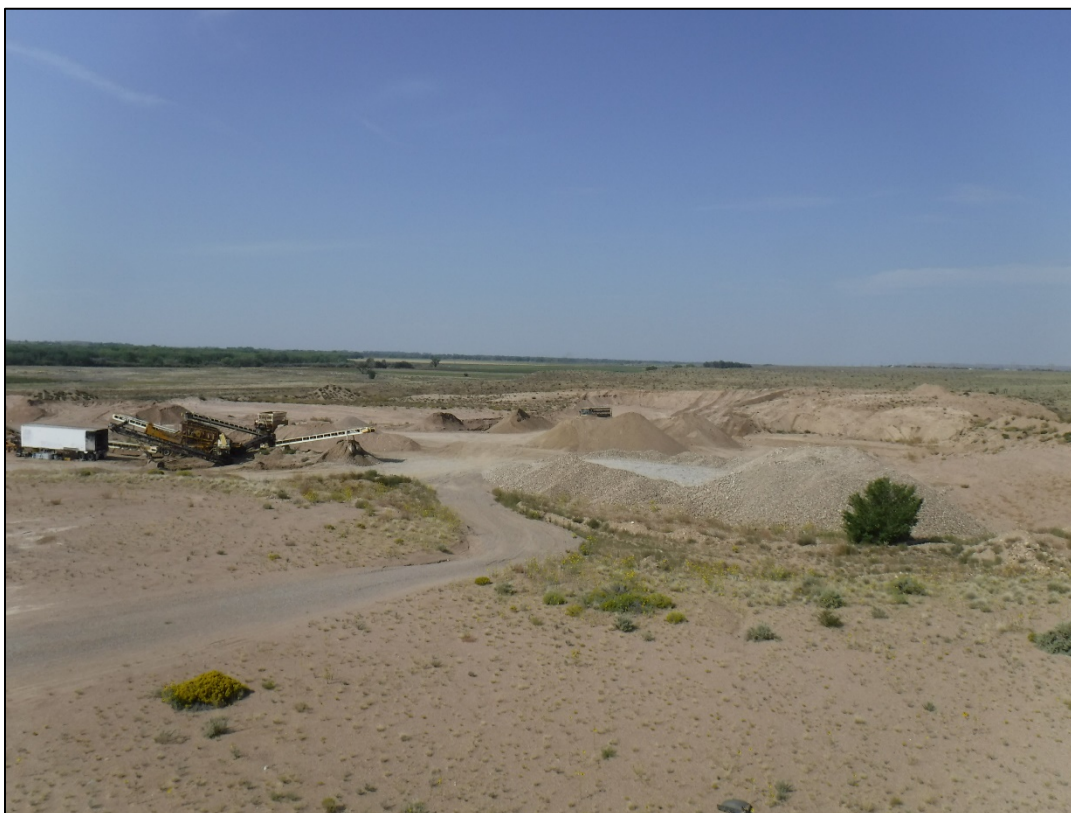
Photo 2: Mine processing area

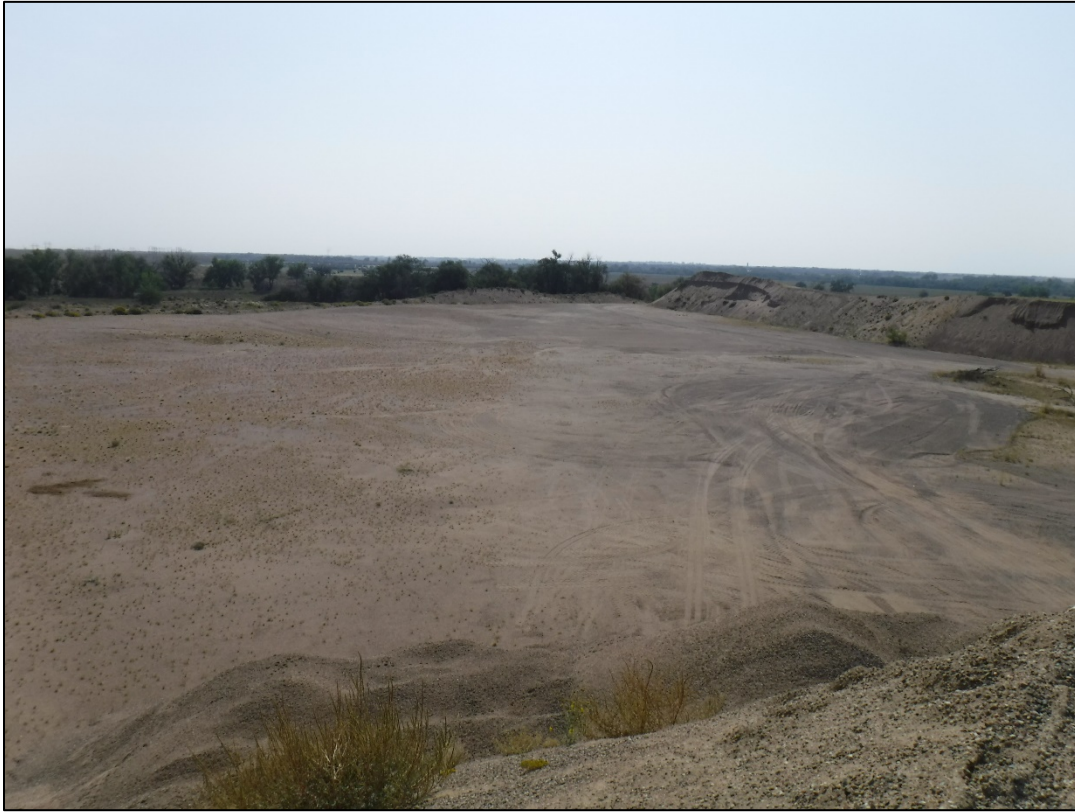
Photo 3: Southeastern area of the permit that has been mined and is in reclamation, although stockpiled material will be removed

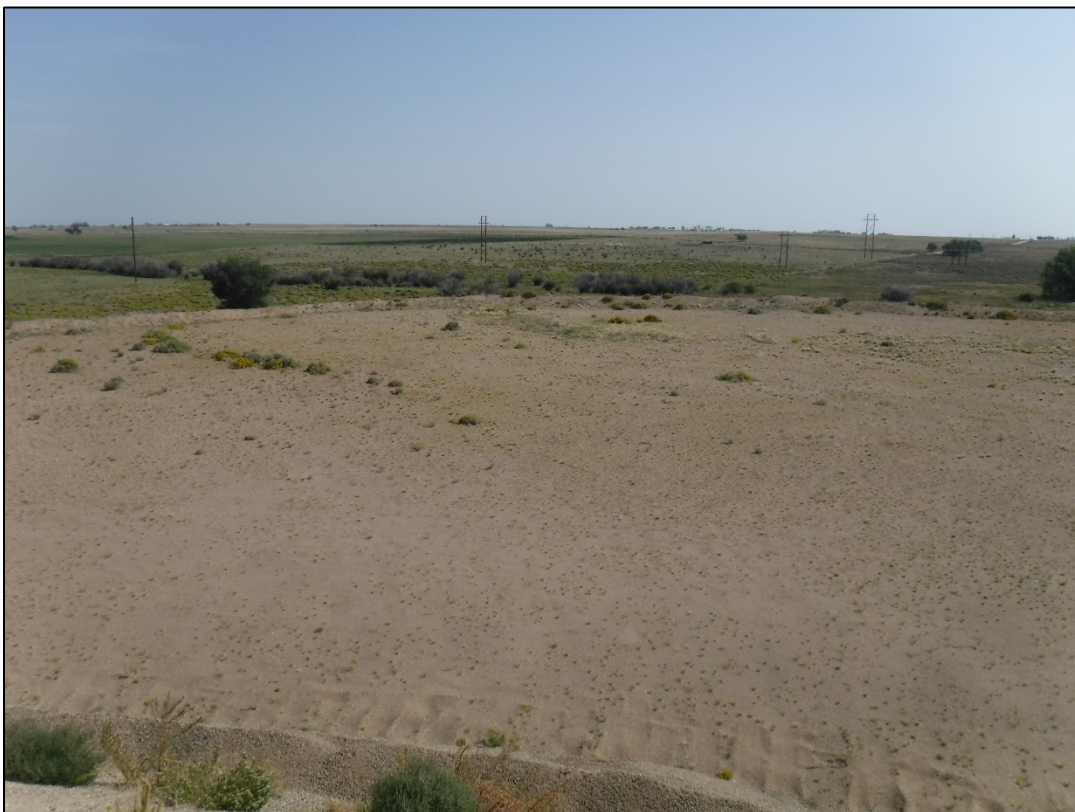
Photo 4: Northeastern area of the permit that has been mined and is in reclamation

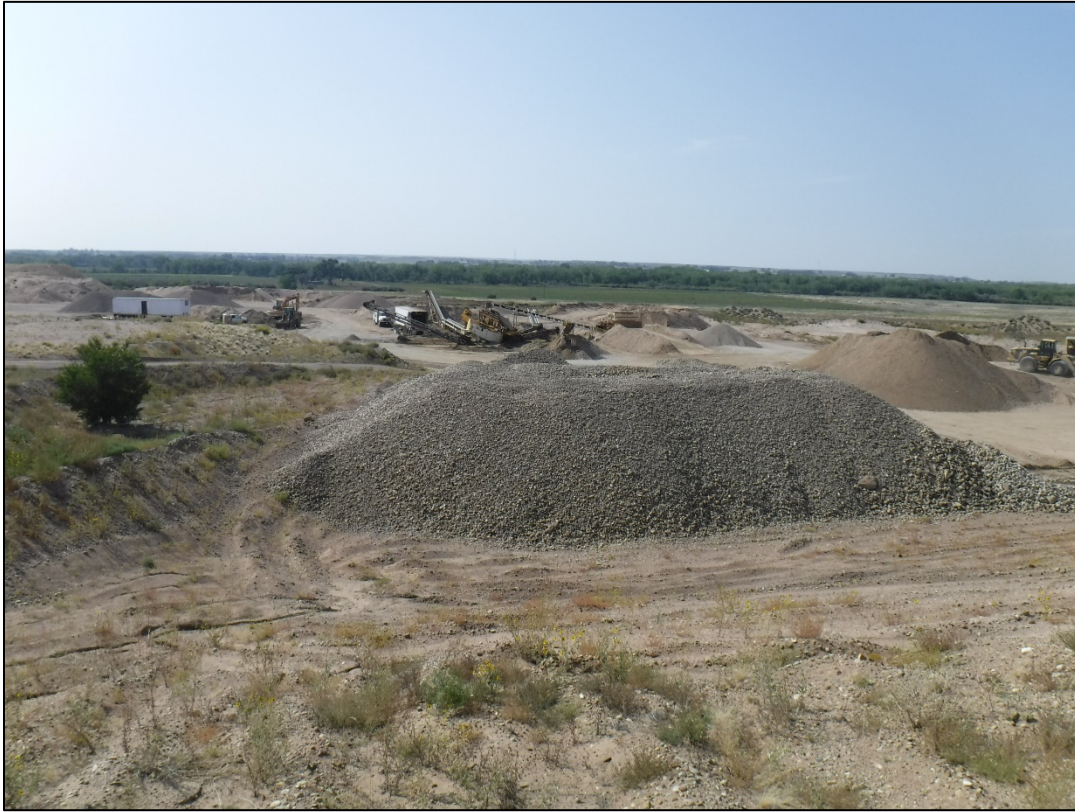
Photo 5: Looking south across processing area

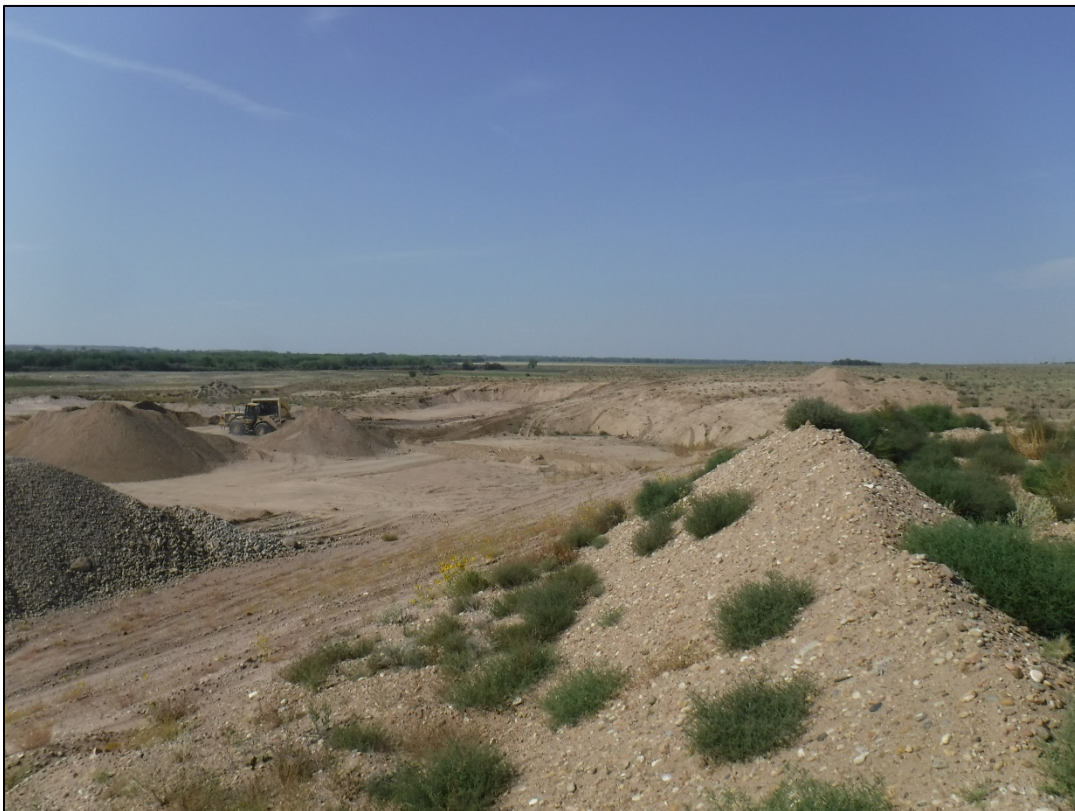
Photo 6: Mining area adjacent to processing area

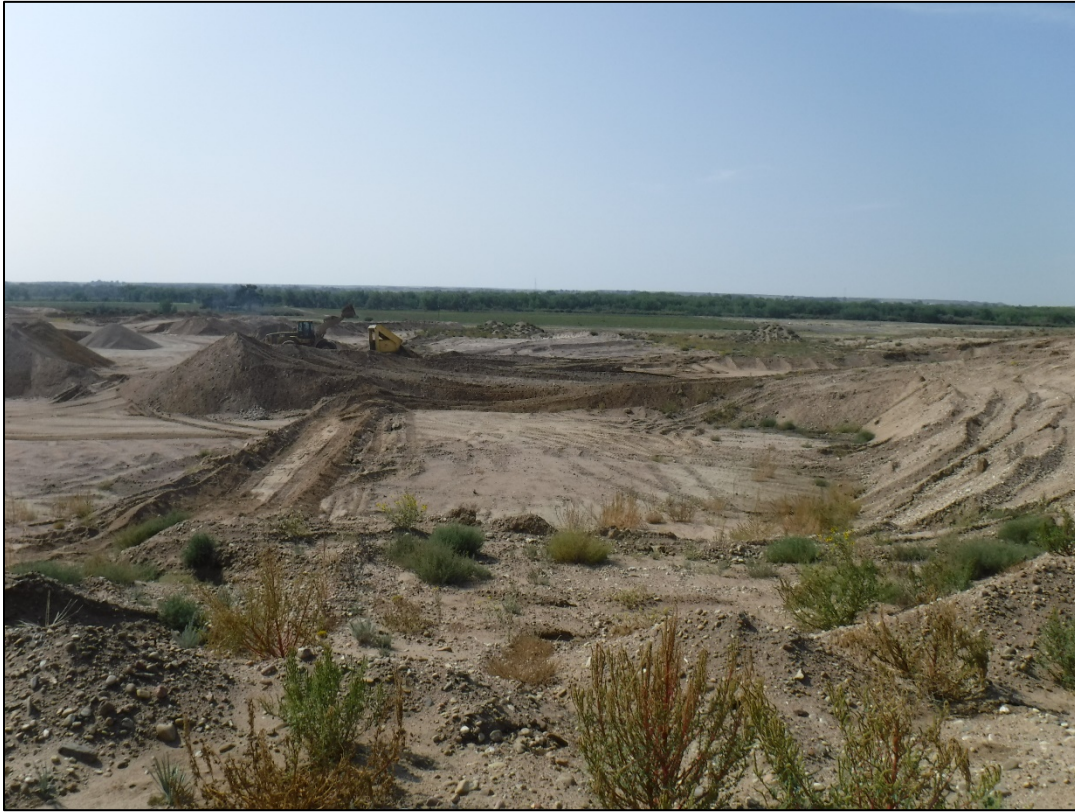
Photo 7: Mining area showing typical highwall

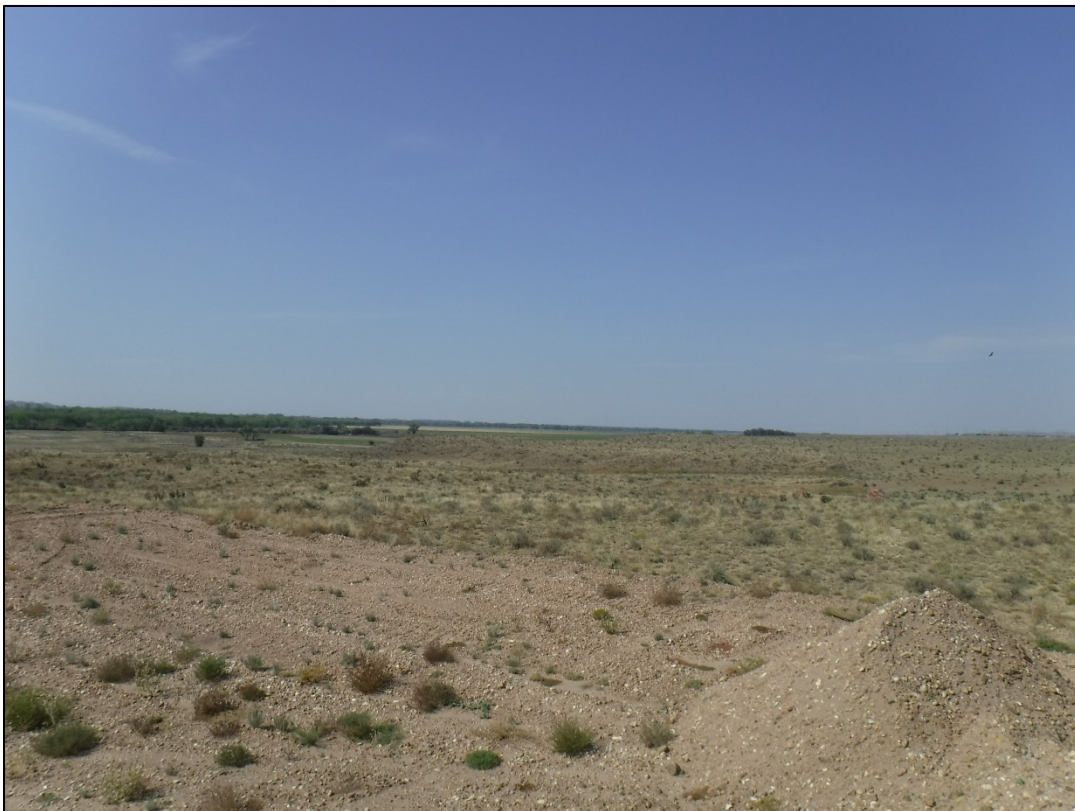
Photo 8: Typical conditions of the surrounding land ahead of mining activities
