**MINERALS PROGRAM INSPECTION REPORT**  
**PHONE: (303) 866-3567**

<b>MINE NAME:</b> Poorman Mine	<b>MINE/PROSPECTING ID#:</b> M-1982-058	<b>MINERAL:</b> Gold and silver	<b>COUNTY:</b> Clear Creek
<b>INSPECTION TYPE:</b> Monitoring	<b>INSPECTOR(S):</b> Peter Hays	<b>INSP. DATE:</b> September 11, 2020	<b>INSP. TIME:</b> 11:00
<b>OPERATOR:</b> Mosch Exploration & Mining, LLC	<b>OPERATOR REPRESENTATIVE:</b> David Mosch	<b>TYPE OF OPERATION:</b> 110(2) - Hard Rock Limited Impact	
<b>REASON FOR INSPECTION:</b> Normal I&E Program	<b>BOND CALCULATION TYPE:</b> Partial Bond	<b>BOND AMOUNT:</b> \$4,803.00	
<b>DATE OF COMPLAINT:</b> NA	<b>POST INSP. CONTACTS:</b> None	<b>JOINT INSP. AGENCY:</b> None	
<b>WEATHER:</b> Clear	<b>INSPECTOR'S SIGNATURE:</b>

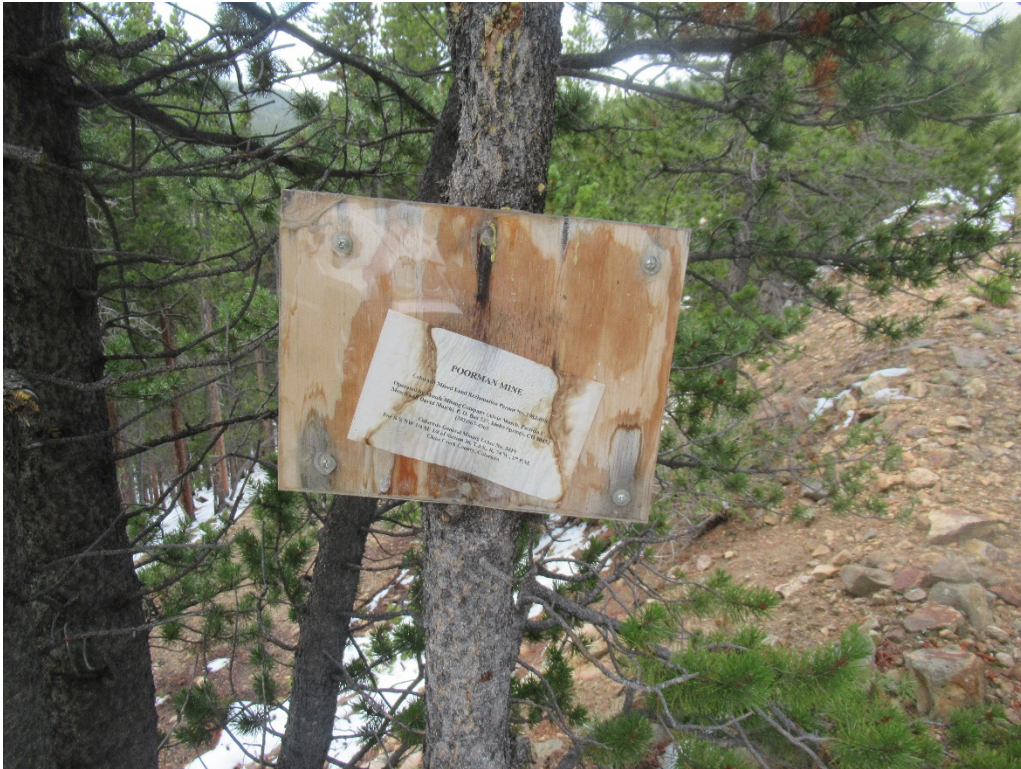
The Division did not observe any discharge from the mine and found no evidence of prior discharges from the mine. The mine sign and boundary markers were observed as required by Rule 3.1.12.

Poorman Mine mine sign

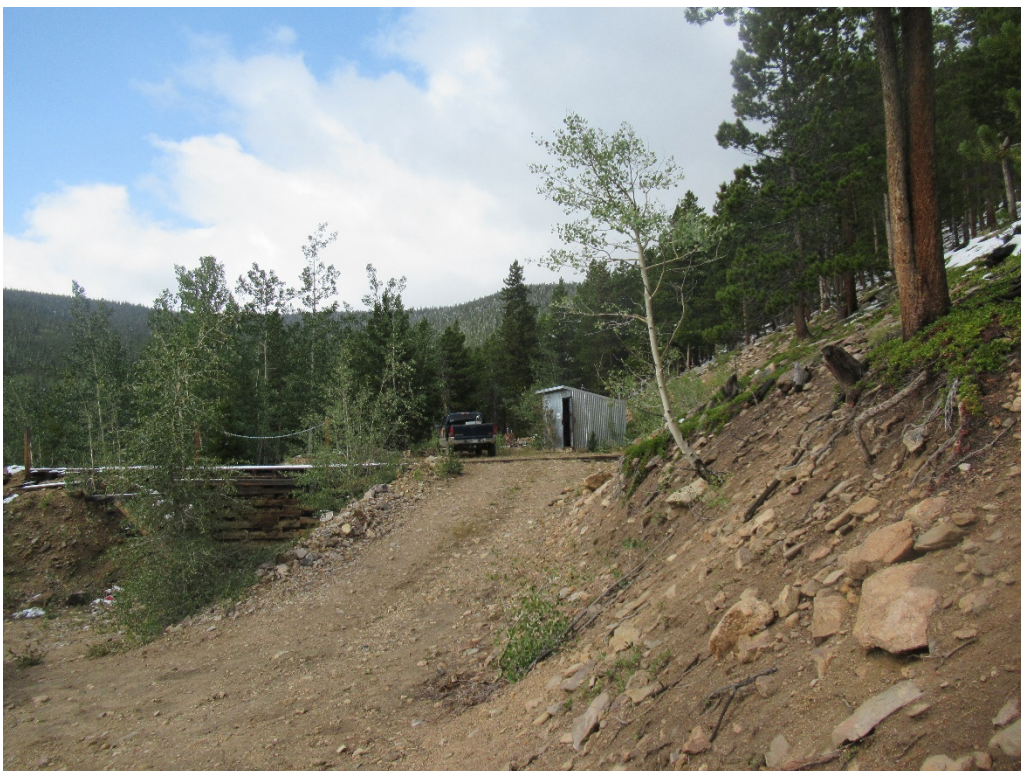
View of the site from the east side looking west

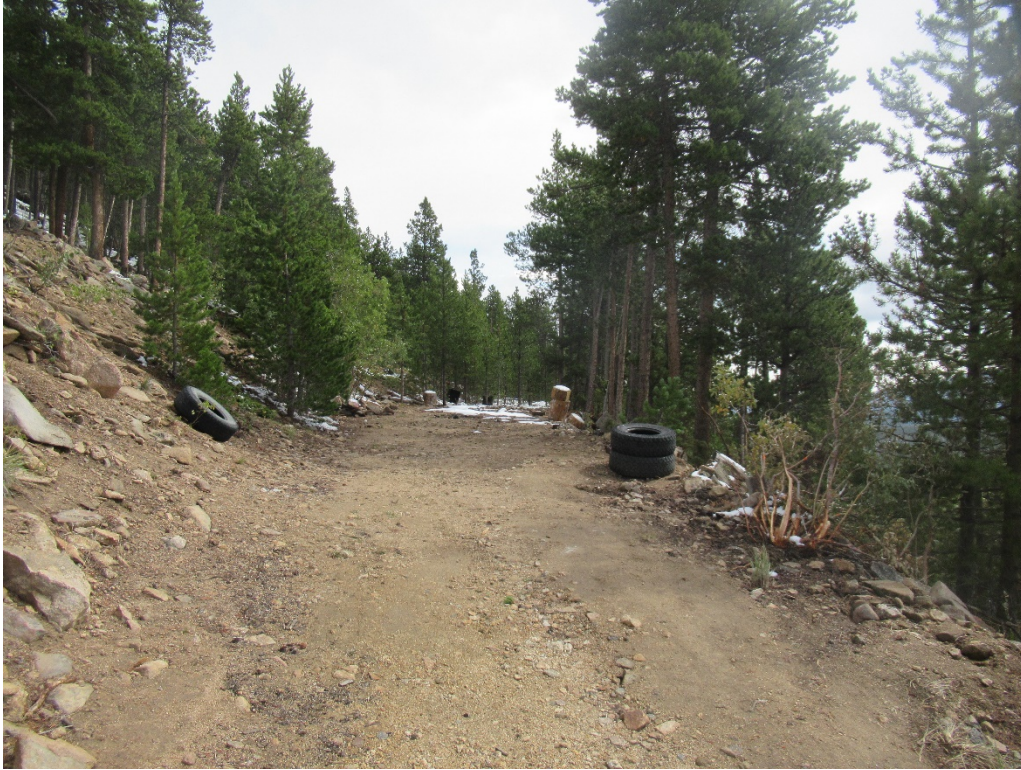
The approved Reclamation Plan states the mine structures will be removed from the site and the area will be graded to a 2.22H:1V slope to match the existing topography. Final reclamation activities were initiated by the Operator this year. The antique school bus was relocated to the Phoenix Mine. The metal storage shed is in the process of being clean out to allow for removal from the site. The shed, timbers and the rail are scheduled to be removed from the site this year. The air compressor was not observed at the site. The generator was covered by a tarp and was not in-use. A small pile of metal debris was observed west of the shed. The debris will need to be removed as part of the site reclamation. The waste dump appeared stable and vegetated with aspen trees and raspberry plants. No erosion features were noted during the inspection.

View of the former location of the school bus, which has been moved to the Phoenix Mine

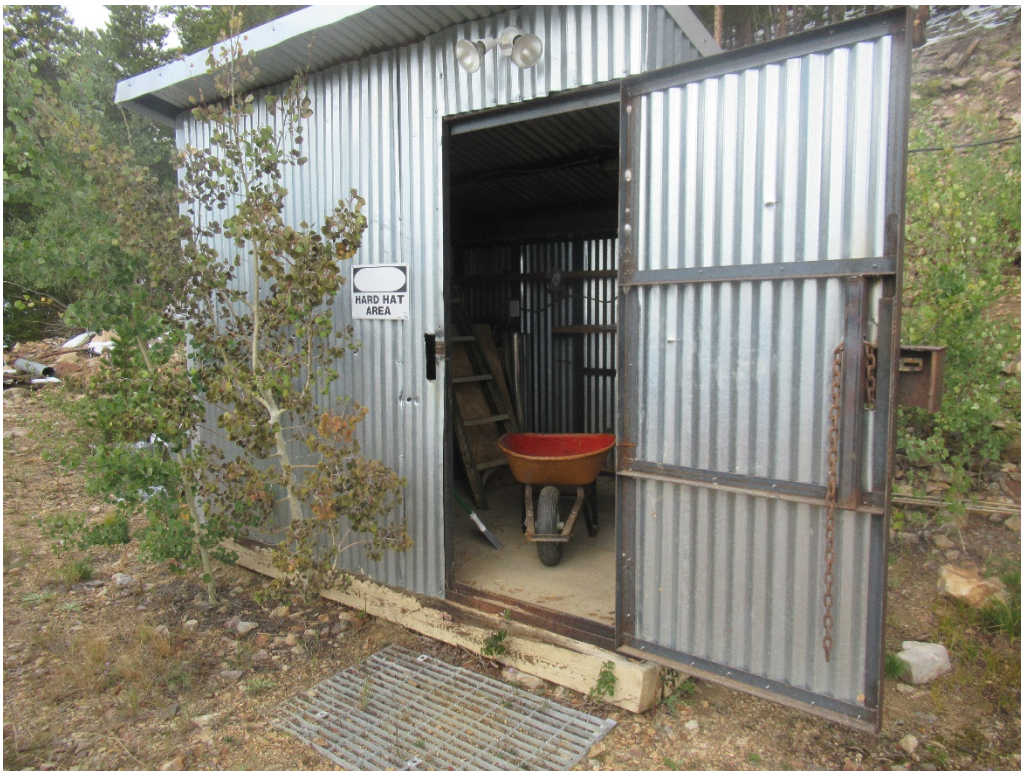
View of the metal shed

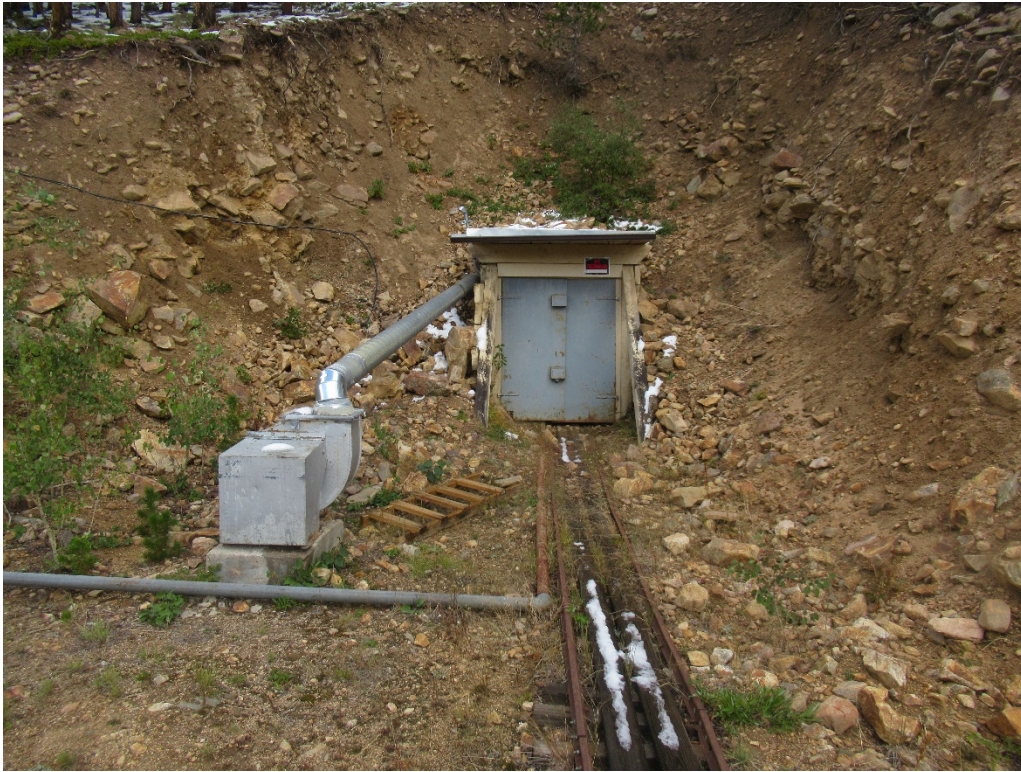
The facilities at the mine include: antique school bus, metal storage shed, generator, air compressor, mine fan, rail, trestle type rail car dumping pocket, a waste dump area and the portal. The portal is secured with a set of locking steel doors. The rail line extends approximately 70 ft. from the portal to trestle dumping pocket. The waste rock dump existed prior to the issuance of the Reclamation Permit. The Operator has not placed additional waste rock on the waste dump.

View of the secured portal and mine fan

The Operator intends to use material from the top of the waste dump and MSHA safety berm to contour the site for stability and to match the existing topography. The Operator intends to leave the locked portal doors exposed during final reclamation, however the Operator will check with SLB on leaving the portal exposed or backfilling the portal area.

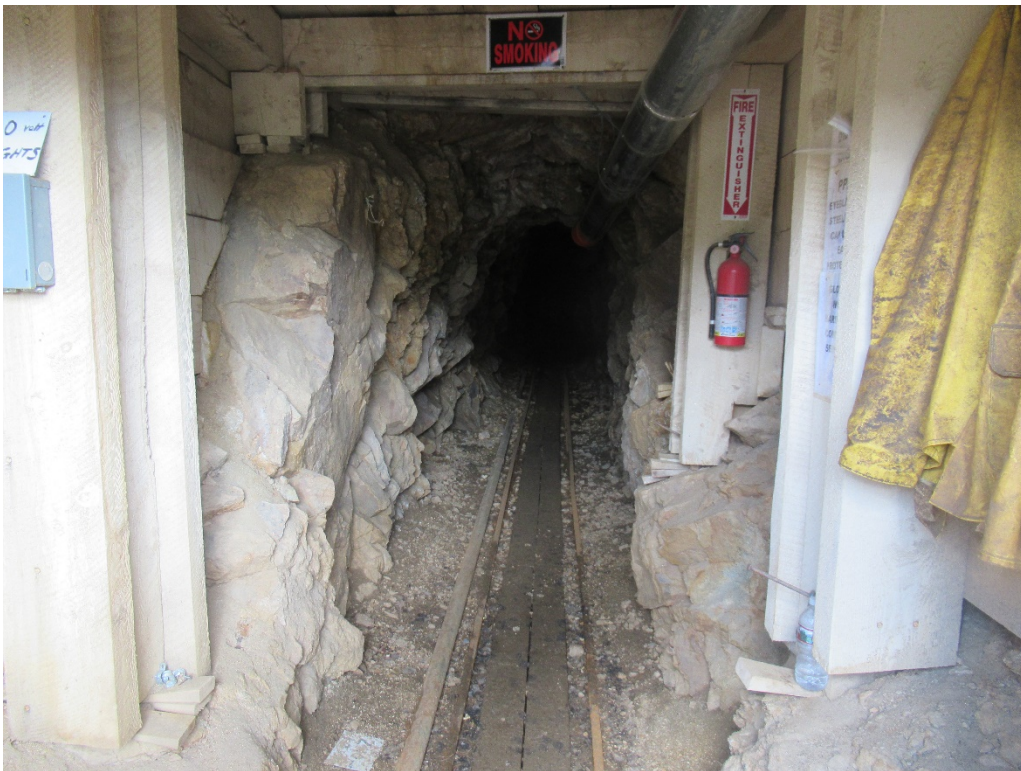
View inside the mine from the portal

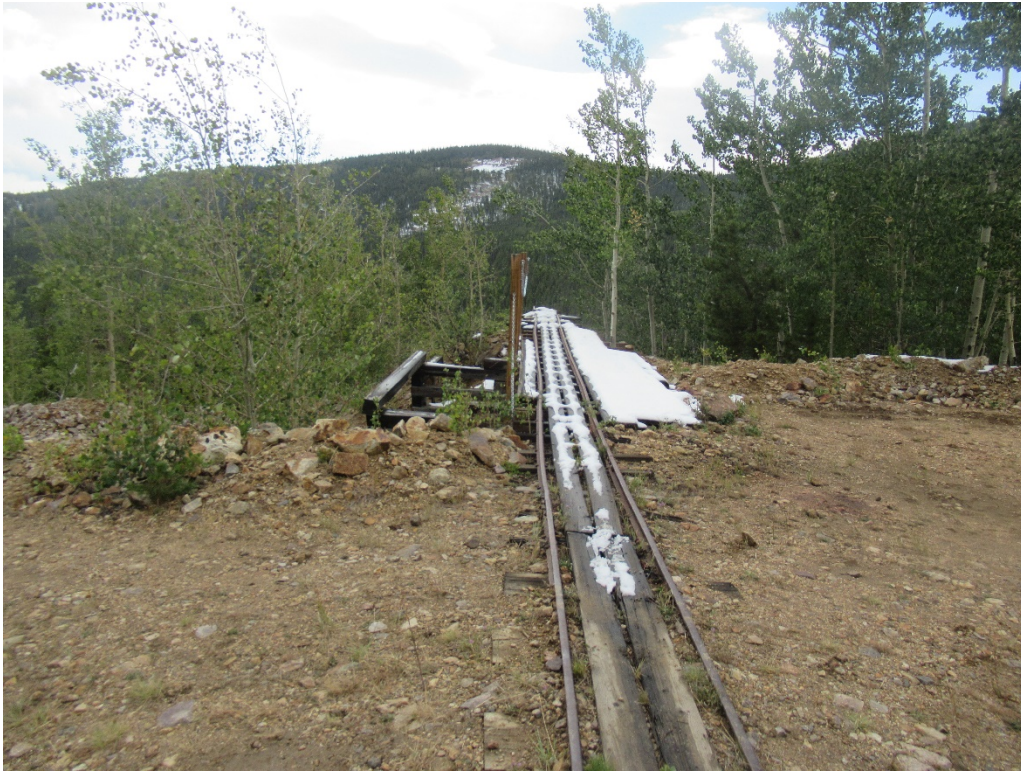
View of the rail from the portal

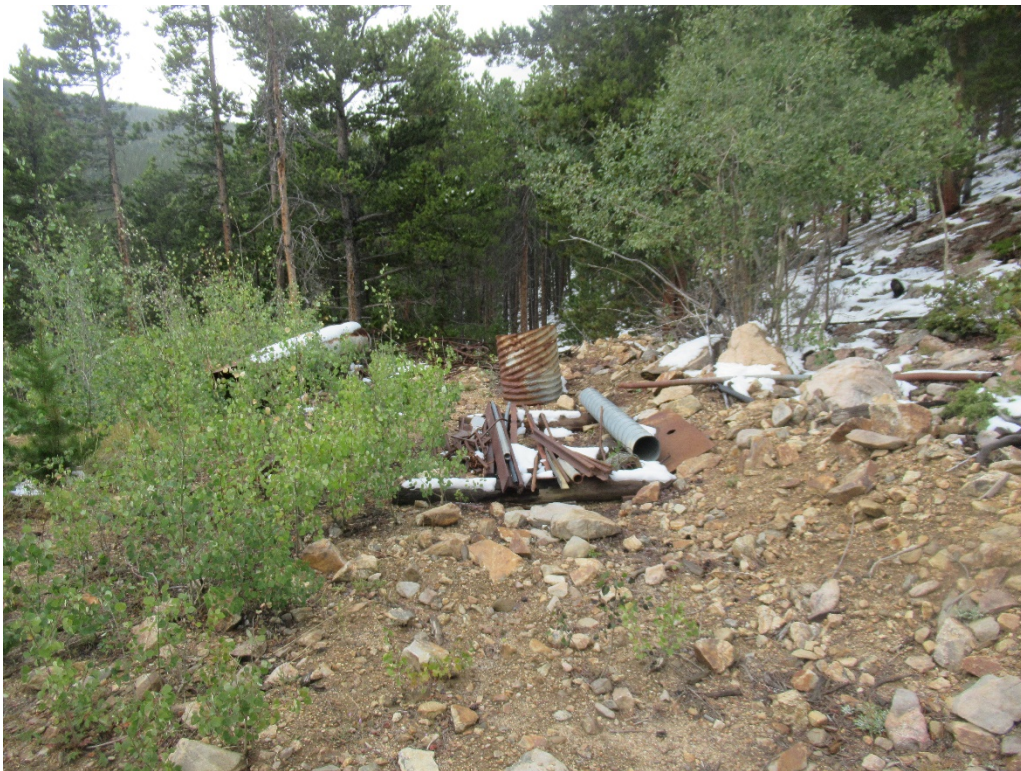
View of debris located west of the shed
