# MINERALS PROGRAM INSPECTION REPORT PHONE: (303) 866-3567

WILLIE TAINIE.	111	nien Rosi Ee inig ib	TITLE (EXTERNAL)	COCITIE.
Bear Hug	P-2	2011-028	Gold and silver	Clear Creek
INSPECTION TYPE:	IN	SPECTOR(S):	INSP. DATE:	INSP. TIME:
Monitoring	Pe	ter Hays	September 11, 2020	13:30
OPERATOR:	Ol	PERATOR REPRESENTATIVE:	TYPE OF OPERATION:	
Terry Winters	Te	rry Winters	MP - Mineral Prospecting	
DEACON EOD INCDECTION.		DOND CALCULATION TYDE.	DOND AMOUNT	n.
REASON FOR INSPECTION:		BOND CALCULATION TYPE:	BOND AMOUNT:	
Normal I&E Program		Partial Bond	\$2,268.23	
DATE OF COMPLAINT:		POST INSP. CONTACTS:	JOINT INSP. AGENCY:	
NA		None	None	
WEATHER:	INSPECTOR'S SIGNATURE:		SIGNATURE DATE:	
Clear	ft/m		October 2, 2020

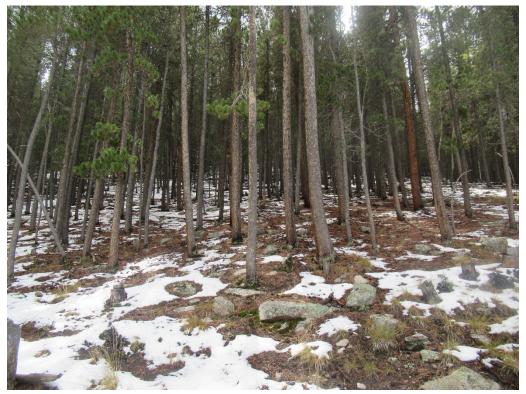
Mr. Winters stated prospecting activities have not occurred for the last 10 years and that next year's prospecting will be the last activity at the site. Mr. Winters indicated the last prospecting area to be excavated and reclaimed during the inspection. The area was covered in pine needles and matched the surrounding topography.

View of the reclaimed last prospecting location

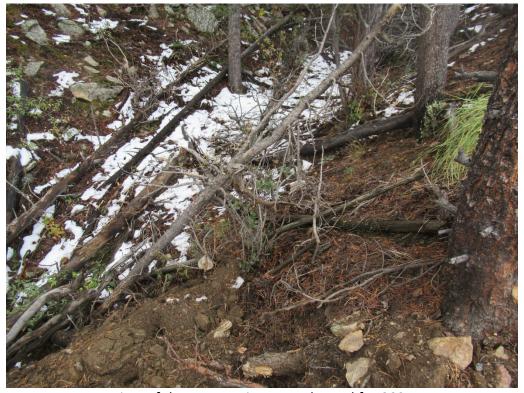
The Division holds a financial warranty in the amount of \$2,268.23, which appears adequate to reclaim the prospecting area planned for 2021.

View of the prospecting area planned for 2021

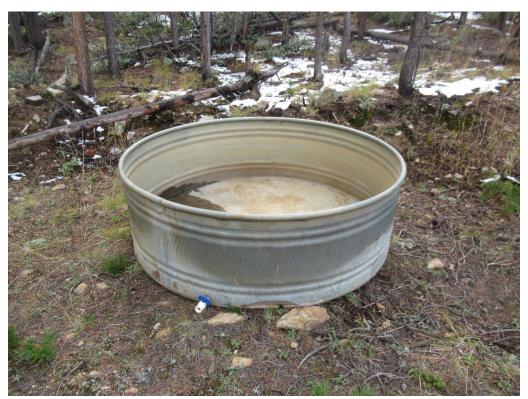
View of the cattle tank to be used to capture rain and snow for prospecting activity

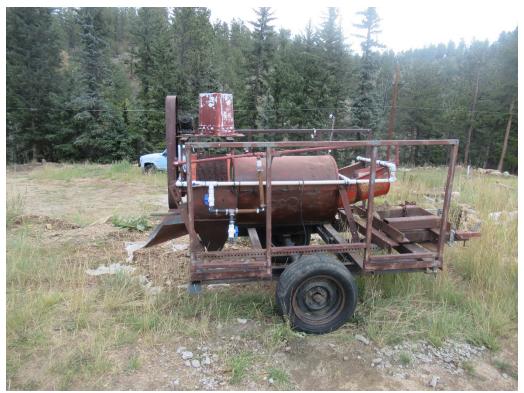
View of trommel
