Aerial inspection of Bowie #1

PERMIT INFORMATION

Permit Number: C-1981-038 Mine Name: Bowie No. 1 Mine Operator: Bowie Resources, LLC Operator Address: Mr. Basil Bear P.O. Box 1488 Paonia, CO 81428	County: Delta Operation Type: Underground Permit Status: Active Ownership: Private
	Operator Representative Present: None
Operator Representative Signature: (Field Issuance Only)

Inspection Start Date: October 1, 2020 Inspection Start Time: 11:45 Inspection End Date: October 1, 2020 Inspection End Time: 12:01		Inspection Type: Aerial Inspection Inspection Reason: Normal I&E Program Weather: Clear	
Joint Inspection Agency: None		Joint Inspection Contacts: 	
Post Inspection Agency: None		Post Inspection Contacts: 	
Inspector(s): Robert Zuber, P.E. Brock Bowles	Inspector's Signature:

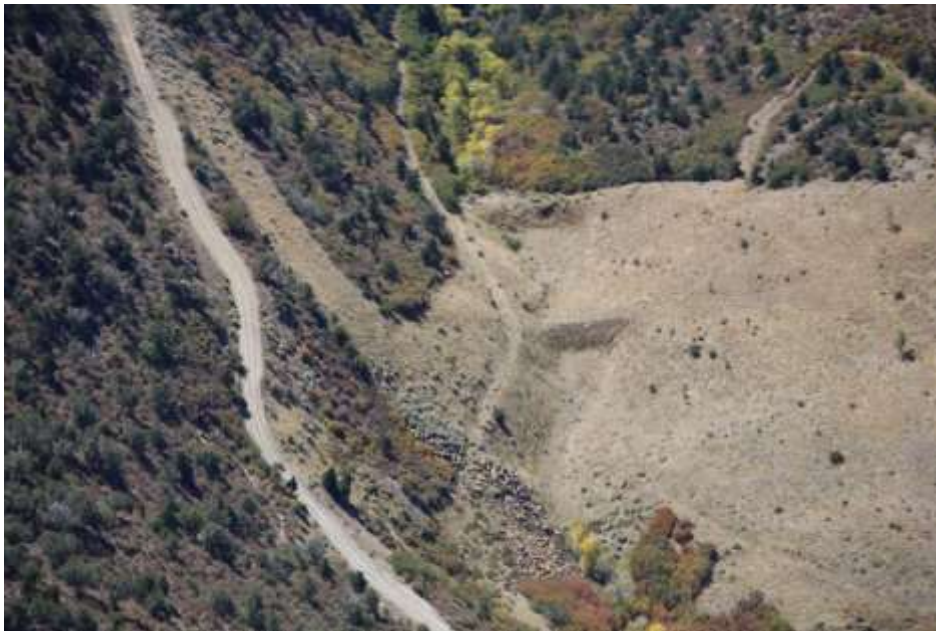
West Mine ponds

The ponds at the West Mine and the pond at the loadout were dry. No problems were seen with the embankments or other portions of these ponds.

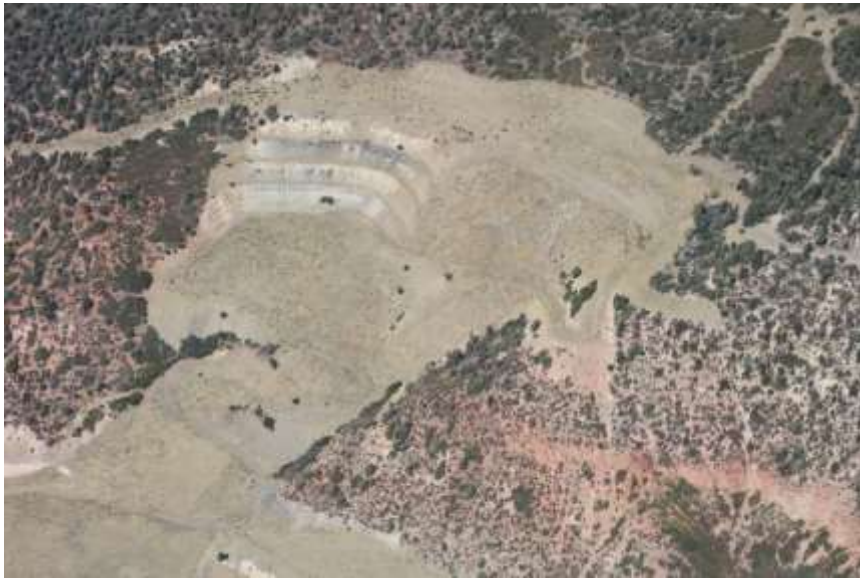
East Mine – upper portion

No erosion problems were identified. The vegetation on these areas is brown, as expected in October. The vegetation also appears to be relatively sparse (even for the autumn season), likely due to the dry conditions at the site for much of 2020.

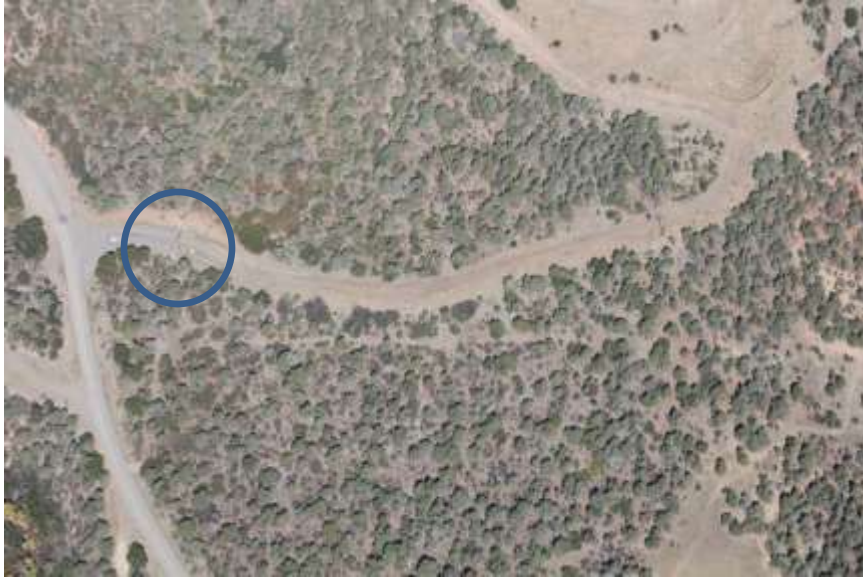
No erosion or other problems were identified with the road at the East Mine.

Entrance road at East Mine (gate is circled)
