Bowie #2 inspection

PERMIT INFORMATION

Permit Number: C-1996-083 Mine Name: Bowie No. 2 Mine Operator: Bowie Resources, LLC Operator Address: Mr. Basil Bear P.O. Box 1488 Paonia, CO 81428	County: Delta Operation Type: Underground Permit Status: Active Ownership: Private
	Operator Representative Present: None
Operator Representative Signature: (Field Issuance Only)

INSPECTION INFORMATION

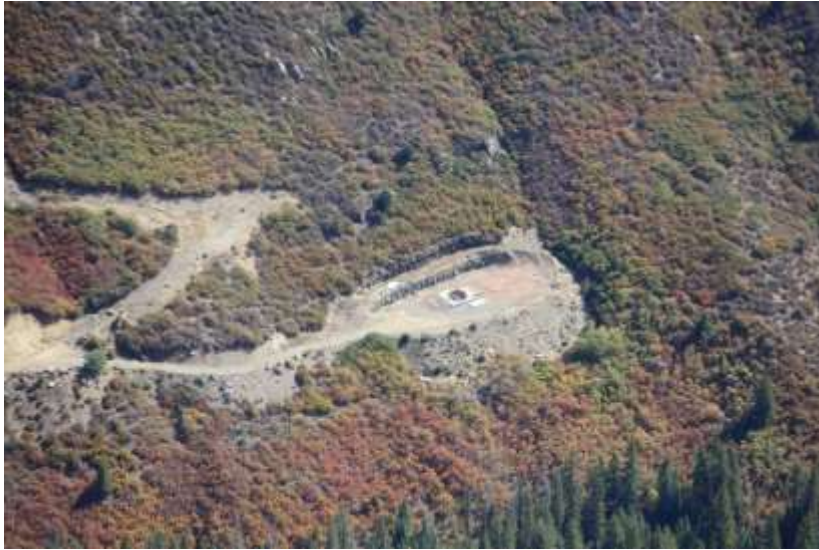
Pad for Terror Creek Vent Shaft (sealed)

The pad for the Terror Creek Vent Shaft and pads for Gob Vent Boreholes B17A-D were inspected. No problems were identified, but GVB B17C has a large cut that must be watched closely in the future.

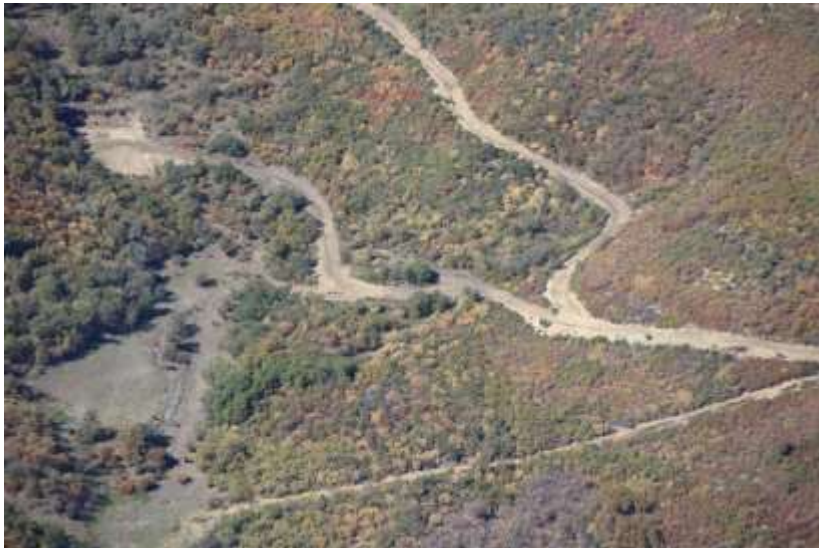
Pads for sealed gob vent boreholes – GVB B17C at upper left

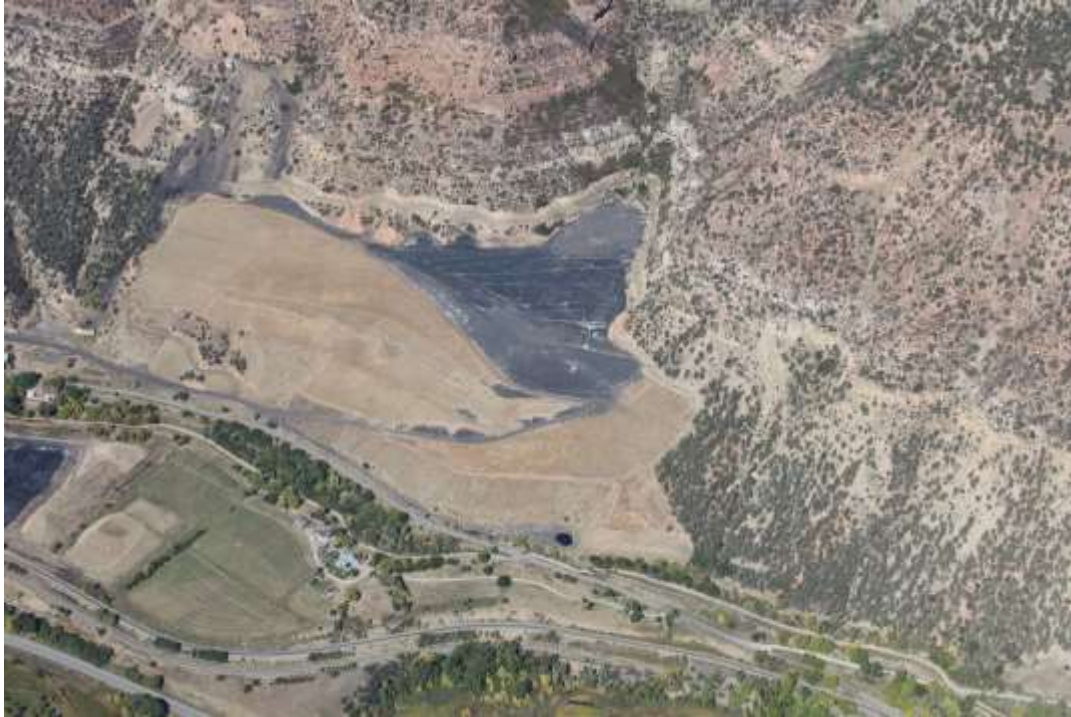
Gob Pile #2 and surrounding area

No problems were detected with any of the surface water control ditches. This includes the diversion ditches above Gob Pile #2 and Gob Pile #4.

Gob Pile #1, Gob Pile #4, and the reclaimed portion of Gob Pile #2 all appear to be in adequate shape with minimal areas that are bare. No signs of significant erosion can be seen in the photographs.

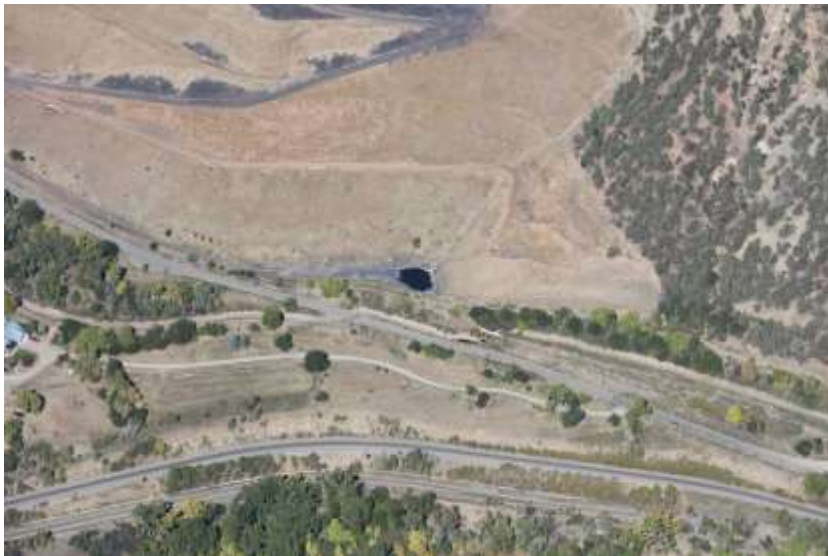
The following ponds were inspected: B, C, D, F, J, and K. All of the ponds appeared to be dry except Ponds F and J (J was very full). No problems were identified with embankments or other features of the ponds.

Gob Pile #2 (lower portion) and Pond F

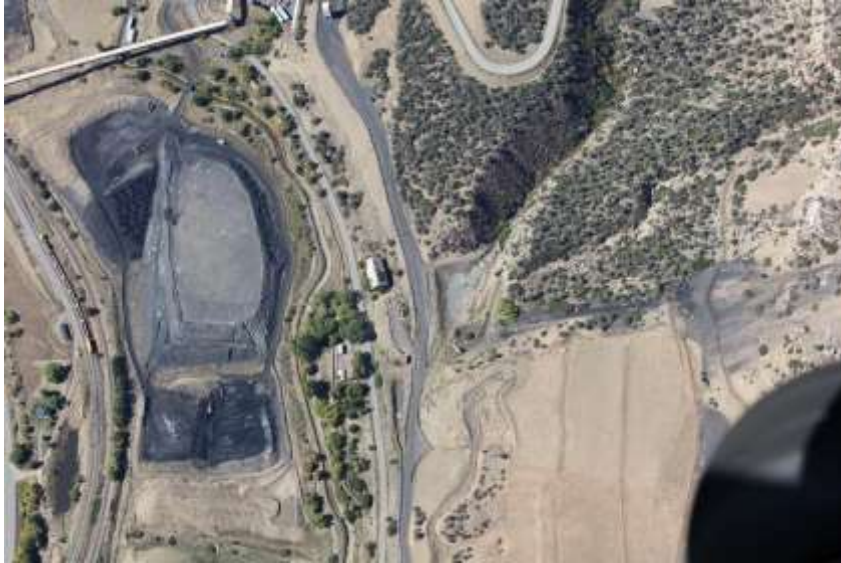
Gob Pile #3 and surrounding area

No evidence of ponding was identified on any of the gob piles, but piles of waste material could be seen on Gob Pile #3. This material must be spread to avoid future ponding. Alternatively, the piles could be re-shaped into rows (perpendicular to contour lines on the piles) to allow for positive drainage.
