MINERALS PROGRAM INSPECTION REPORT
PHONE: (303) 866-3567

MINE NAME: Santiago Mine	MINE/PROSPECTING ID#: P-2016-014	MINERAL: Silver, gold, copper,	COUNTY: Clear Creek
INSPECTION TYPE: Monitoring	INSPECTOR(S): Peter Hays	INSP. DATE: September 17, 2020	INSP. TIME: 11:00
OPERATOR: Santiago Mining Company, LLC	OPERATOR REPRESENTATIVE: None	TYPE OF OPERATION: MP - Mineral Prospecting

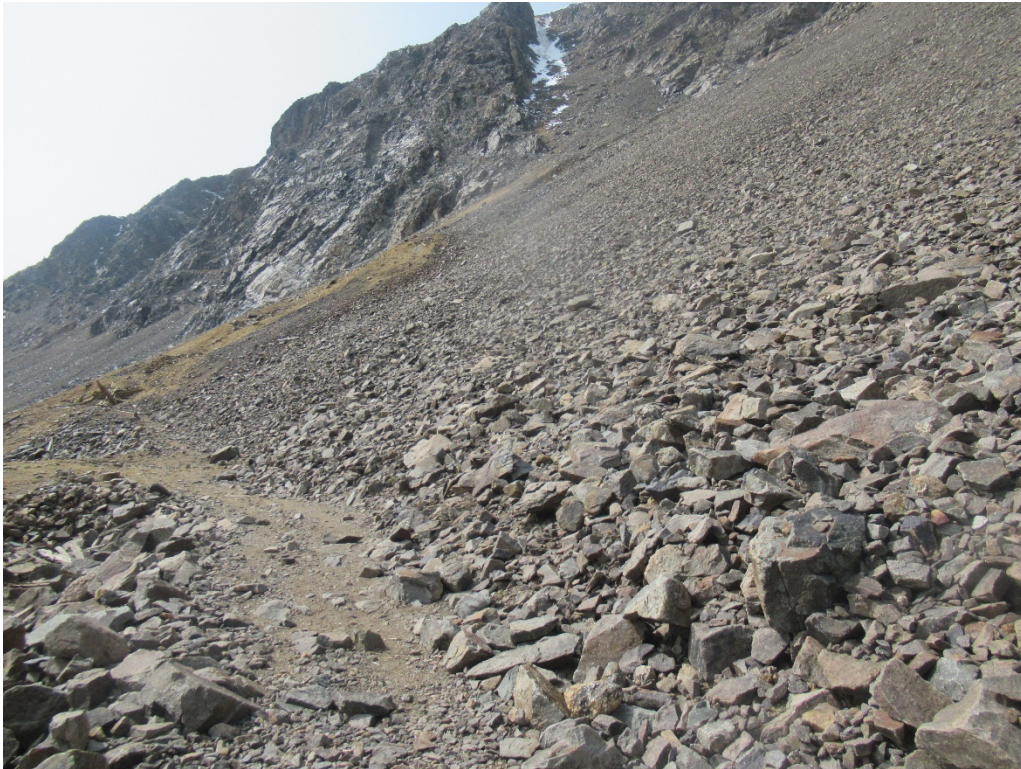
No evidence of prospecting activity was observed during the inspection. The location of the proposed drill pad consisted of an undisturbed talus field.

View of the proposed drill pad location looking south

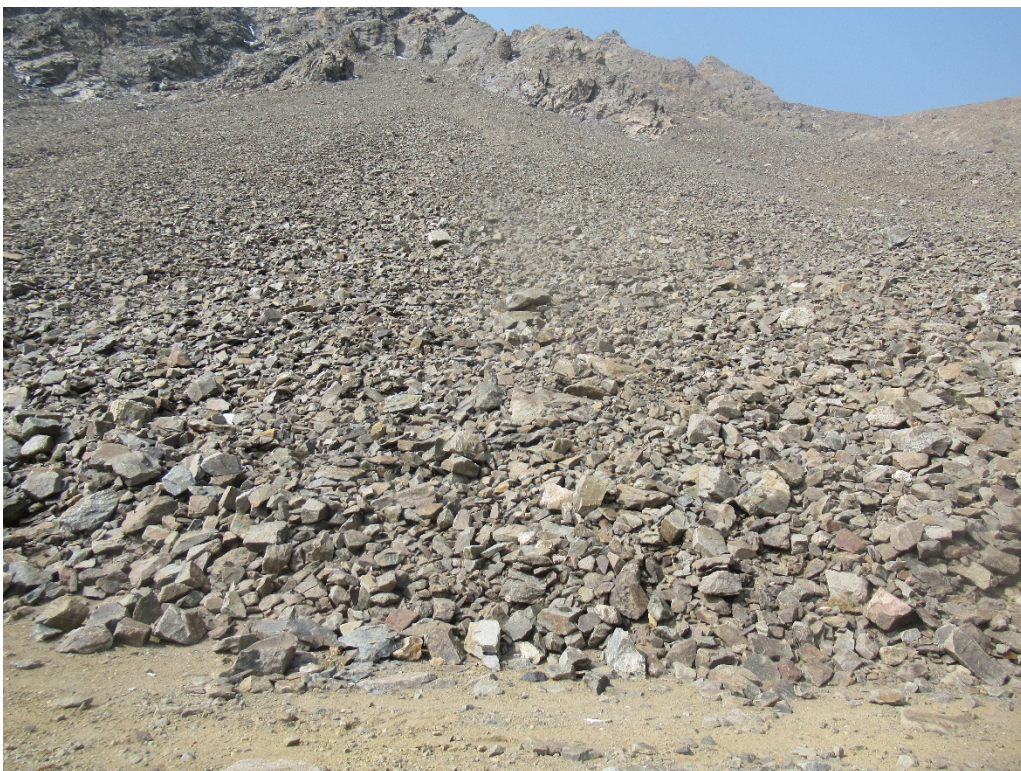
View of the proposed drill pad location looking west

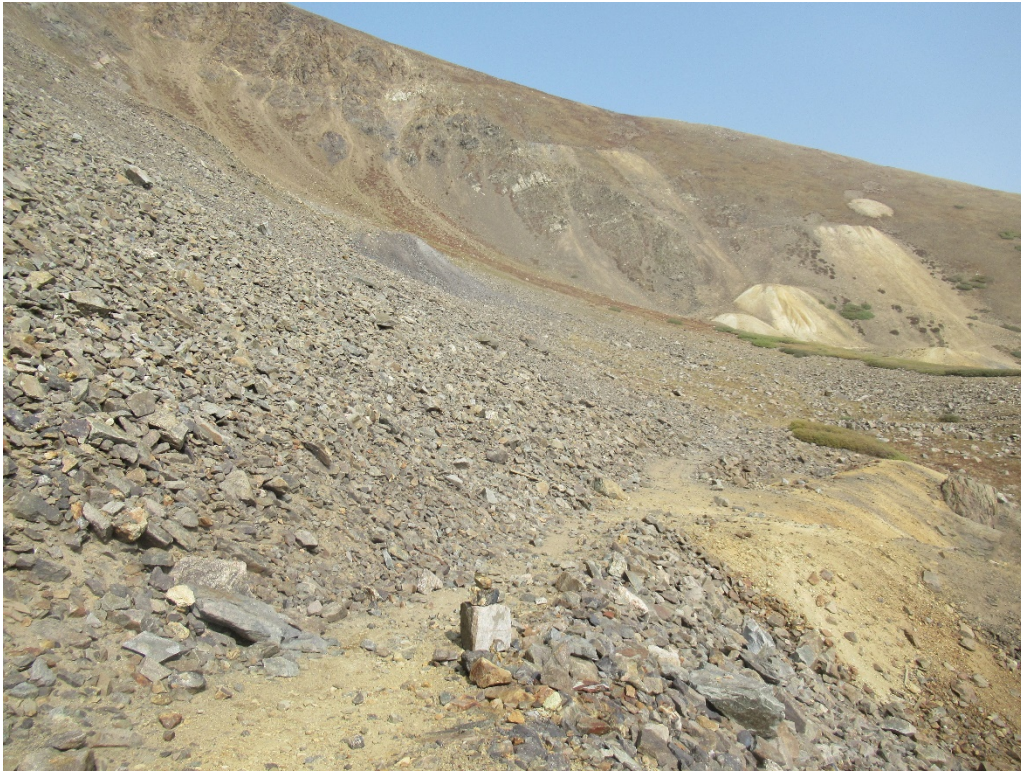
View of the proposed drill pad location looking north
