**PERMIT INFORMATION**

<b>Permit Number:</b> C-1981-041 <b>Mine Name:</b> Roadside Portals <b>Operator:</b> Snowcap Coal Company, Inc. <b>Operator Address:</b> MS Tonya Hammond P.O. Box 1430 Palisade, CO 81526	<b>County:</b> Mesa <b>Operation Type:</b> Underground <b>Permit Status:</b> Active <b>Ownership:</b> Private
	<b>Operator Representative Present:</b>  NA
<b>Operator Representative Signature: (Field Issuance Only)</b>

**INSPECTION INFORMATION**

<b>Inspection Start Date:</b> October 1, 2020 <b>Inspection Start Time:</b> 11:25 <b>Inspection End Date:</b> October 1, 2020 <b>Inspection End Time:</b> 11:27	<b>Inspection Type:</b> Aerial Inspection <b>Inspection Reason:</b> Normal I&E Program <b>Weather:</b> Clear
<b>Joint Inspection Agency:</b>  None	<b>Joint Inspection Contacts:</b>  None
<b>Post Inspection Agency:</b>  None	<b>Post Inspection Contacts:</b>  None
<b>Inspector(s):</b>  Clayton Wein  Brock Bowles	<b>Inspector's Signature:</b>  <i>Clayton Wein</i>  <b>Signature Date:</b>  10/6/2020

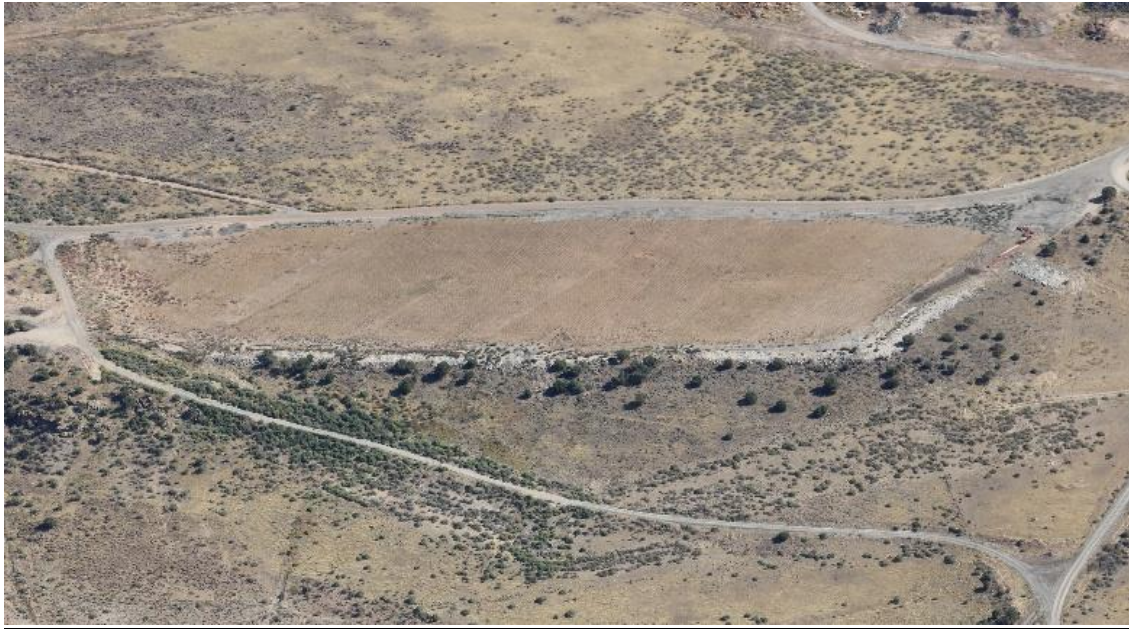
At the time of the inspection the Carey Pit was dry. There was no evidence of recent use of the pit. The trench leading into the pit was also dry. There was no indication of recent water applications to the landowner's middle field (Photo 1). The field was dry during the inspection. The trenches on top of the Tract 70 mesa were dry (Photo 2). Trenches that extend from the south end to the north end of the mesa showed no signs of recent water application. The cliffs on the north end of the tract 70 mesa were similar to the other recent Division aerial inspections (Photo 3). The cliffs seem to remain stable. There were no locations observed with major amounts of seepage. The portals for the Roadside South Mine were dry and stable (Photo 4). There were no indications of seepage. The ditches extending from the base of the French drain were observed to be dry. The drainage above the reclaimed refuse pile was dry. There were no indications of recent flow in the drainage. The reclaimed refuse pile was dry and stable. There was no evidence of hydrologic impacts to the pile.

**Photo 1:** The Landowner's Middle Field. Located east of the TR-69 reclaimed area. The Photo was taken looking to the east.

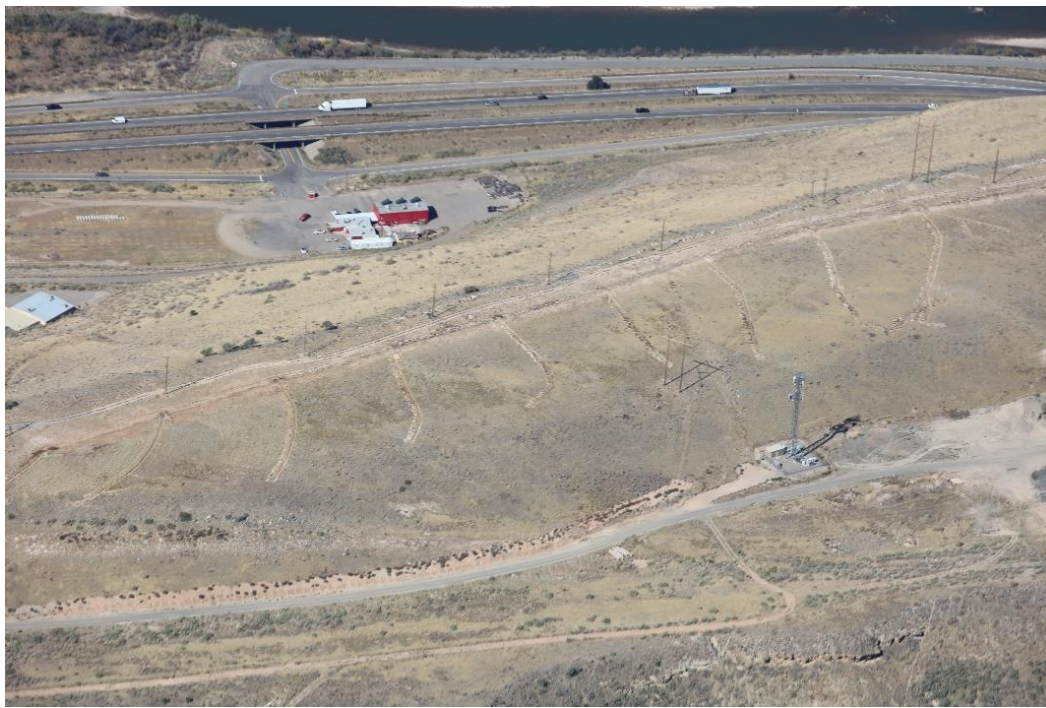
**Photo 2:** The trenches located on top of the Tract 70 Mesa. Photo is looking west.

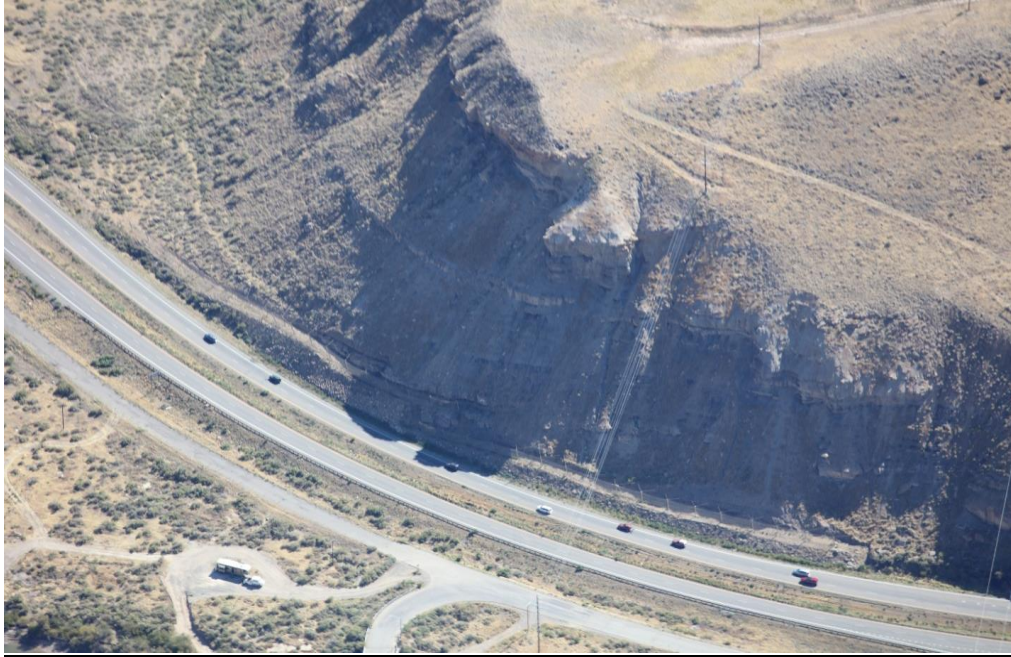
**Photo 3:** The cliffs at the north end of the Tract 70 Mesa. The photo was taken looking to the east.

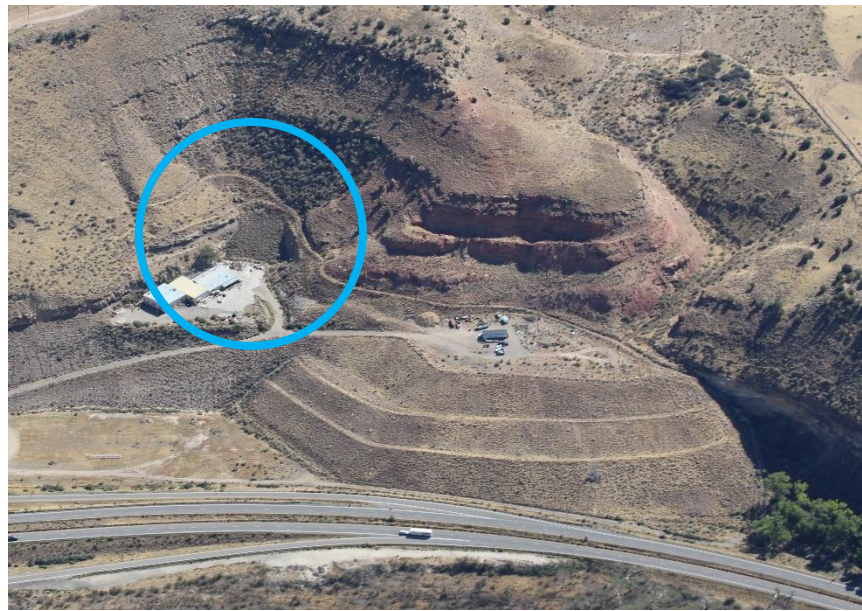
**Photo 4:** The Roadside South Portals are outlined in a blue circle in the photo above. The photo was taken looking east.

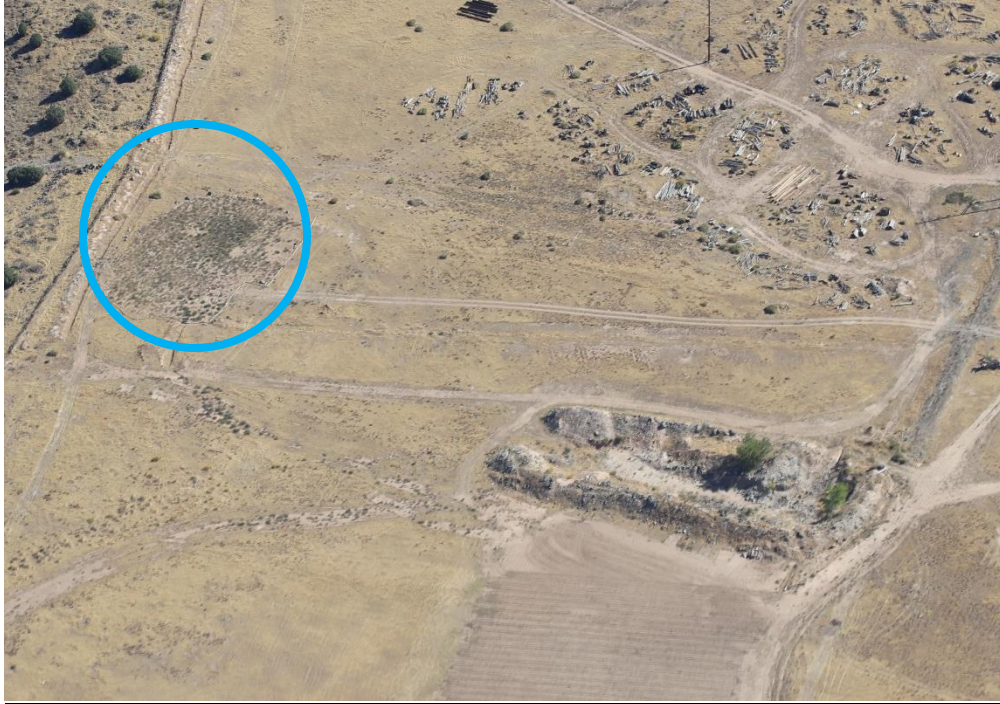
The remaining disturbed area at the mine site is associated with the repair work completed for TR-69. The site was reclaimed and reseeded in the fall of 2019. The site was stable and dry during the inspection (Photo 5).

There were no erosional features identified. No concerns of surface settling were seen. The reclaimed area is 0.4 acres in size. The disturbance boundary markers were observed to be in place. The sediment logs were observed to be in good condition, located at the base of the reclaimed area. There were no observed off-site impacts.

**Photo 5:** The TR-69 reclaimed area is outlined in the blue circle in the photo above. The photo was taken looking to the east.
