Horse Gulch Fill Quarterly Inspection Report

Third Quarter 2020

**Trapper Mining Inc.
Trapper Mine
Craig, Colorado**

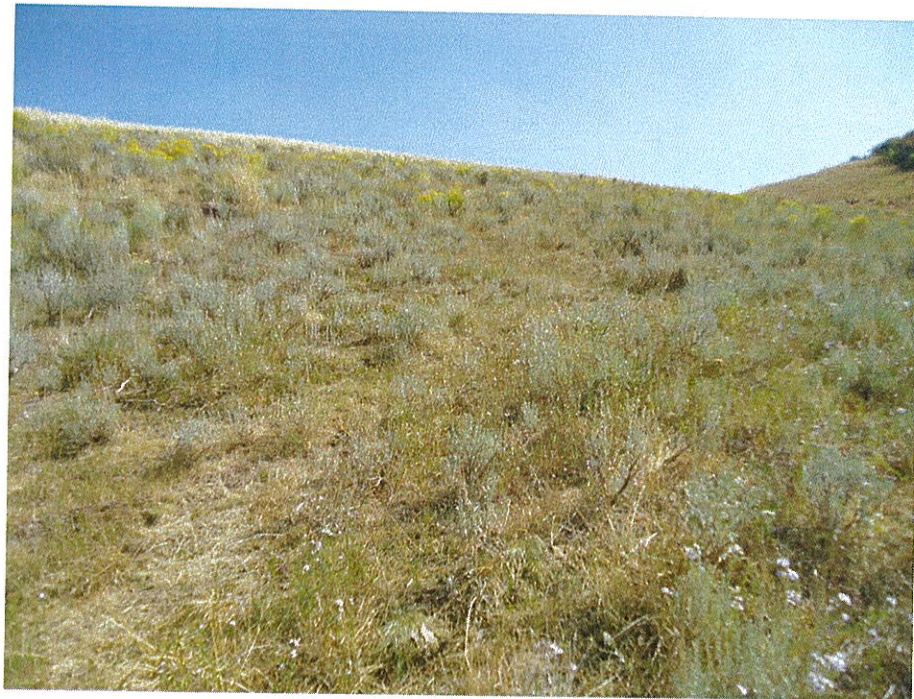
The two spots above the 7350' elevation on the south side of the dump that showed some differential settling in the second quarter of 2013 were inspected and there was no additional settling (Photographs 1 and 2).

Photograph 1: South Site above the 7350 Bench Elevation (9/24/2020)

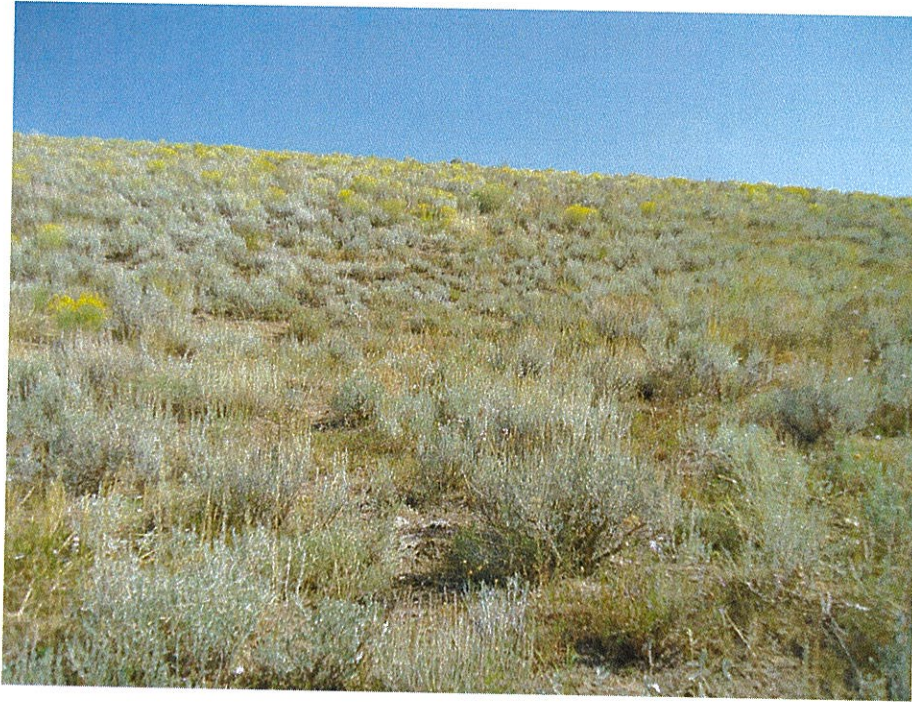
Photograph 2: North Site above the 7350 Bench Elevation (9/24/2020)

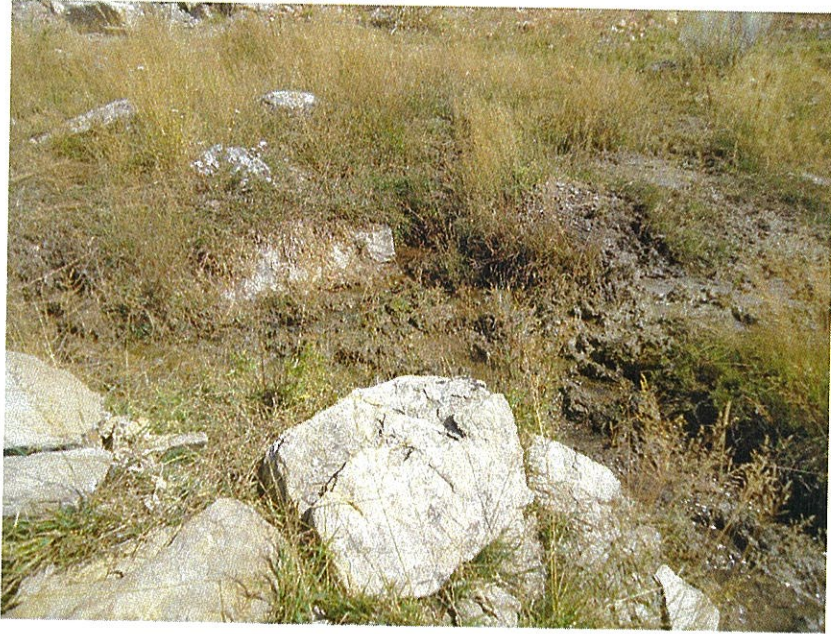
The underdrainage system was completed in the first quarter of 2010; additional work on this system is not anticipated. During the time of the inspection, there was approximately a 1.5 gallons per minute of water flow. (Photograph 3).

Photograph 3: Water from the Underdrainage System (9/24/2020)

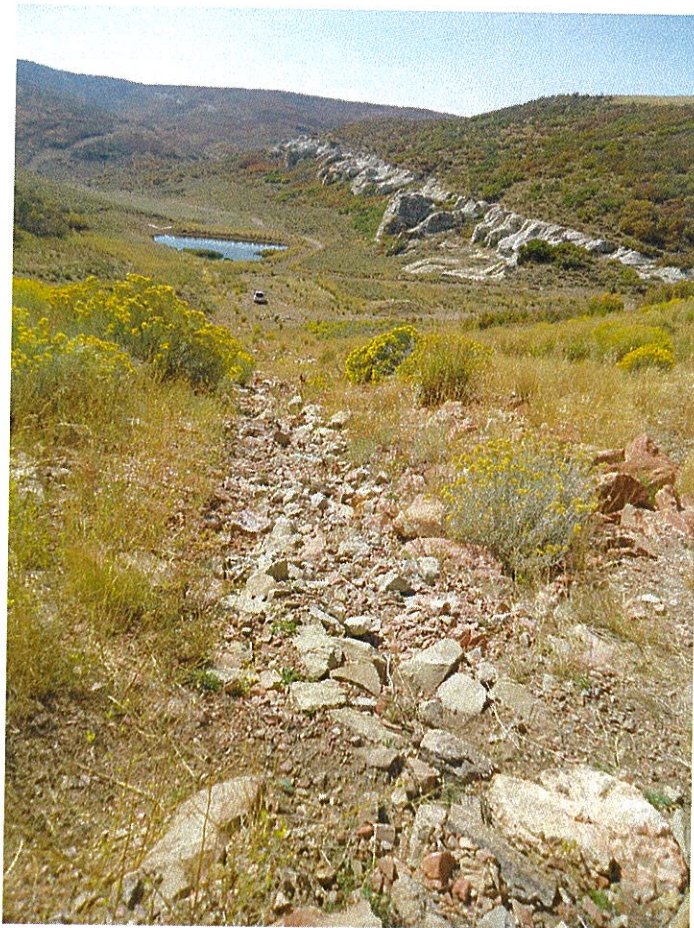
Both the north and south surface drains were inspected (Photographs 4 and 5). At the time of the inspection there was no water flow.

Photograph 4: North Surface Drain Looking West (9/24/2020)

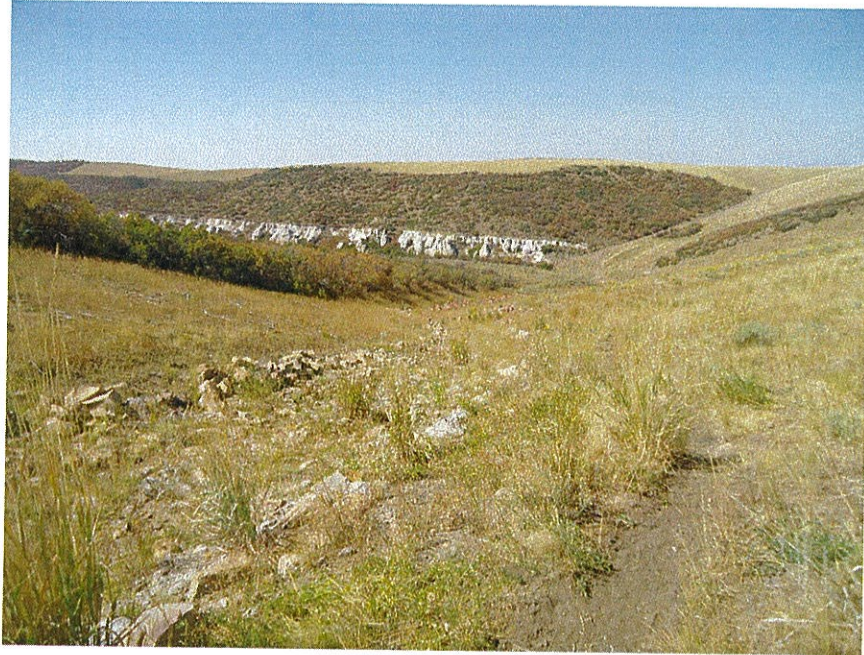
Photograph 5: South Surface Drain Looking West (9/24/2020)

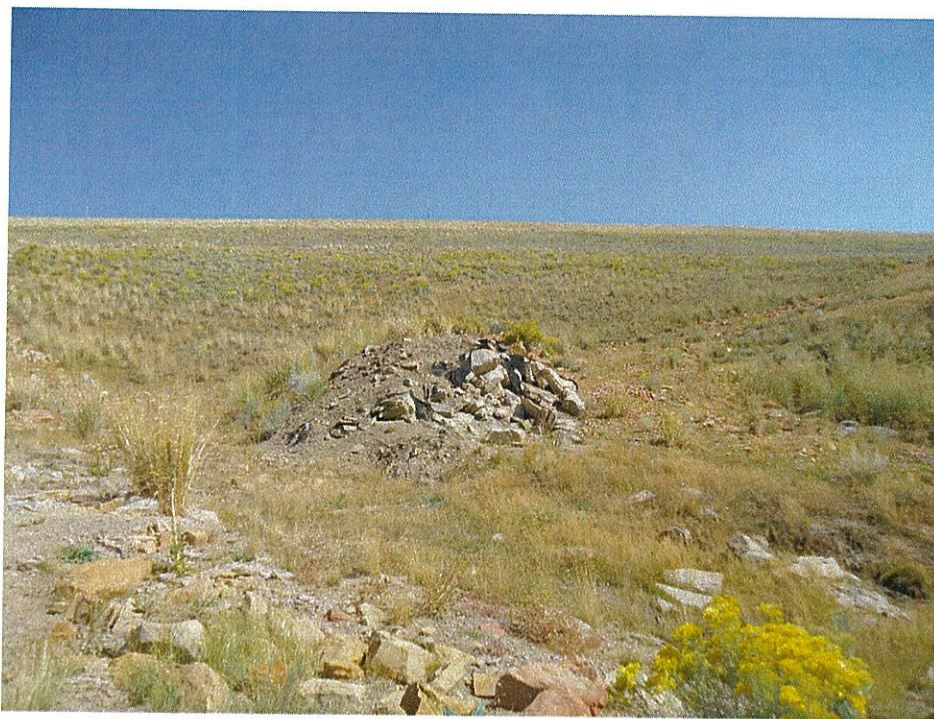
Photograph 6 depicts the west facing slope of the fill in the area where the slope of the fill is at 3H: 1V.

Photograph 6: West Side Fill 3H: 1V Face Looking East (9/24/2020)
