Re: King II Mine  
Pond Quarterly Inspection  
3rd Quarter 2020

Re: King Coal II - Annual Water Quality Improvements Inspection

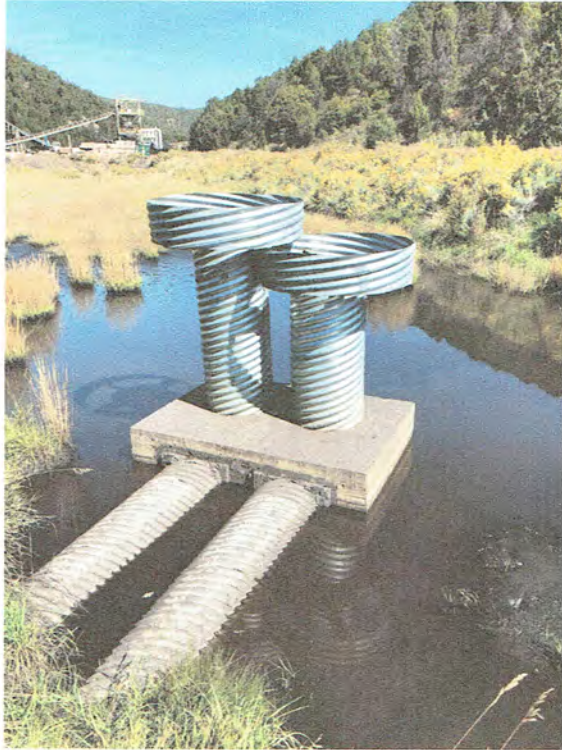
The vegetation both inside and out of the pond is well established to minimize the erosion impacts of storm runoff. The outlet structure shows no signs of damage and was functioning as designed at the time of the inspection (see Pic. 1). The water quality pond appears to be in generally good condition. There were no signs of weakness or distress to either the outlet structure or the embankment material though the vegetative cover made observation extremely difficult. The water quality pond has the storage capacity to function as designed.

Pic. 1 – Detention Pond outlet in good condition.

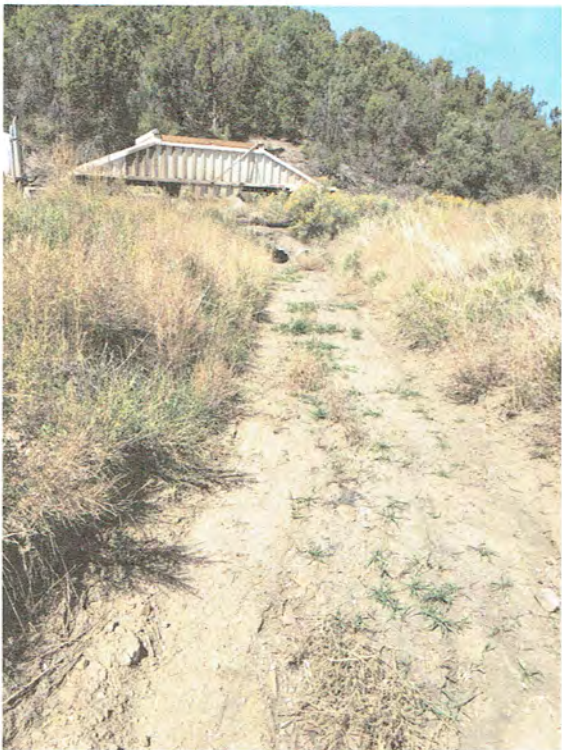
The east clear water ditch, the lower west clear water ditch (east of the driveway access) and the main drainage ditch (combined clear water ditches) had recently been maintained and were found to be in generally good condition and clean of debris (see Pic. 2 & 3). All ditches should be inspected and repaired as necessary, especially after storm events.

Pic. 2 – West clear water ditch downstream from driveway access.

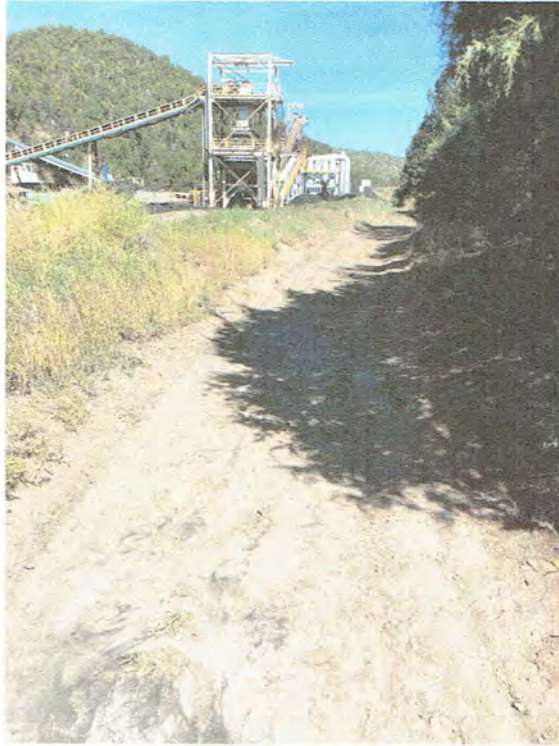
Pic. 3 East clean water ditch.

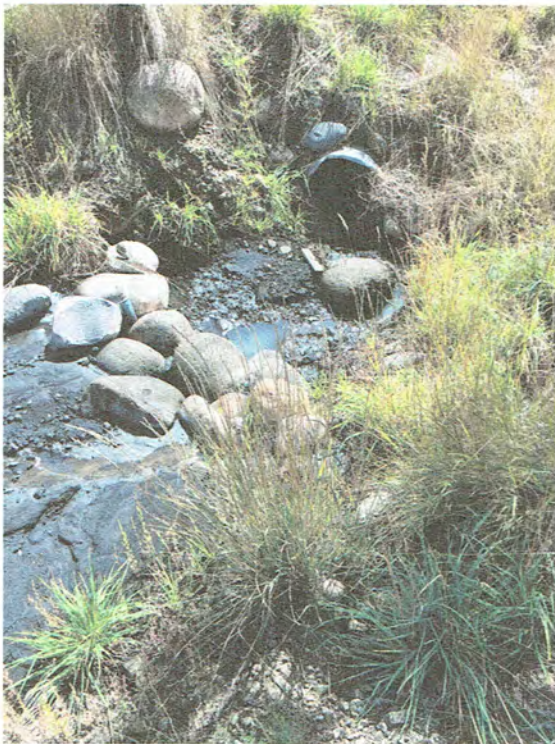
The culvert pipes on the site were in generally good condition overall (see Pic. 4). The culvert pipes should be monitored after storm events and cleaned out in the event that sedimentation occurs or debris buildup at the culvert inlets or outlets is observed.

Pic. 4 –Culvert below the scale house to detention pond.
