**MINERALS PROGRAM INSPECTION REPORT**  
**PHONE: (303) 866-3567**

<b>MINE NAME:</b> Climax Mine	<b>MINE/PROSPECTING ID#:</b> M-1977-493	<b>MINERAL:</b> Molybdenum	<b>COUNTY:</b> Lake, Summit
<b>INSPECTION TYPE:</b> Monitoring	<b>INSPECTOR(S):</b> Stephanie Mitchell	<b>INSP. DATE:</b> August 26, 2020	<b>INSP. TIME:</b> 11:00
<b>OPERATOR:</b> Climax Molybdenum Company	<b>OPERATOR REPRESENTATIVE:</b> Alex Ungers	<b>TYPE OF OPERATION:</b> 112d-3 - Designated Mining Operation	
<b>REASON FOR INSPECTION:</b> Normal I&E Program	<b>BOND CALCULATION TYPE:</b>	<b>BOND AMOUNT:</b> \$91,011,850.00	
<b>DATE OF COMPLAINT:</b> NA	<b>POST INSP. CONTACTS:</b> None	<b>JOINT INSP. AGENCY:</b> None	
<b>WEATHER:</b> Clear	<b>INSPECTOR'S SIGNATURE:</b>

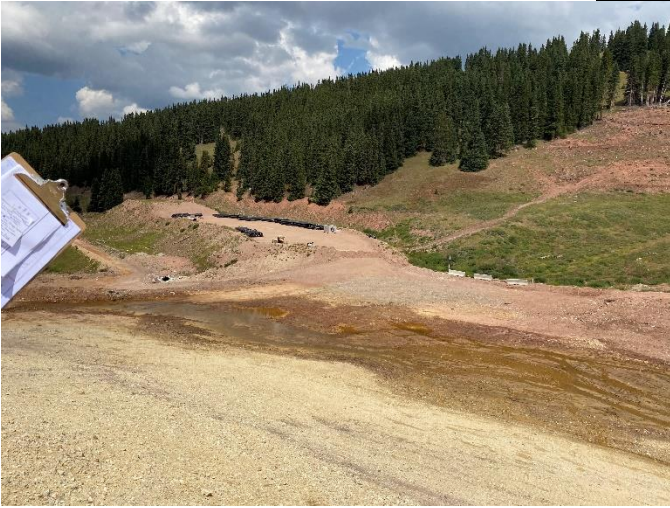
McNulty Underdrain Repair Area

Rip Rap was delivered, but no repairs were completed as of yet. Climax completed survey for underdrain pipe. Staff estimates that the repair will take 3 days to complete.

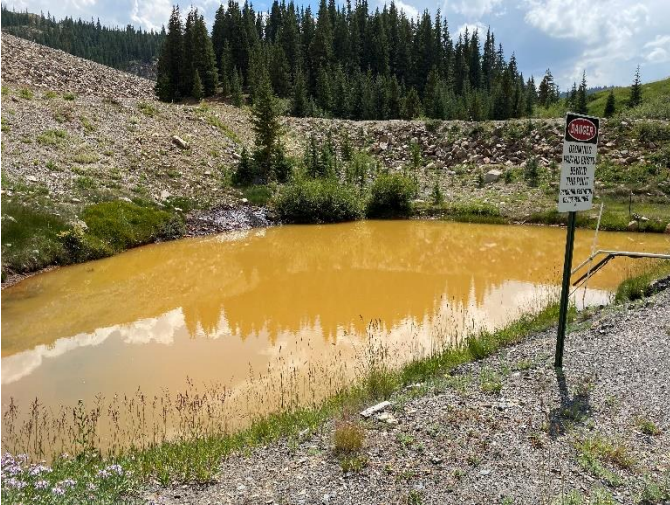
4 Dam Seepwater Pump System: This system appears to be working properly.

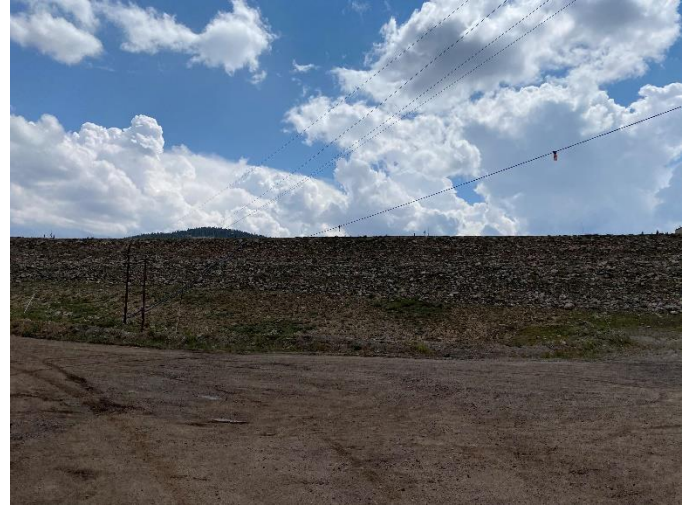
Robinson Dam

Robinson Lake and Dam: Multiple piezometers were noted near the top of dam.

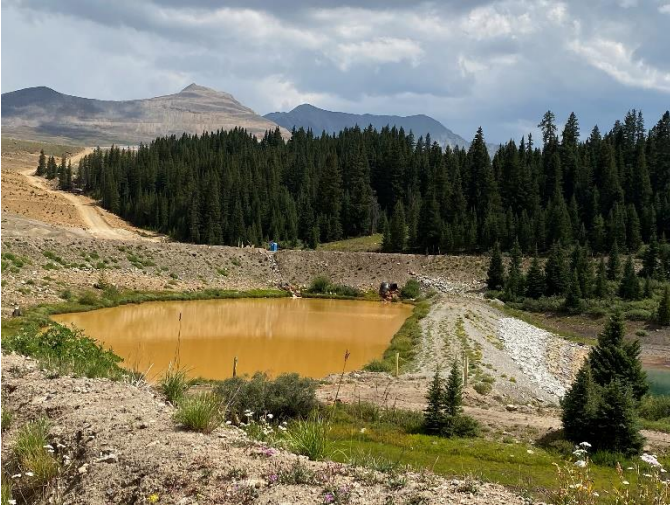
Tim's Pond- Collects 1 dam seep water and reports to Warrens
