**MINERALS PROGRAM INSPECTION REPORT**  
**PHONE: (303) 866-3567**

<b>MINE NAME:</b> Hasser Borrow Pit	<b>MINE/PROSPECTING ID#:</b> M-2019-015	<b>MINERAL:</b> Borrow material for construction	<b>COUNTY:</b> Prowers
<b>INSPECTION TYPE:</b> Monitoring	<b>INSPECTOR(S):</b> Amy Eschberger	<b>INSP. DATE:</b> September 17, 2020	<b>INSP. TIME:</b> 11:30
<b>OPERATOR:</b> Castle Rock Construction Company of Colorado, LLC	<b>OPERATOR REPRESENTATIVE:</b> Darren Janssen	<b>TYPE OF OPERATION:</b> 111 - Construction by Government Agency

## **OBSERVATIONS**

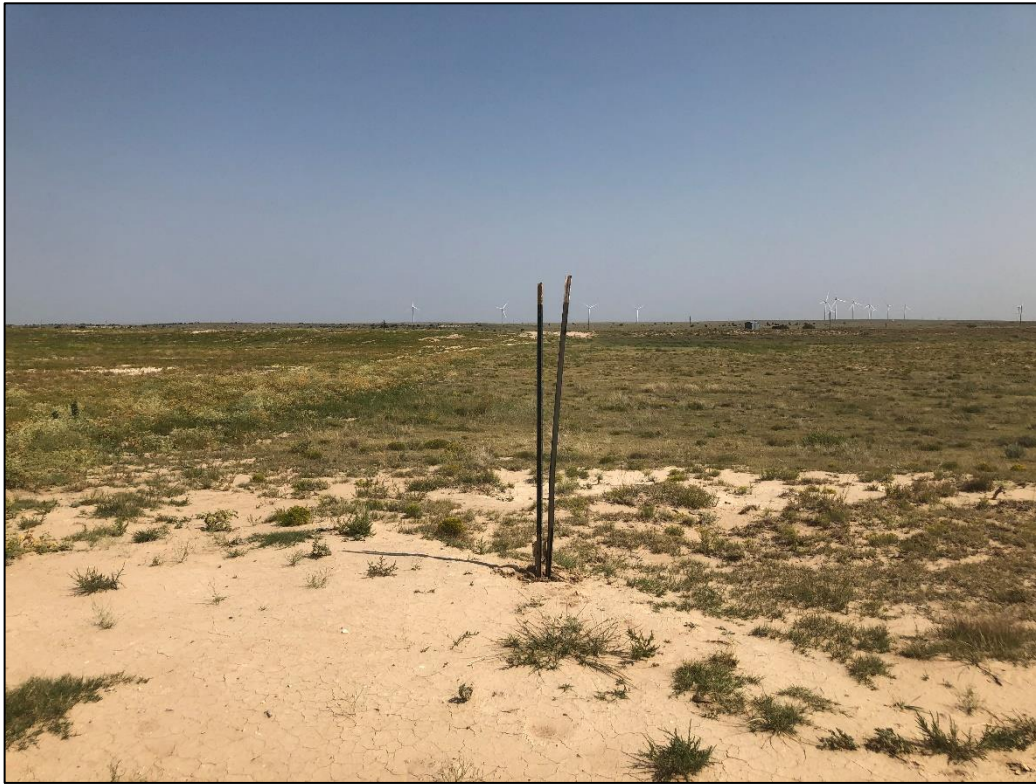
**Photo 1.** View looking east from access road, showing T-posts marking southwestern corner of permit boundary.

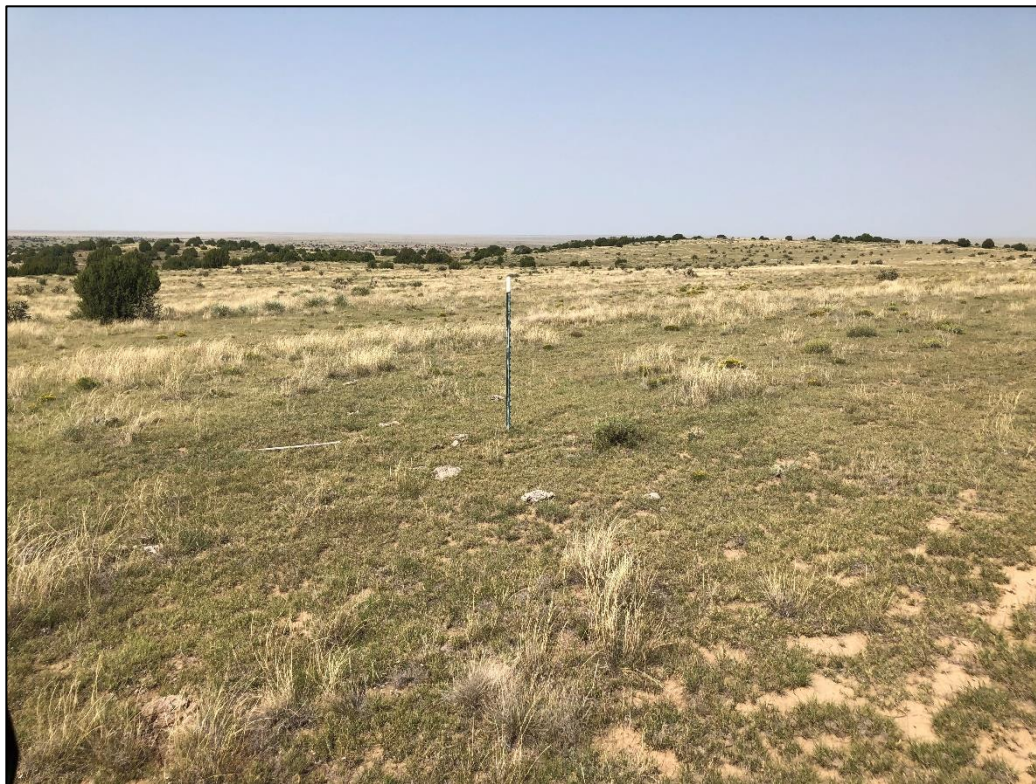
**Photo 2.** View looking west from access road, showing T-post marking northwestern corner of permit boundary.

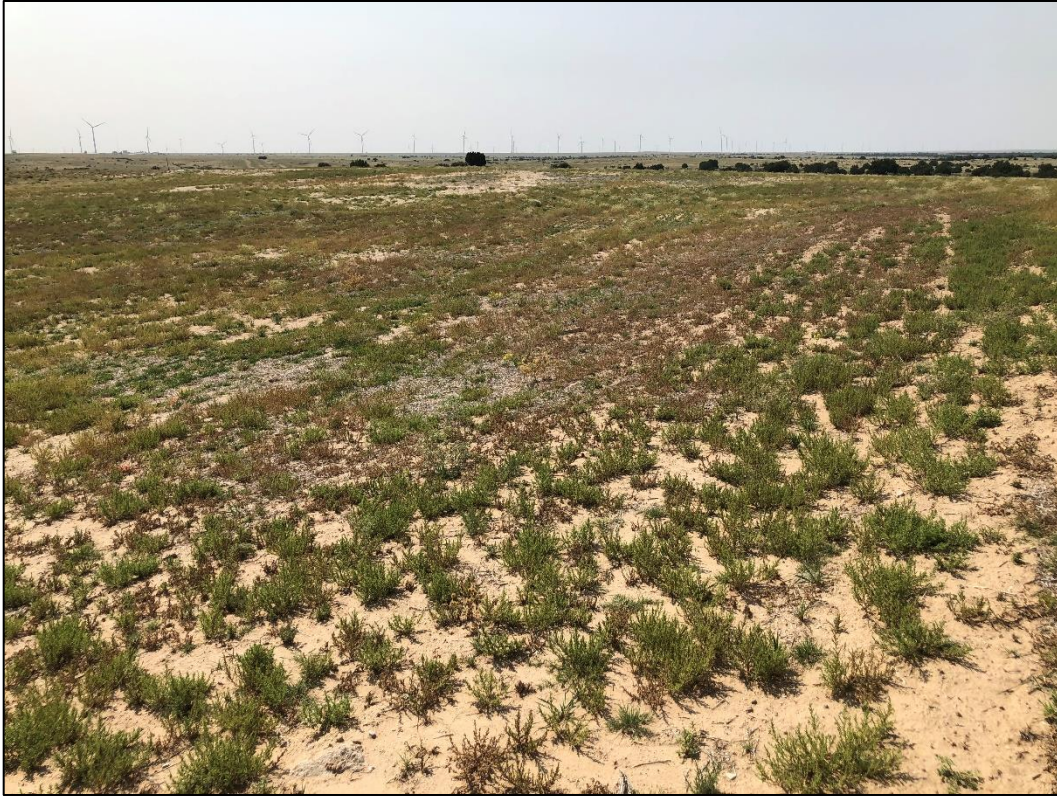
The Division observed some grasses growing in the seeded area. However, the vegetative cover at this time consists primarily of weeds (e.g., kochia, curlycup gumweed, wild sunflowers). The vegetative cover was more sparse in some areas, particularly along the top edges of the pit slopes. The Division recommends the operator continue to monitor revegetation success in seeded areas and reseed the site as needed. Additionally, the operator will need to implement the weed control plan for the site to prevent nuisance weeds from hindering the growth of desired vegetation. The operator currently has plans to reseed the site next spring if needed.

**Photo 3.** View looking southwest across northwestern portion of pit in reclamation, showing slopes graded 4H:1V or flatter and vegetative cover consisting of some grasses but primarily of weeds (e.g., kochia, curlycup gumweed, wild sunflowers).

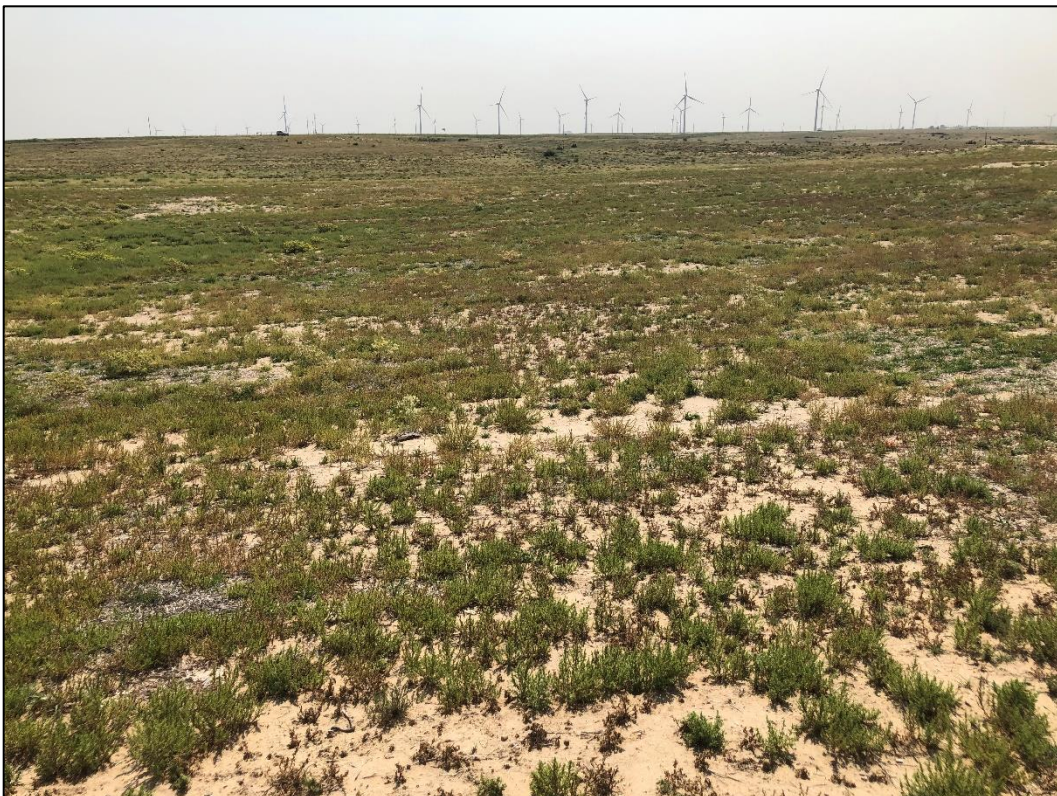
**Photo 4.** View looking southeast across pit floor in reclamation, showing vegetative cover consisting of some grasses but primarily of weeds (e.g., kochia, curlycup gumweed, wild sunflowers).

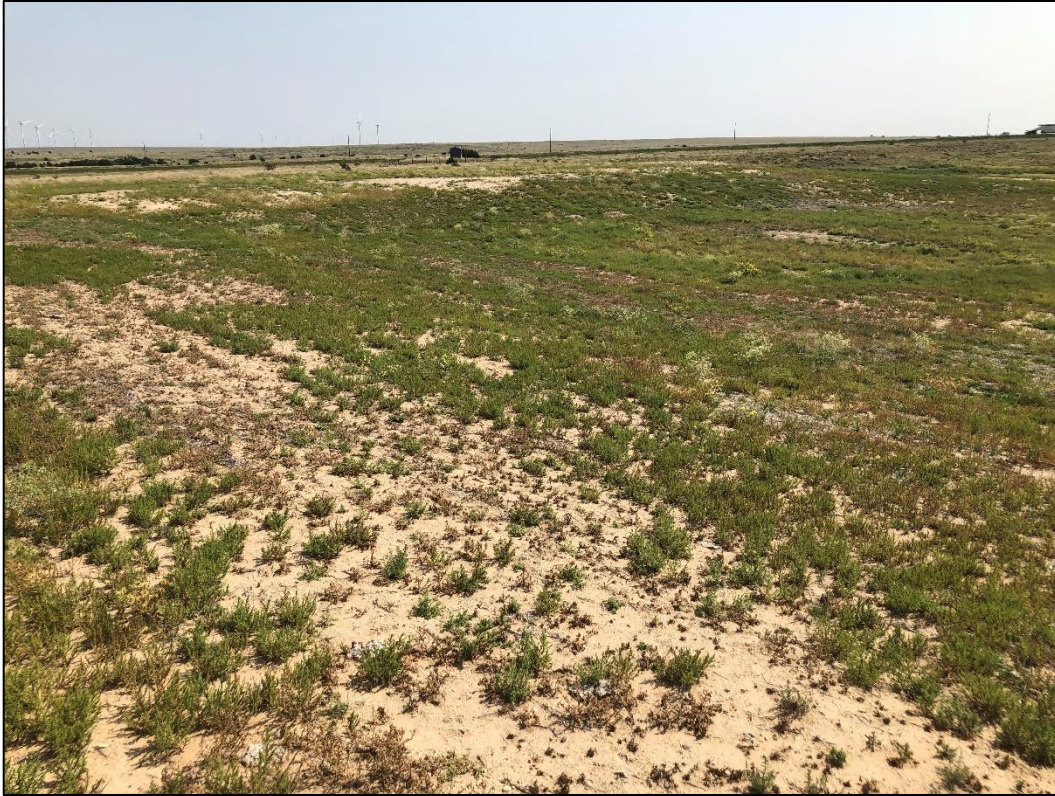
**Photo 5.** View looking east across northeastern portion of pit in reclamation, showing slopes graded 4H:1V or flatter and vegetative cover consisting of some grasses but primarily of weeds (e.g., kochia, curlycup gumweed, wild sunflowers). Note vegetative cover more sparse along top of pit slope.

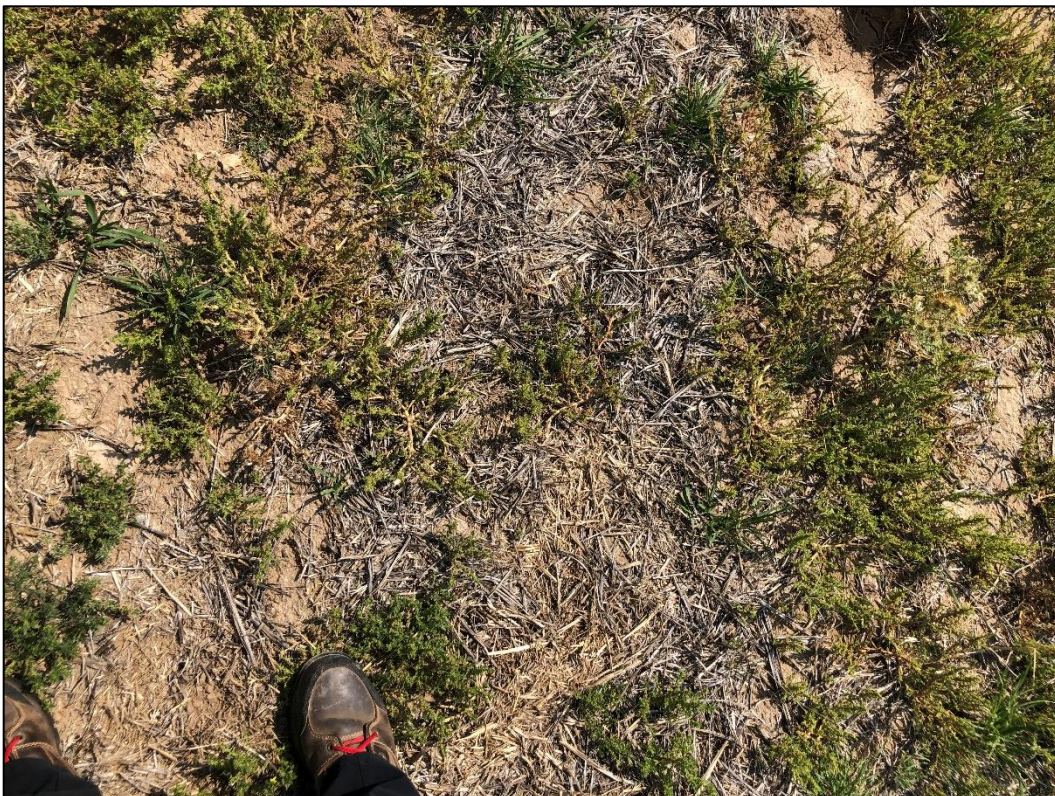
**Photo 6.** Ground view of area in reclamation, showing vegetative cover consisting of some grasses but primarily weeds (mainly kochia in this photo). Note straw mulch that remains from initial seeding completed in Fall of 2019.

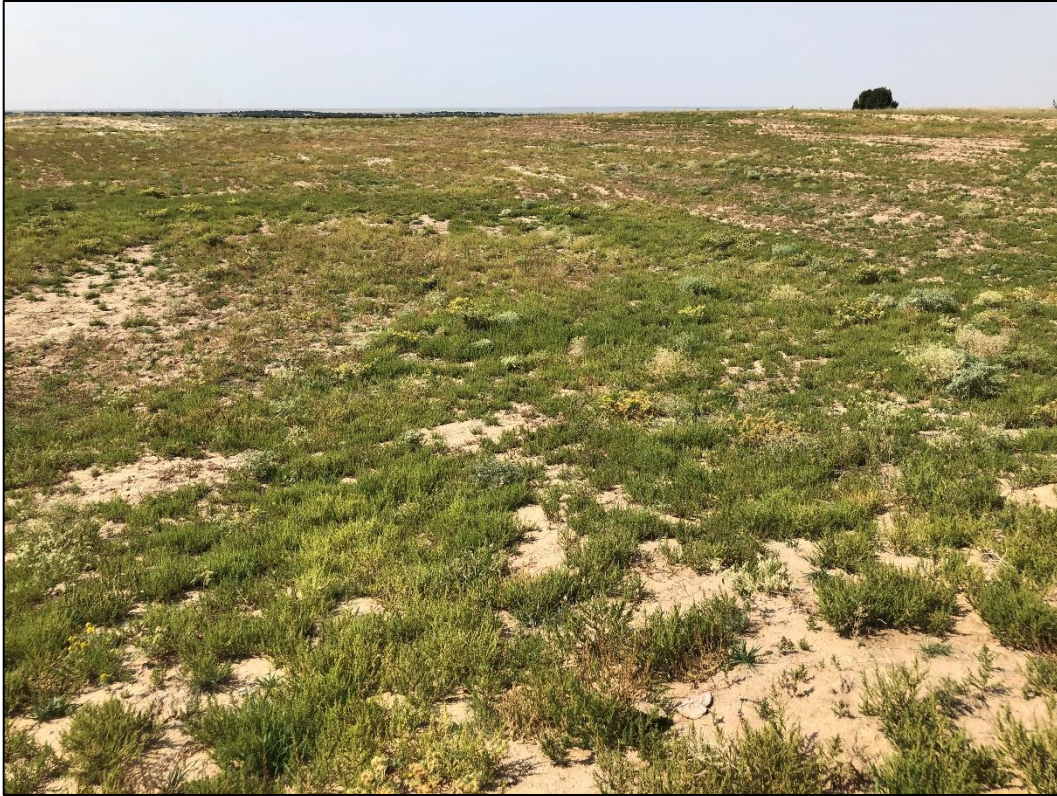
**Photo 7.** View looking west across northern half of pit in reclamation, showing slopes graded 4H:1V or flatter and vegetative cover consisting of some grasses but primarily of weeds (e.g., kochia, curlycup gumweed, wild sunflowers).

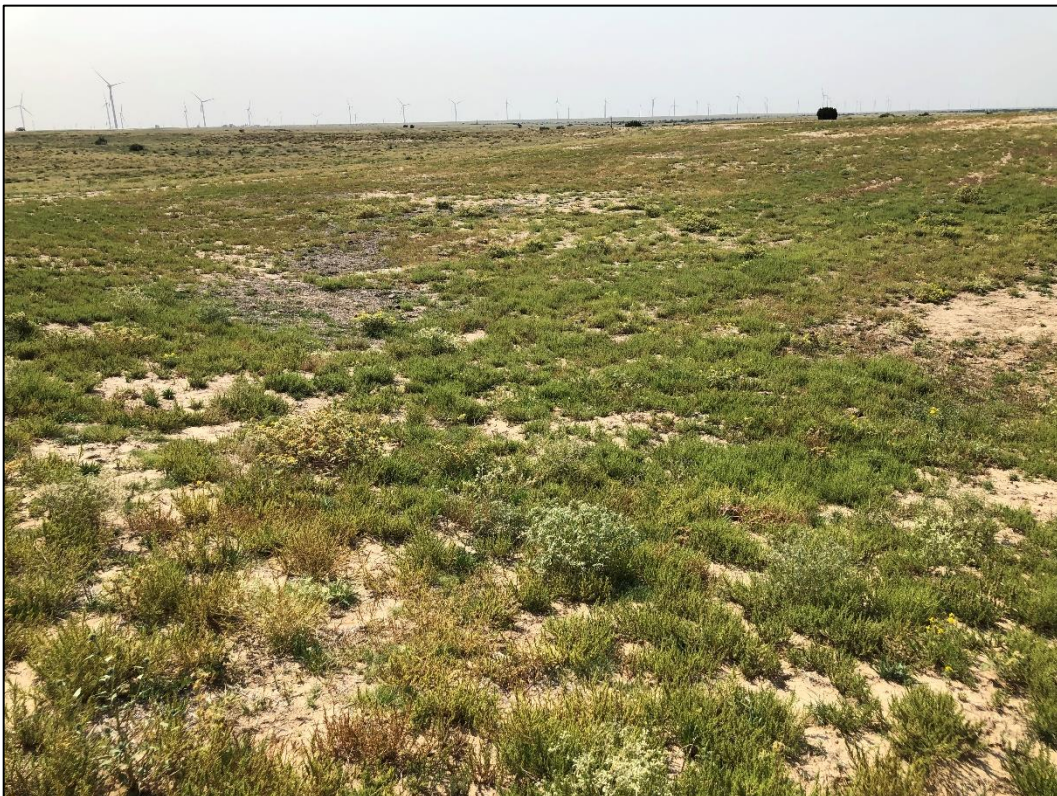
**Photo 8.** View looking south across southern half of pit in reclamation, showing slopes graded 4H:1V or flatter and vegetative cover consisting of some grasses but primarily of weeds (e.g., kochia, curlycup gumweed, wild sunflowers).

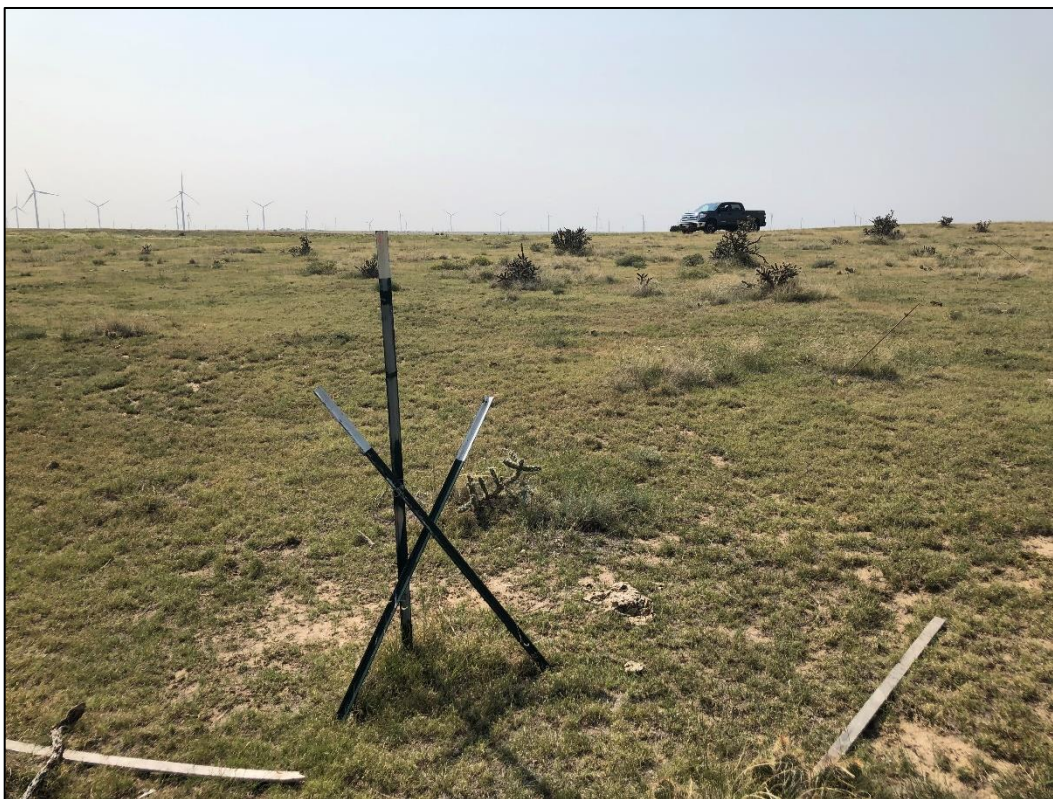
**Photo 9.** View looking southeast, showing T-posts marking northeastern corner of permit boundary.

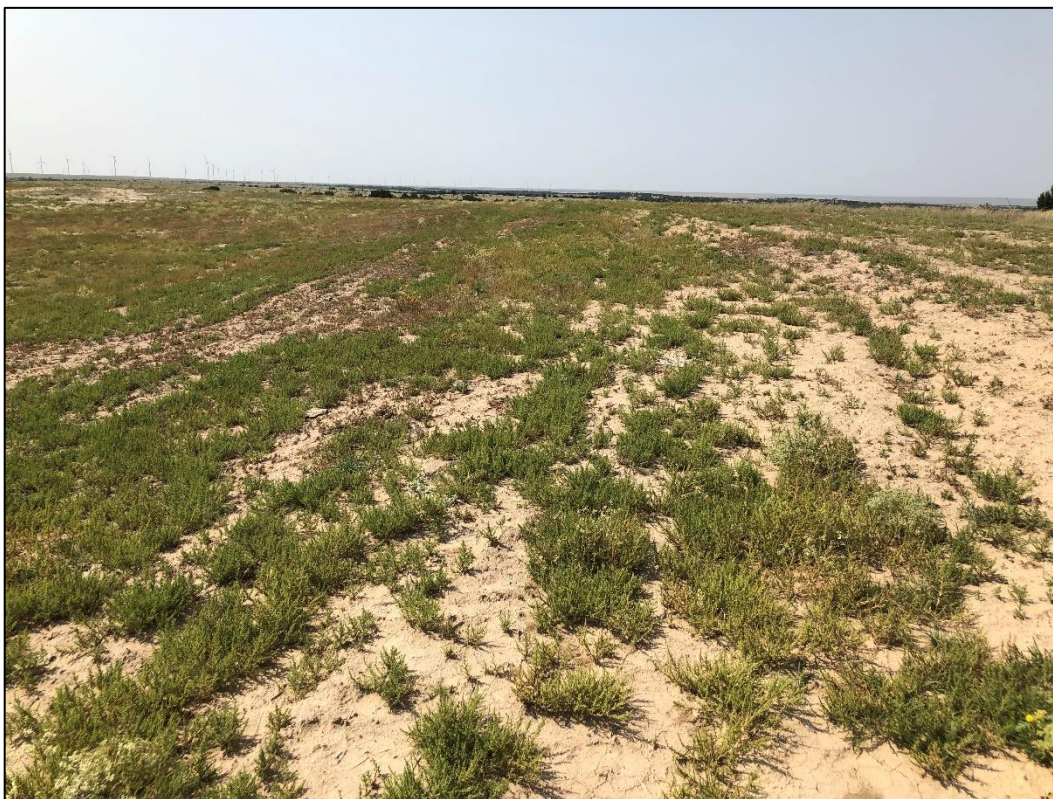
**Photo 10.** View looking northwest across eastern slope of pit in reclamation, showing slopes graded 4H:1V or flatter and vegetative cover consisting of some grasses but primarily of weeds (e.g., kochia, curlycup gumweed, wild sunflowers). Note vegetative cover more sparse along top of pit slope.

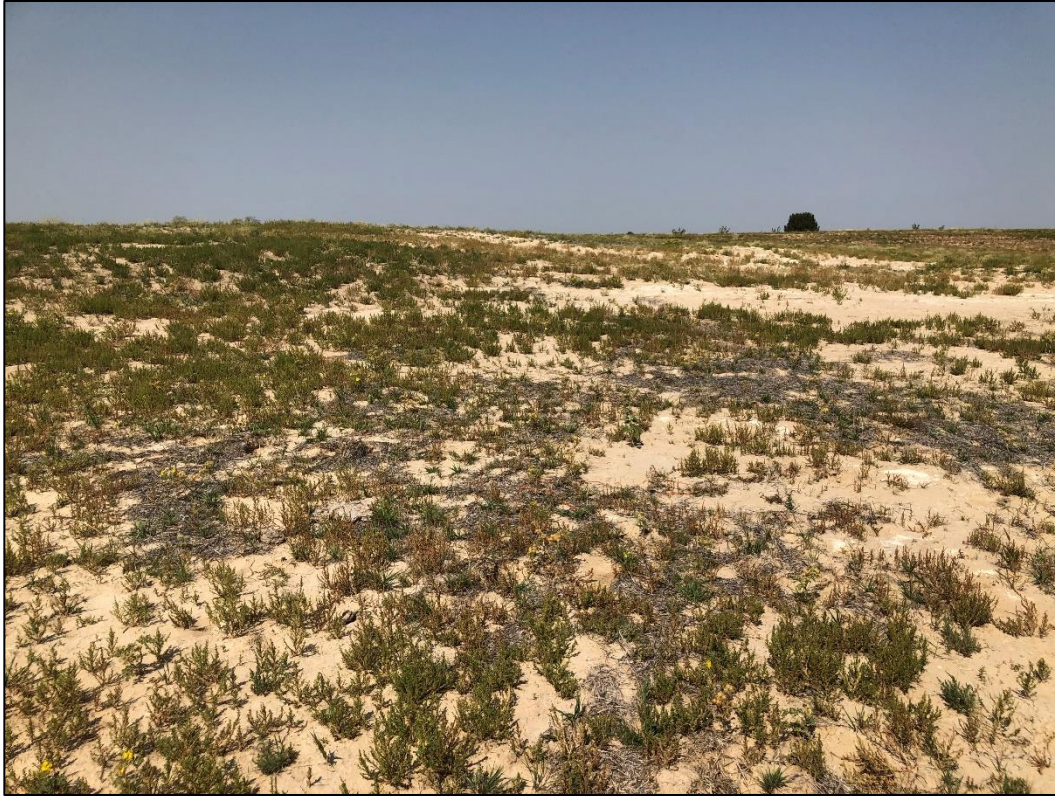
**Photo 11.** View looking west across southern edge of pit in reclamation, showing vegetative cover consisting of some grasses but primarily of weeds (e.g., kochia, curlycup gumweed, wild sunflowers).

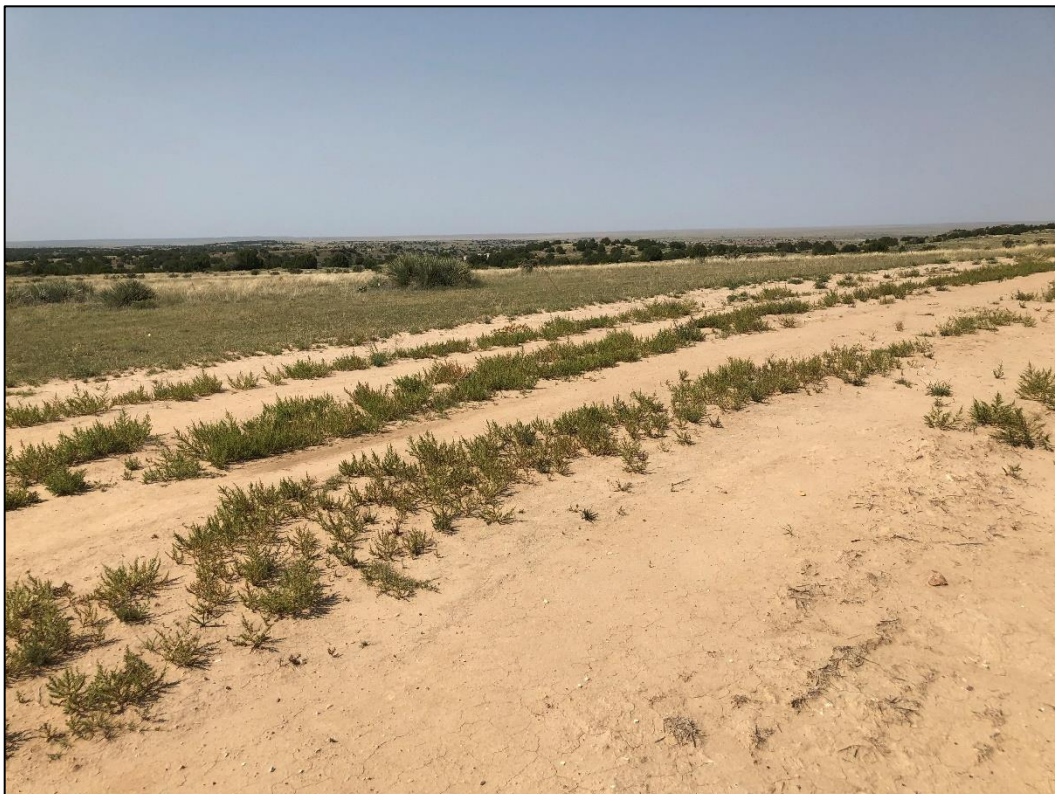
**Photo 12.** View looking west, showing existing ranch road that will remain after reclamation.
