**COLORADO**  
Division of Reclamation,  
Mining and Safety  
Department of Natural Resources

**PERMIT INFORMATION**

<b>Permit Number:</b> C-1981-019 <b>Mine Name:</b> Colowyo Coal Mine <b>Operator:</b> Colowyo Coal Company L.P. <b>Operator Address:</b> Mr Tony Tennyson 5731 State Highway 13 Meeker, CO 81641	<b>County:</b> Moffat, Rio Blanco <b>Operation Type:</b> Surface <b>Permit Status:</b> Active <b>Ownership:</b> Private
	<b>Operator Representative Present:</b>  None
<b>Operator Representative Signature: (Field Issuance Only)</b>

<b>Inspection Start Date:</b> October 1, 2020 <b>Inspection Start Time:</b> 11:00 <b>Inspection End Date:</b> October 1, 2020 <b>Inspection End Time:</b> 11:10		<b>Inspection Type:</b> Aerial Inspection <b>Inspection Reason:</b> Normal I&E Program <b>Weather:</b> Clear	
<b>Joint Inspection Agency:</b>  None		<b>Joint Inspection Contacts:</b>  None	
<b>Post Inspection Agency:</b>  None		<b>Post Inspection Contacts:</b>  None	
<b>Inspector(s):</b>  Zach Trujillo  Brock Bowles	<b>Inspector's Signature:</b>

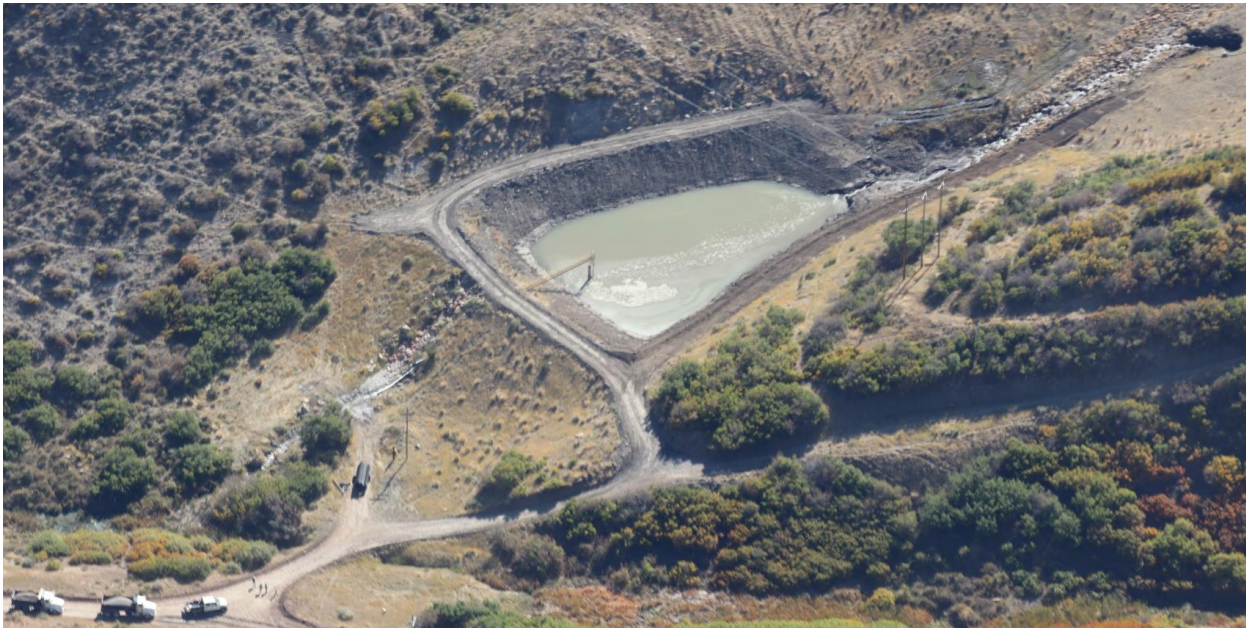
West/East/South Taylor Pit Ponds: Section 16, Prospect, Streeter, West Taylor, and East Taylor Ponds were inspected. These ponds held water but it is undeterminable on whether discharge was occurring. It appears that construction on the East Taylor french drain was beginning during the inspection. West Pit pond was also inspected and was dry. No issues were observed with any sediment pond associated with the West/East/South Taylor Pit ponds.

French drain construction.

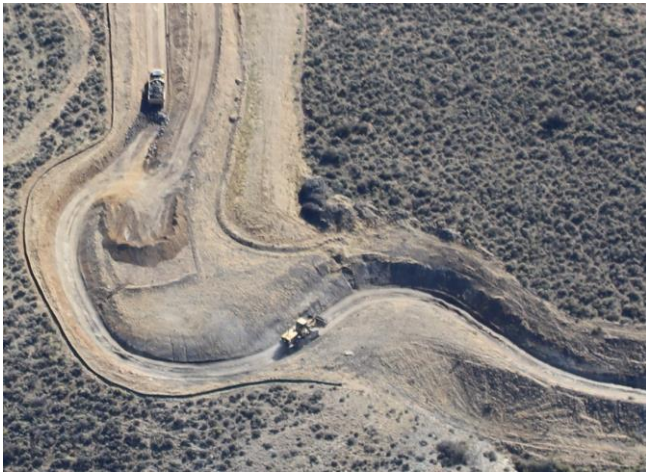
The Collom Pile Collector Ditches were also inspected. The ditches included D-1, 2, 3, 4, 5 and 6. Each ditch appeared stable with no issues observed. Rip rap placement was observed to be occurring in ditch D-2.

Rip rap placement in ditch D-2.

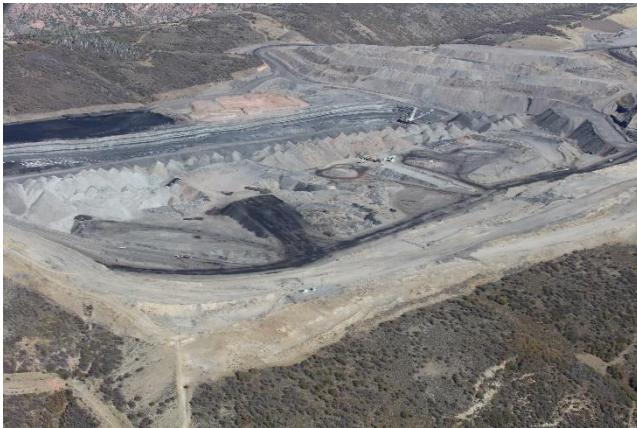
Mining operations continue as approved within the South Taylor and Collom Pits.

South Taylor Pit.

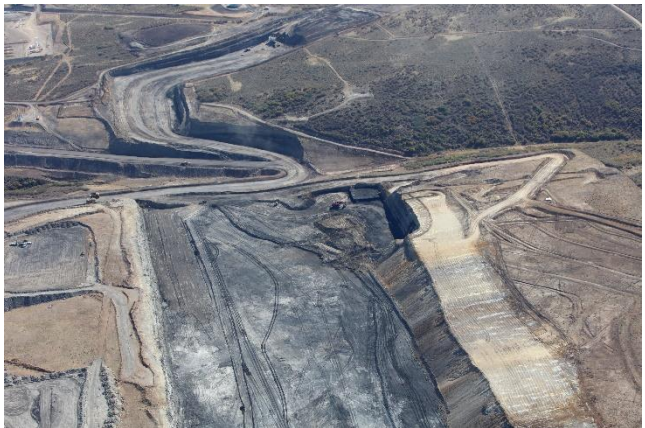
Collom Pit.

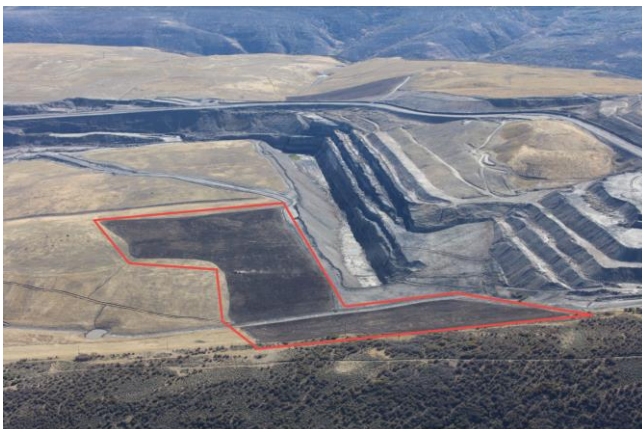
It appears top soiling has occurred along the southern end of the West Pit 2020 reclamation parcels. It also appears that additional top soiling has occurred along the northern end of the East Pit.

Top soiling in the West Pit.

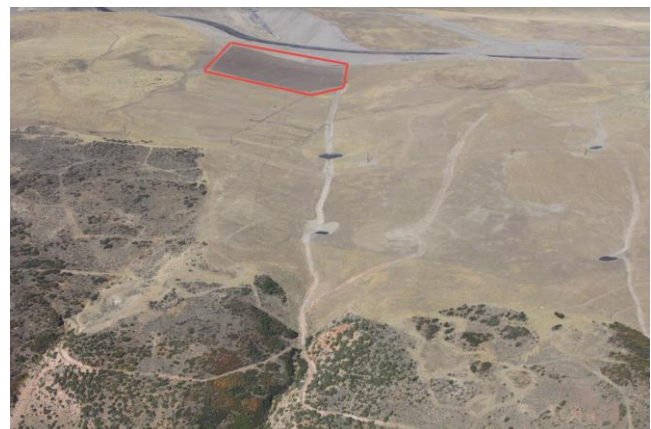
Potential re-top soiling in the East Pit.
