MINERALS PROGRAM INSPECTION REPORT
PHONE: (303) 866-3567

MINE NAME: Keenesburg Project	MINE/PROSPECTING ID#: M-2019-027	MINERAL: Sand	COUNTY: Weld
INSPECTION TYPE: Monitoring	INSPECTOR(S): Peter Hays	INSP. DATE: October 7, 2020	INSP. TIME: 10:00
OPERATOR: Colorado Sand Company LLC	OPERATOR REPRESENTATIVE: Jim Beck	TYPE OF OPERATION: 110c - Construction Limited Impact	
REASON FOR INSPECTION: Normal I&E Program	BOND CALCULATION TYPE: Partial Bond	BOND AMOUNT: \$291,546.90	
DATE OF COMPLAINT: NA	POST INSP. CONTACTS: None	JOINT INSP. AGENCY: None	
WEATHER: Clear	INSPECTOR'S SIGNATURE:

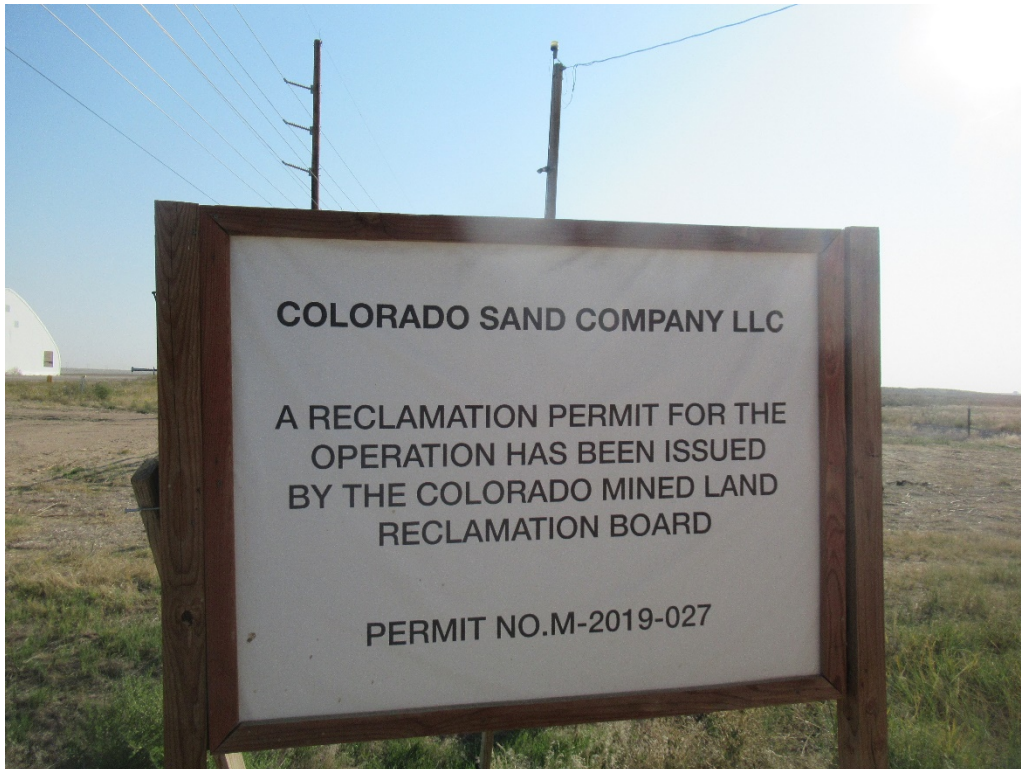
The portions of the site disturbed by the mining operation will be revegetated with a rangeland seed mixture, except for the area surrounding the West Product Stockpile Building. The site will be fenced to prevent cattle grazing for 5 years to allow the establishment of the reclamation grasses. The mine sign and boundary markers delineated by fence and the ranch road were observed as required by Rule 3.1.12.

Keenesburg Project mine sign

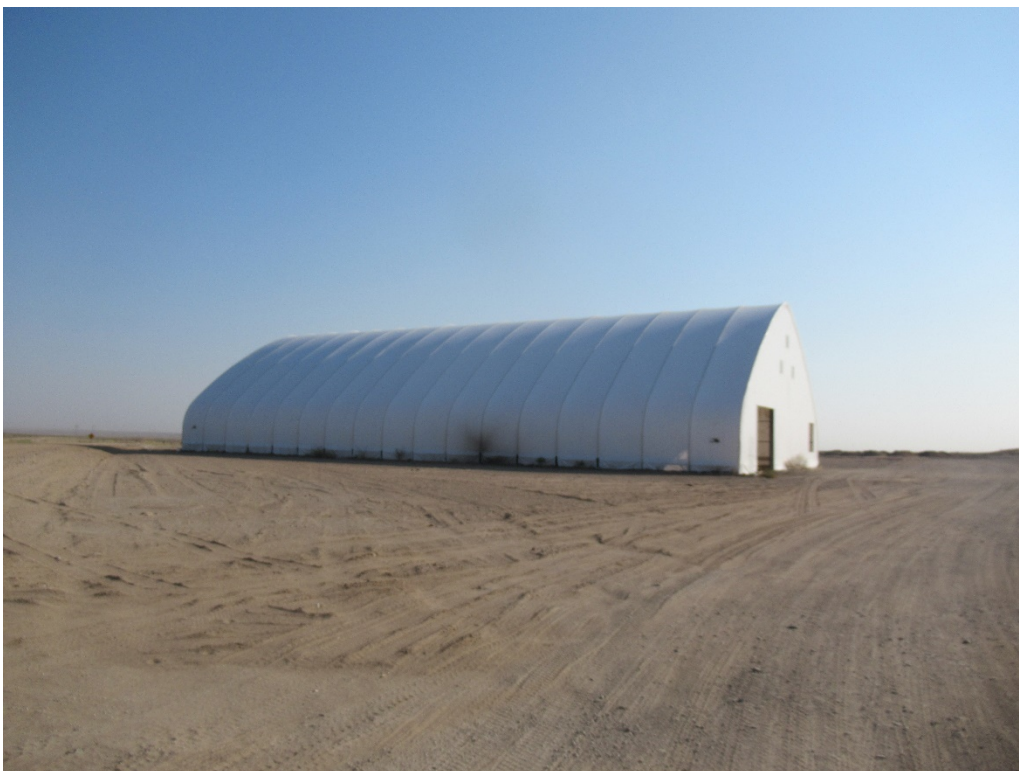
The Operator submitted the technical revision request (TR-01) on September 28, 2020. The Division is required by Rule 1.9 to act on a technical revision within 30 days after being filed with the Division. The technical revision proposes for the West Product Storage Building and immediate surroundings to remain following final reclamation. The Operator included a letter from Guttersen Ranches signed by Shawn Guttersen acknowledging and requesting the revision to the approved Reclamation Plan. The building consists of internal metal trusses covered by a canvas to form the structure. The foundation for the trusses appears to be driven piles. The trusses are bolted to the piles on each end of the truss. The building appeared in good condition and appropriate to remain after final reclamation for use by the landowner.

View of the West Product Building from the southwest permit boundary looking northeast

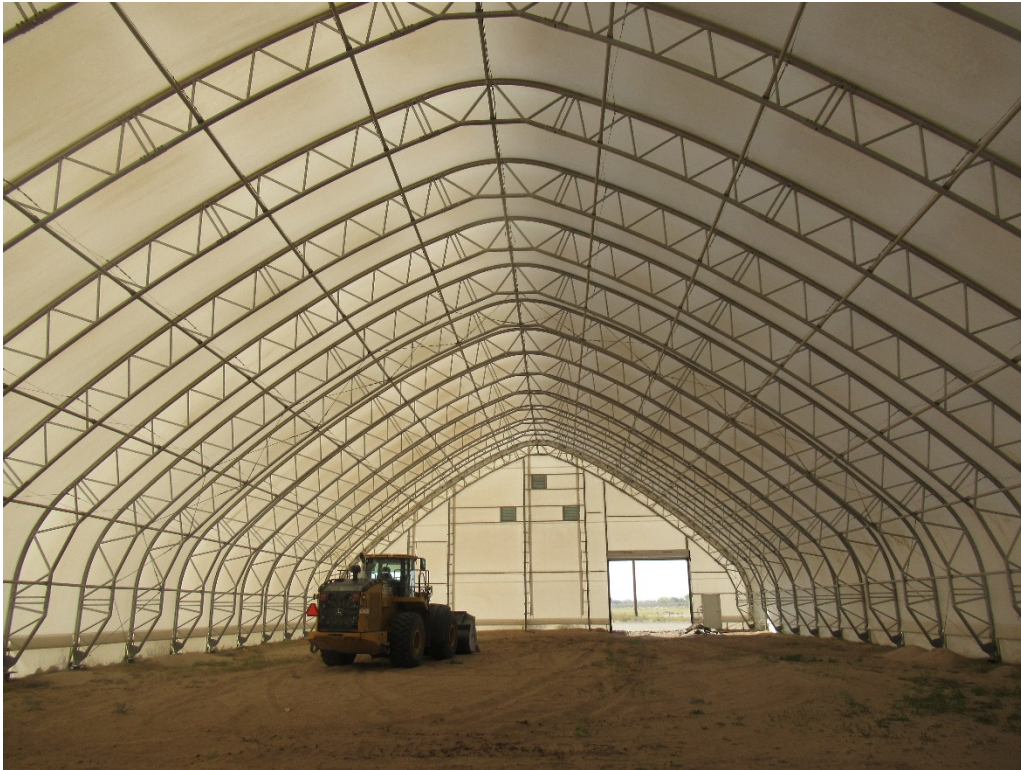
View of the inside of the West Product Building from the north end looking south

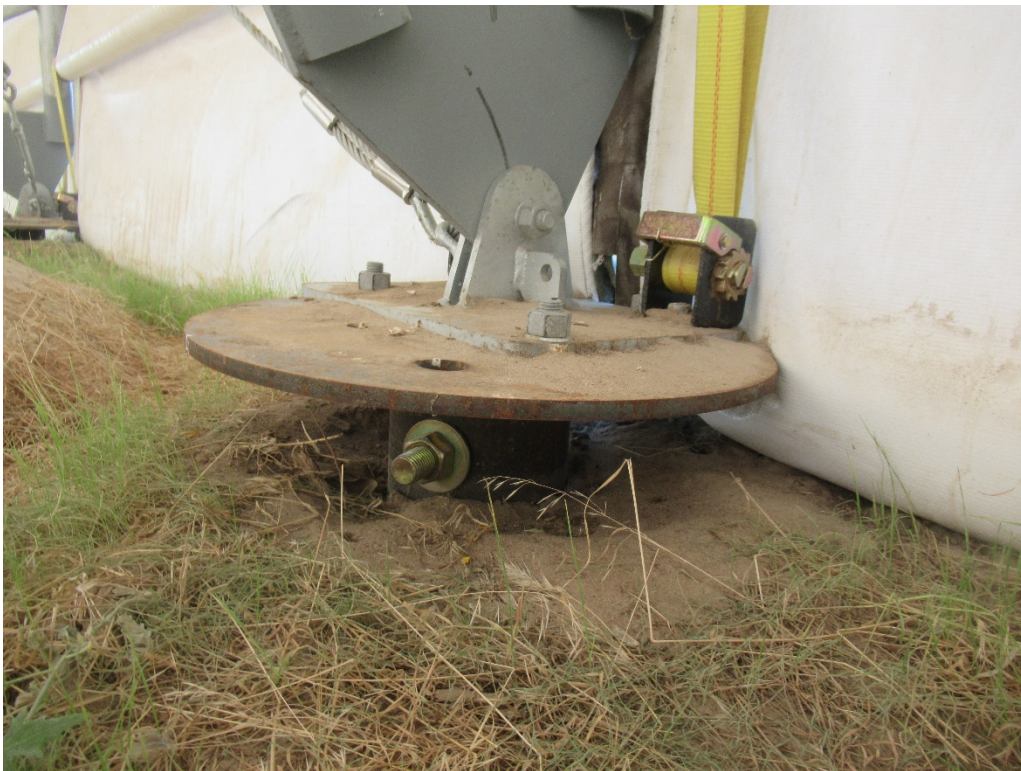
View of typical metal truss foundation

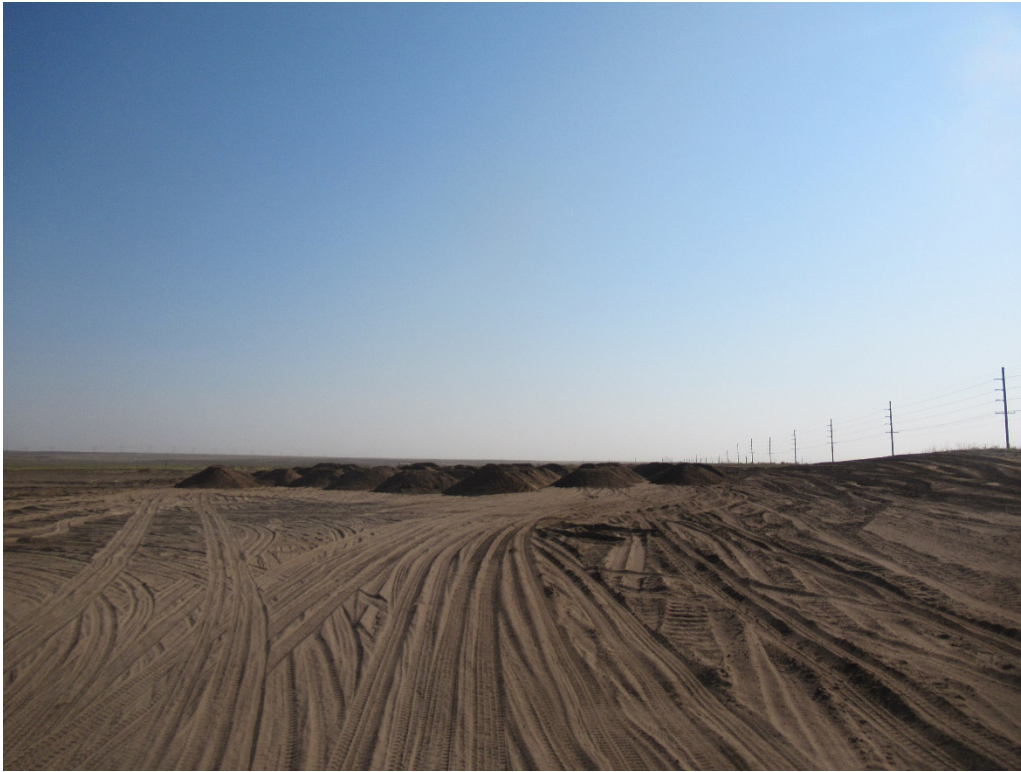
The approved post-mining land use is rangeland, which was the land use prior to the mining operation. The approved Reclamation Plan states the upper 12 inches of topsoil will be stripped and salvaged for reclamation. Topsoil stockpiles were observed west of the Main Mine Pit. The topsoil will be replaced at a depth of 8 to 12 inches during reclamation. The process plant and the East Product Storage Building have been removed from the site. The fines recovery pit has been backfilled completely. The final main mine pit is approximately half of the planned pit size consisting of only the eastern portion of the proposed final excavation. The main mine pit was rough graded to an estimated 3H:1V slope. The pit was estimated at 15 to 20 feet in depth. No groundwater was observed in the main mine pit. During the inspection, a dozer was mobilized to the site presumably to complete the final grading and topsoil placement at the site. The perimeter road has been ripped and rough graded to match the surrounding topography.

View of the topsoil stockpile located west of the main mine pit

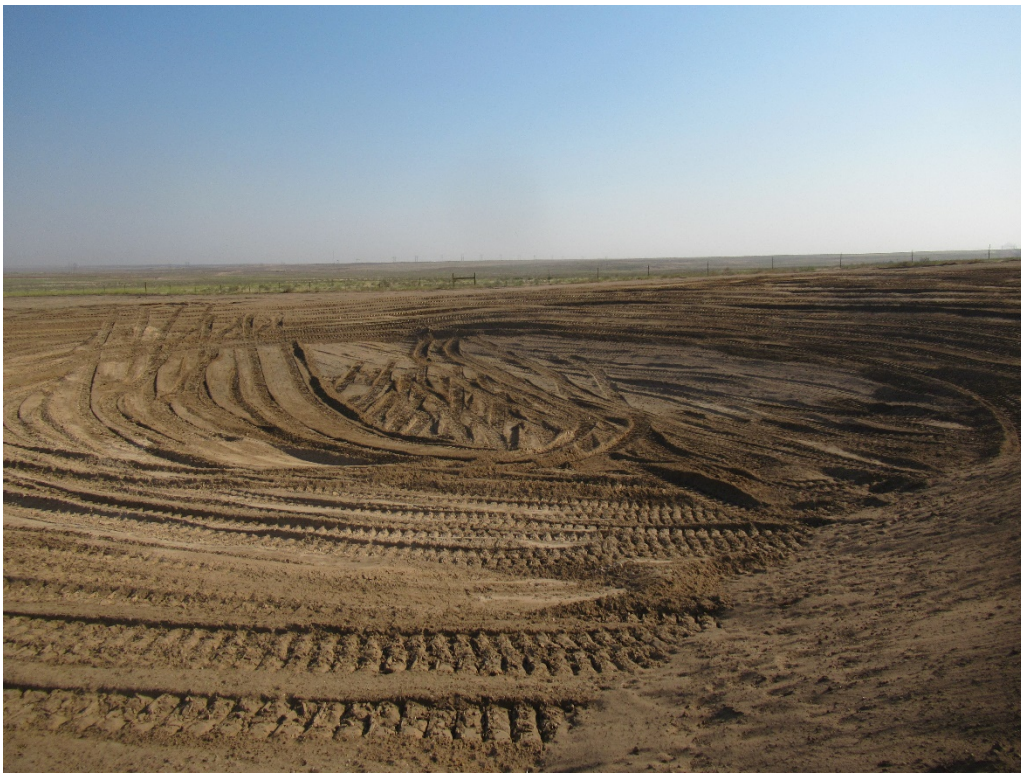
View of the rough graded main mine pit

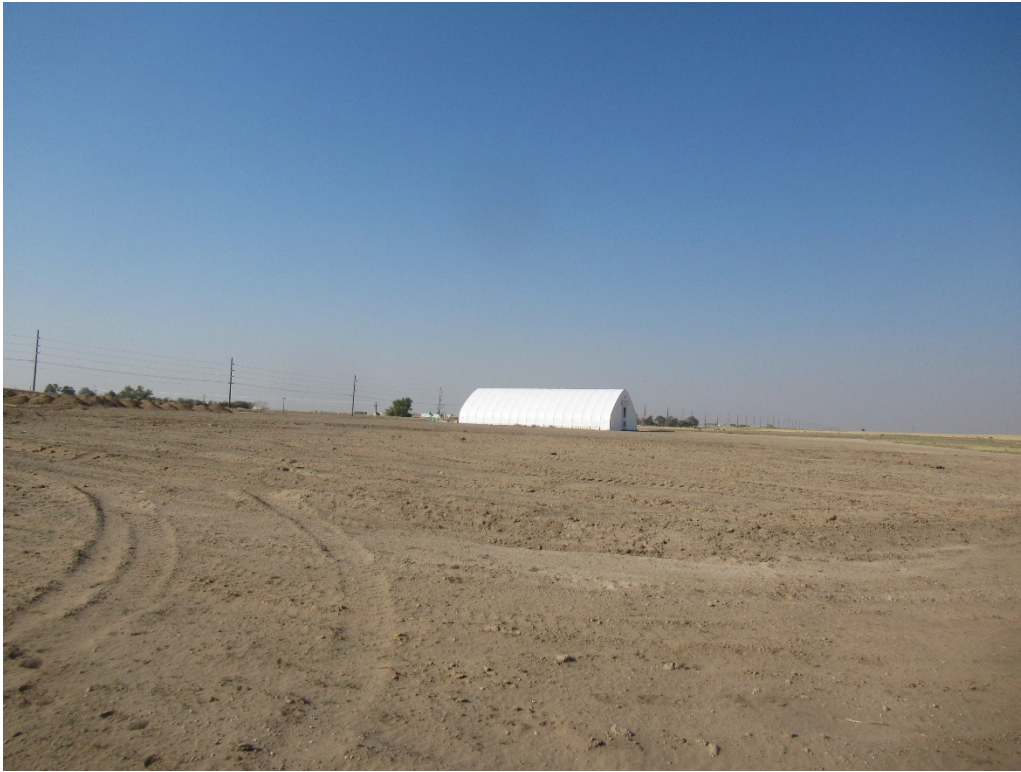
View of the site from the northeast corner looking southwest
