MINERALS PROGRAM INSPECTION REPORT
PHONE: (303) 866-3567

MINE NAME: Lord Reservoir	MINE/PROSPECTING ID#: M-2019-056	MINERAL: Borrow materials	COUNTY: Weld
INSPECTION TYPE: Surety Release Inspection	INSPECTOR(S): Peter Hays	INSP. DATE: October 7, 2020	INSP. TIME: 11:00
OPERATOR: H-2 Enterprises, LLC	OPERATOR REPRESENTATIVE: Lance Miller	TYPE OF OPERATION: 111(1)(b) - Special One-Time Incidental	
REASON FOR INSPECTION: Surety Release Requested	BOND CALCULATION TYPE: None	BOND AMOUNT: \$50,000.00	
DATE OF COMPLAINT: NA	POST INSP. CONTACTS: None	JOINT INSP. AGENCY: None	
WEATHER: Clear	INSPECTOR'S SIGNATURE:

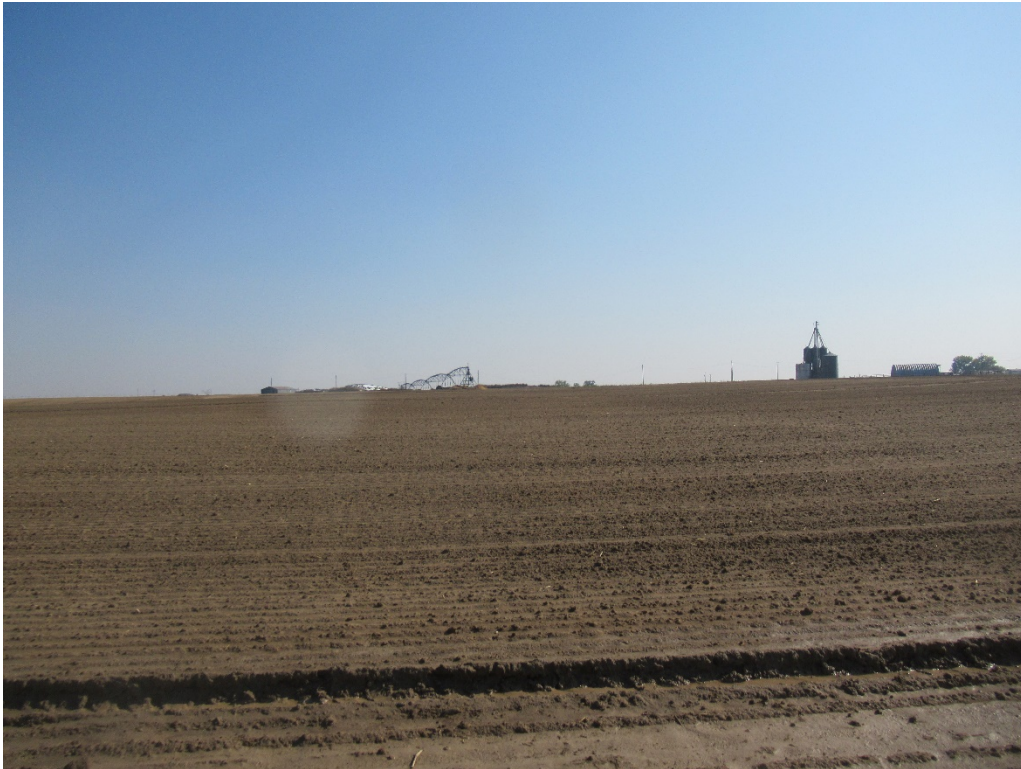
View of the center pivot sprinkler from the west side of the site looking east

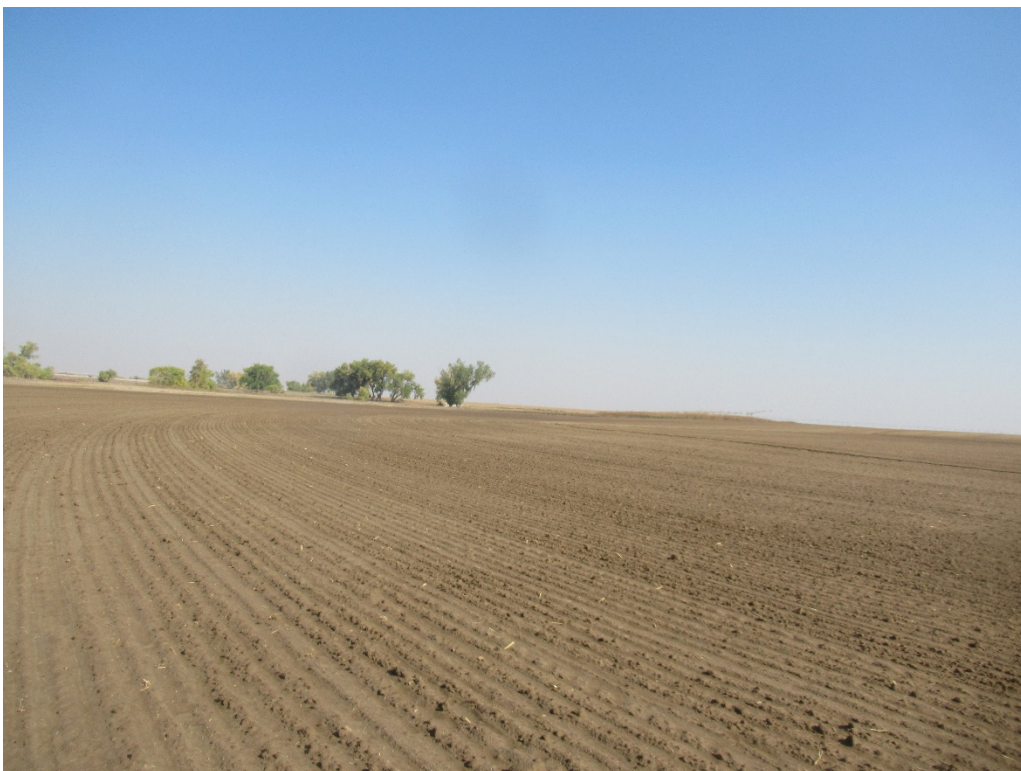
The site was seeded with the approved reclamation dryland quick establishment seed mixture 20 days before the inspection. Juvenile western wheatgrass was observed in the pivot crop rows. The area was previously vegetated with alfalfa hay. The hay was bailed and stack in the southwest corner of the site. Overall, the site was stable and consistent with the approved Reclamation Plan and the post-mining land use of cropland.

View of the site from the southeast corner looking northwest

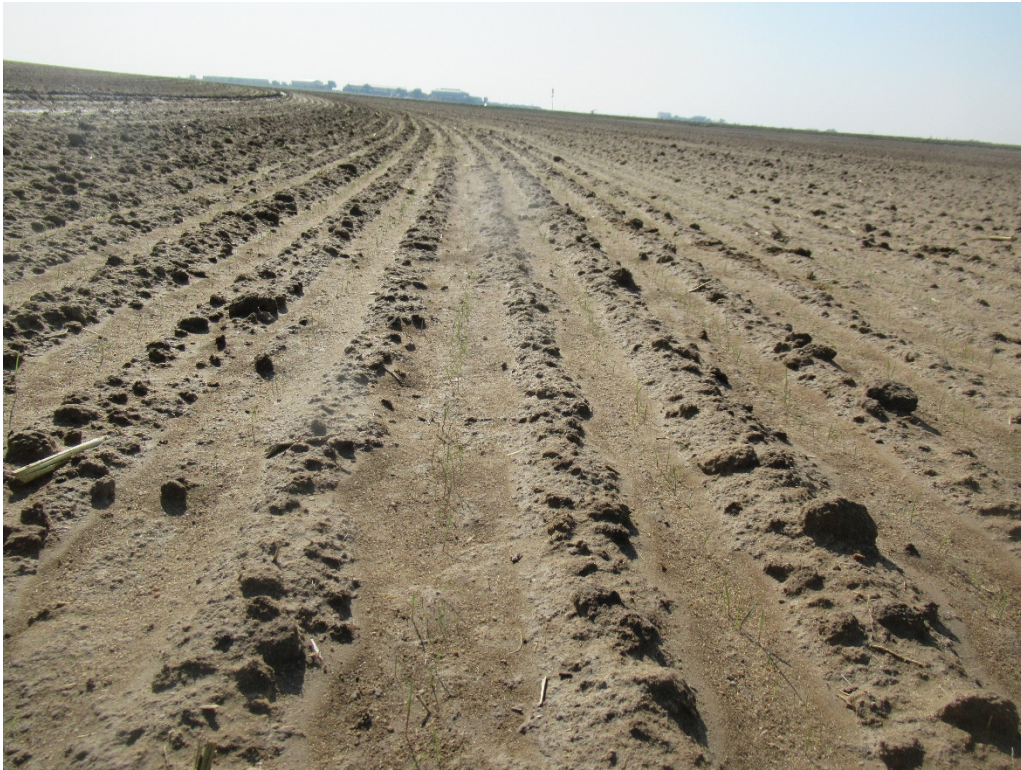
View of the western wheatgrass in the crop rows

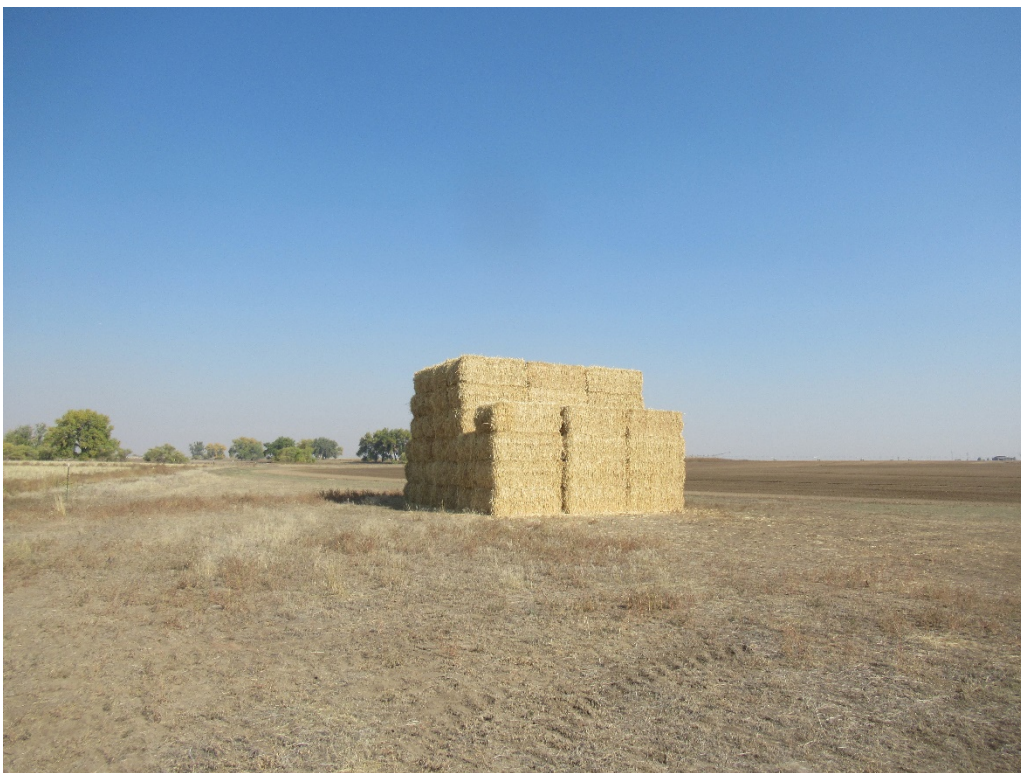
View of the stacked hay bales grown at the site
