MINERALS PROGRAM INSPECTION REPORT
PHONE: (303) 866-3567

MINE NAME: Native/Pierre Mine	MINE/PROSPECTING ID#: M-1977-321	MINERAL: Clay (general)	COUNTY: Pueblo
INSPECTION TYPE: Preoperation Inspection	INSPECTOR(S): Patrick Lennberg	INSP. DATE: September 24, 2020	INSP. TIME: 14:00
OPERATOR: Summit Brick & Tile Co.	OPERATOR REPRESENTATIVE: Julie Welte	TYPE OF OPERATION: 110c - Construction Limited Impact	
REASON FOR INSPECTION: Preoperation Inspection	BOND CALCULATION TYPE: None	BOND AMOUNT: \$6,500.00	
DATE OF COMPLAINT: NA	POST INSP. CONTACTS: None	JOINT INSP. AGENCY: None	
WEATHER: Clear	INSPECTOR'S SIGNATURE:

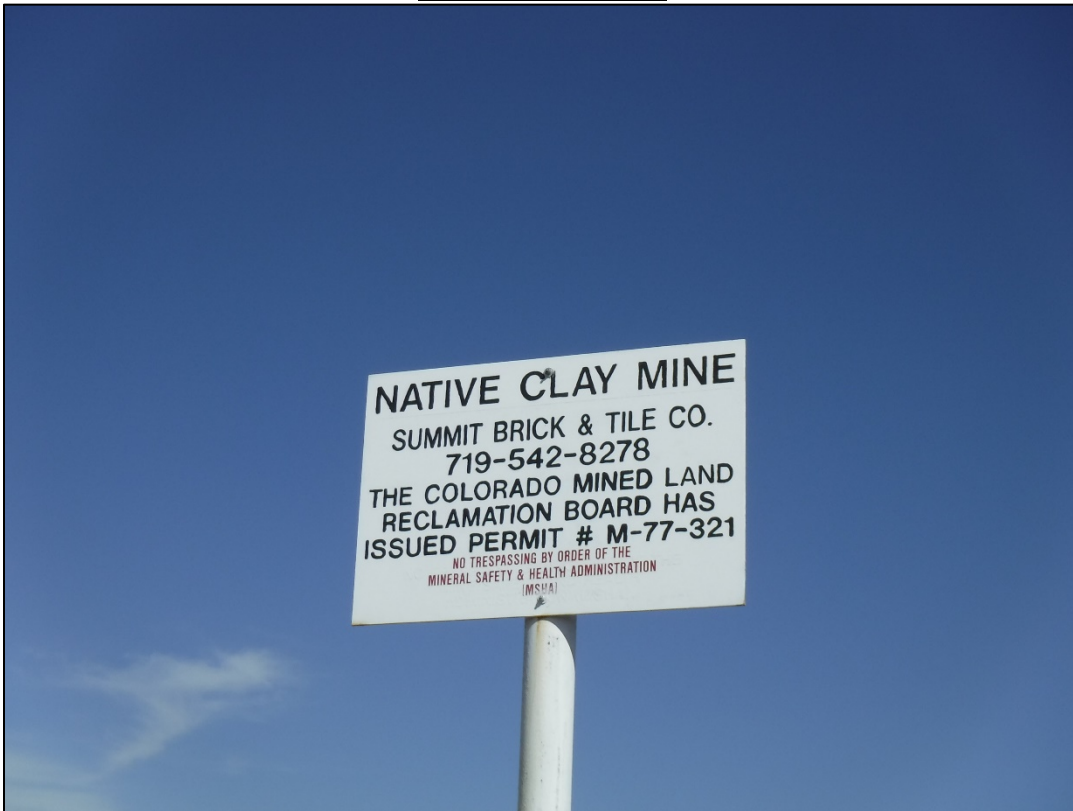
Photo 1: Mine permit sign posted at mine entrance

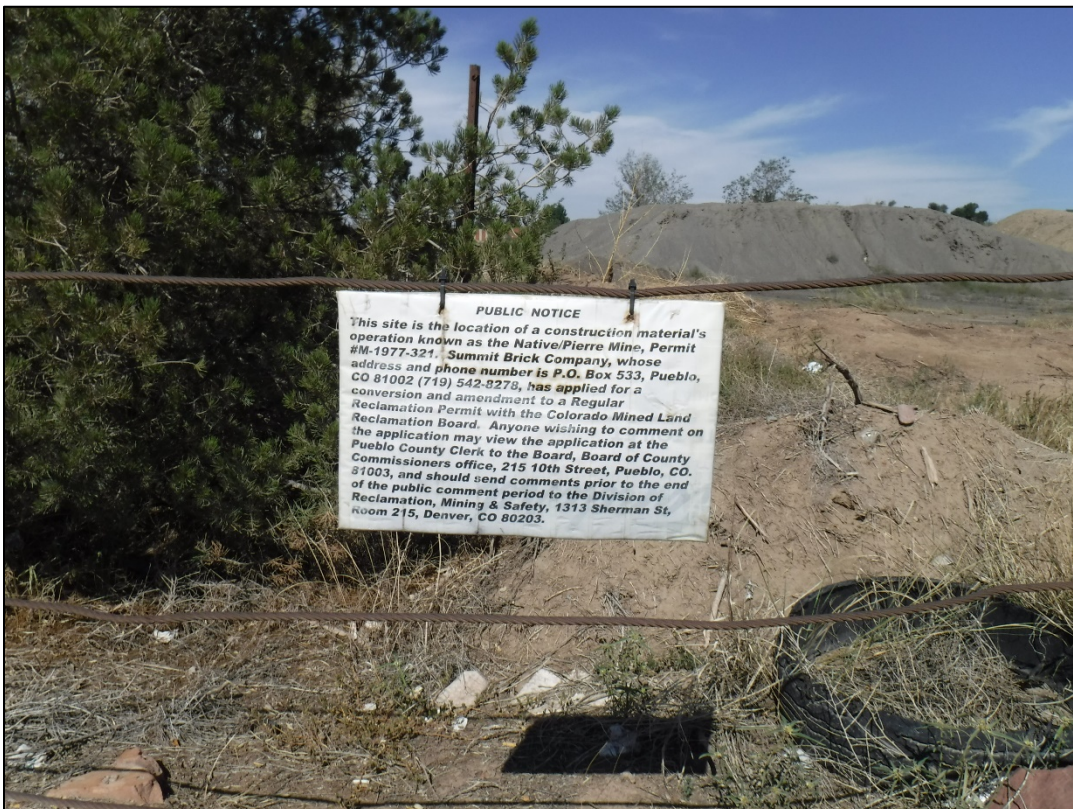
Photo 2: Notice sign posted at the mine entrance

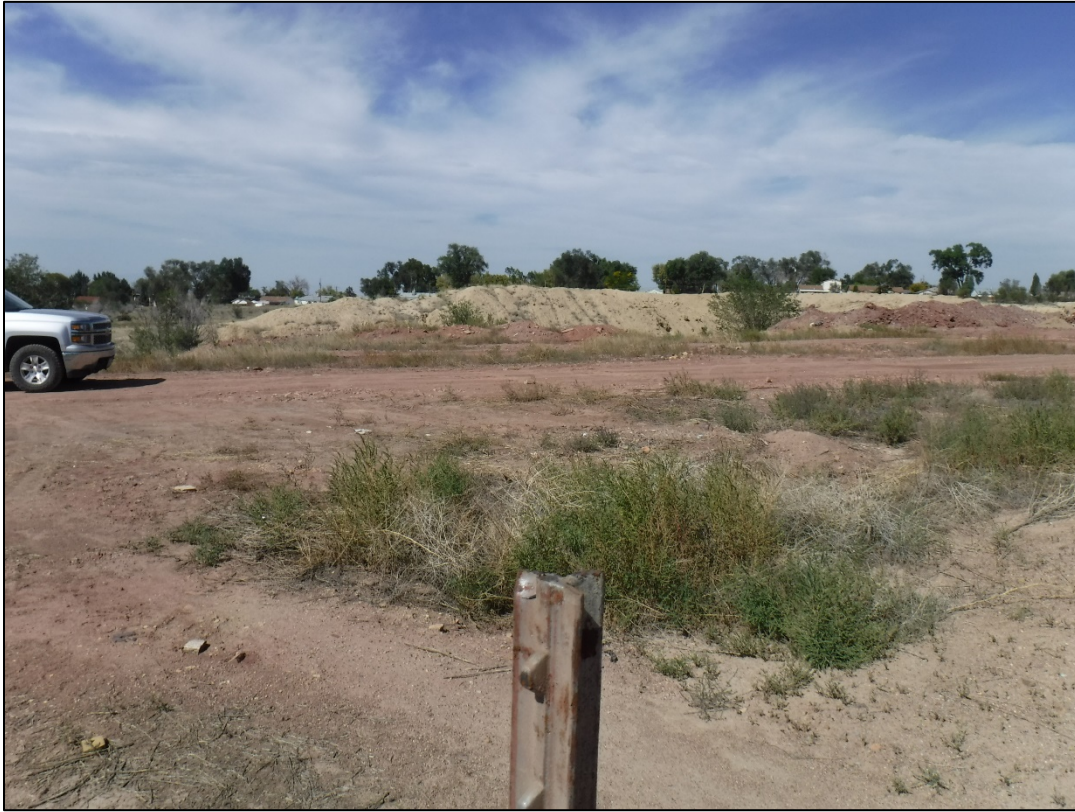
As stated above the current permit is 9.9 acres and the conversion application is seeking to expand the permit area to 35.23 acres. All structures observed during the inspection were accurately depicted on the maps within the permit application with the exception that the topsoil stockpile was relocated some time ago but was not reflected on the application maps. The maps will be updated during the adequacy response. At the time of the inspection there was an area to the south of the proposed area that was being used as a laydown area by a contractor that was installing a water pipeline in the neighborhood.

Photo 3: Relocated topsoil stockpile

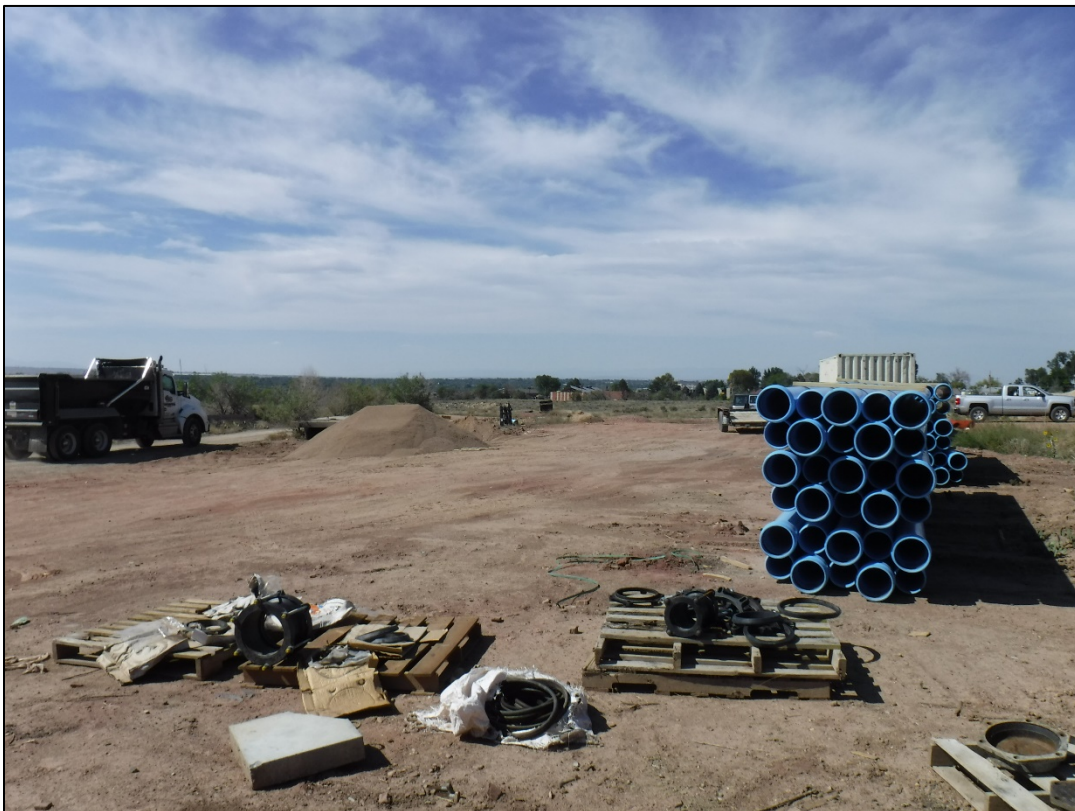
Photo 4: Proposed permit area being used by water line contractor

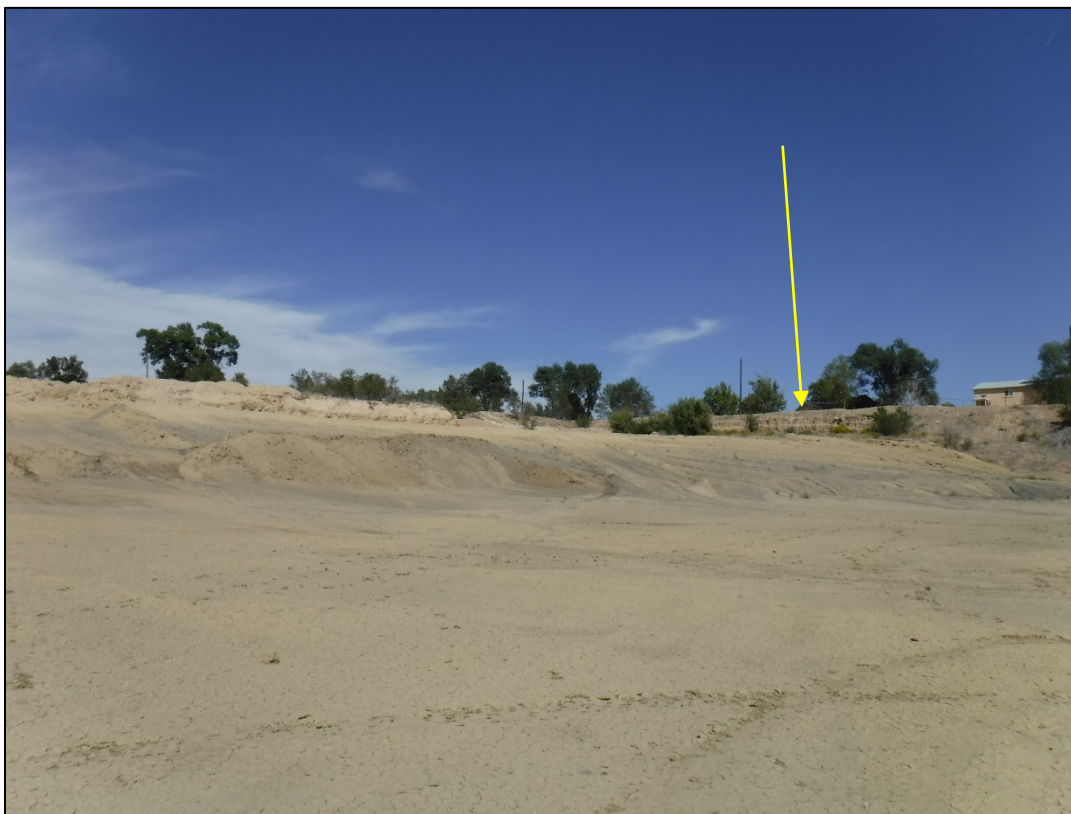
The Division did note that there is highwall immediately adjacent to La Crosse Ave, within 30 feet of roadway, in the northeast corner of the permit area. The highwall is near vertical and approximately 10-15 feet in height and 150 feet in length. The highwall will need to be backfilled or submit a slope stability analysis completed by a professional engineer that demonstrates that the highwall will not fail to the point that it will negatively impact property outside the permit boundary to prevent off site damages, note this is a similar issue that the Division cited as problem in its 2005 inspection.

Photo 5: Looking towards the northeast corner of permit area, highwall marked by arrow

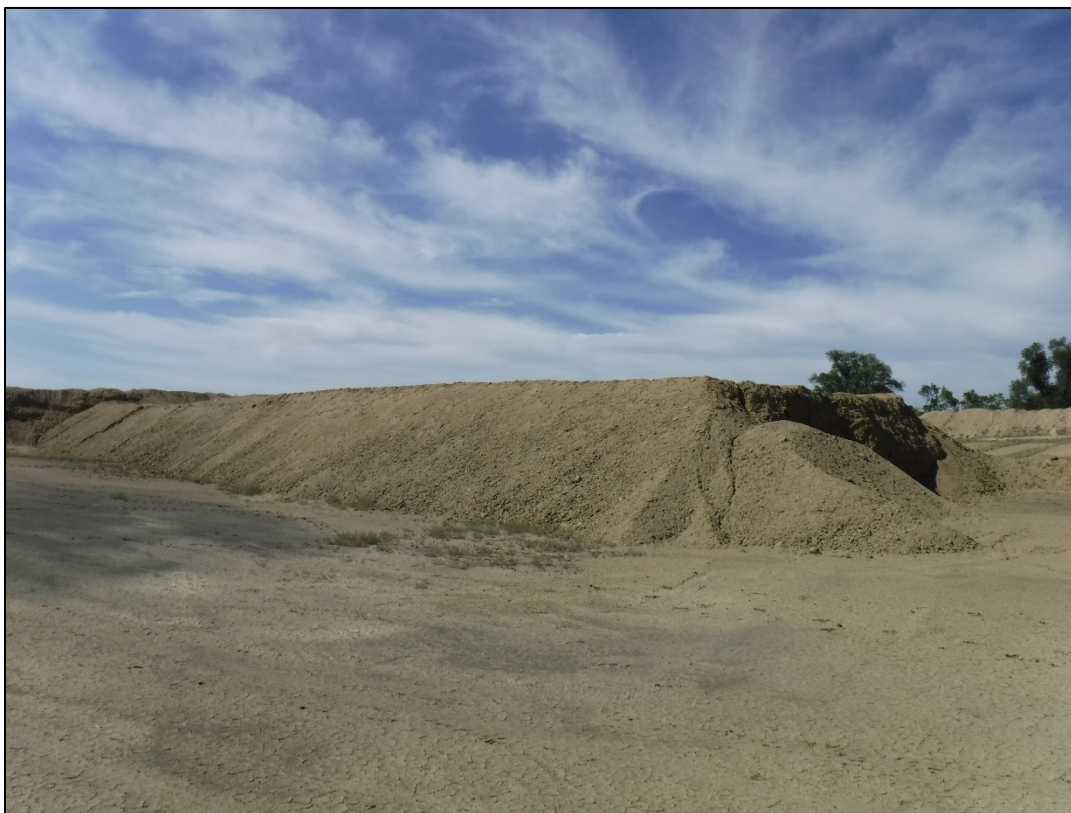
Photo 6: Product stockpile

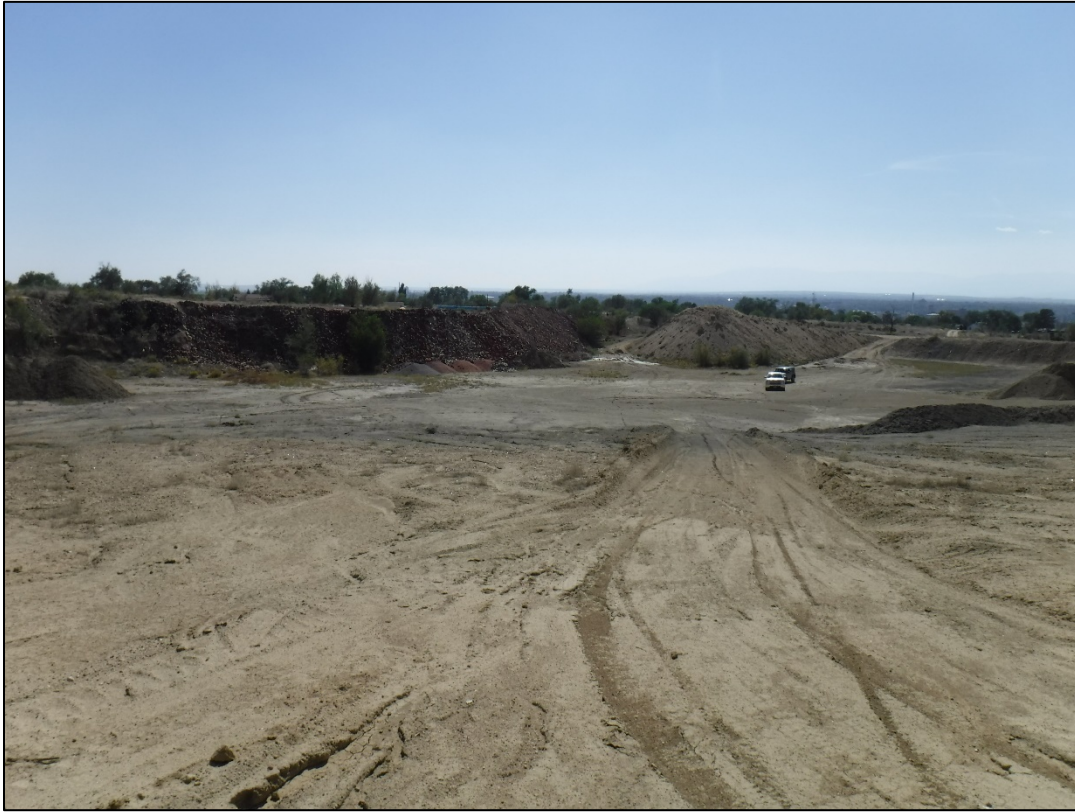
Photo 7: Looking south across recently mined area

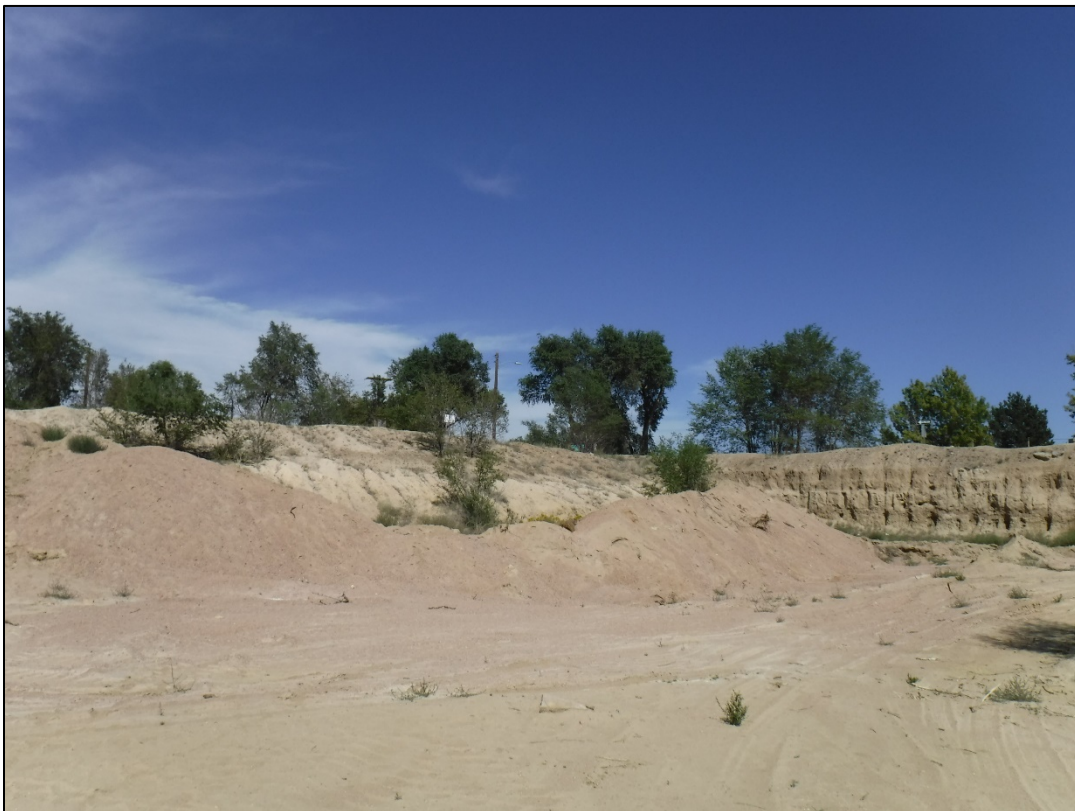
Photo 8: Looking at the northeast corner of permit area

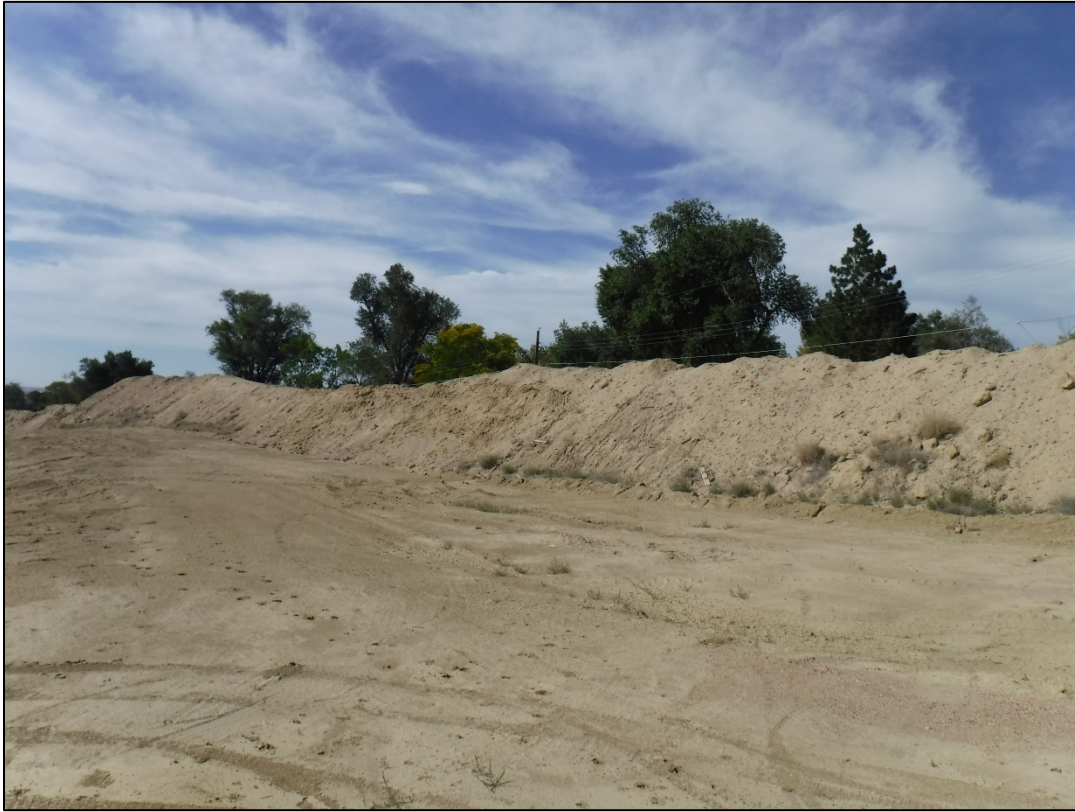
Photo 9: Safety berm adjacent to alley

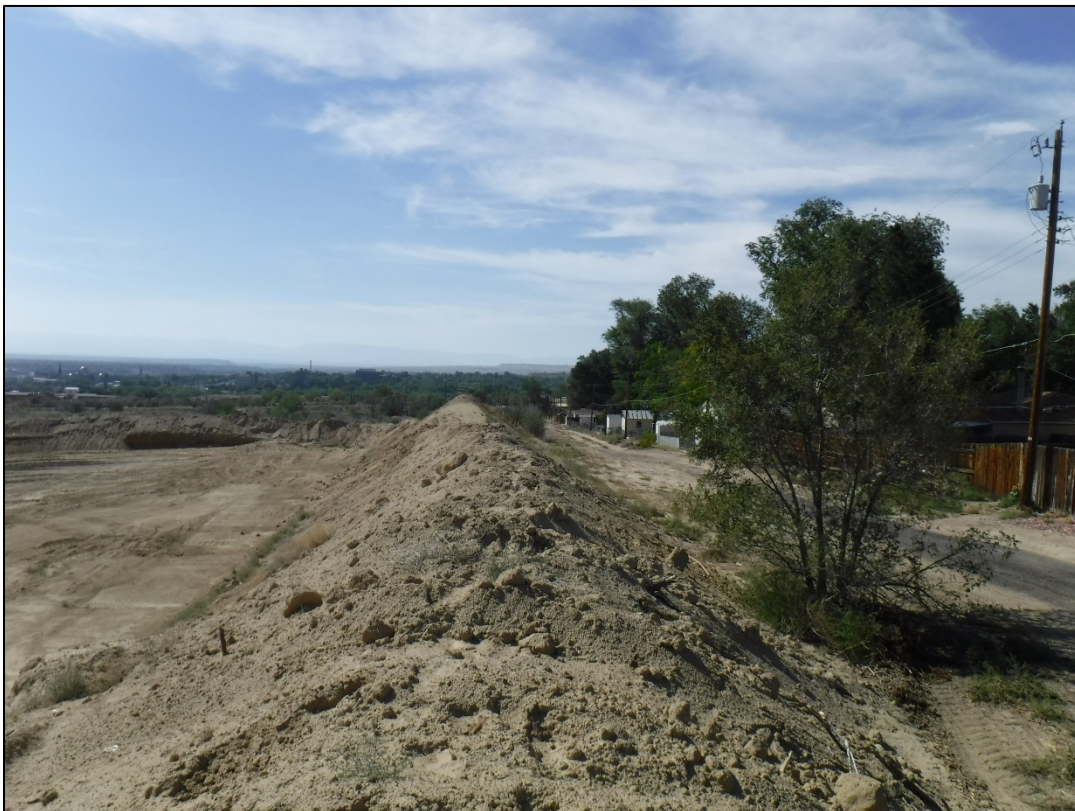
Photo 10: Safety berm adjacent to alley

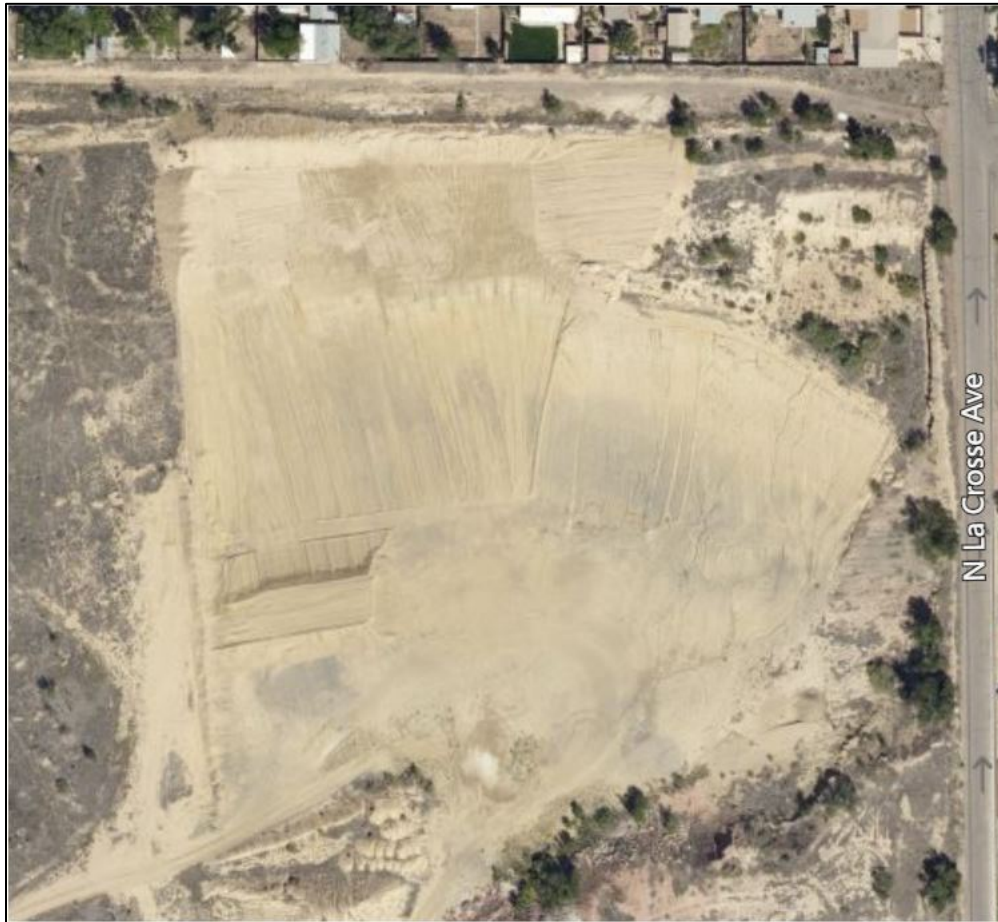
Photo 11: Recent aerial view of mining area
