MINERALS PROGRAM INSPECTION REPORT
PHONE: (303) 866-3567

MINE NAME: Henderson Mine	MINE/PROSPECTING ID#: M-1977-342	MINERAL: Molybdenum	COUNTY: Clear Creek, Grand
INSPECTION TYPE: Monitoring	INSPECTOR(S): Peter Hays	INSP. DATE: October 8, 2020	INSP. TIME: 10:30
OPERATOR: Climax Molybdenum Company	OPERATOR REPRESENTATIVE: Aaron Hilshorst	TYPE OF OPERATION: 112d-3 - Designated Mining Operation	
REASON FOR INSPECTION: Normal I&E Program	BOND CALCULATION TYPE: None	BOND AMOUNT: \$49,690,538.00	
DATE OF COMPLAINT: NA	POST INSP. CONTACTS: None	JOINT INSP. AGENCY: None	
WEATHER: Clear	INSPECTOR'S SIGNATURE:

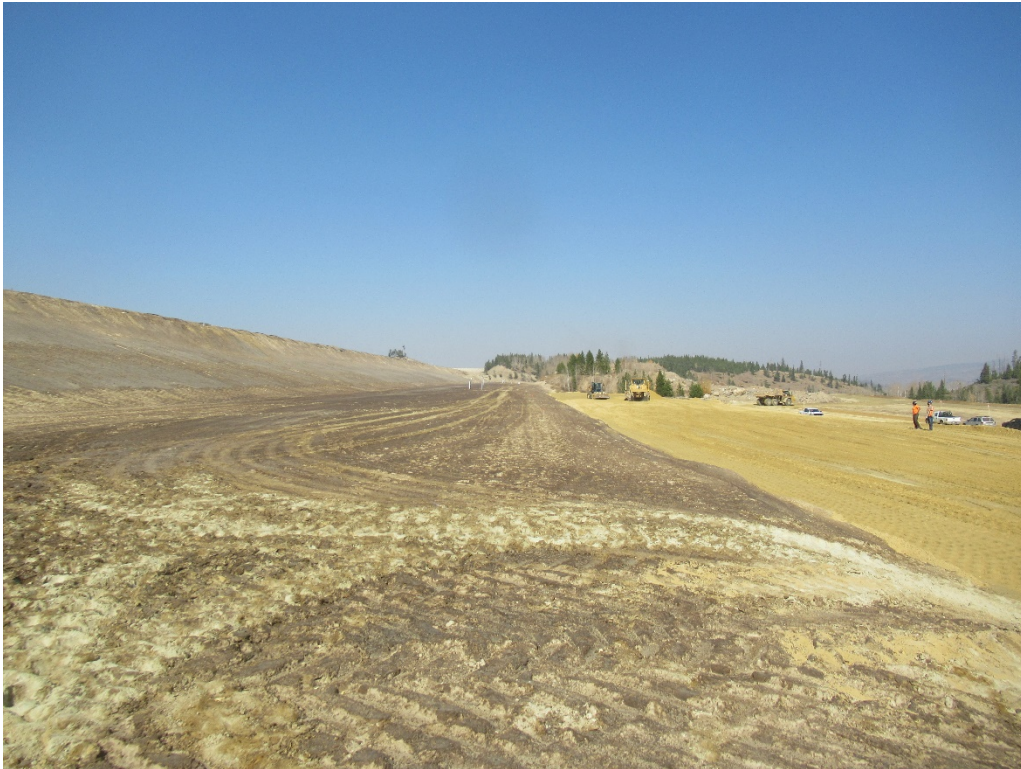
The placement and compaction of the buttress material was observed on the upper face of the south area of 3-Dam during the inspection. The buttress material was delivered by haul trucks and placed with a GPS controlled dozer. The tailings material was being placed and compacted from south to north in 1 foot lifts. Compaction was achieved by the haul trucks and a sheepsfoot compactor. The buttress material is required to be compacted to 95% maximum density with a moisture content within a range of the optimal moisture. The compaction and moisture content are verified by AECOM with nuclear density tests every lift.

View of the upper bench of the upper face of the 3-Dam south area buttress

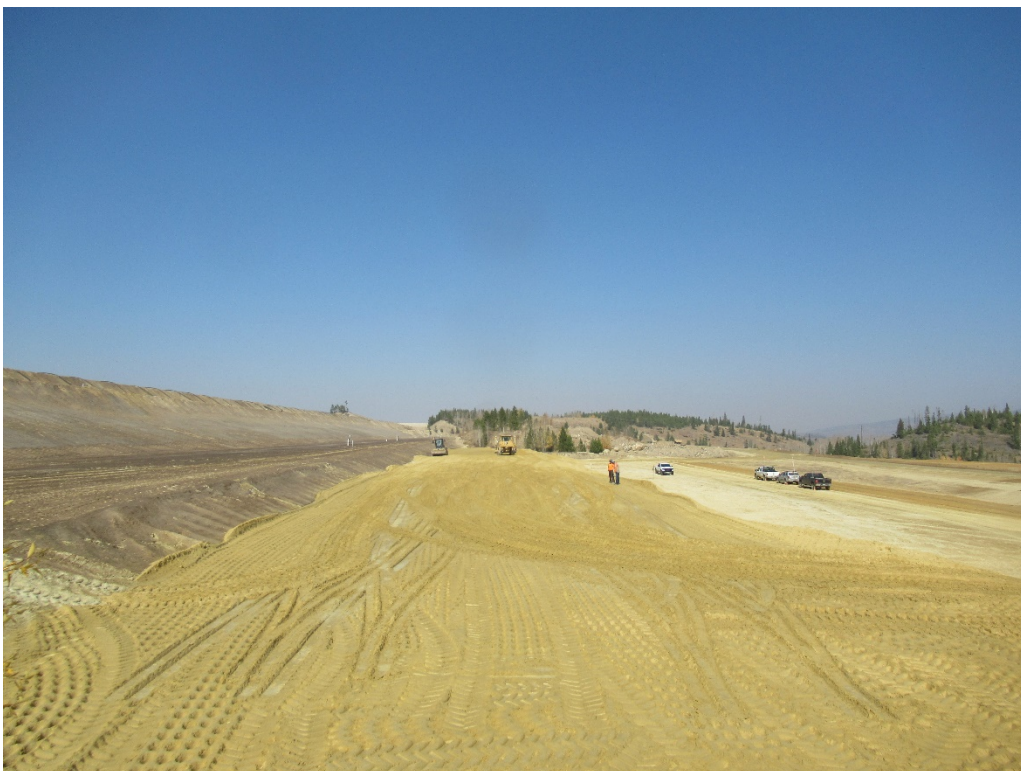
Approximately, one (1) foot of buttress material remained to be placed on the lower bench of the upper face of the south area of 3-Dam at the time of the inspection. The placement and compaction of the buttress material will continue up the face of the south area and proceed to the upper face of the north area. The locations of the buttress for the upper face of the south and north areas were indicated by survey lathes.

View of the lower bench of the upper face of the 3-Dam south area buttress

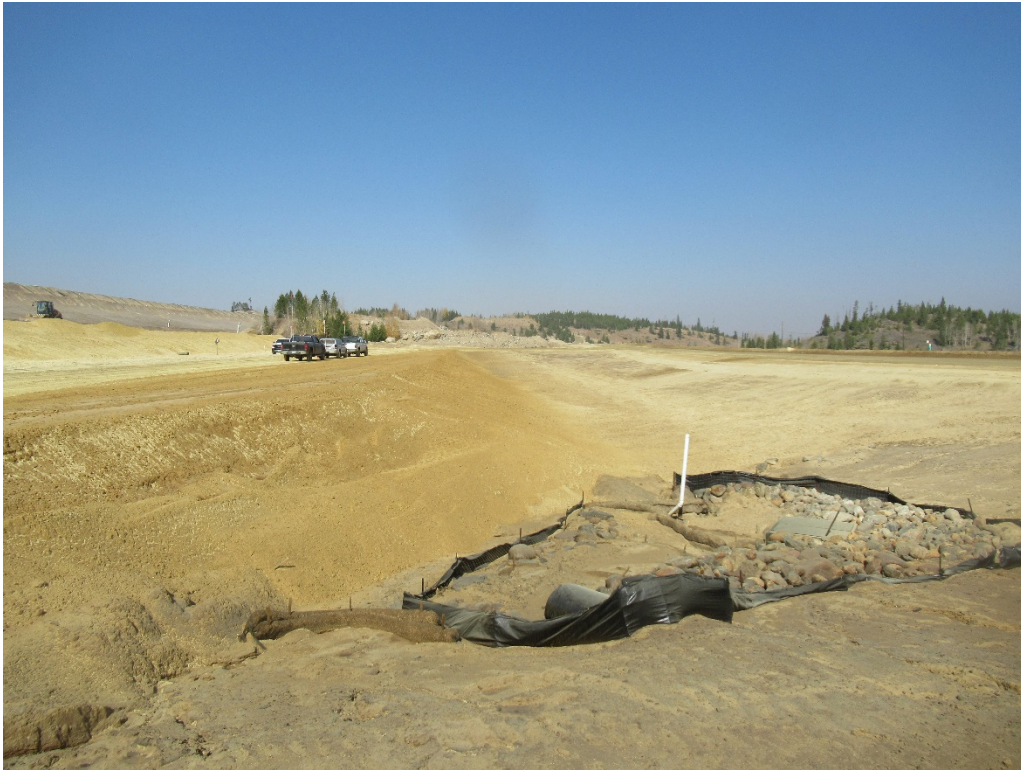
The Phase 2 buttress construction is complete at the toe, lower and middle faces of the south area of 3-Dam. The areas were treated with coherex to prevent erosion.

View of the completed middle face of the 3-Dam south area buttress

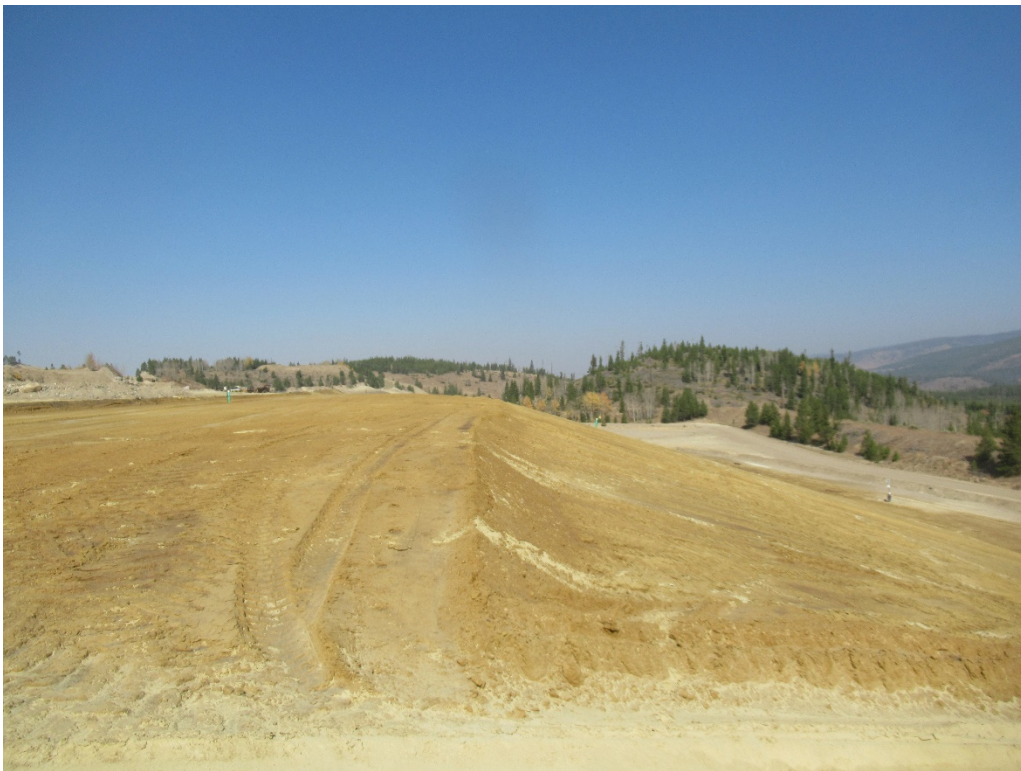
View of the completed lower face of the 3-Dam south area buttress

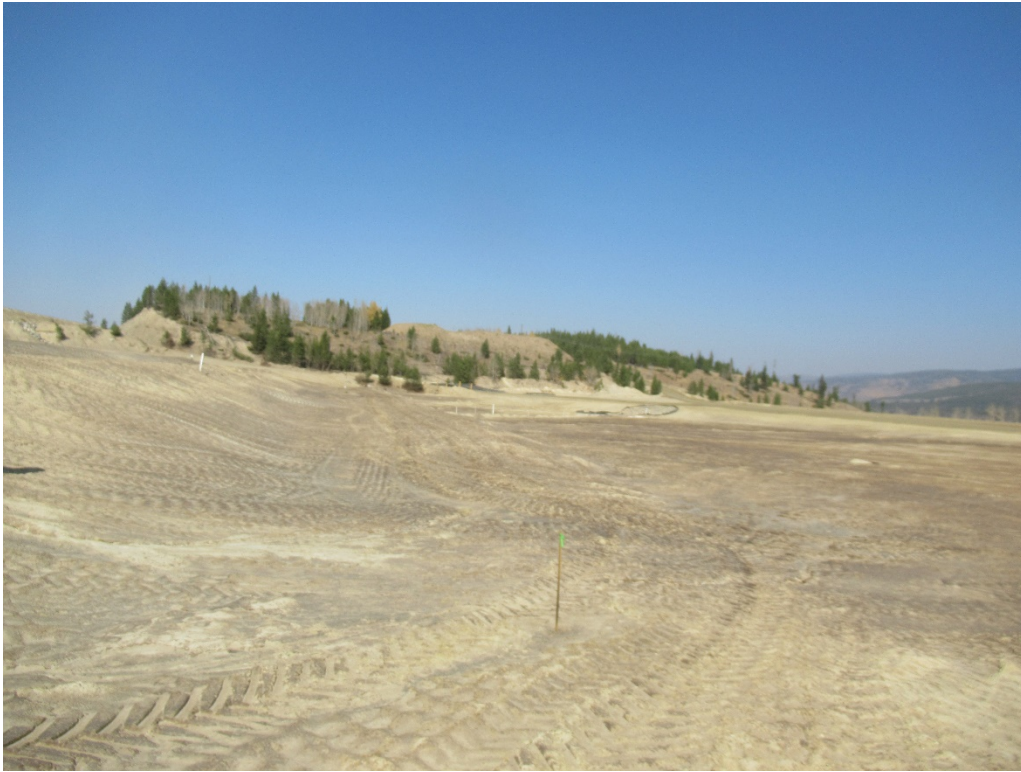
View of the upper face on the north area of 3-Dam

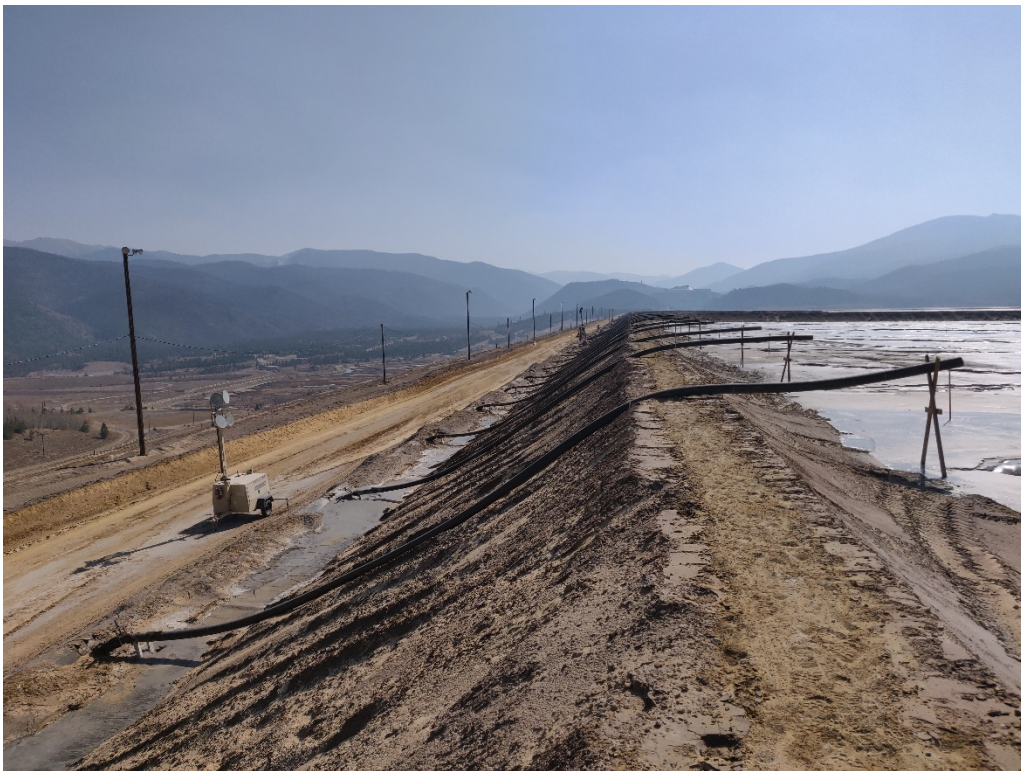
View of the dam crest for cell 9 on 1-Dam looking south

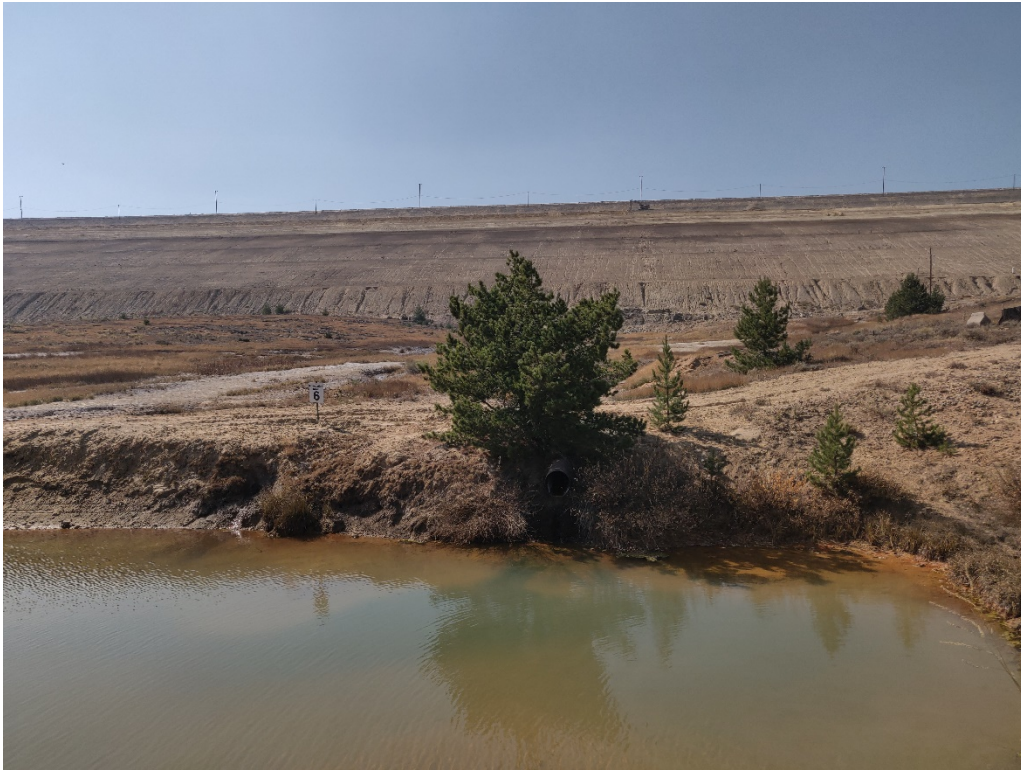
View of Foundation Drain #6

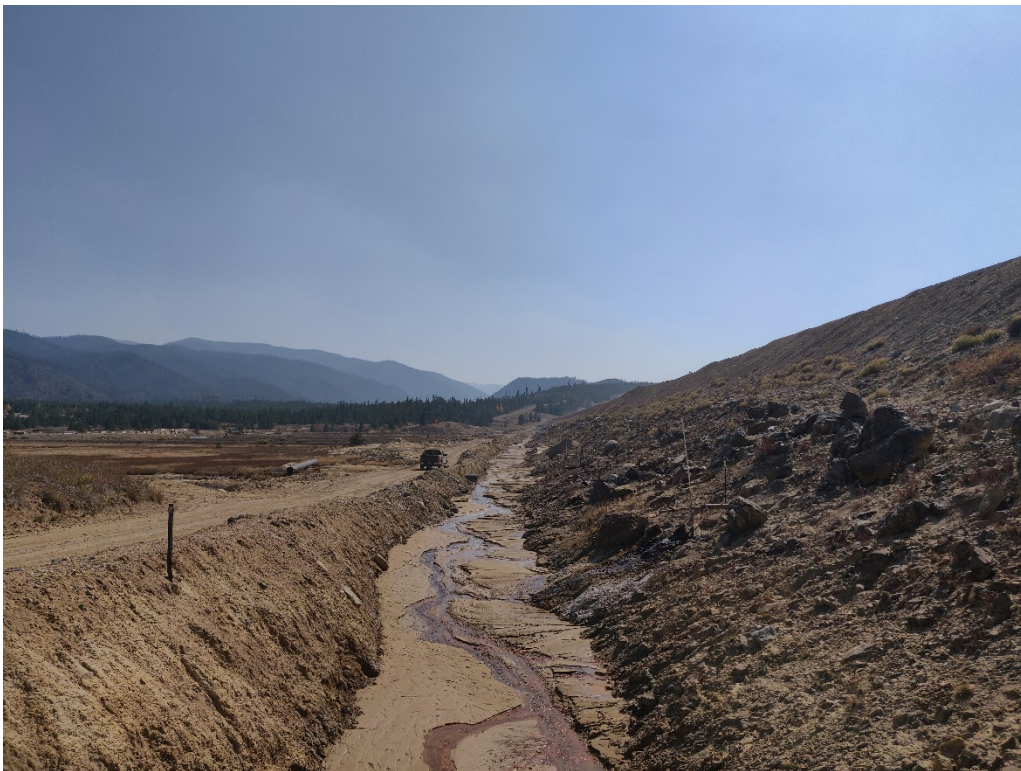
View of the seep collection ditch at the toe of 1-Dam looking south

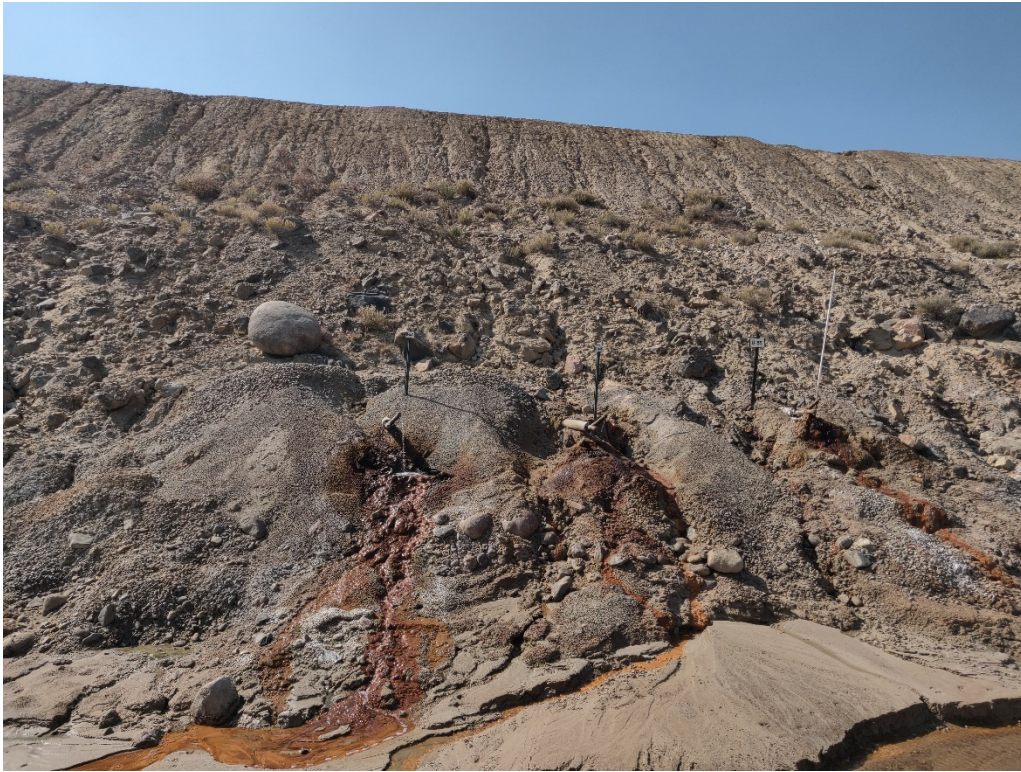
View of typical horizontal drains at the toe of 1-Dam

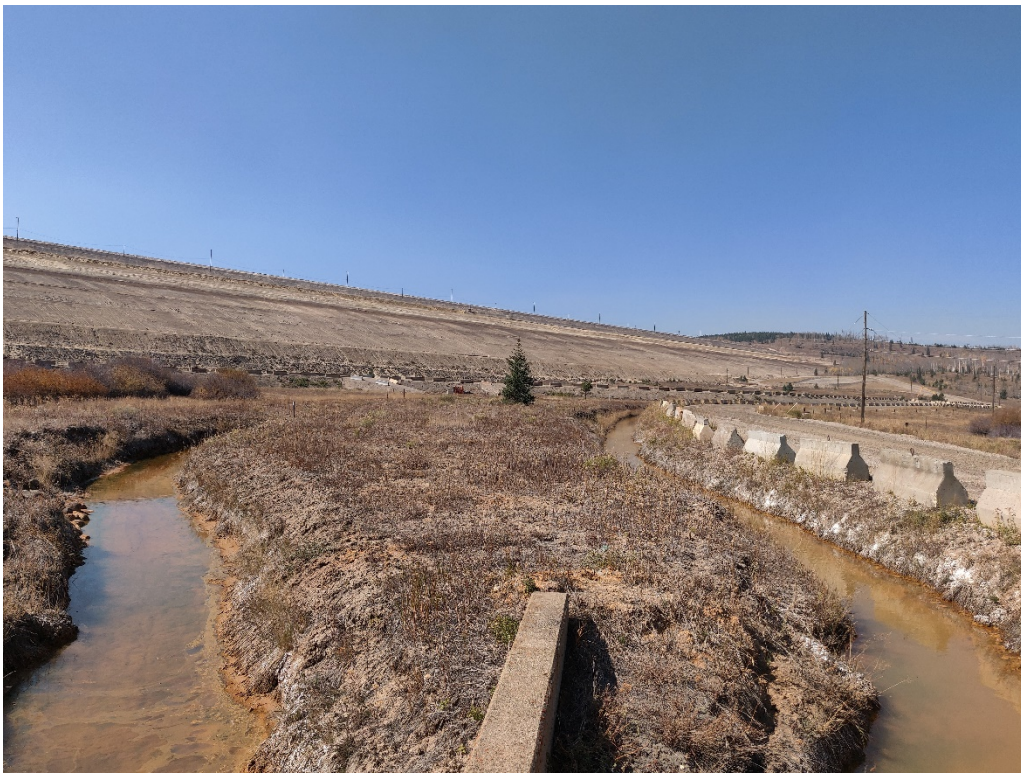
View of the seep collection canals at the Ute Park Pump station looking northwest
