**MINERALS PROGRAM INSPECTION REPORT**  
**PHONE: (303) 866-3567**

<b>MINE NAME:</b> Broken Spear Pit	<b>MINE/PROSPECTING ID#:</b> M-2000-050	<b>MINERAL:</b> Sand and gravel	<b>COUNTY:</b> Lincoln
<b>INSPECTION TYPE:</b> Monitoring	<b>INSPECTOR(S):</b> Daniel Cunningham	<b>INSP. DATE:</b> September 9, 2020	<b>INSP. TIME:</b> 13:30
<b>OPERATOR:</b> Lincoln County	<b>OPERATOR REPRESENTATIVE:</b> Fred Lundy	<b>TYPE OF OPERATION:</b> 110c - Construction Limited Impact

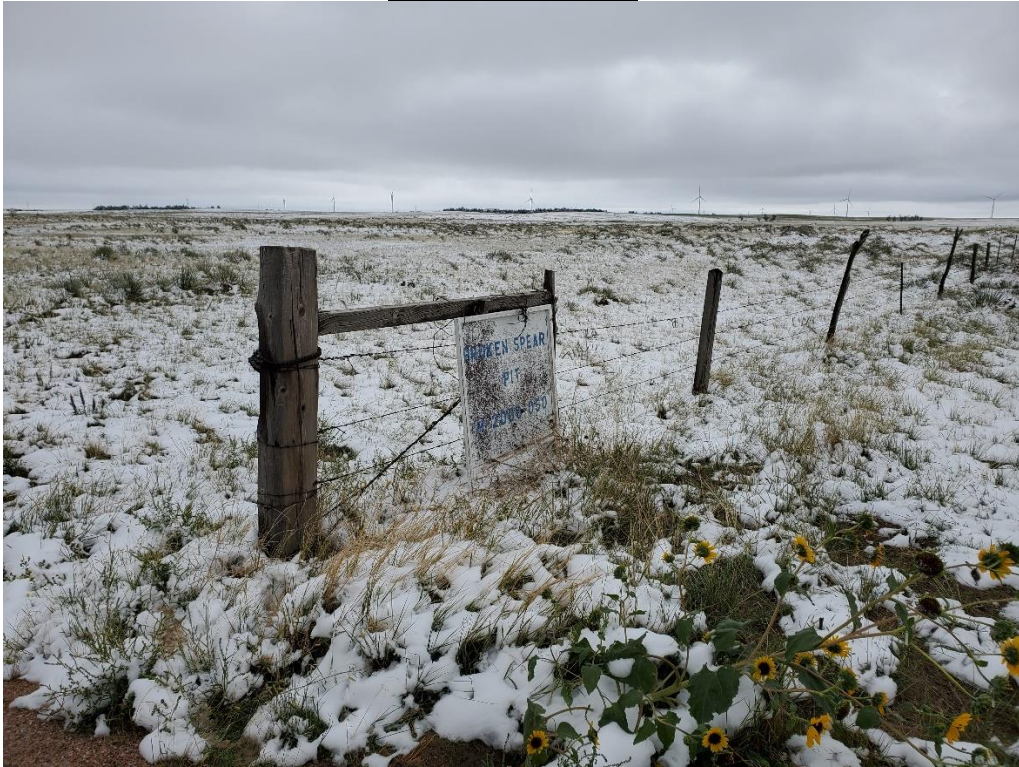
The site identification sign was posted at the mine entrance and the boundary was marked. A topsoil pile was located at the mine entrance.

Mine Entrance

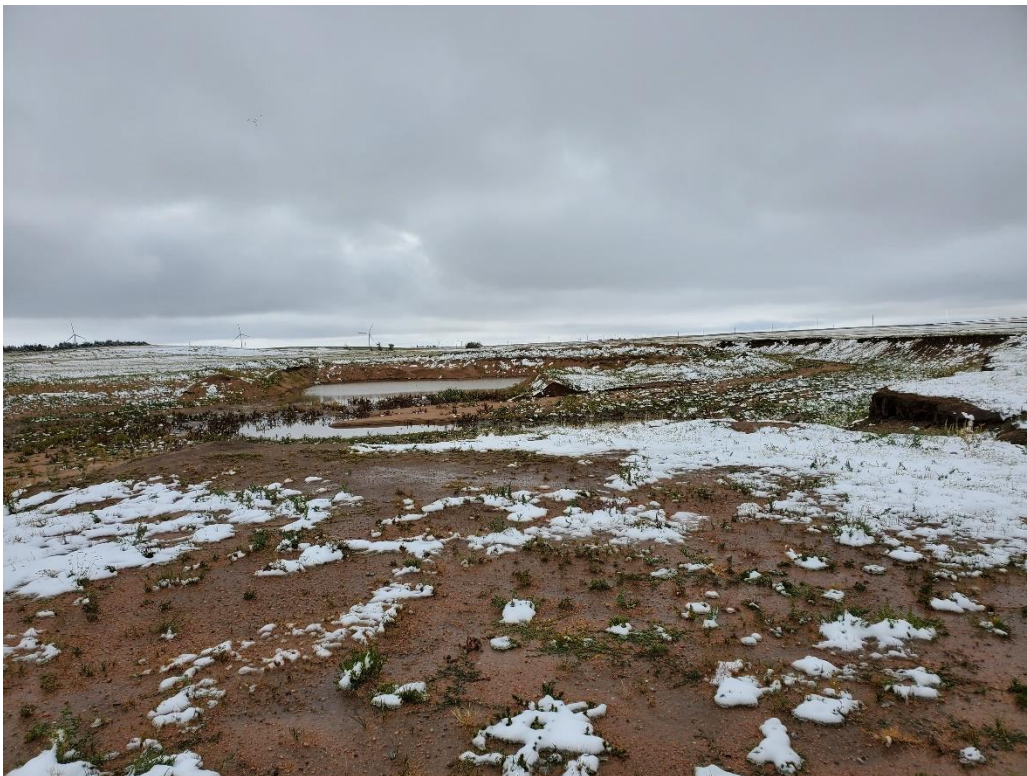
**PROBLEM:** Standing water was noted in the bottom of the mine pit. This water is likely a mixture of impounded

surface water and possibly exposed groundwater. The Division has no evidence that the operator has a valid well permit, substitute water supply plan, or approved water augmentation plan for the exposed groundwater at the site or surface water impounded for greater than 72 hours. This is a problem related to 34-32.5-116(4)(h) of the Colorado Revised Statutes and Rule 3.1.6(1)(a) of the Construction Materials Rules and Regulations governing injury to existing water rights.

The site was retaining a large amount of water on the bottom of the pit floor. This was mention in the 2017 inspection report. This water is likely a mixture of surface and groundwater and appears to remain in the pit for longer than 72 hours. This is noted as a problem at the beginning of the report. The Operator will need to contact the Division of Water Resources (State Engineer's Office) and ensure they are in compliance with their rules and regulations regarding impacts to water rights. The Operator is not approved to expose groundwater at the site or impound surface water for greater than 72 hours. Given this, the Operator will either need to backfill the pit excavation to at least two feet above the groundwater table, conduct earthwork so that the affected lands positively drain without causing off-site sedimentation; or submit documentation that they have obtained a valid well permit and substitute water supply plan or permanent plan for augmentation from the Colorado Division of Water Resources.

First impoundment of water

**CORRECTIVE ACTIONS:** The Operator shall demonstrate that the operation is in compliance with the Office of the State Engineer(SEO), show evidence that the Operator is taking measures to bring the site into compliance with the SEO, backfill the pits to at least two feet above the groundwater surface or ensure the mine pit positively drains by the corrective action date specified.

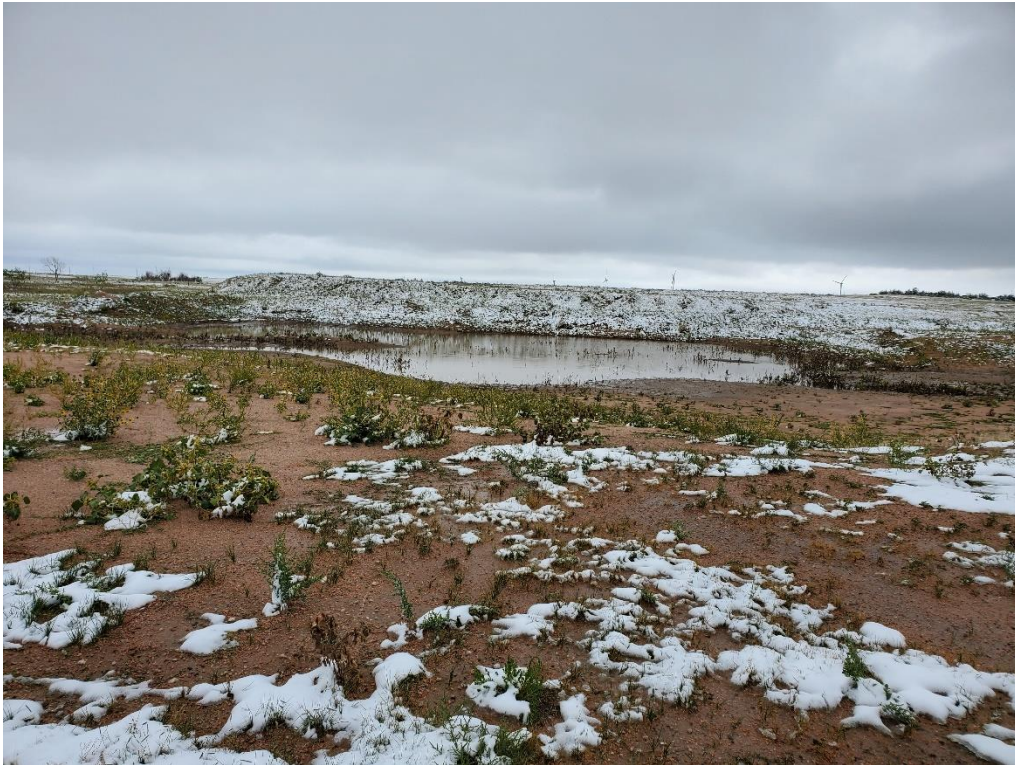
Second impoundment of water

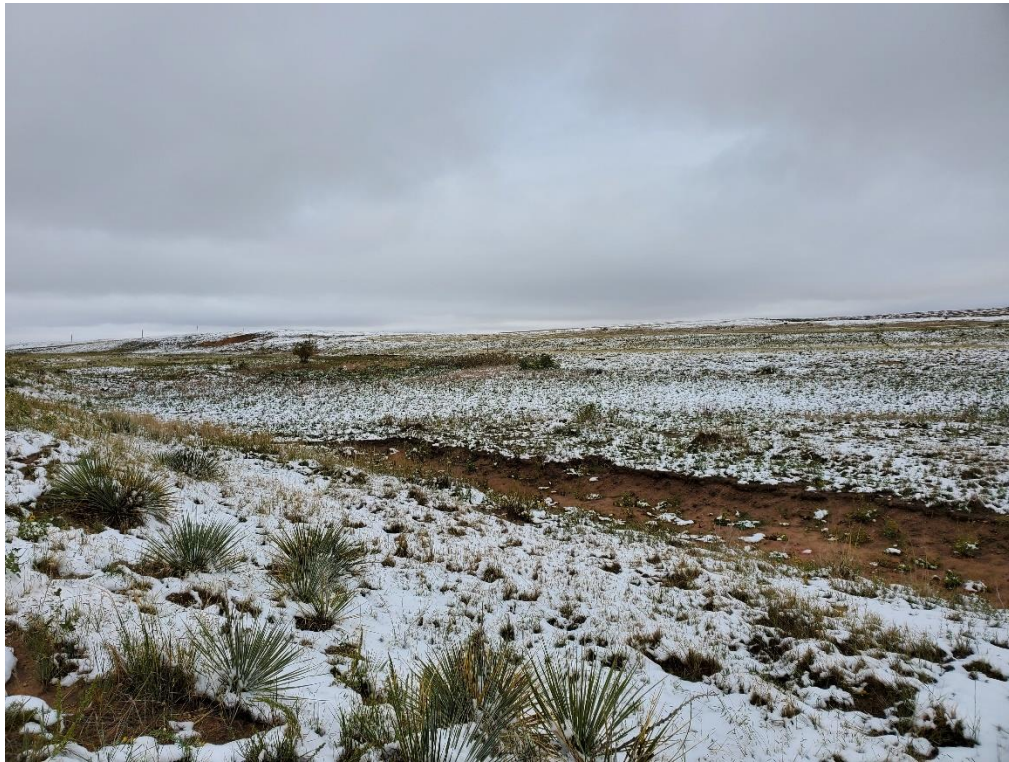
Permit facing North
